JOURNEY RISK MANAGEMENT (JRM) STUDY

IOCL Coimbatore Terminal to Sri Murugan Agencies

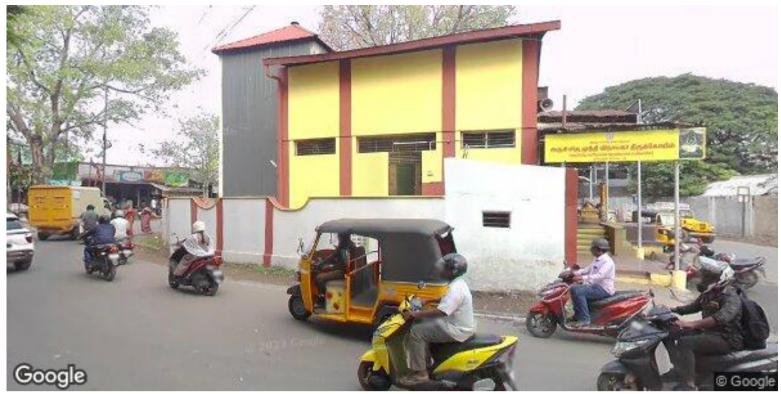
Risk Type: Roundabout
Risk Level: High
Speed Limit: 15 KM/Hr
Coordinates: 11.00410, 76.99311

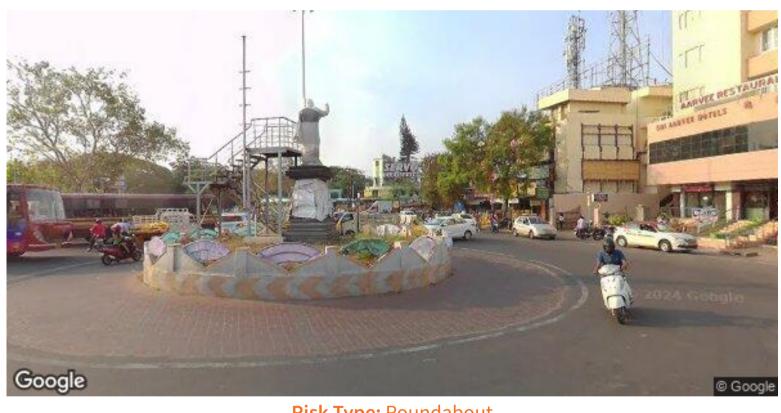
Coordinates: 11.01617, 76.97043

Risk Type: Roundabout
Risk Level: High
Speed Limit: 15 KM/Hr

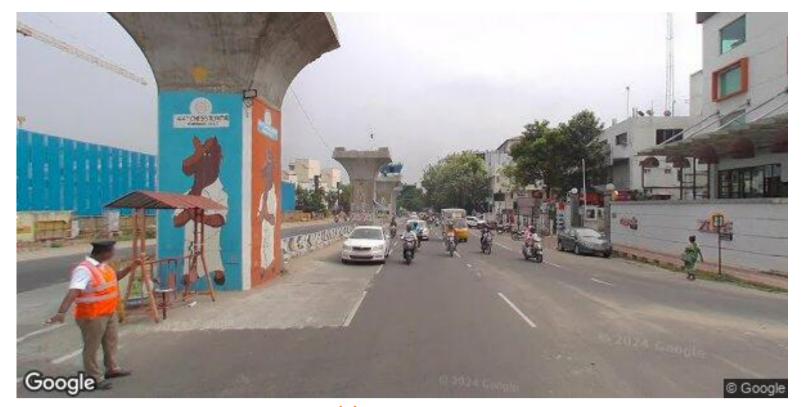
Coordinates: 11.011602, 76.9841897

Risk Type: U-Turn
Risk Level: High
Speed Limit: 10 KM/Hr

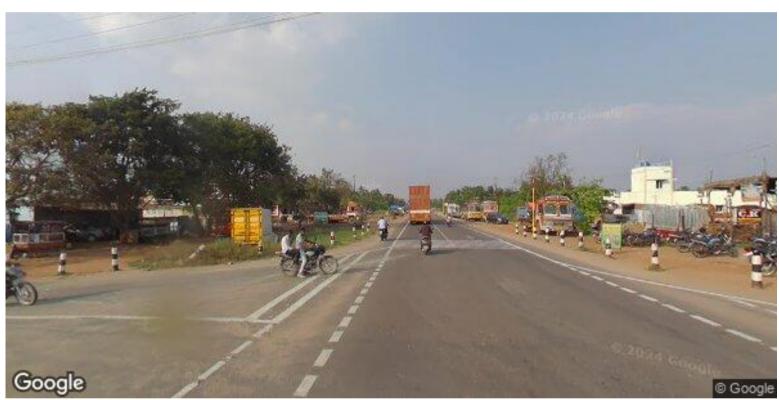
Coordinates: 11.03211, 77.07640

Risk Type: Blind Spot
Risk Level: Blind Spot
Speed Limit: 10 KM/Hr

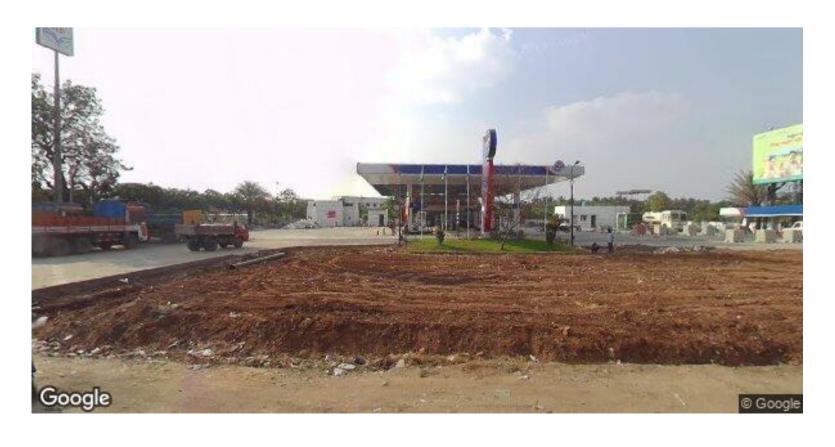
Coordinates: 11.00873, 77.07114

Risk Type: Turn
Risk Level: Medium
Speed Limit: 30 KM/Hr

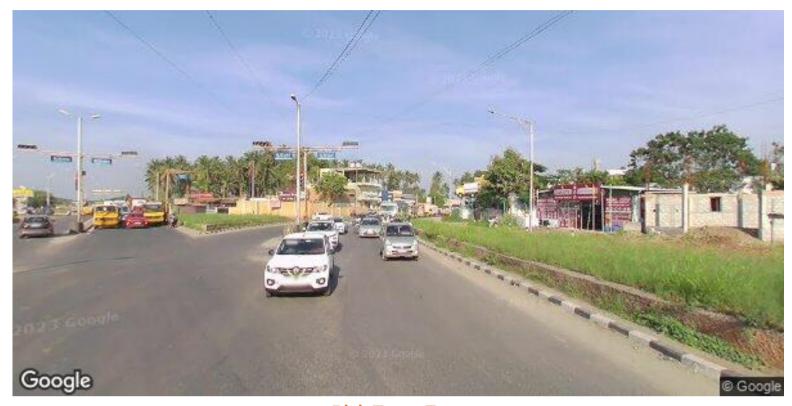
Risk Type: Turn
Risk Level: Medium
Speed Limit: 30 KM/Hr
Coordinates: 11.00737, 77.07049

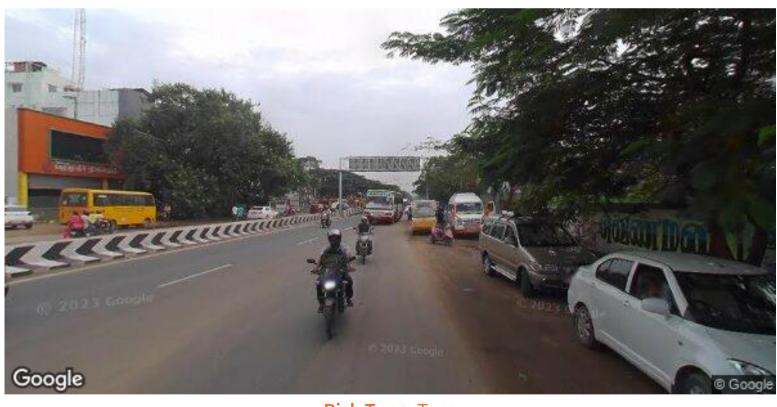
Risk Type: Turn
Risk Level: Medium
Speed Limit: 30 KM/Hr
Coordinates: 10.99678, 77.00653

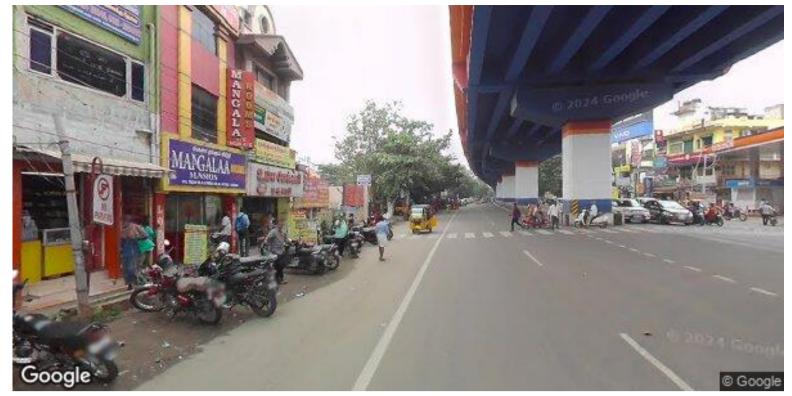
Risk Type: Turn
Risk Level: High
Speed Limit: 15 KM/Hr
Coordinates: 10.99699, 76.99565

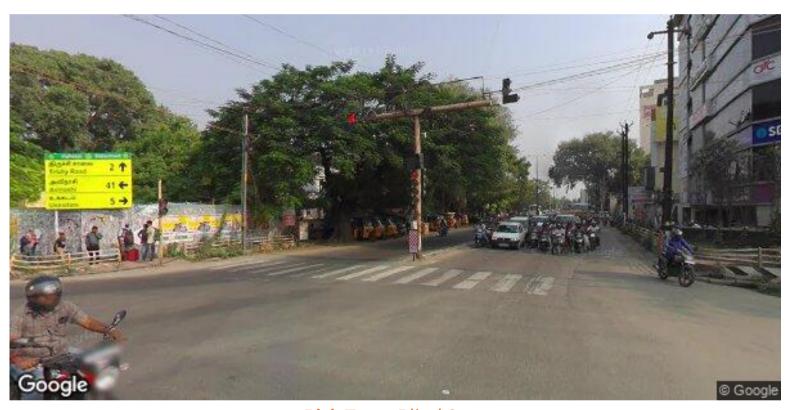
Risk Type: Blind Spot
Risk Level: Blind Spot
Speed Limit: 10 KM/Hr
Coordinates: 11.01285, 76.98611

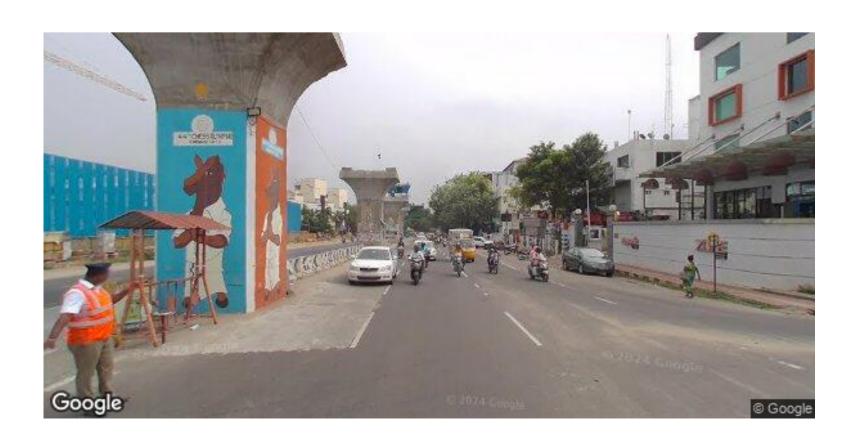
Coordinates: 11.01160, 76.98419

Risk Type: Turn
Risk Level: High
Speed Limit: 15 KM/Hr

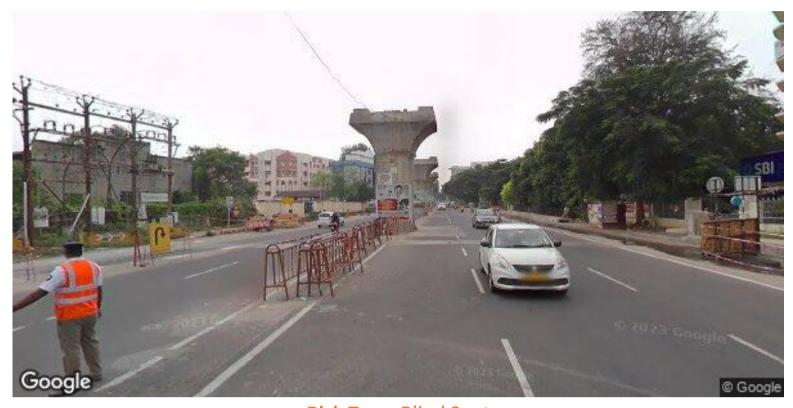
Risk Type: Blind Spot
Risk Level: Blind Spot
Speed Limit: 10 KM/Hr
Coordinates: 11.01176, 76.98410

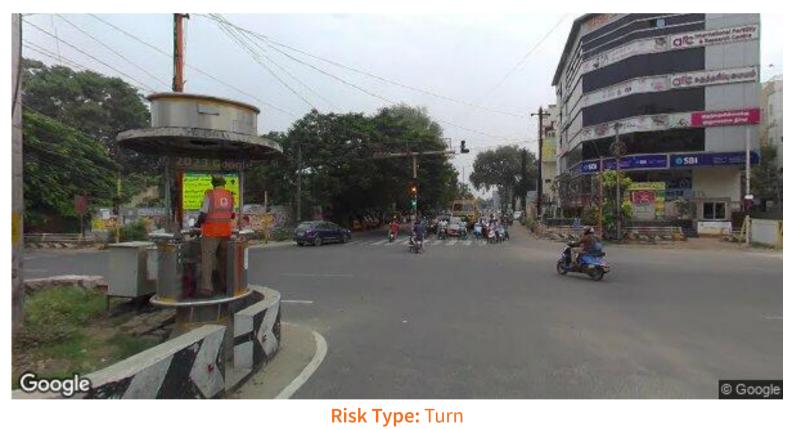
Risk Type. Turn
Risk Level: High
Speed Limit: 15 KM/Hr
Coordinates: 11.01298, 76.98601

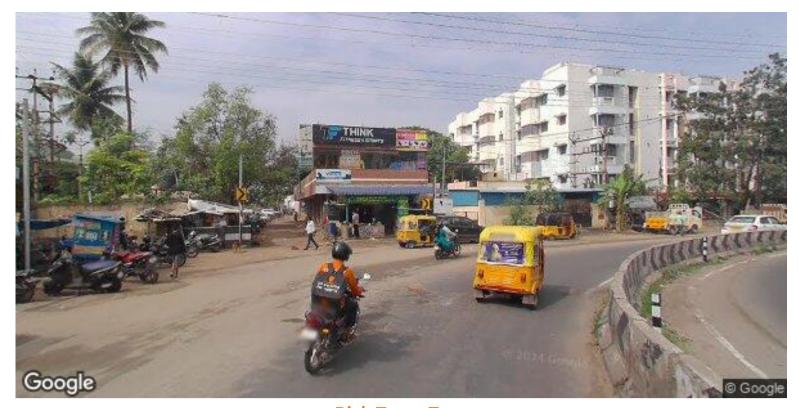
Risk Type: Turn
Risk Level: Medium
Speed Limit: 30 KM/Hr
Coordinates: 11.01367, 76.97915

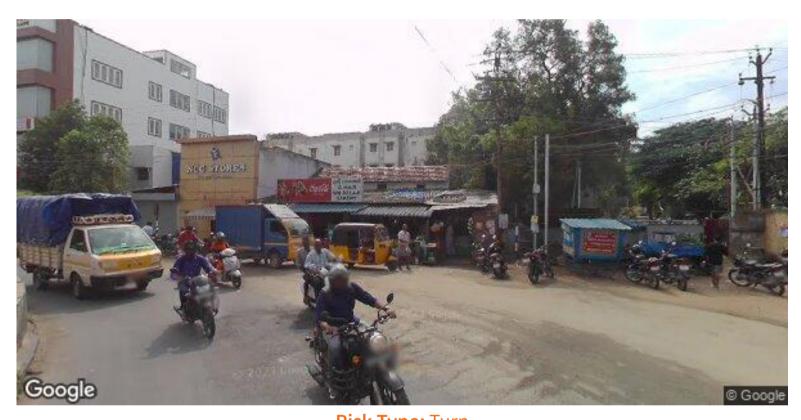
Risk Type: Turn
Risk Level: Medium
Speed Limit: 30 KM/Hr
Coordinates: 11.01374, 76.97905

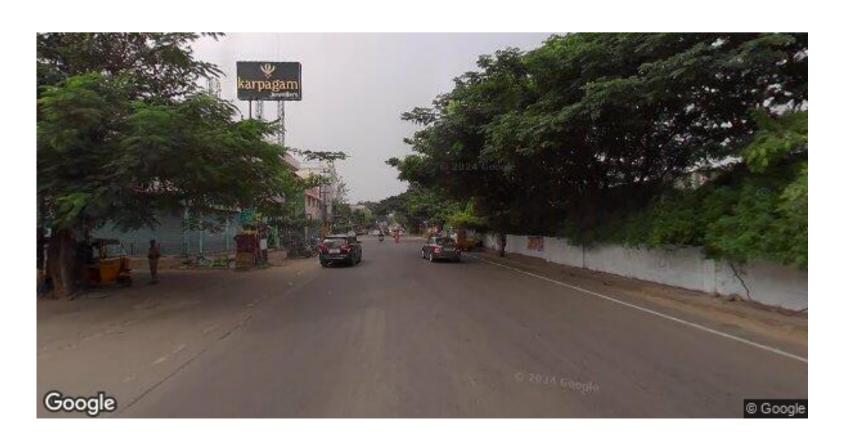
Coordinates: 11.01688, 76.95998

Risk Type: Turn
Risk Level: Medium
Speed Limit: 30 KM/Hr

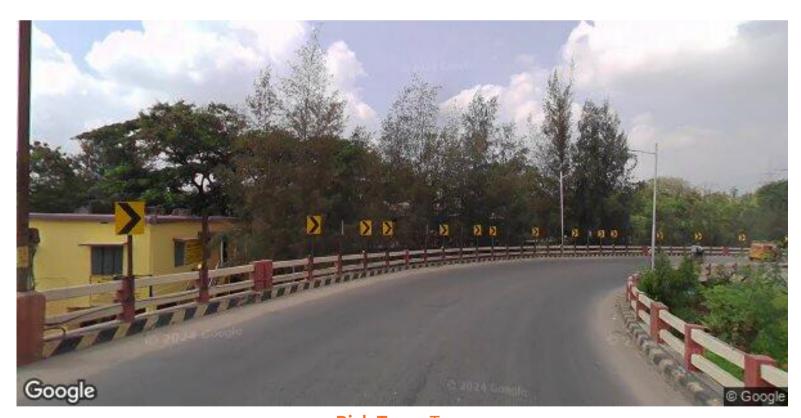
Risk Type: Turn
Risk Level: Medium
Speed Limit: 30 KM/Hr
Coordinates: 11.01666, 76.95341

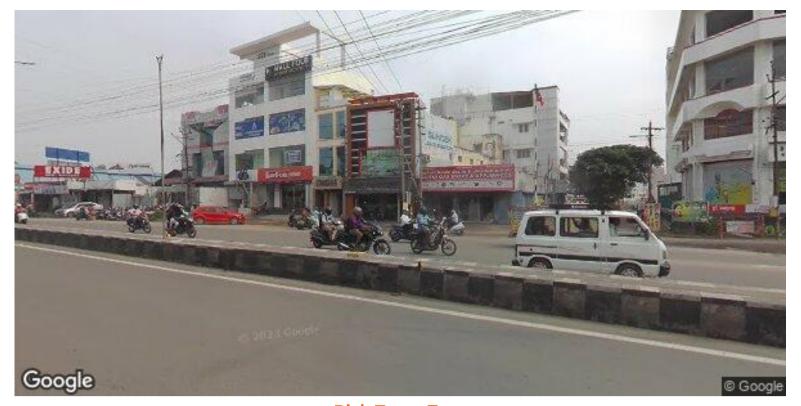
Risk Type: Turn
Risk Level: High
Speed Limit: 15 KM/Hr
Coordinates: 11.01801, 76.95367

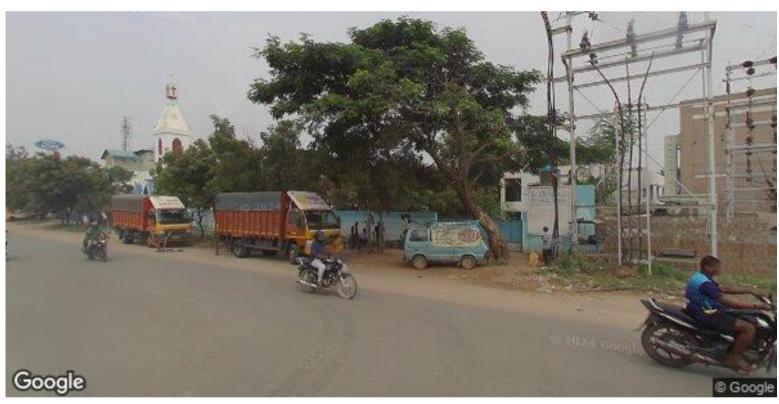
Risk Type: Blind Spot
Risk Level: Blind Spot
Speed Limit: 10 KM/Hr
Coordinates: 11.05584, 76.94560

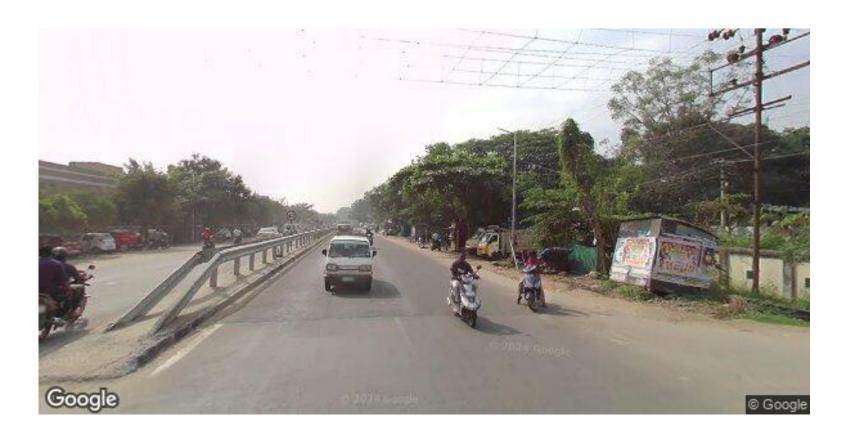
Coordinates: 11.05583, 76.94553

Risk Type: Blind Spot Risk Level: Blind Spot Speed Limit: 10 KM/Hr

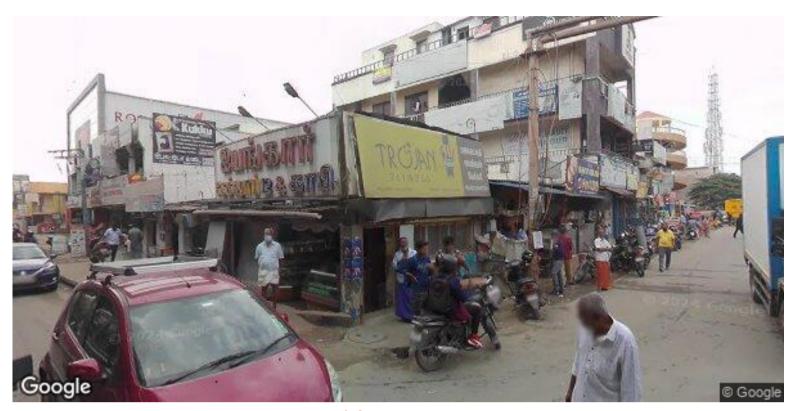
Coordinates: 11.05958, 76.94473

Risk Type: Turn
Risk Level: High
Speed Limit: 15 KM/Hr
