JOURNEY RISK MANAGEMENT (JRM) STUDY

Salem Terminal to TSA ENTERPRISES

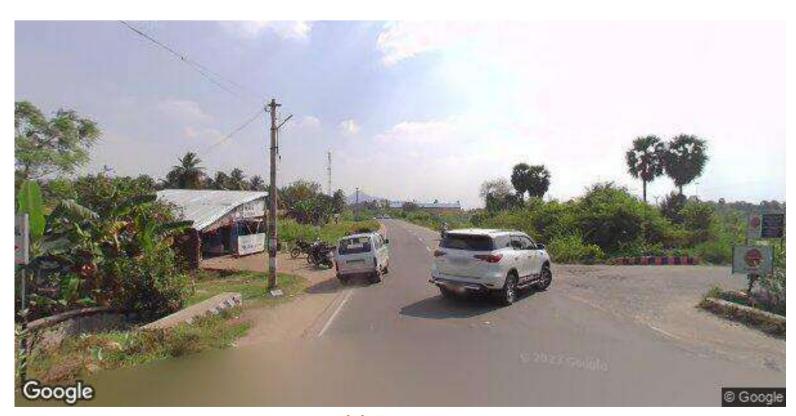
Risk Type: Turn
Risk Level: High
Speed Limit: 15 KM/Hr
Coordinates: 11.44029, 77.87544

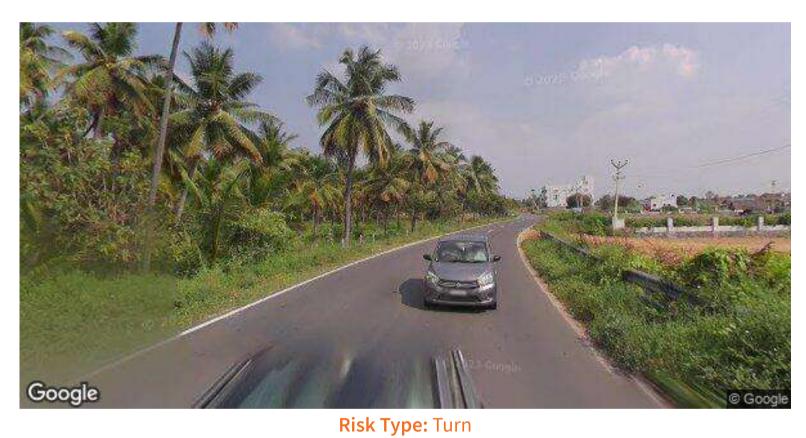
Coordinates: 11.45357, 77.85789

Risk Level: Medium

Speed Limit: 30 KM/Hr

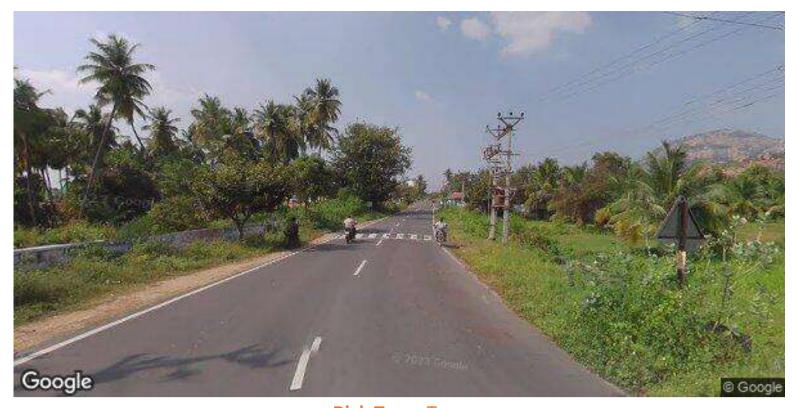
Risk Type: Turn
Risk Level: Medium
Speed Limit: 30 KM/Hr
Coordinates: 11.45352, 77.85698

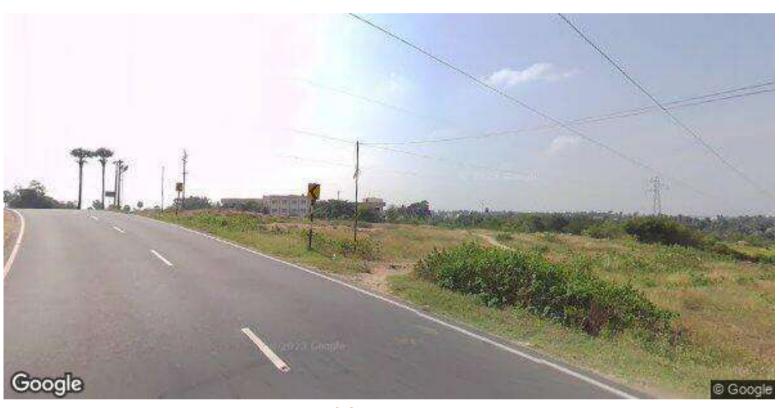
Risk Type: Turn
Risk Level: Medium
Speed Limit: 30 KM/Hr
Coordinates: 11.46048, 77.85036

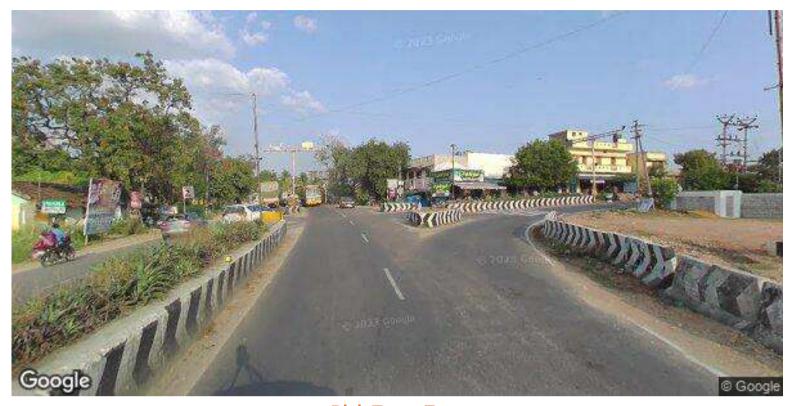
Coordinates: 11.46318, 77.84913

Risk Type: Turn
Risk Level: Medium
Speed Limit: 30 KM/Hr

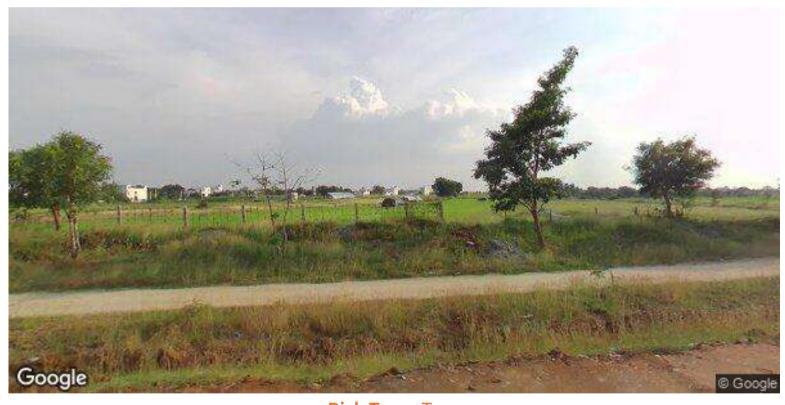
Risk Type: Turn
Risk Level: Medium
Speed Limit: 30 KM/Hr
Coordinates: 11.29288, 77.59029

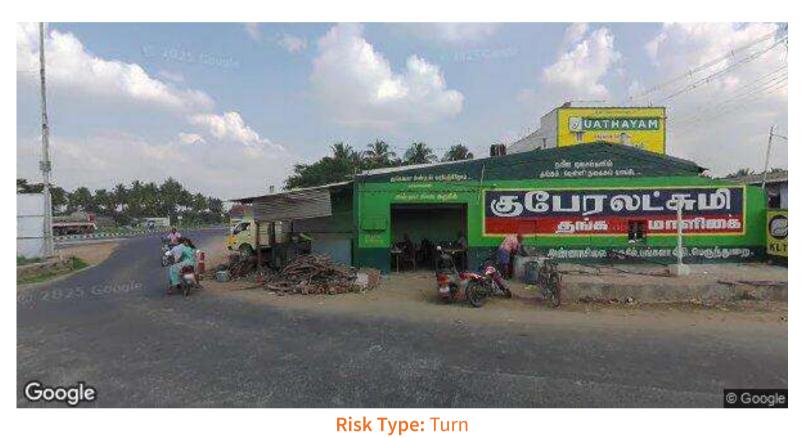
Risk Level: High
Speed Limit: 15 KM/Hr
Coordinates: 11.29158, 77.58600

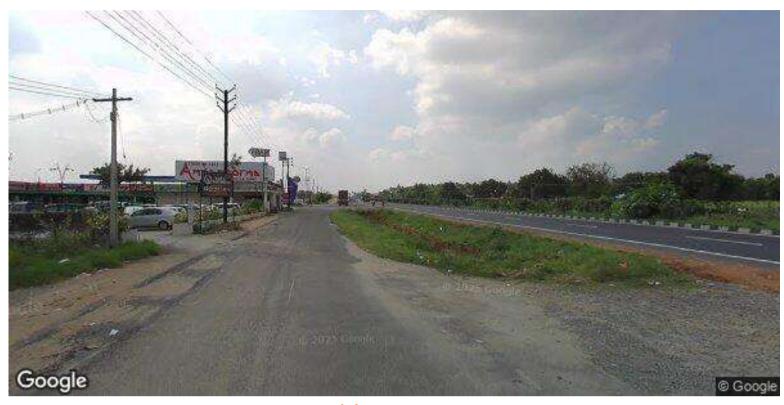
Risk Type: Turn
Risk Level: Medium
Speed Limit: 30 KM/Hr
Coordinates: 11.29140, 77.58253

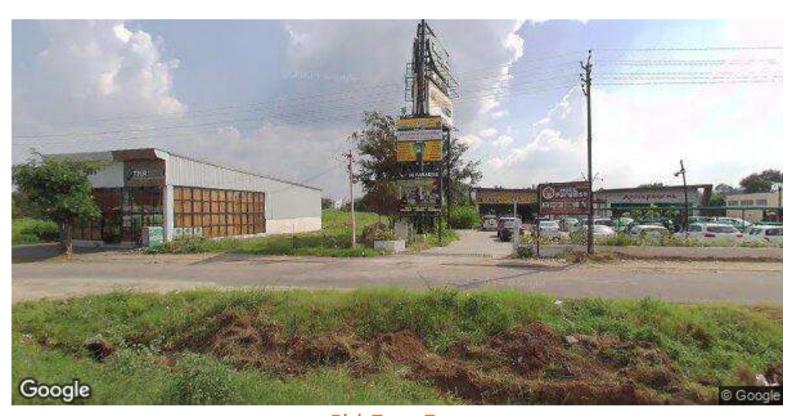
Risk Type: Turn
Risk Level: Medium
Speed Limit: 30 KM/Hr
Coordinates: 11.29154, 77.58236

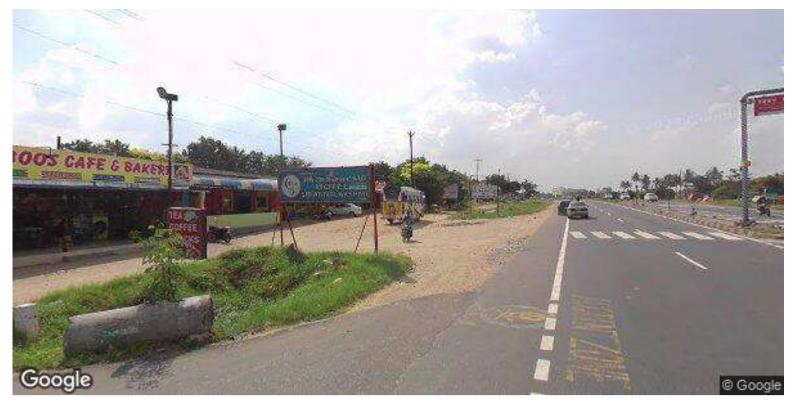
Risk Type: Turn
Risk Level: High
Speed Limit: 15 KM/Hr
Coordinates: 11.29157, 77.57721

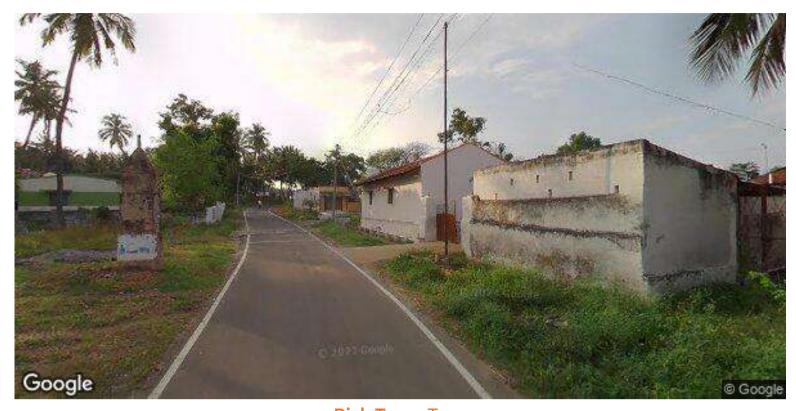
Risk Type: Turn
Risk Level: Medium
Speed Limit: 30 KM/Hr
Coordinates: 11.29700, 77.57492

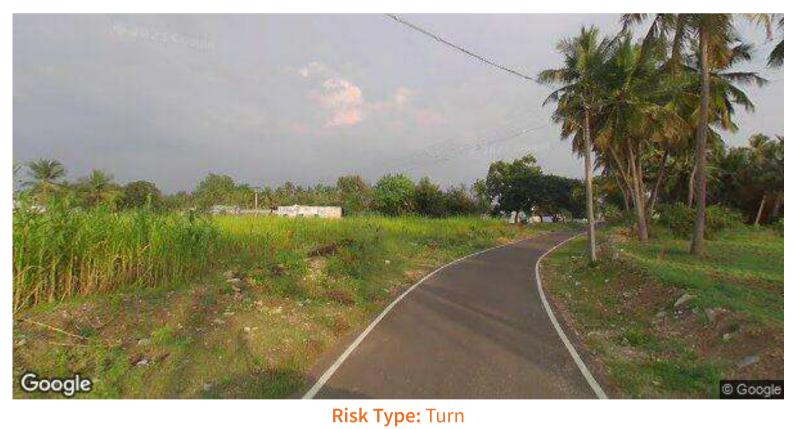
Risk Type. Turn
Risk Level: Medium
Speed Limit: 30 KM/Hr
Coordinates: 11.29744, 77.57339

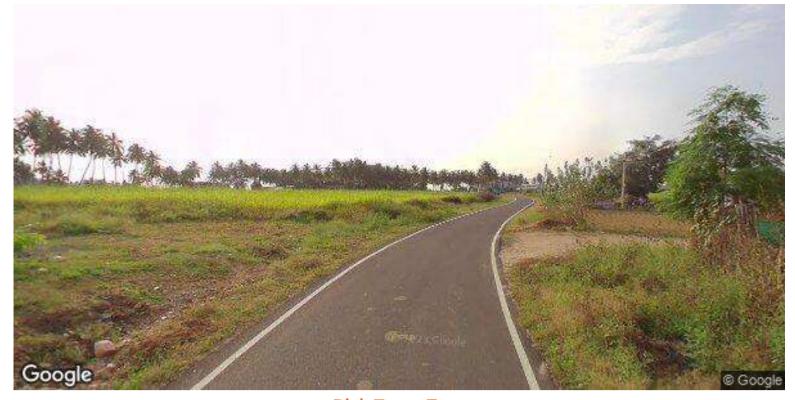
Risk Type: Turn
Risk Level: Medium
Speed Limit: 30 KM/Hr
Coordinates: 11.29736, 77.57272

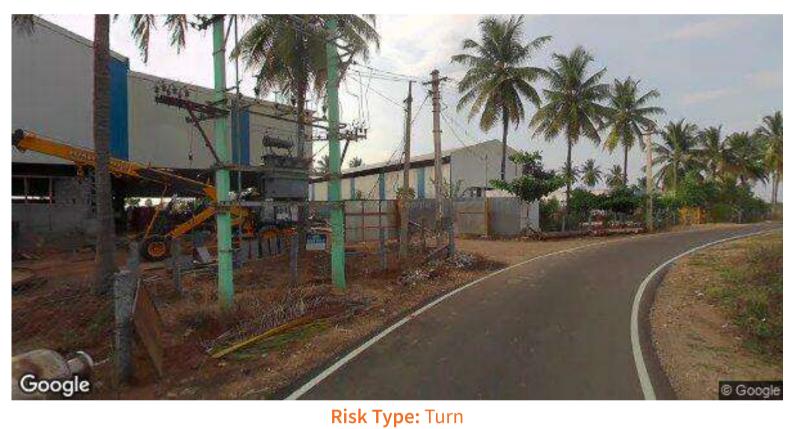
Risk Type: Turn
Risk Level: Medium
Speed Limit: 30 KM/Hr
Coordinates: 11.29841, 77.57022

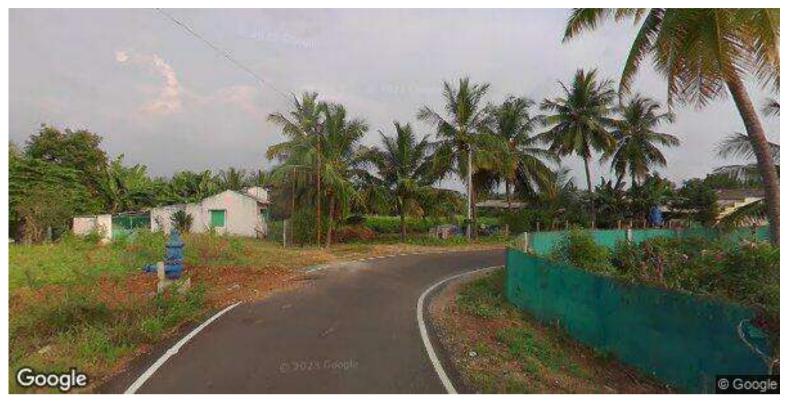
Coordinates: 11.29960, 77.57008

Risk Type: Turn
Risk Level: High
Speed Limit: 15 KM/Hr

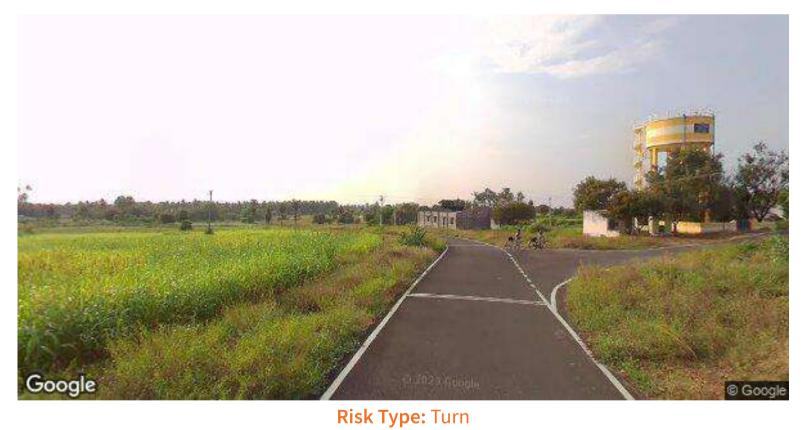
Risk Level: Medium
Speed Limit: 30 KM/Hr
Coordinates: 11.29965, 77.56919

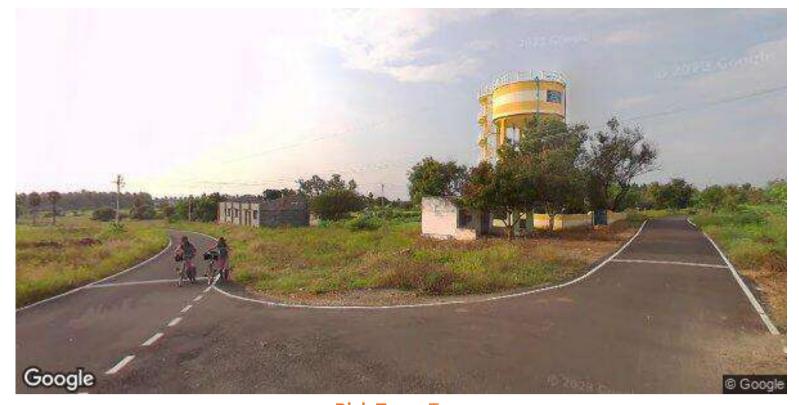
Coordinates: 11.29976, 77.56904

Risk Type: Turn
Risk Level: Medium
Speed Limit: 30 KM/Hr

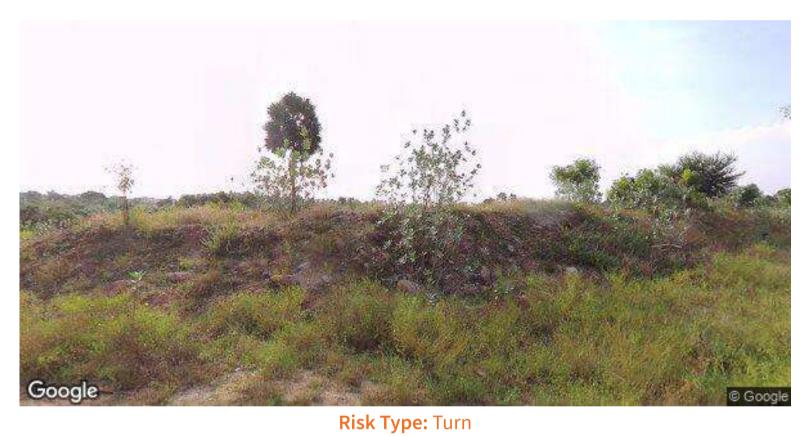
Coordinates: 11.29968, 77.56335

Risk Type: Turn

Risk Level: High

Speed Limit: 15 KM/Hr

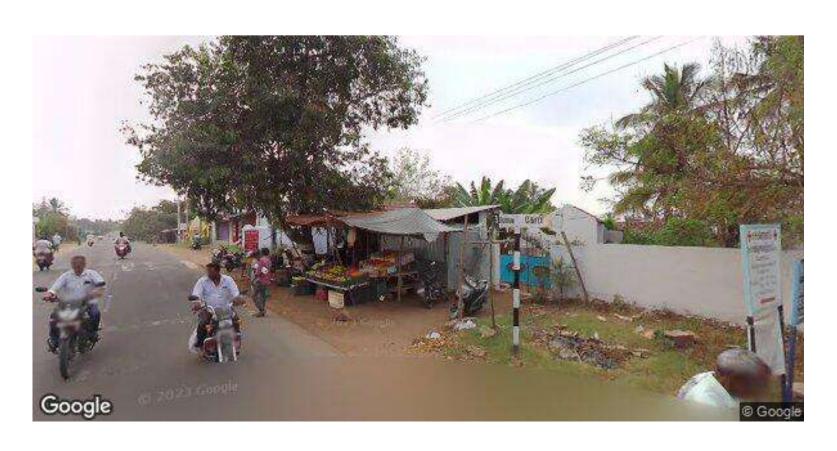
Coordinates: 11.29195, 77.56218

Risk Type: Blind Spot Risk Level: Blind Spot Speed Limit: 10 KM/Hr

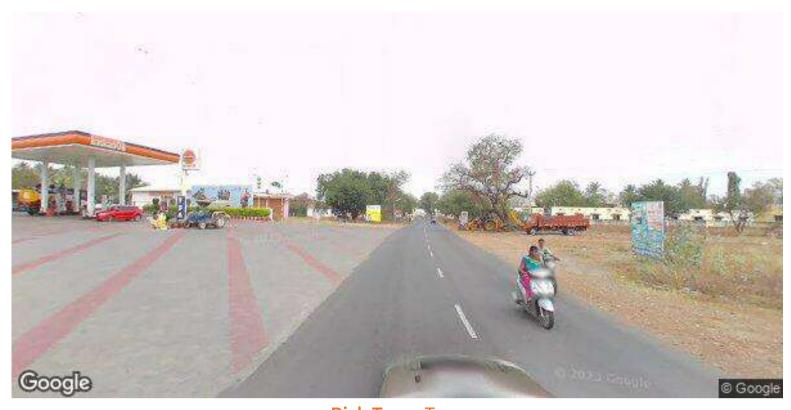
Coordinates: 11.29869, 77.55489

Risk Type: Turn
Risk Level: High
Speed Limit: 15 KM/Hr
