JOURNEY RISK MANAGEMENT (JRM) STUDY

Salem Terminal TO G A S STAATION

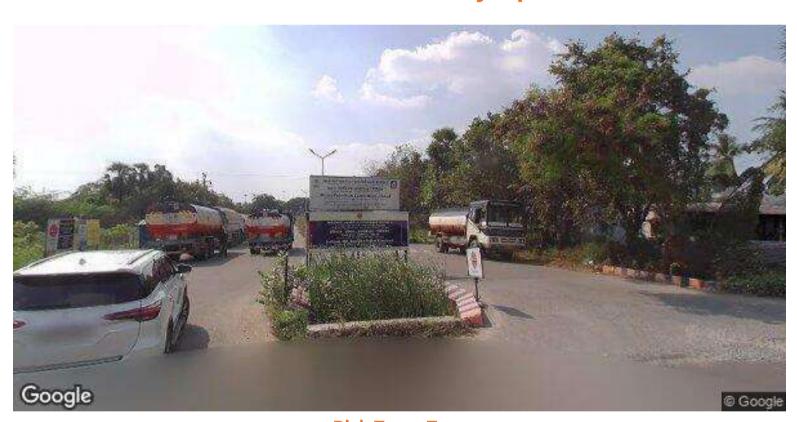
Coordinates: 11.44024, 77.87528

Risk Type: Turn
Risk Level: High
Speed Limit: 15 KM/Hr

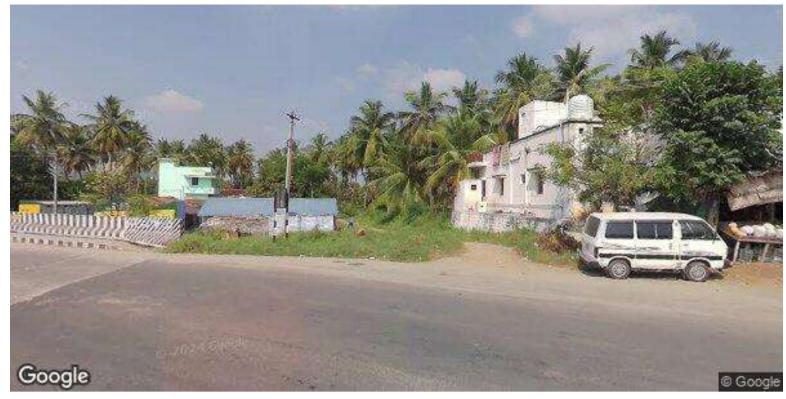
Risk Type: Turn
Risk Level: High
Speed Limit: 15 KM/Hr
Coordinates: 11.44898, 77.87410

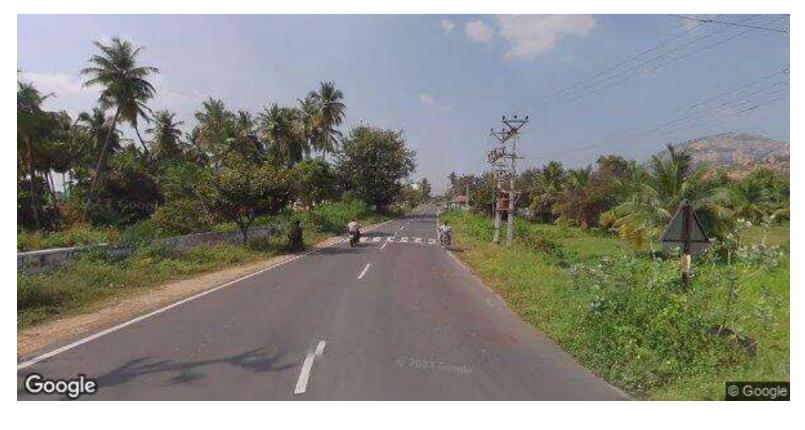
Coordinates: 11.45352, 77.85698

Risk Type: Turn
Risk Level: High
Speed Limit: 15 KM/Hr

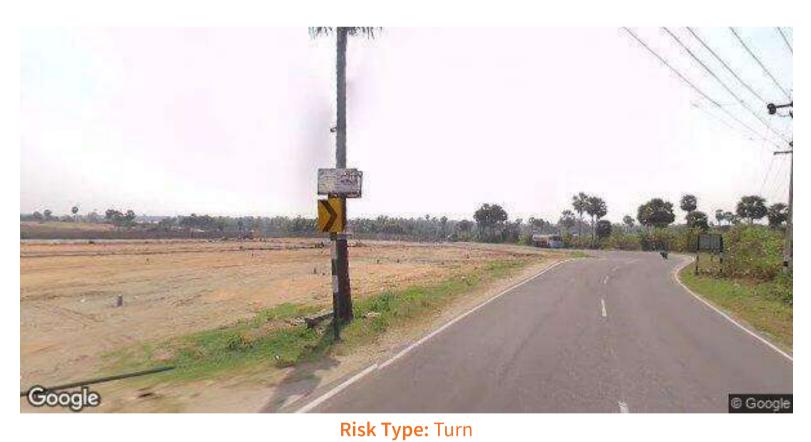
Coordinates: 11.45898, 77.85135

Risk Type: Turn
Risk Level: Medium
Speed Limit: 30 KM/Hr

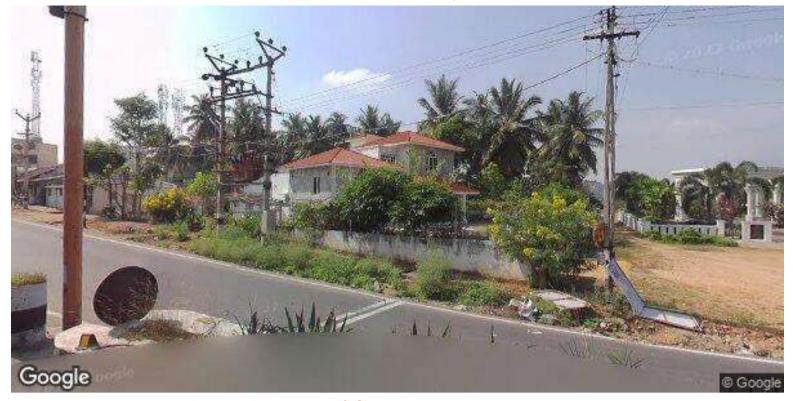
Risk Type: Turn
Risk Level: High
Speed Limit: 15 KM/Hr
Coordinates: 11.46303, 77.84945

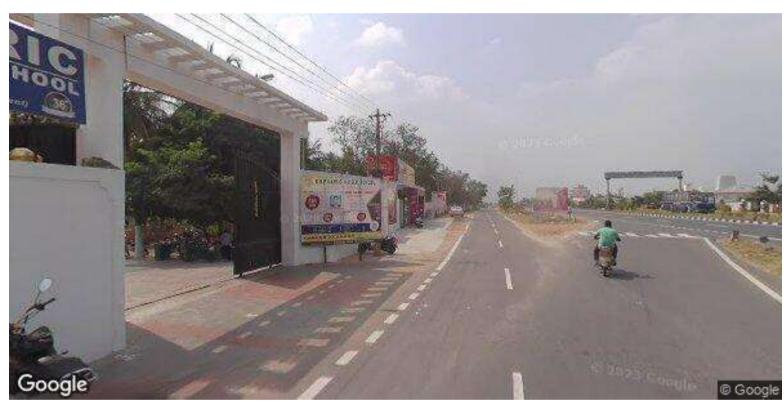
Risk Type: Turn
Risk Level: Medium
Speed Limit: 30 KM/Hr
Coordinates: 11.45509, 77.81383

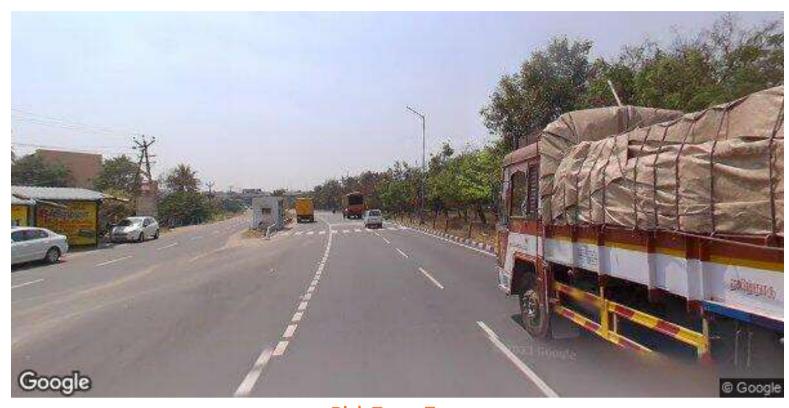
Coordinates: 11.43165, 77.67734

Risk Type: Turn
Risk Level: Medium
Speed Limit: 30 KM/Hr

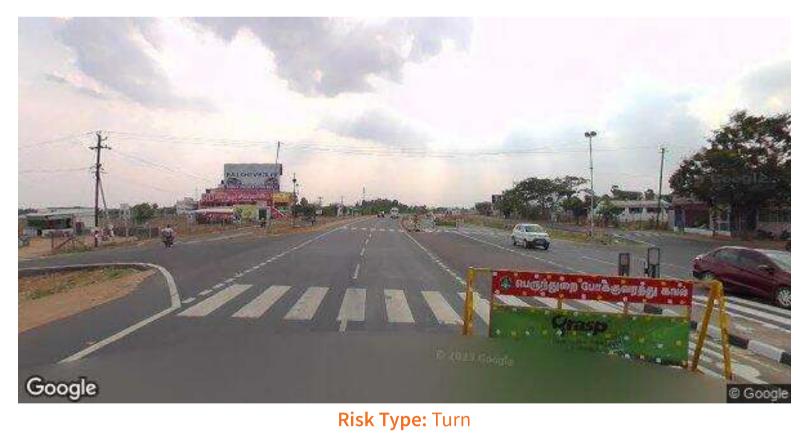
Coordinates: 11.23724, 77.50686

Risk Level: Medium
Speed Limit: 30 KM/Hr

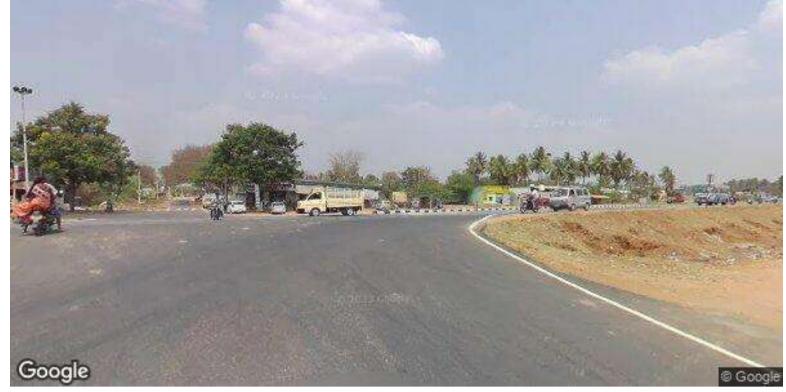
Risk Type: Turn
Risk Level: High
Speed Limit: 15 KM/Hr
Coordinates: 11.23704, 77.50676

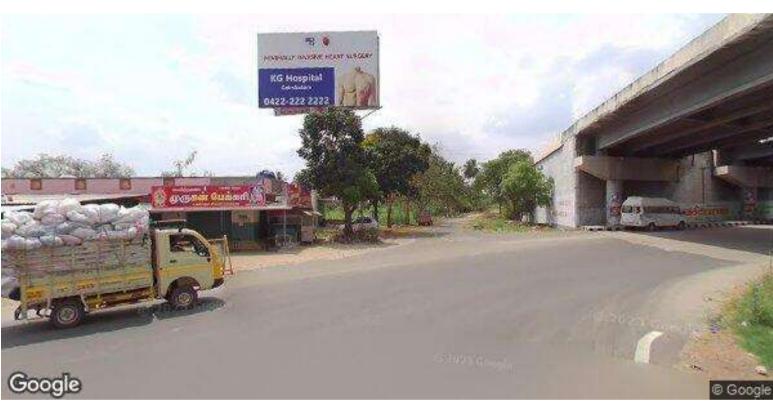
Risk Type: Blind Spot
Risk Level: Blind Spot
Speed Limit: 10 KM/Hr
Coordinates: 11.23686, 77.50216

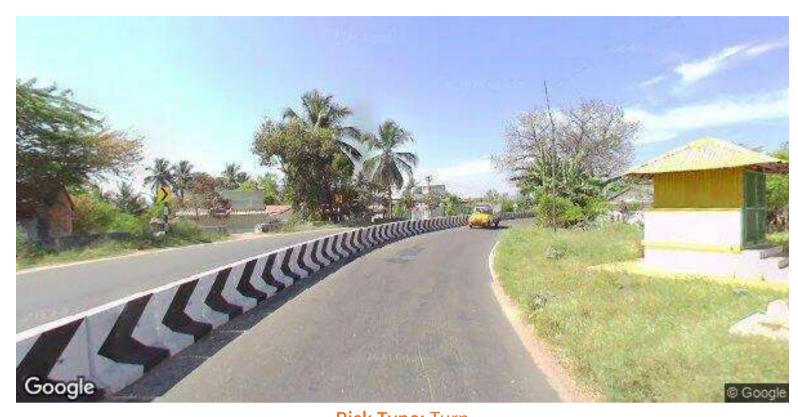
Coordinates: 11.23396, 77.50105

Risk Type: Turn
Risk Level: High
Speed Limit: 15 KM/Hr

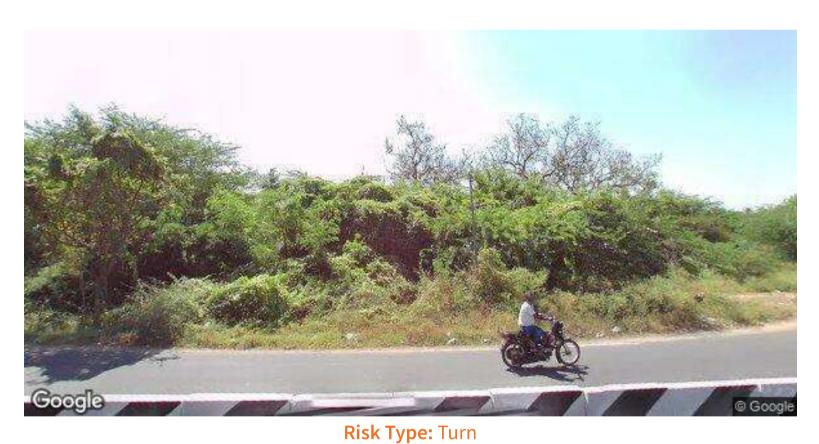
Coordinates: 11.23329, 77.49966

Risk Level: Medium
Speed Limit: 30 KM/Hr

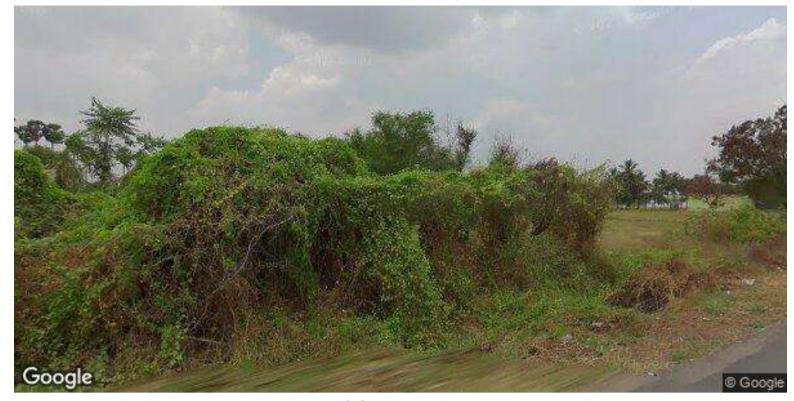
Risk Type: Turn
Risk Level: Medium
Speed Limit: 30 KM/Hr
Coordinates: 11.17851, 77.46169

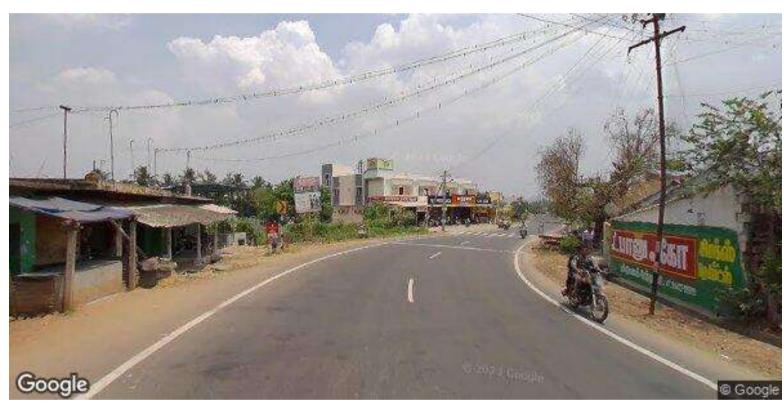
Risk Type: Turn
Risk Level: Medium
Speed Limit: 30 KM/Hr
Coordinates: 11.17368, 77.45730

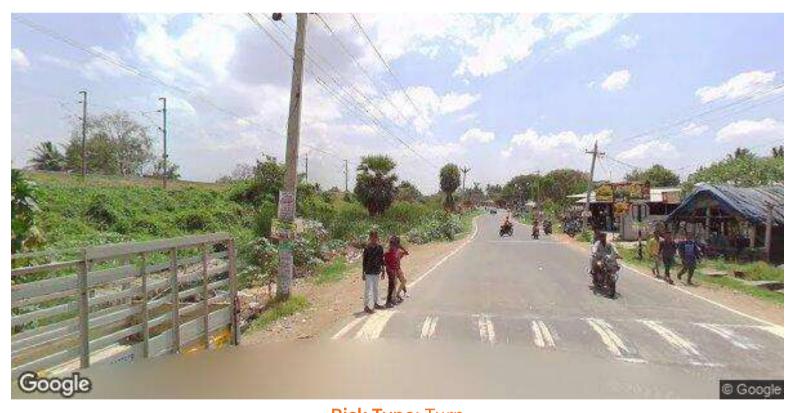
Coordinates: 11.16706, 77.45494

Risk Type: Turn
Risk Level: Medium
Speed Limit: 30 KM/Hr

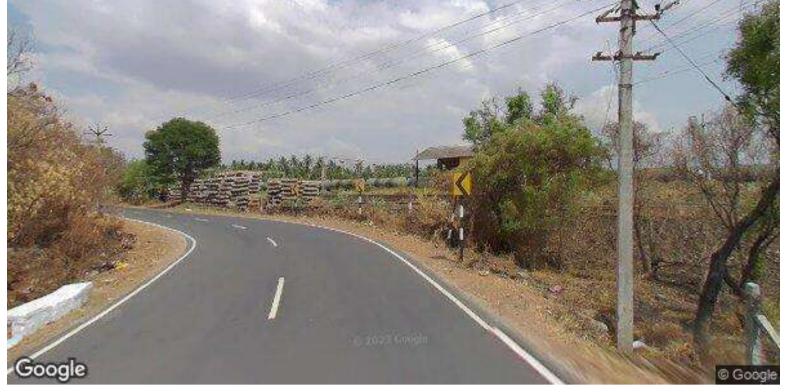
Risk Type: Turn
Risk Level: High
Speed Limit: 15 KM/Hr
Coordinates: 11.15693, 77.44742

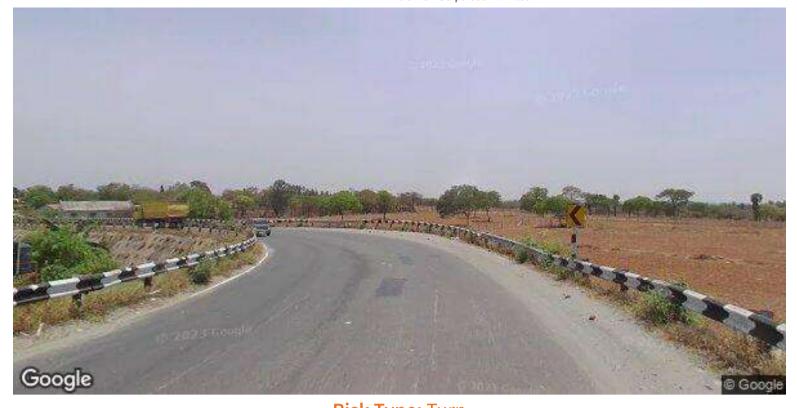
Risk Type: Turn
Risk Level: Medium
Speed Limit: 30 KM/Hr
Coordinates: 11.15034, 77.44341

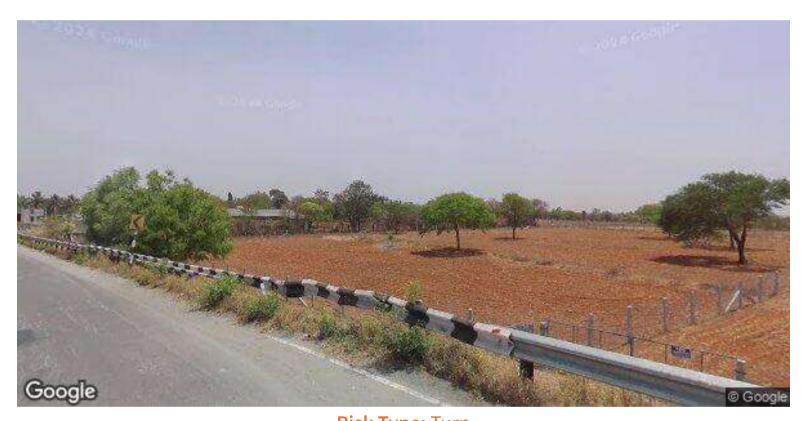
Risk Type: Turn
Risk Level: Medium
Speed Limit: 30 KM/Hr
Coordinates: 11.15010, 77.44365

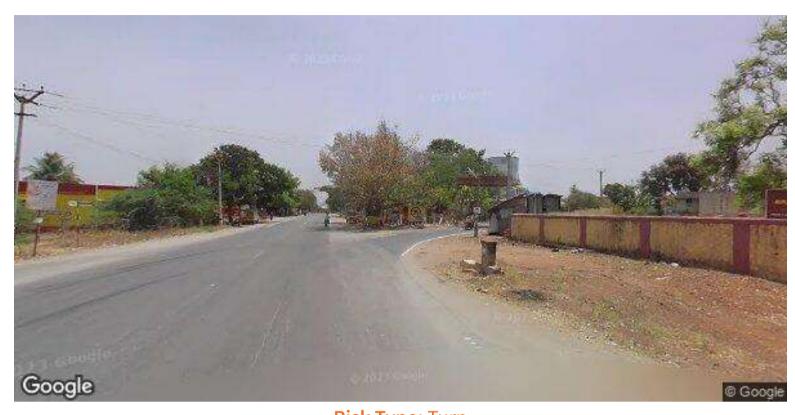
Coordinates: 11.14957, 77.44526

Risk Type: Turn
Risk Level: High
Speed Limit: 15 KM/Hr

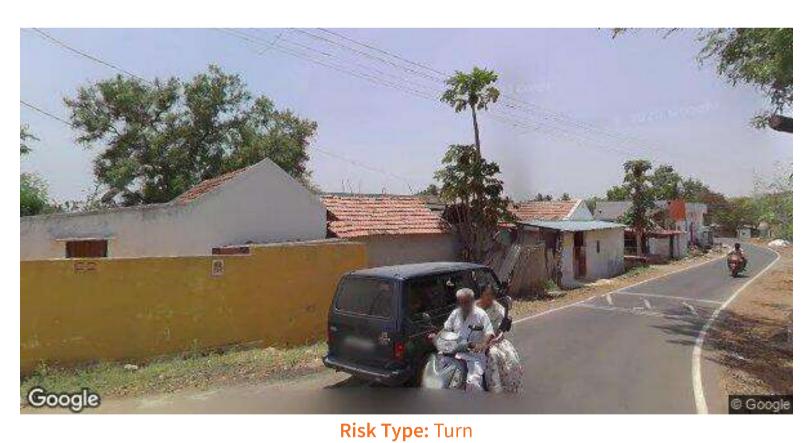
Coordinates: 11.14479, 77.44350

Risk Type: Turn
Risk Level: High
Speed Limit: 15 KM/Hr

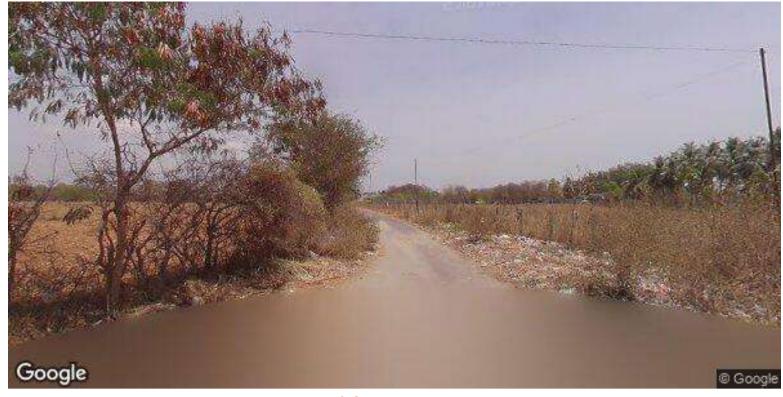
Risk Type: Turn
Risk Level: High
Speed Limit: 15 KM/Hr
Coordinates: 11.14525, 77.43906

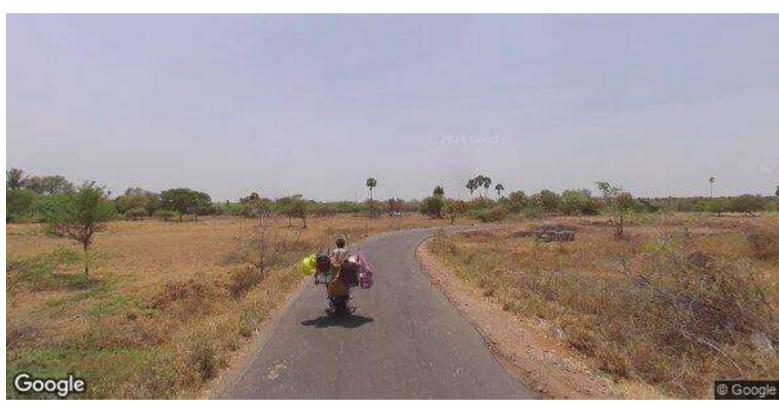
Risk Type: Turn
Risk Level: Medium
Speed Limit: 30 KM/Hr
Coordinates: 11.13230, 77.43321

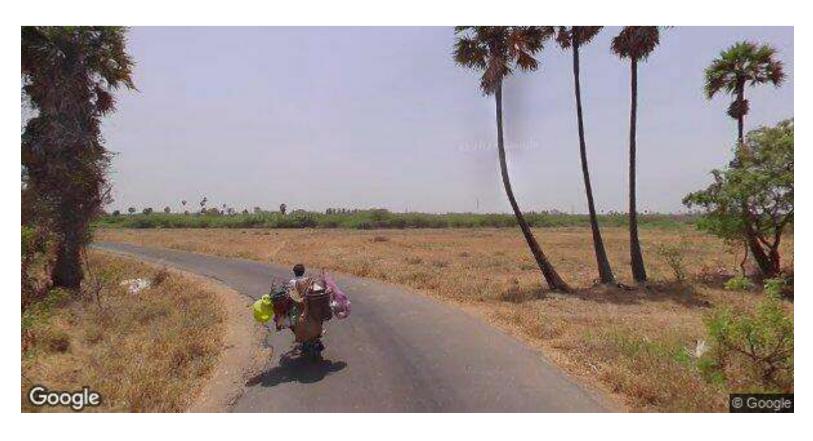
Coordinates: 11.13163, 77.43254

Risk Type: Turn
Risk Level: High
Speed Limit: 15 KM/Hr

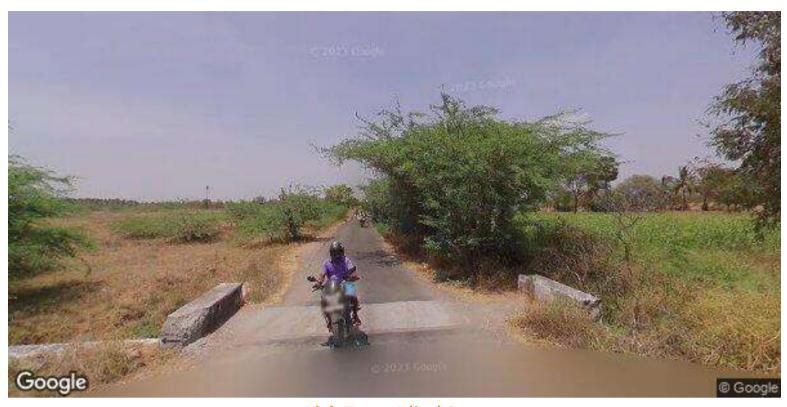
Risk Type: Blind Spot
Risk Level: Blind Spot
Speed Limit: 10 KM/Hr
Coordinates: 11.13022, 77.43358

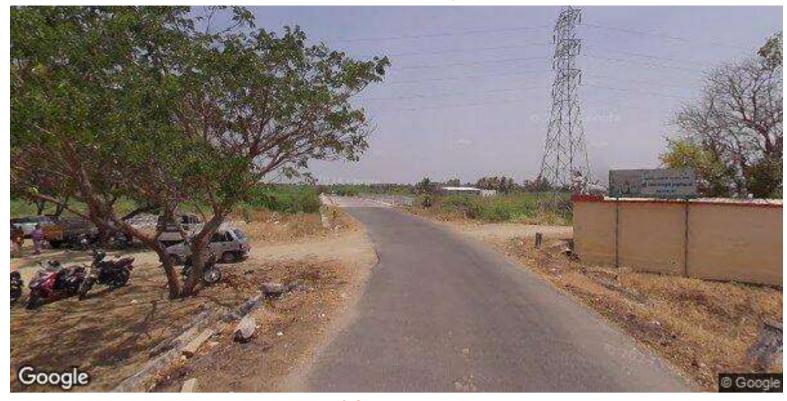
Risk Type: Turn
Risk Level: High
Speed Limit: 15 KM/Hr
Coordinates: 11.12744, 77.43053

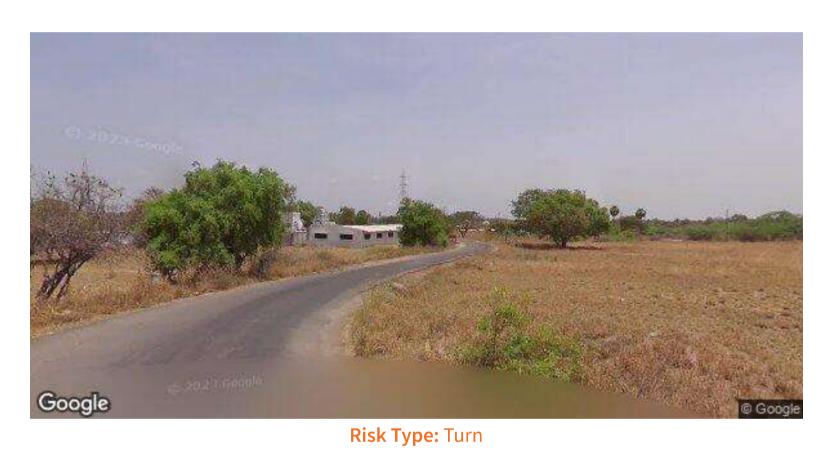
Risk Level: High
Speed Limit: 15 KM/Hr
Coordinates: 11.12731, 77.42945

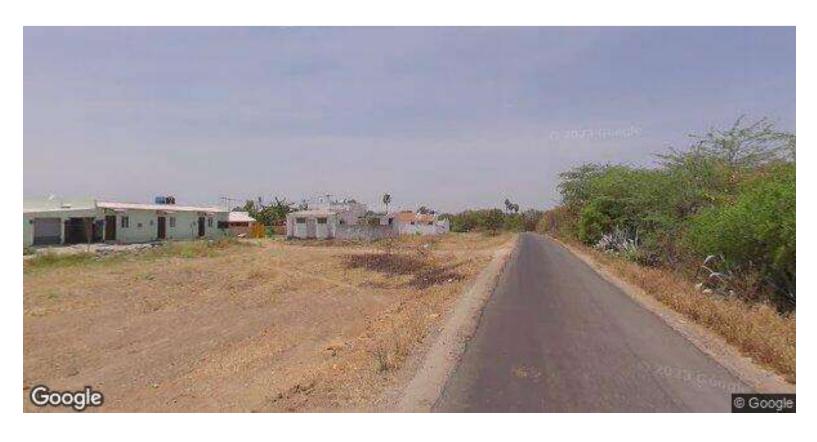
Coordinates: 11.12638, 77.42910

Risk Type: Turn
Risk Level: High
Speed Limit: 15 KM/Hr

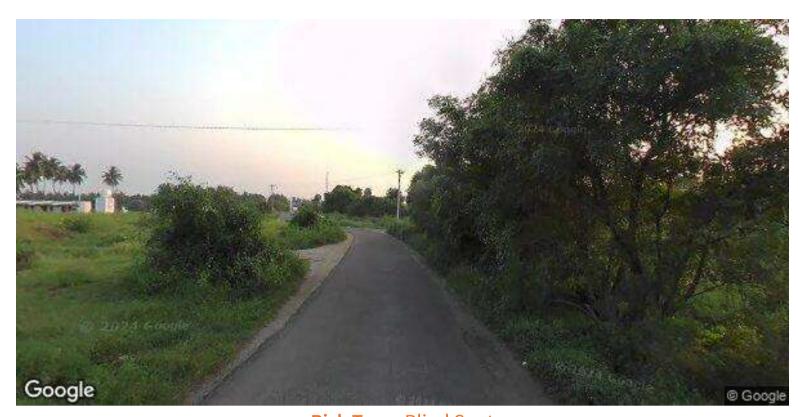
Risk Type: Blind Spot
Risk Level: Blind Spot
Speed Limit: 10 KM/Hr
Coordinates: 11.12638, 77.42801

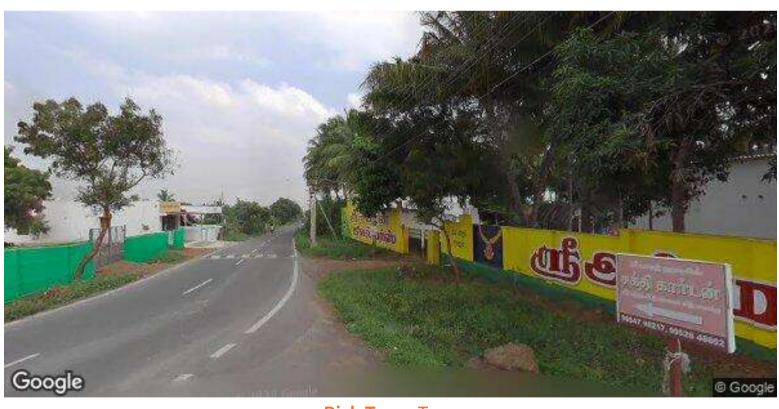
Risk Type: Turn
Risk Level: Medium
Speed Limit: 30 KM/Hr
Coordinates: 11.10417, 77.42302

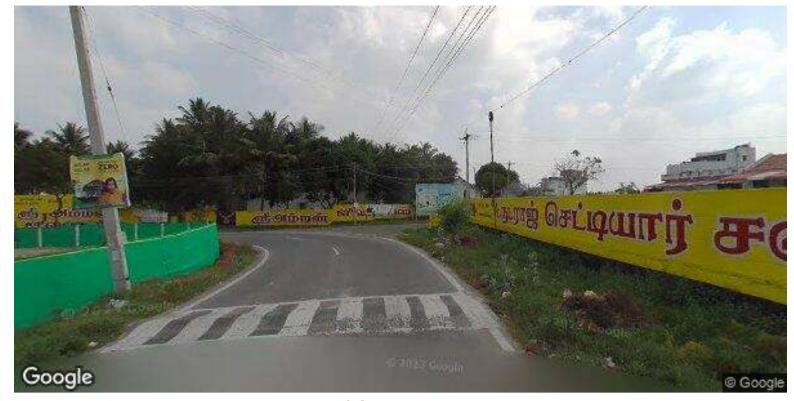
Risk Type: Turn
Risk Level: Medium
Speed Limit: 30 KM/Hr
Coordinates: 11.10404, 77.42280

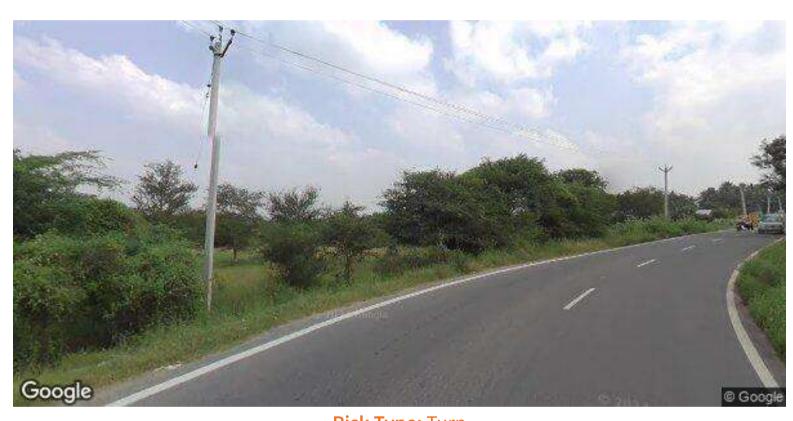
Risk Type: Turn
Risk Level: Medium
Speed Limit: 30 KM/Hr
Coordinates: 11.10419, 77.42108

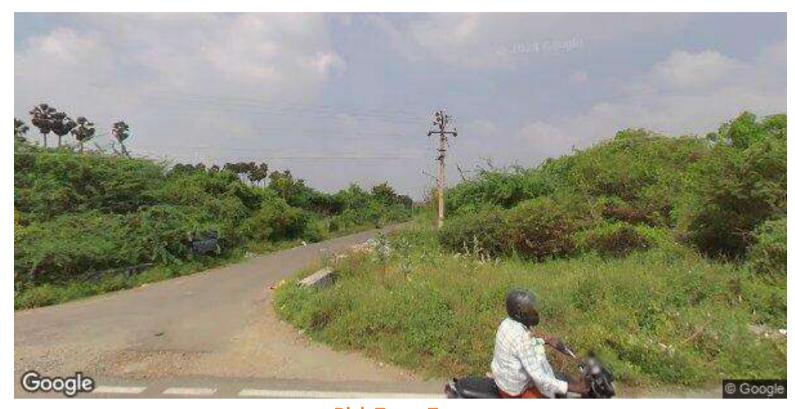
Risk Type: Turn
Risk Level: Medium
Speed Limit: 30 KM/Hr
Coordinates: 11.10331, 77.41739
