JOURNEY RISK MANAGEMENT (JRM) STUDY

Salem Terminal To SMS FUELS

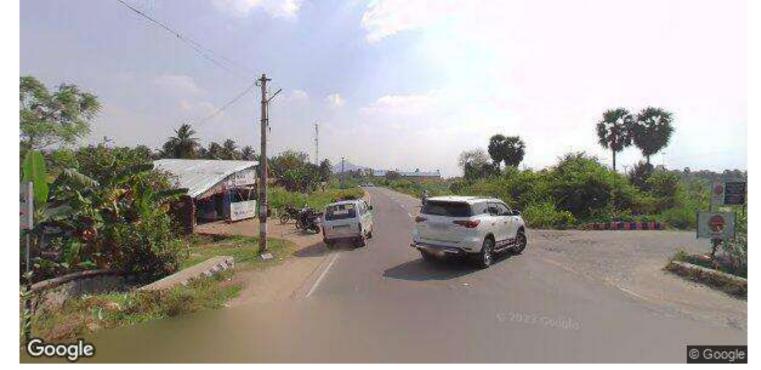
Risk Type: Turn
Risk Level: High
Speed Limit: 15 KM/Hr
Coordinates: 11.44029, 77.87544

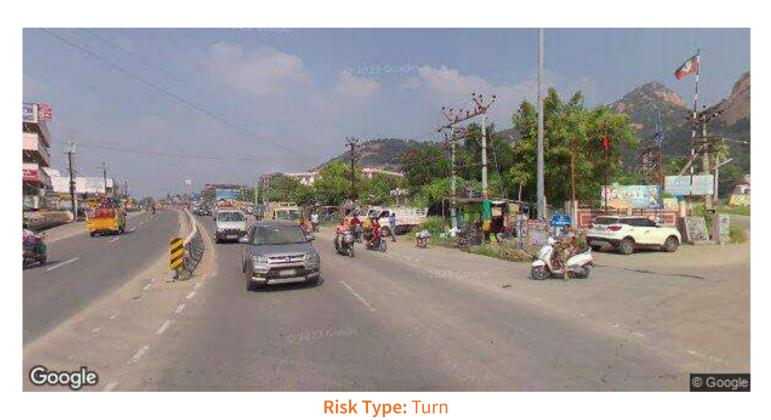
Risk Level: Medium
Speed Limit: 30 KM/Hr
Coordinates: 11.39671, 77.88878

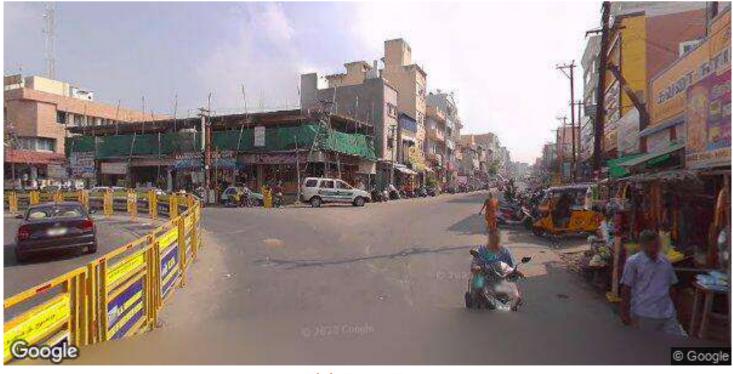
Risk Type: Turn Risk Level: High

Speed Limit: 15 KM/Hr Coordinates: 11.37862, 77.89488

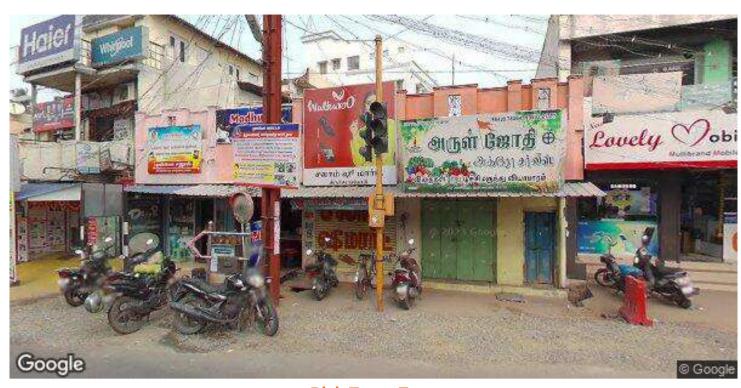
Risk Type: Turn
Risk Level: High
Speed Limit: 15 KM/Hr
Coordinates: 11.37850, 77.89453

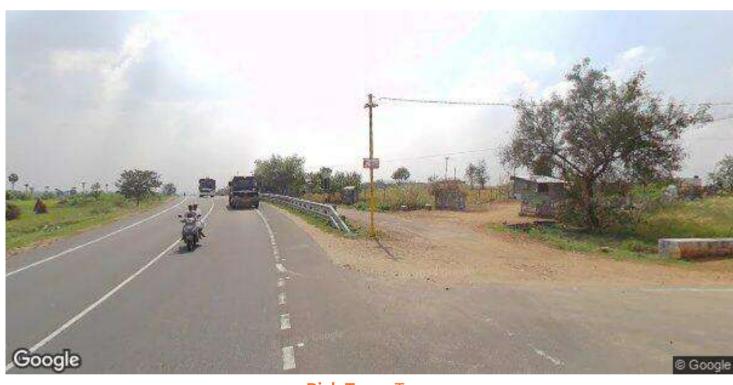
Risk Type: Turn
Risk Level: Medium
Speed Limit: 30 KM/Hr
Coordinates: 11.34151, 77.90137

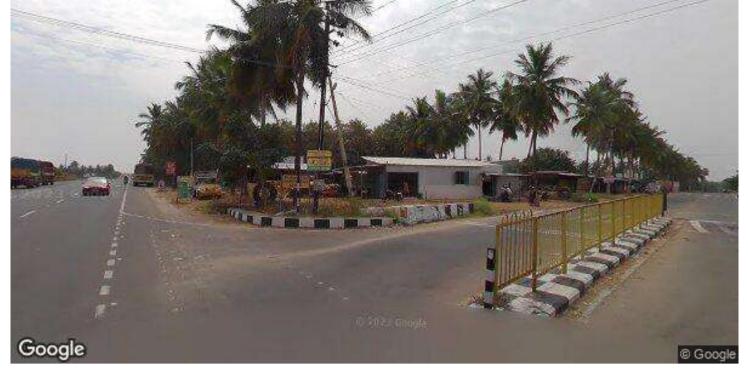
Risk Type: Turn
Risk Level: High
Speed Limit: 15 KM/Hr
Coordinates: 11.30859, 77.92918

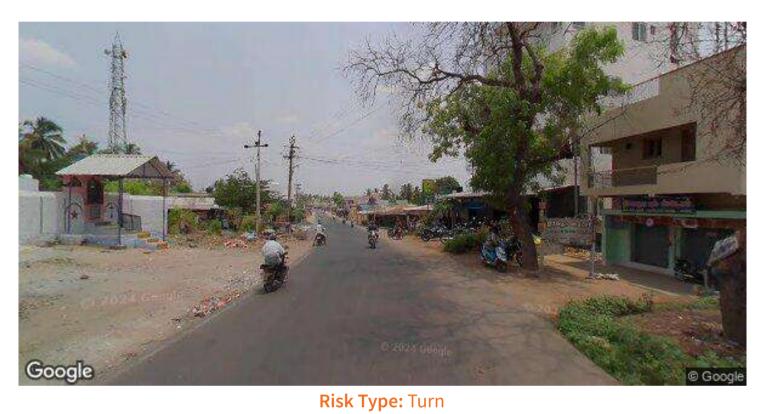
Risk Level: Medium
Speed Limit: 30 KM/Hr
Coordinates: 11.24421, 77.87541

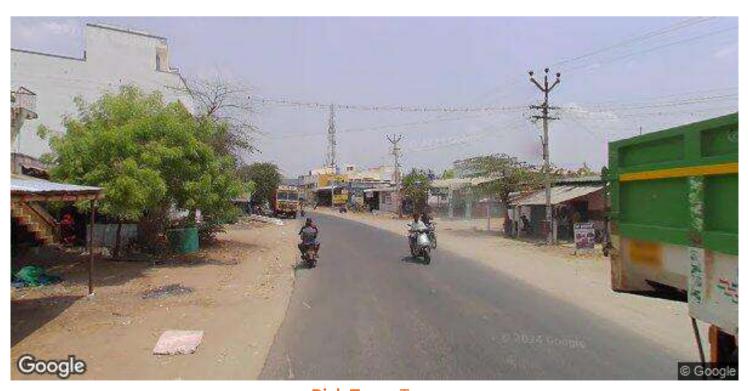
Risk Type: Turn
Risk Level: Medium

Speed Limit: 30 KM/Hr Coordinates: 11.24192, 77.87363

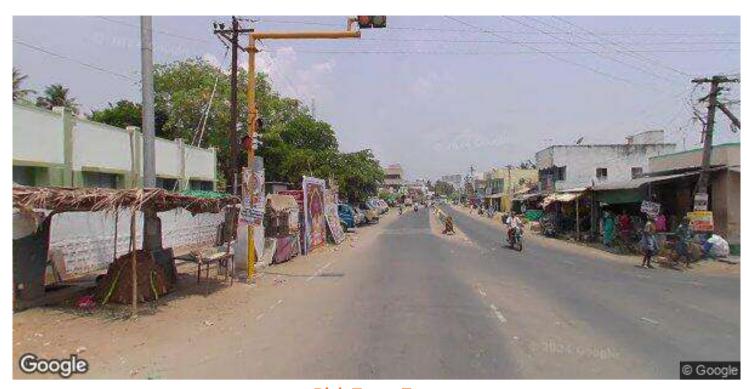
Risk Type: Turn
Risk Level: High
Speed Limit: 15 KM/Hr
Coordinates: 11.24001, 77.87368

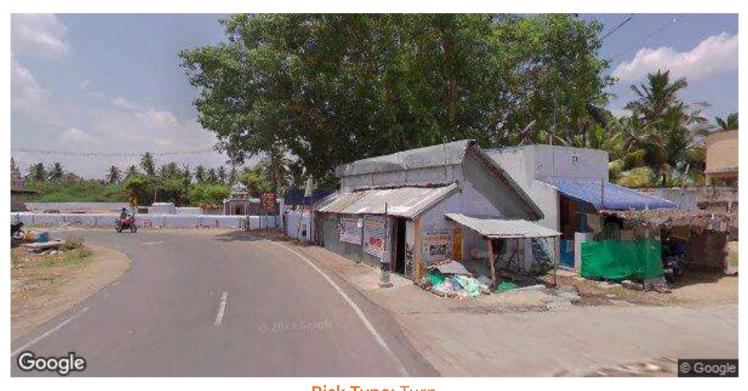
Risk Type: Turn
Risk Level: High
Speed Limit: 15 KM/Hr
Coordinates: 11.24061, 77.86899

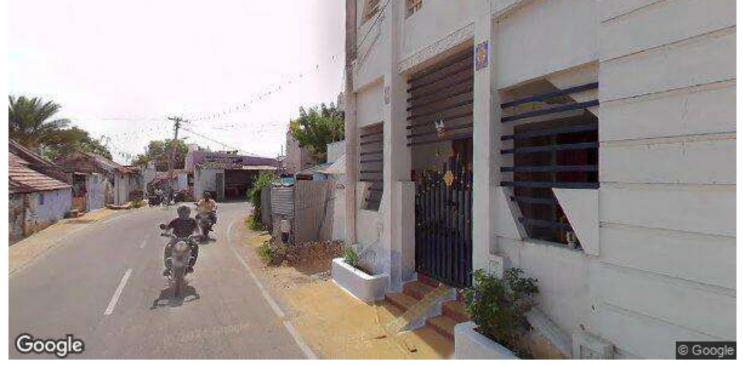
Risk Type: Turn
Risk Level: High
Speed Limit: 15 KM/Hr
Coordinates: 11.24157, 77.86876

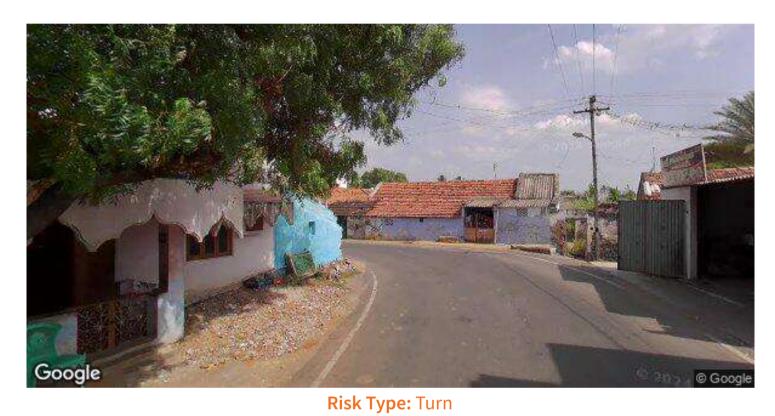
Risk Level: High
Speed Limit: 15 KM/Hr
Coordinates: 11.24167, 77.86843

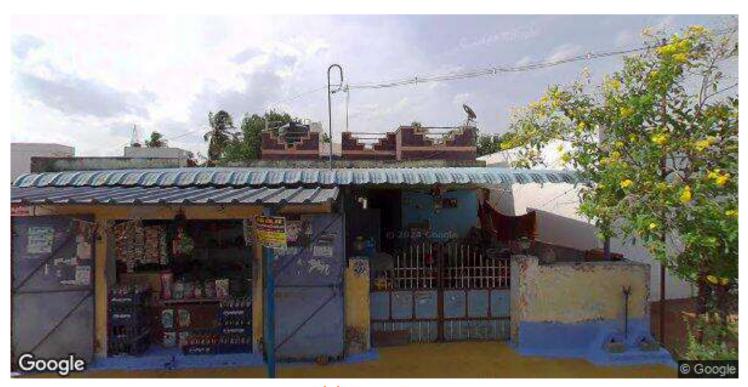
Risk Type: Turn Risk Level: High

Speed Limit: 15 KM/Hr Coordinates: 11.24242, 77.86833

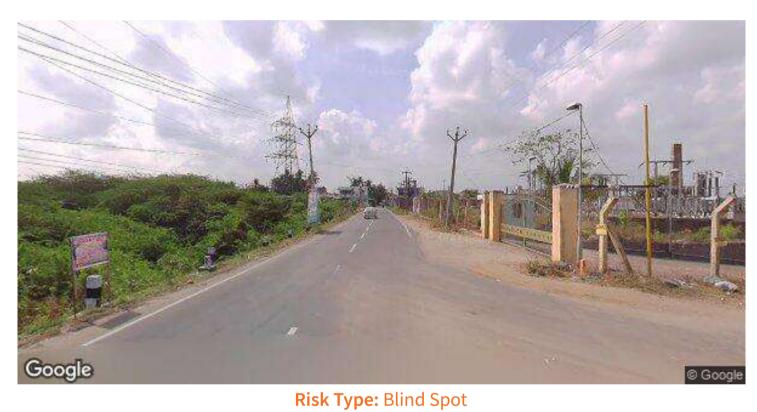
Risk Level: Blind Spot
Speed Limit: 10 KM/Hr
Coordinates: 11.24384, 77.86689

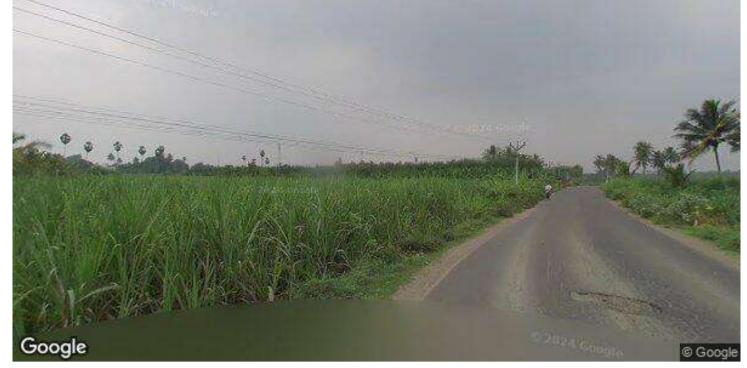
Risk Type: Turn
Risk Level: High
Speed Limit: 15 KM/Hr

Coordinates: 11.24101, 77.86023

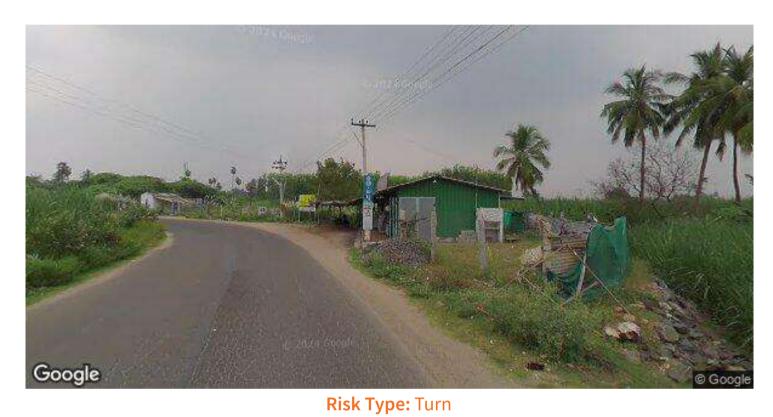
Risk Level: Medium
Speed Limit: 30 KM/Hr
Coordinates: 11.24198, 77.85893

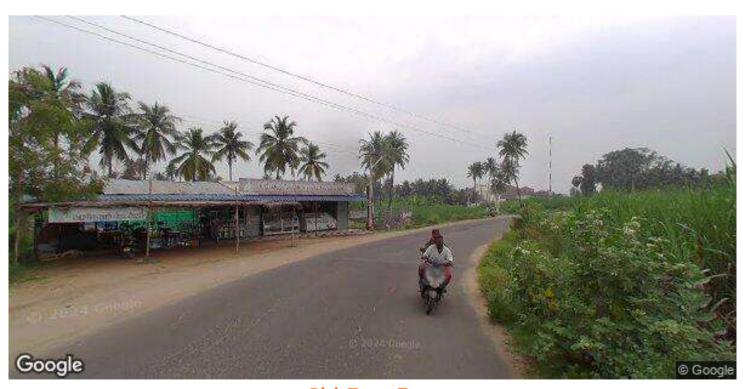
Risk Type: Turn
Risk Level: Medium

Speed Limit: 30 KM/Hr Coordinates: 11.24198, 77.85860

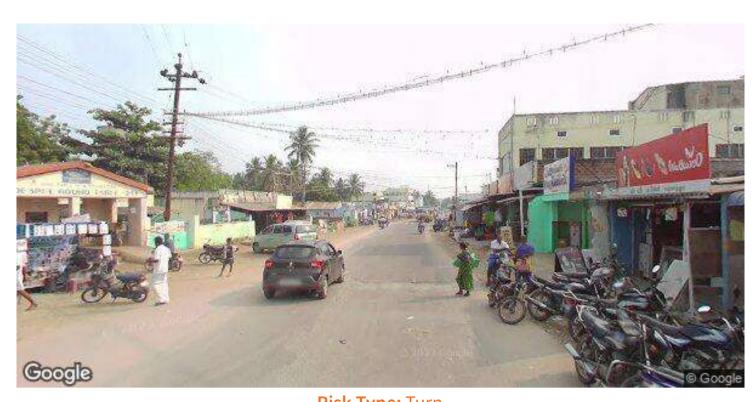
Risk Type: Turn
Risk Level: High
Speed Limit: 15 KM/Hr
Coordinates: 11.18850, 77.77113

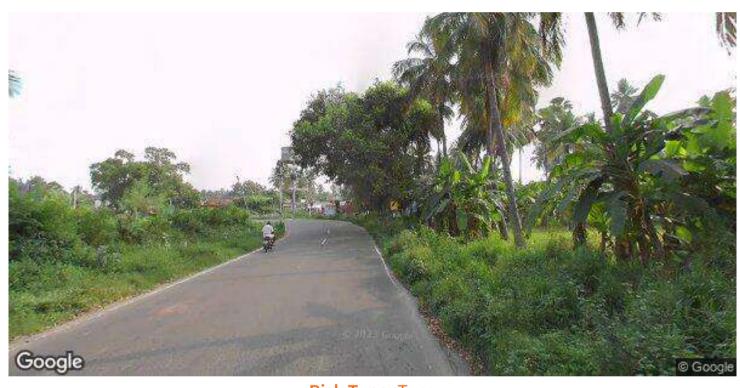
Risk Type: Turn
Risk Level: Medium
Speed Limit: 30 KM/Hr
Coordinates: 11.16450, 77.77357

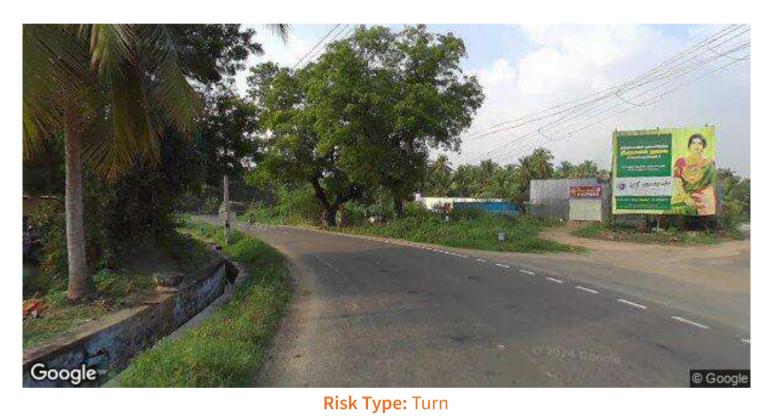
Risk Level: Medium
Speed Limit: 30 KM/Hr
Coordinates: 11.16357, 77.77434

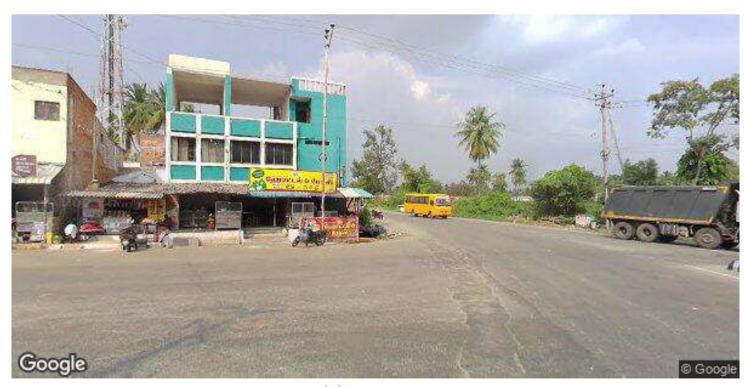
Risk Type: Turn Risk Level: High

Speed Limit: 15 KM/Hr Coordinates: 11.13667, 77.76526

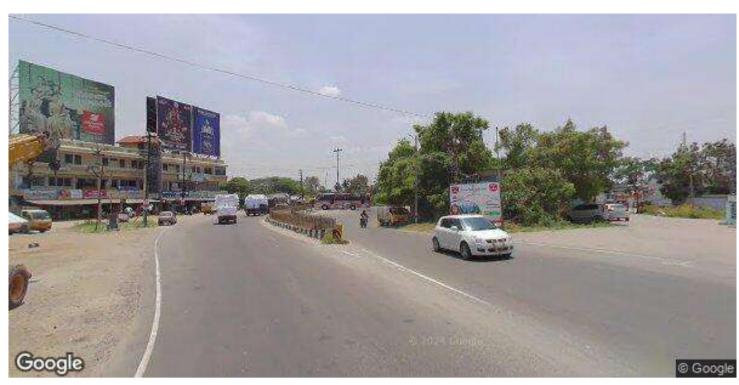
Risk Type: Turn
Risk Level: Medium
Speed Limit: 30 KM/Hr
Coordinates: 11.04703, 77.73745

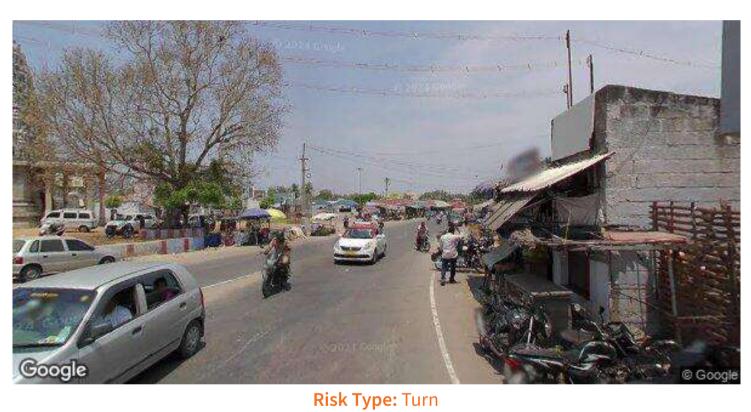
Risk Level: Medium
Speed Limit: 30 KM/Hr
Coordinates: 11.04528, 77.73627

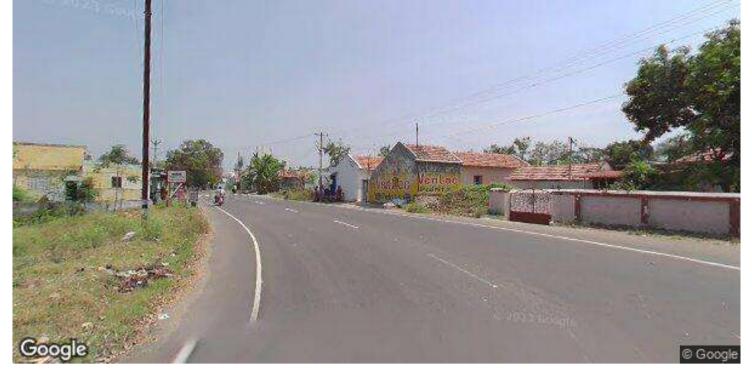
Risk Type: Turn
Risk Level: High
Speed Limit: 15 KM/Hr
Coordinates: 10.99029, 77.72513

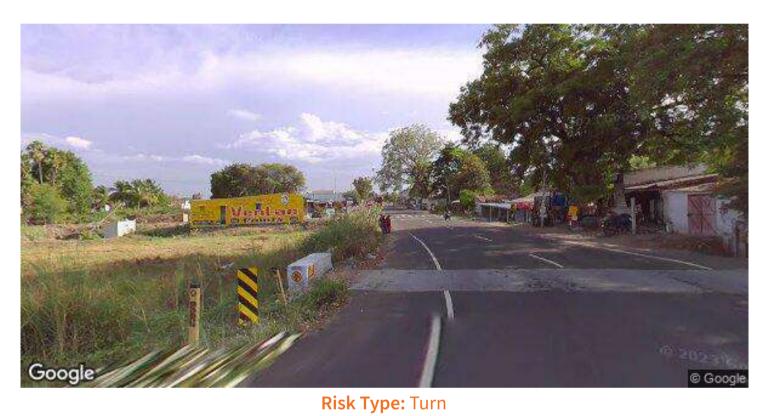
Risk Level: Medium
Speed Limit: 30 KM/Hr
Coordinates: 10.98961, 77.72379

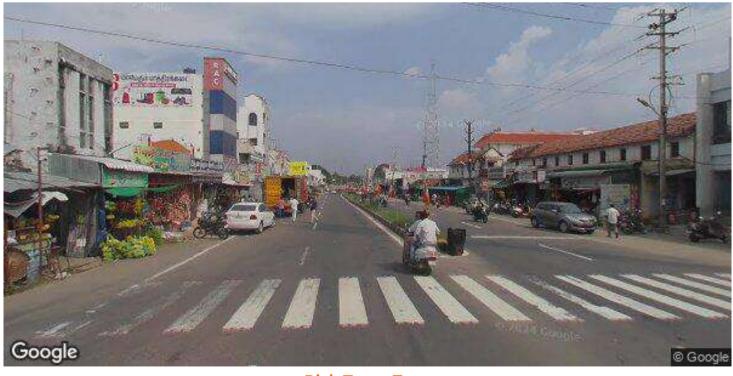
Risk Type: Turn Risk Level: High Speed Limit: 15 KM/Hr Coordinates: 10.94597, 77.71319

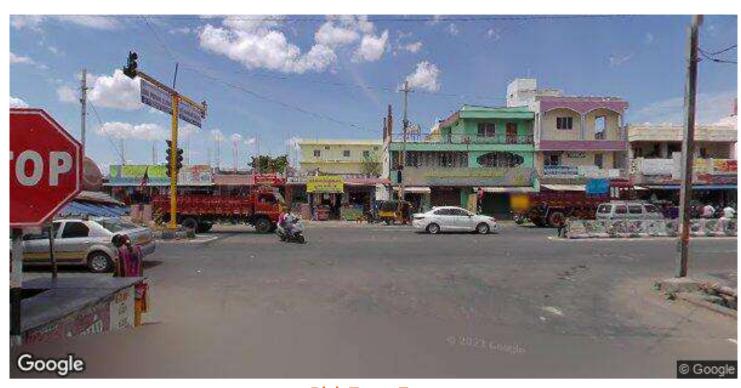
Risk Type: Turn
Risk Level: High
Speed Limit: 15 KM/Hr
Coordinates: 10.94582, 77.71257

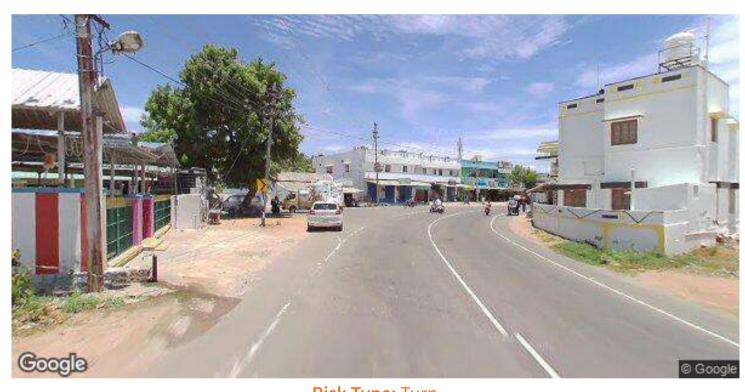
Risk Type: Turn
Risk Level: Medium
Speed Limit: 30 KM/Hr
Coordinates: 10.93825, 77.70342
