JOURNEY RISK MANAGEMENT (JRM) STUDY

Salem Terminal TO JPS SAMY FUELS

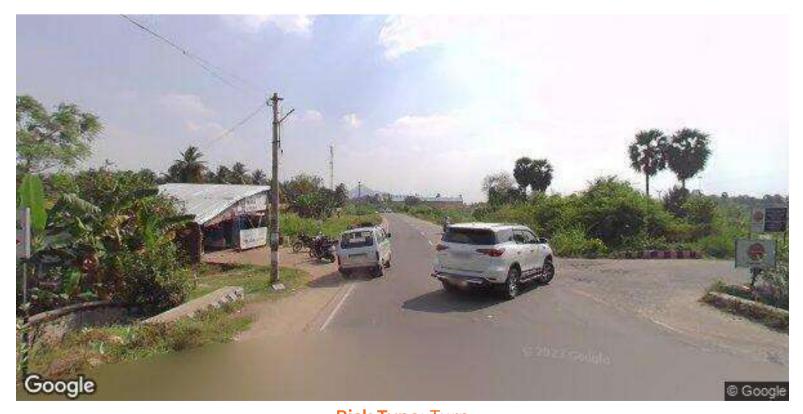
Risk Type: Turn
Risk Level: High
Speed Limit: 15 KM/Hr
Coordinates: 11.44029, 77.87544

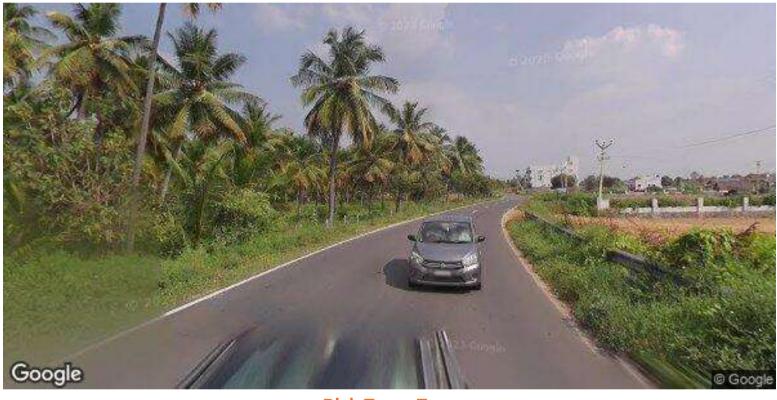
Coordinates: 11.45357, 77.85789

Risk Type: Turn
Risk Level: Medium
Speed Limit: 30 KM/Hr

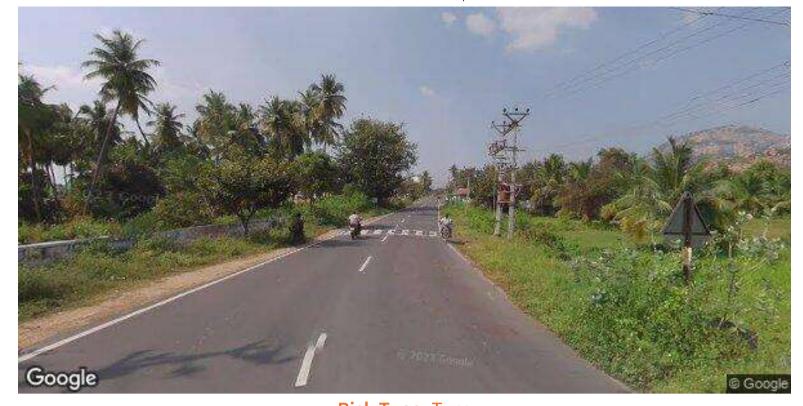
Risk Type: Turn
Risk Level: Medium
Speed Limit: 30 KM/Hr
Coordinates: 11.45352, 77.85698

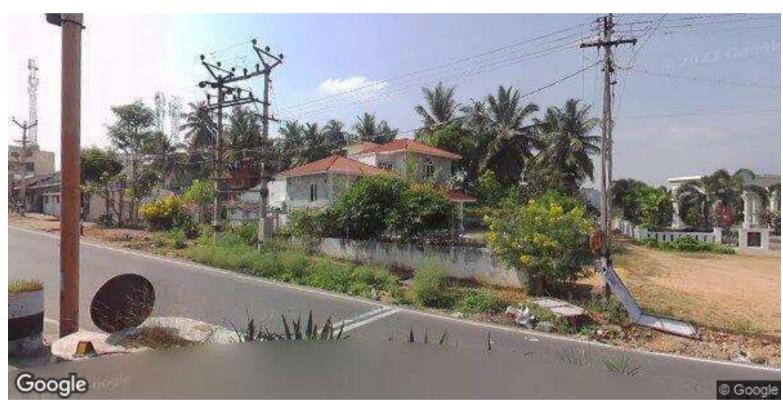
Risk Type: Turn
Risk Level: Medium
Speed Limit: 30 KM/Hr
Coordinates: 11.46303, 77.84945

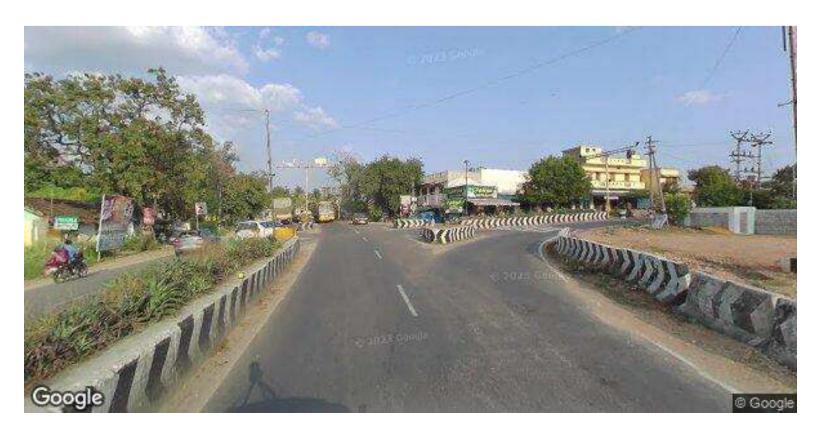
Coordinates: 11.46318, 77.84913

Risk Type: Turn
Risk Level: Medium
Speed Limit: 30 KM/Hr

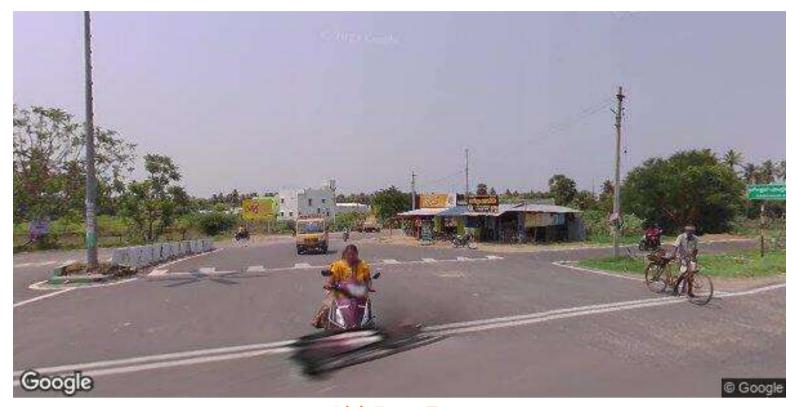
Coordinates: 11.34530, 77.64058

Risk Type: Turn
Risk Level: High
Speed Limit: 15 KM/Hr

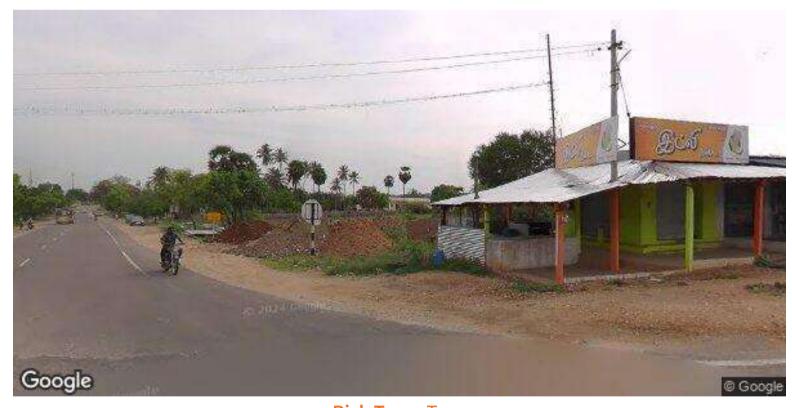
Coordinates: 11.34499, 77.64081

Risk Type: Turn
Risk Level: High
Speed Limit: 15 KM/Hr

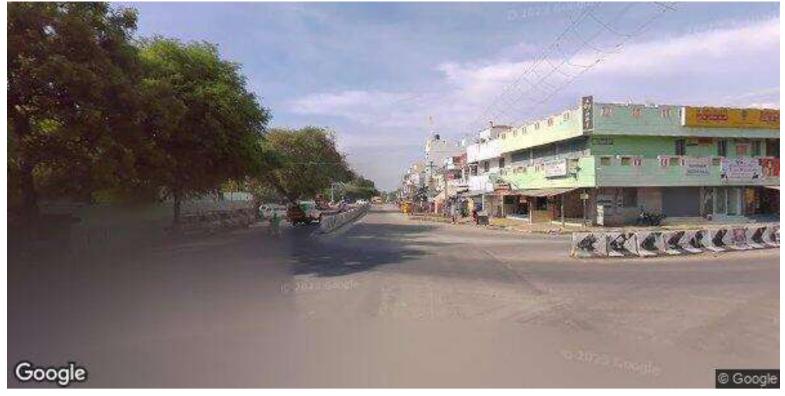
Risk Type: Blind Spot
Risk Level: Blind Spot
Speed Limit: 10 KM/Hr
Coordinates: 11.33828, 77.63811

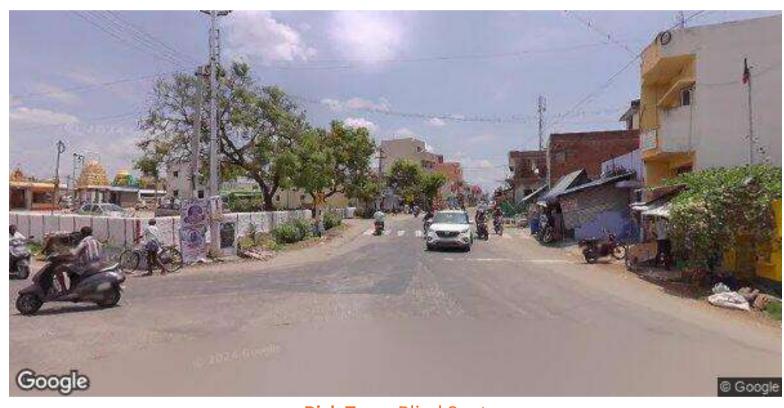
Risk Type: Blind Spot
Risk Level: Blind Spot
Speed Limit: 10 KM/Hr
Coordinates: 11.33843, 77.64074

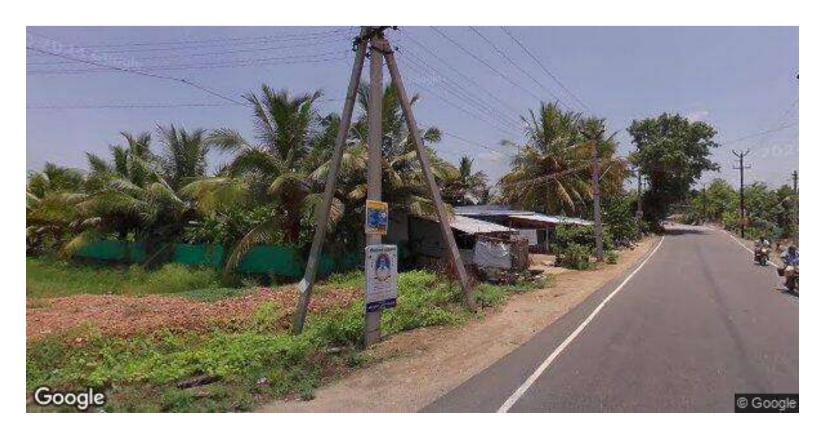
Coordinates: 11.31036, 77.64416

Risk Type: Turn
Risk Level: High
Speed Limit: 15 KM/Hr

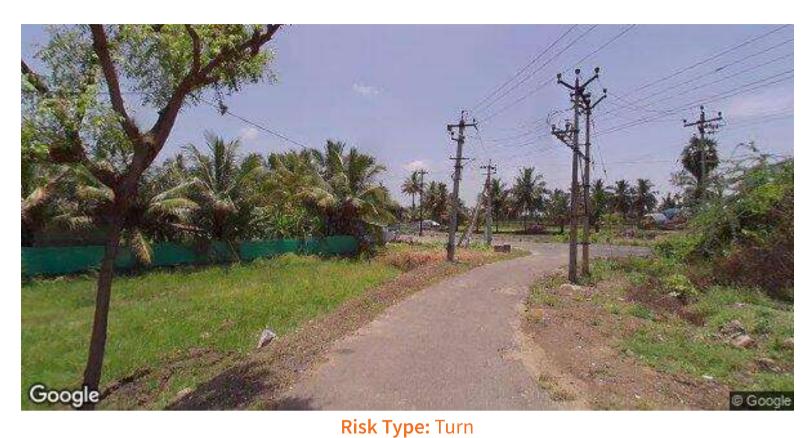
Risk Type: Turn
Risk Level: Medium
Speed Limit: 30 KM/Hr
Coordinates: 11.31017, 77.64390

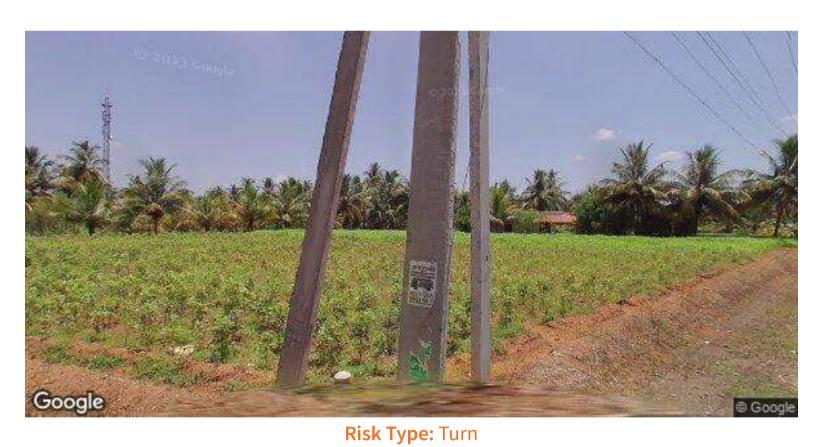
Risk Level: High
Speed Limit: 15 KM/Hr
Coordinates: 11.30925, 77.64361

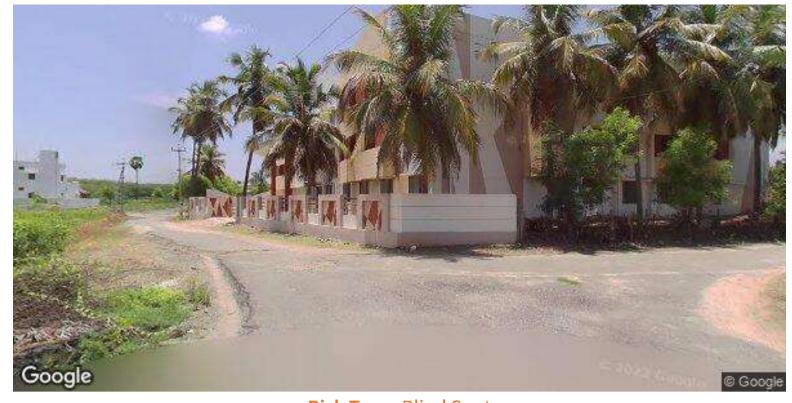
Risk Type: Blind Spot
Risk Level: Blind Spot
Speed Limit: 10 KM/Hr
Coordinates: 11.30899, 77.64304

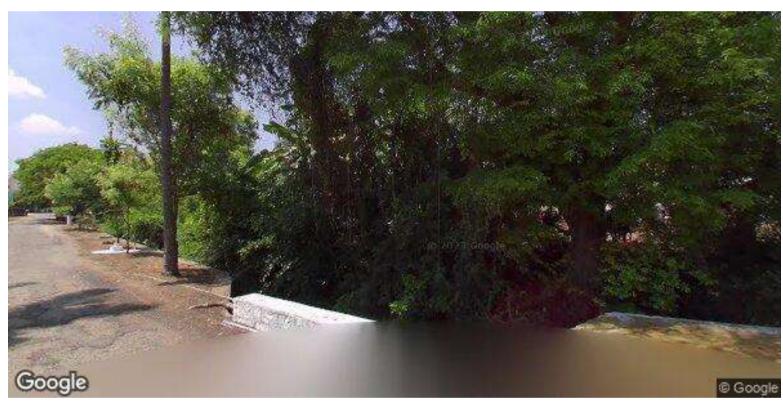
Coordinates: 11.30535, 77.64365

Risk Type: Blind Spot Risk Level: Blind Spot Speed Limit: 10 KM/Hr

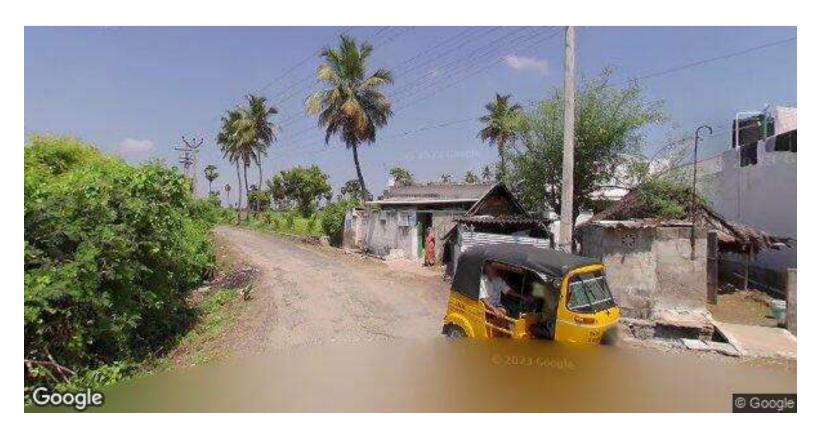
Coordinates: 11.30536, 77.64333

Risk Type: Turn
Risk Level: Medium
Speed Limit: 30 KM/Hr

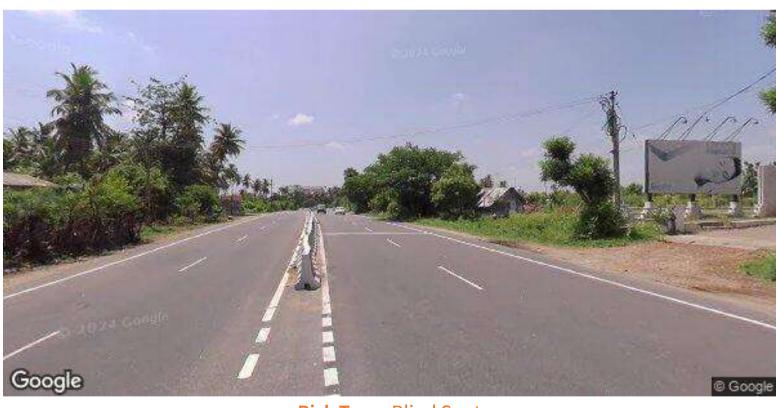
Coordinates: 11.29945, 77.64212

Risk Type: Blind Spot Risk Level: Blind Spot Speed Limit: 10 KM/Hr
