JOURNEY RISK MANAGEMENT (JRM) STUDY

Salem Terminal to ARAVINTH AGENCIES

Route Safety Analysis for the Route between Sangagiri to Kangeyam via Tiruchengode, Tamil Nadu, India

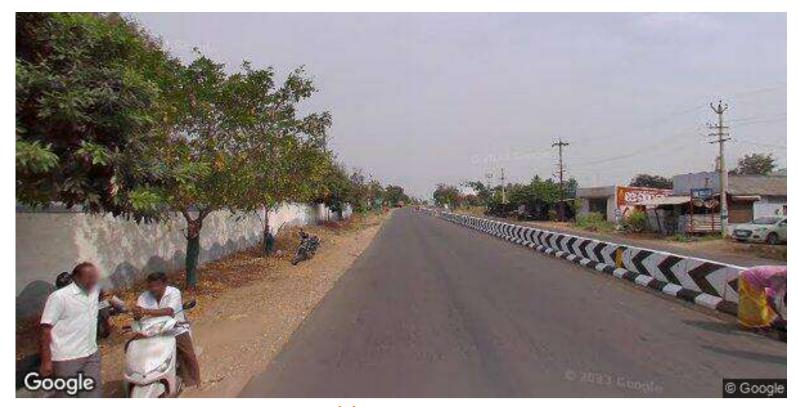
Coordinates: 11.0131468, 77.5636391

Risk Type: U-Turn
Risk Level: High
Speed Limit: 10 KM/Hr

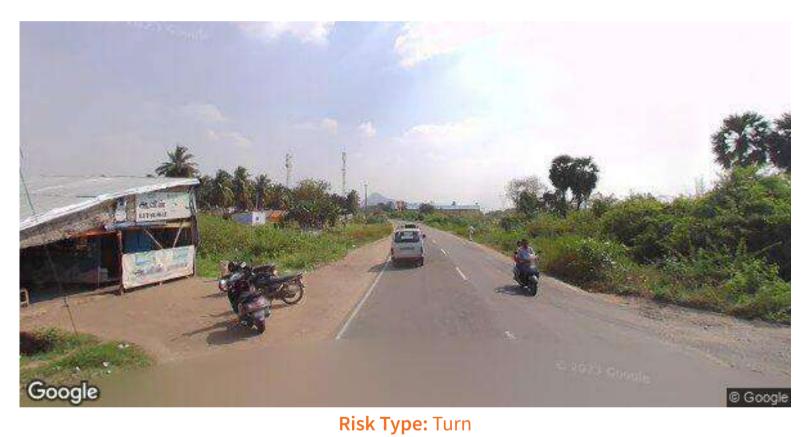
Risk Type: Turn
Risk Level: High
Speed Limit: 15 KM/Hr
Coordinates: 11.44022, 77.87546

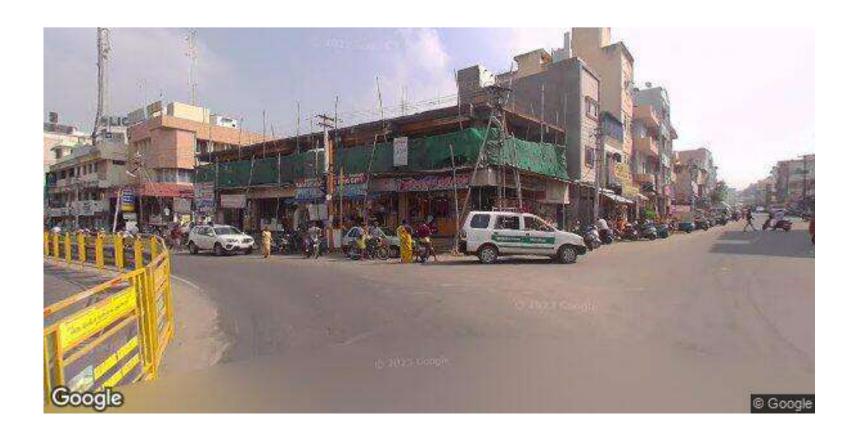
Coordinates: 11.37868, 77.89498

Risk Type: Turn
Risk Level: High
Speed Limit: 15 KM/Hr

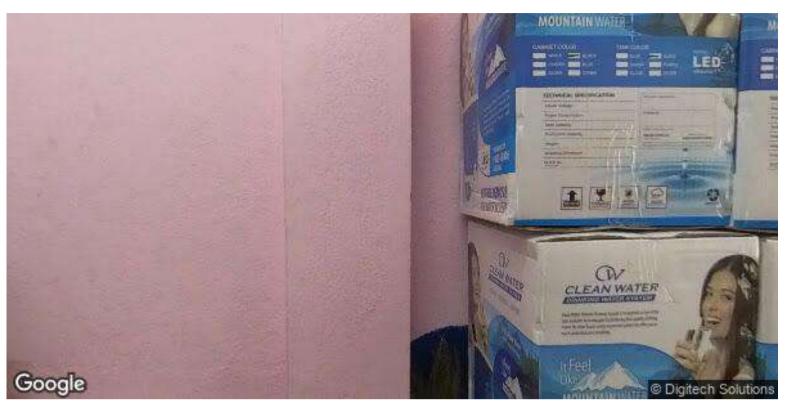
Coordinates: 11.37862, 77.89530

Risk Type: Blind Spot
Risk Level: Blind Spot
Speed Limit: 10 KM/Hr

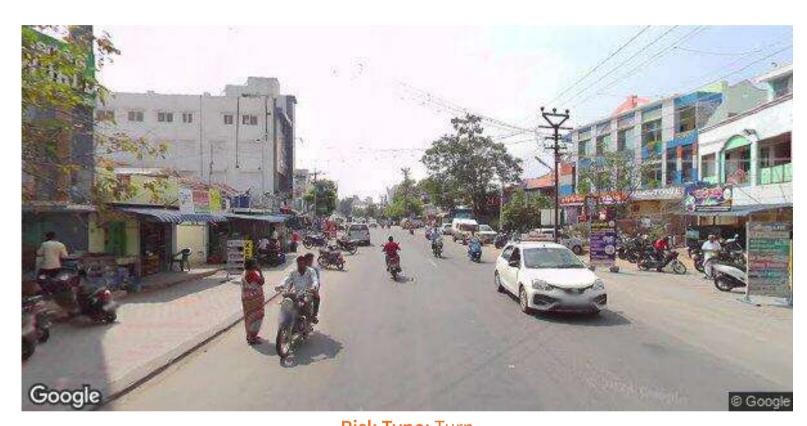
Risk Type: Turn
Risk Level: Medium
Speed Limit: 30 KM/Hr
Coordinates: 11.36919, 77.88934

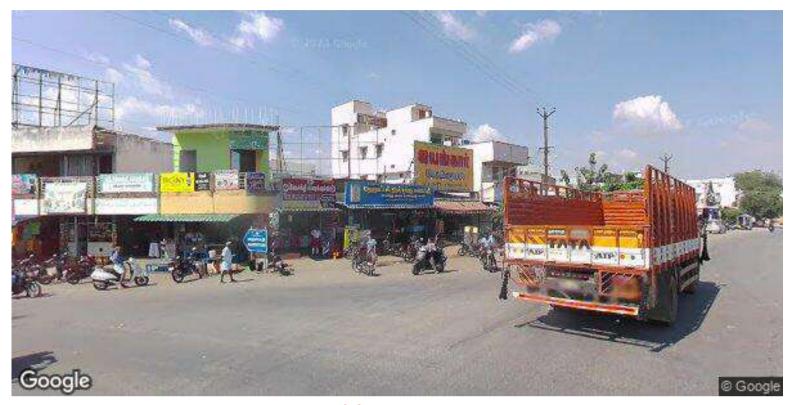
Coordinates: 11.36602, 77.88875

Risk Type: Turn
Risk Level: Medium
Speed Limit: 30 KM/Hr

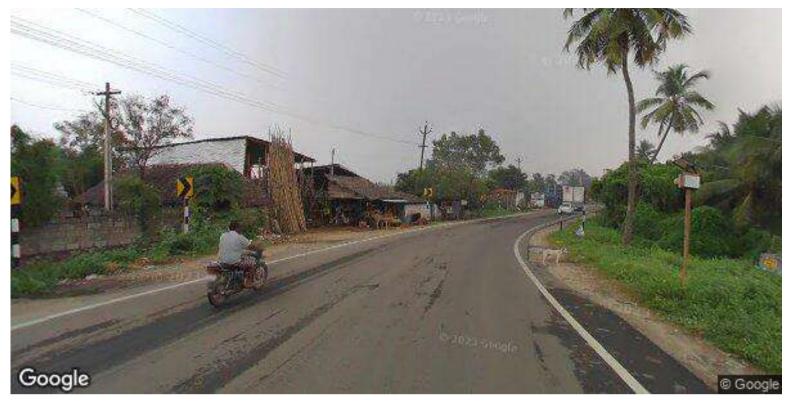
Coordinates: 11.30963, 77.76695

Risk Type: Turn
Risk Level: Medium
Speed Limit: 30 KM/Hr

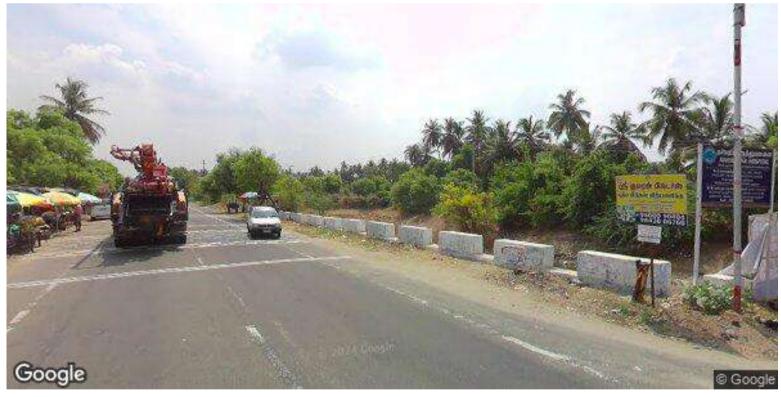
Coordinates: 11.29490, 77.74685

Risk Type: Turn
Risk Level: High
Speed Limit: 15 KM/Hr

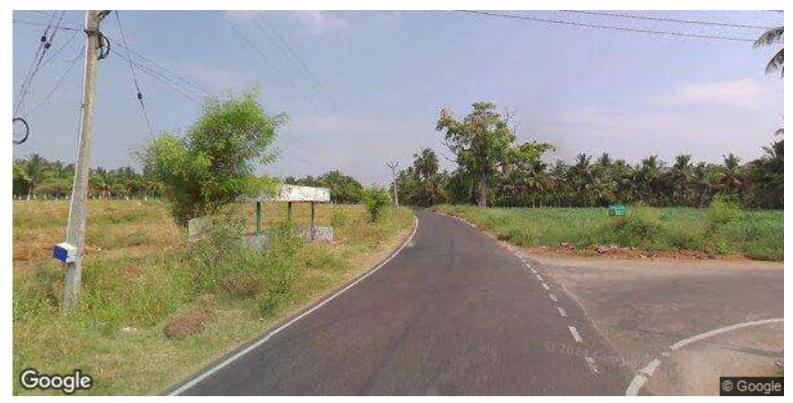
Risk Type: Turn
Risk Level: High
Speed Limit: 15 KM/Hr
Coordinates: 11.29141, 77.74662

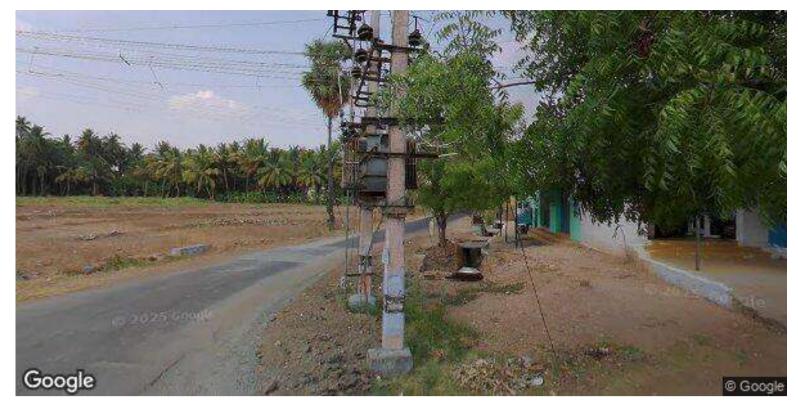
Coordinates: 11.27330, 77.72715

Risk Type: Blind Spot Risk Level: Blind Spot Speed Limit: 10 KM/Hr

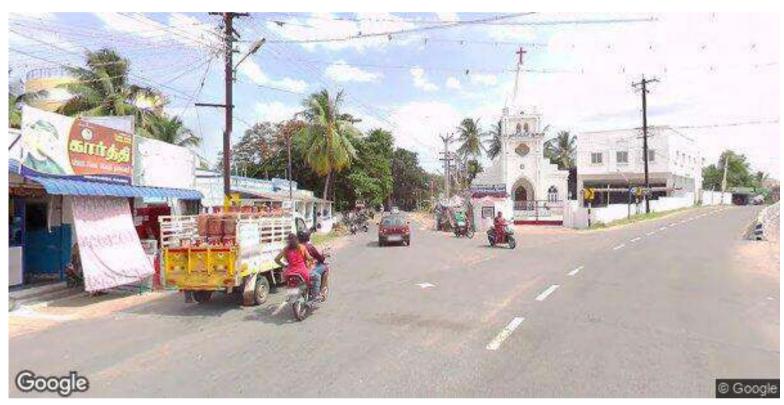
Risk Type: Turn
Risk Level: Medium
Speed Limit: 30 KM/Hr
Coordinates: 11.23054, 77.71796

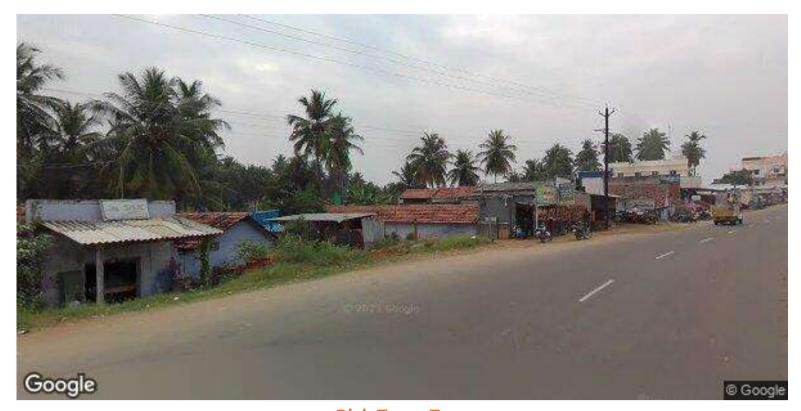
Risk Type: Turn
Risk Level: Medium
Speed Limit: 30 KM/Hr
Coordinates: 11.08730, 77.66436

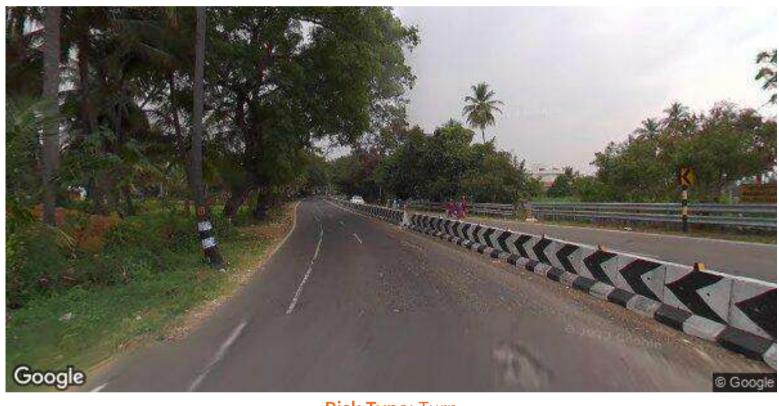
Risk Type: Turn
Risk Level: Medium
Speed Limit: 30 KM/Hr
Coordinates: 11.08282, 77.65837

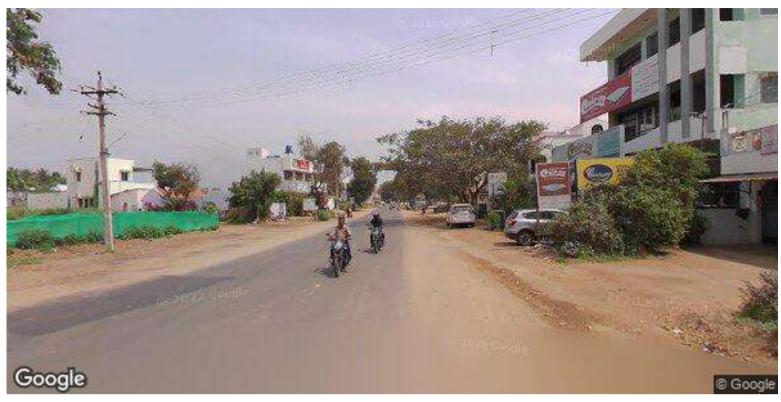
Risk Type: Turn
Risk Level: Medium
Speed Limit: 30 KM/Hr
Coordinates: 11.00744, 77.56586

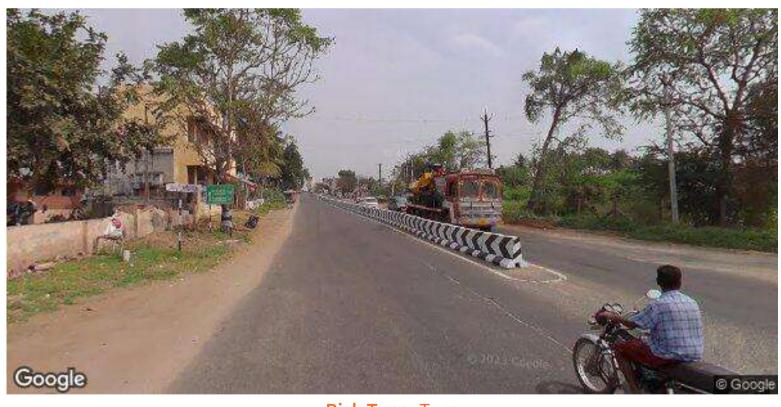
Risk Type: Turn
Risk Level: High
Speed Limit: 15 KM/Hr
Coordinates: 11.00915, 77.56212

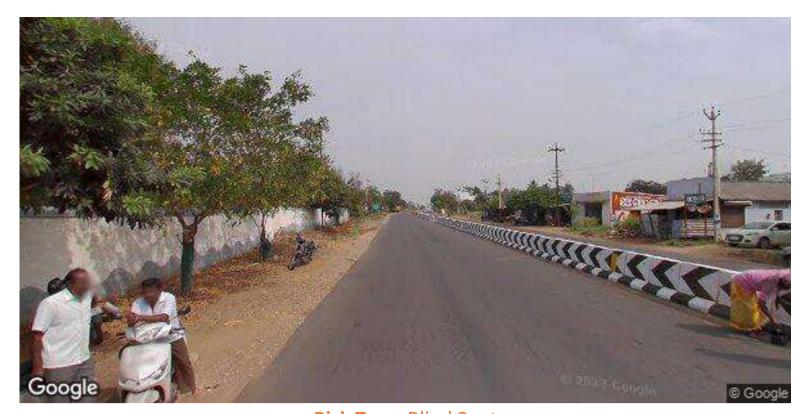
Coordinates: 11.01315, 77.56364

Risk Type: Blind Spot Risk Level: Blind Spot Speed Limit: 10 KM/Hr
