JOURNEY RISK MANAGEMENT (JRM) STUDY

Salem Terminal To SRI KALYAN PERUMAL FUELS

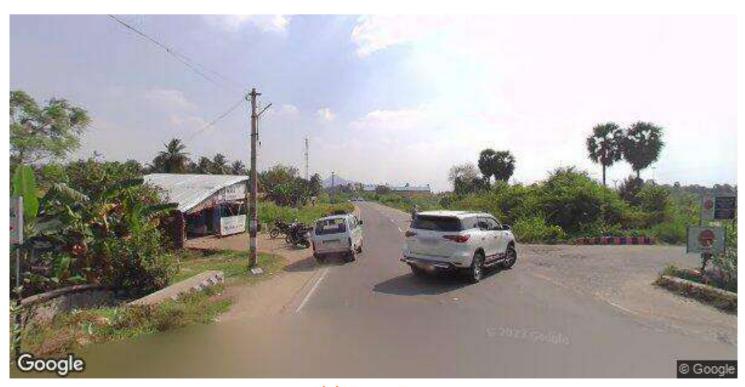
Risk Type: Turn Risk Level: High

Speed Limit: 15 KM/Hr Coordinates: 11.44029, 77.87544

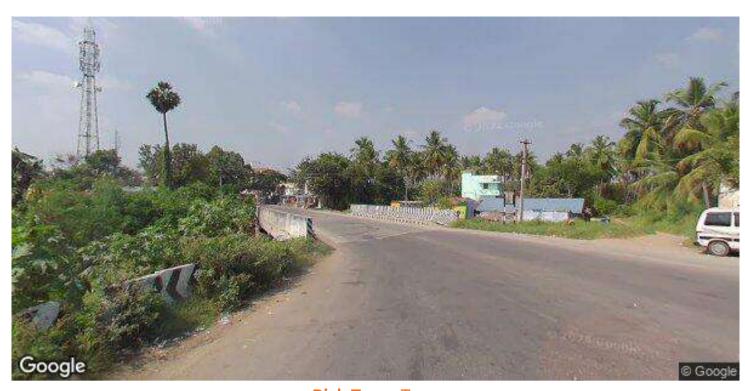
Risk Type: Turn
Risk Level: Medium
Speed Limit: 30 KM/Hr
Coordinates: 11.44893, 77.87413

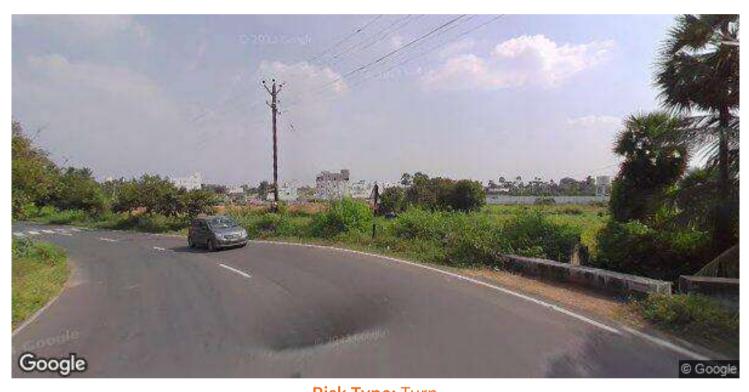
Risk Type: Turn
Risk Level: High
Speed Limit: 15 KM/Hr
Coordinates: 11.45350, 77.85700

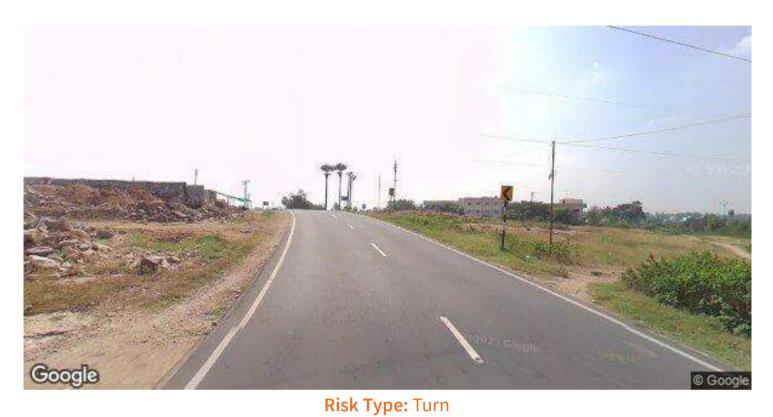
Risk Level: Medium
Speed Limit: 30 KM/Hr
Coordinates: 11.46046, 77.85037

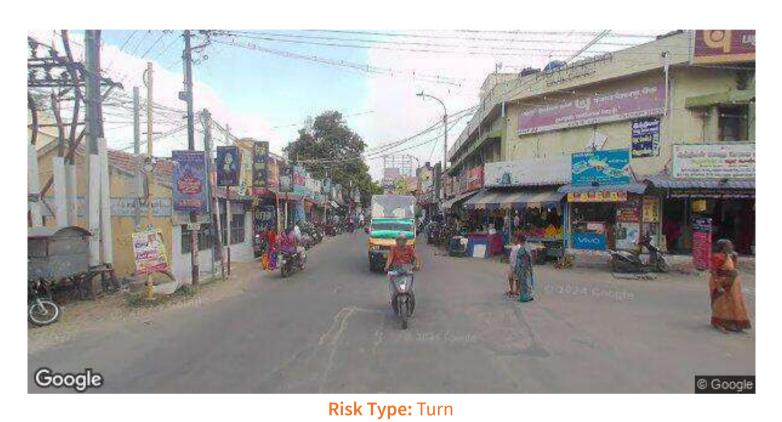
Risk Level: High
Speed Limit: 15 KM/Hr
Coordinates: 11.33913, 77.72832

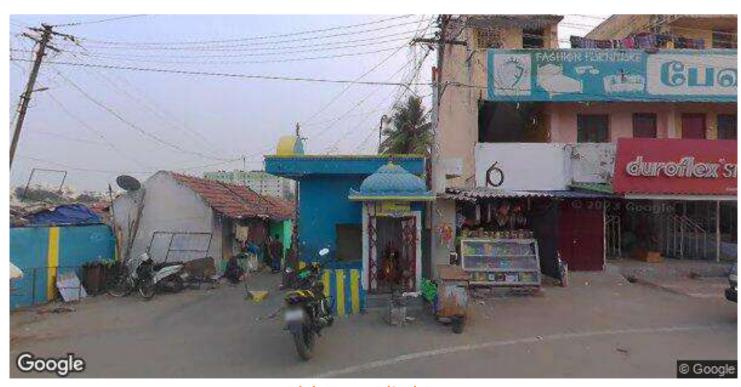
Risk Type: Blind Spot Risk Level: Blind Spot Speed Limit: 10 KM/Hr Coordinates: 11.33618, 77.72865

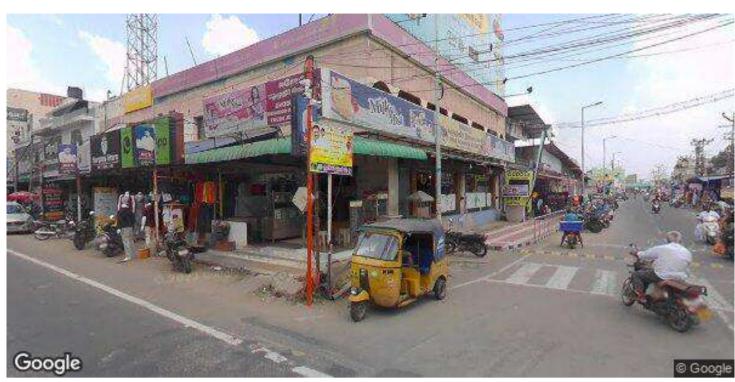
Risk Type: Blind Spot
Risk Level: Blind Spot
Speed Limit: 10 KM/Hr
Coordinates: 11.33582, 77.72712

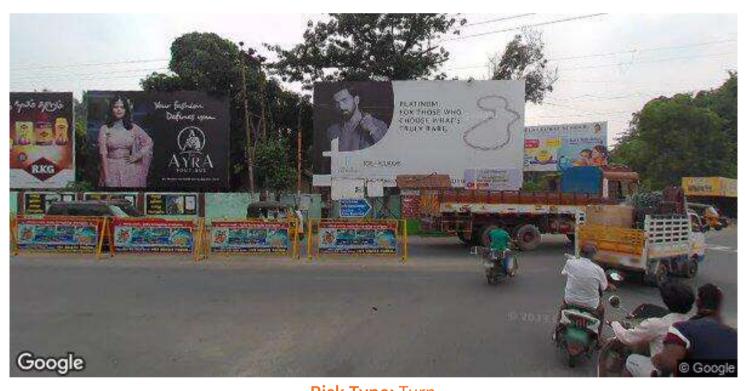
Risk Type: Turn
Risk Level: Medium
Speed Limit: 30 KM/Hr
Coordinates: 11.33092, 77.72748

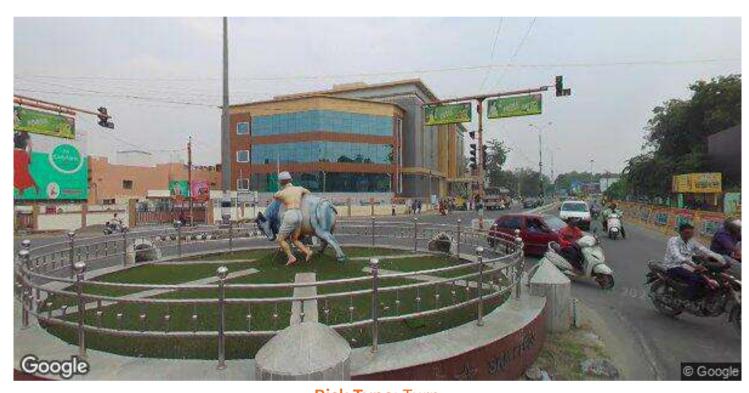
Risk Type: Turn
Risk Level: Medium
Speed Limit: 30 KM/Hr
Coordinates: 11.33083, 77.72740

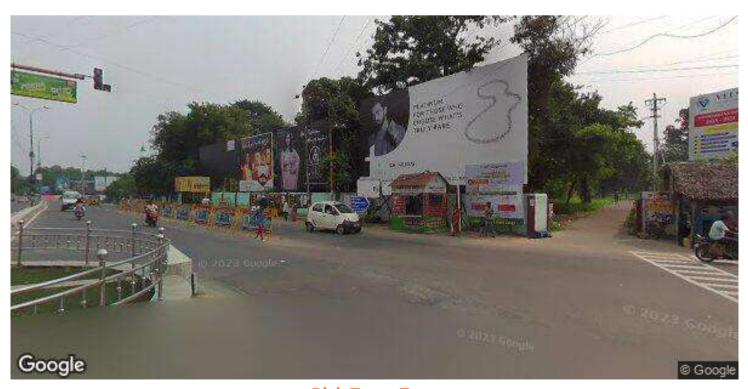
Risk Type: Turn
Risk Level: Medium

Speed Limit: 30 KM/Hr Coordinates: 11.33083, 77.72732

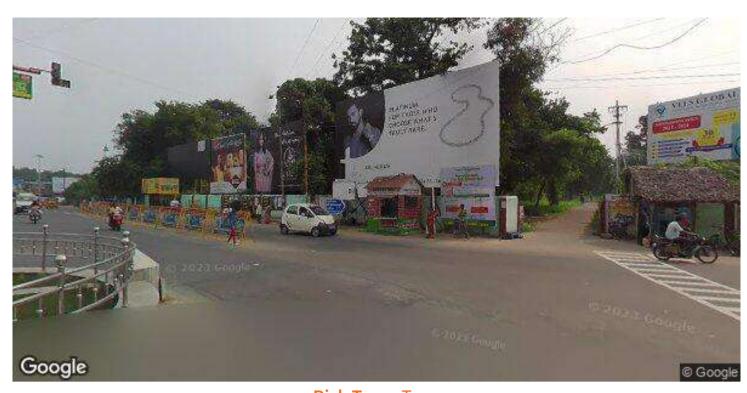
Risk Type: Turn
Risk Level: High
Speed Limit: 15 KM/Hr
Coordinates: 11.33085, 77.72730

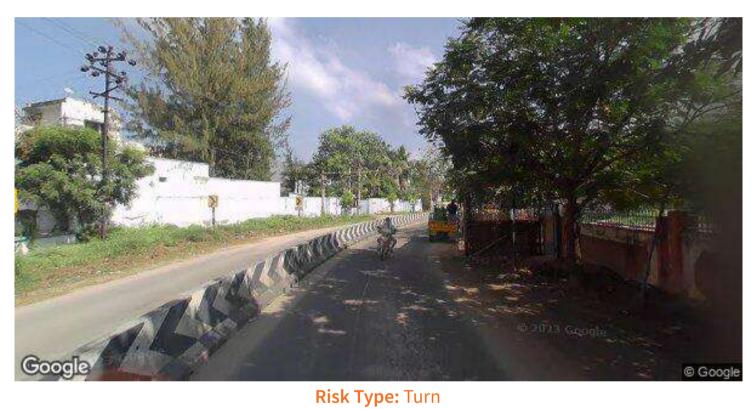
Risk Level: Medium
Speed Limit: 30 KM/Hr
Coordinates: 11.32259, 77.71458

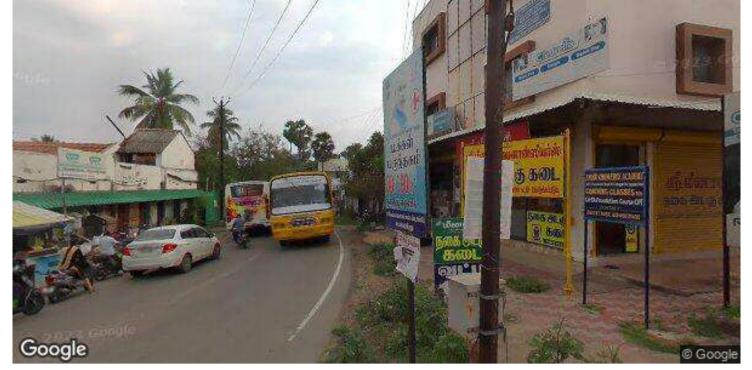
Risk Type: Turn
Risk Level: High
Speed Limit: 15 KM/Hr
Coordinates: 11.31165, 77.70717

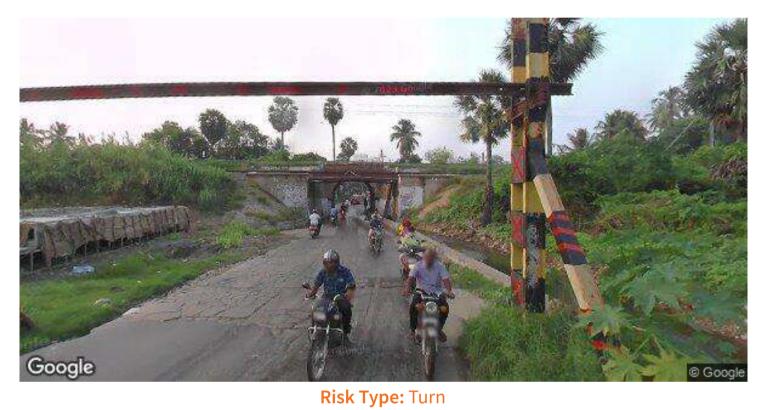
Risk Level: Medium
Speed Limit: 30 KM/Hr
Coordinates: 11.31050, 77.70781

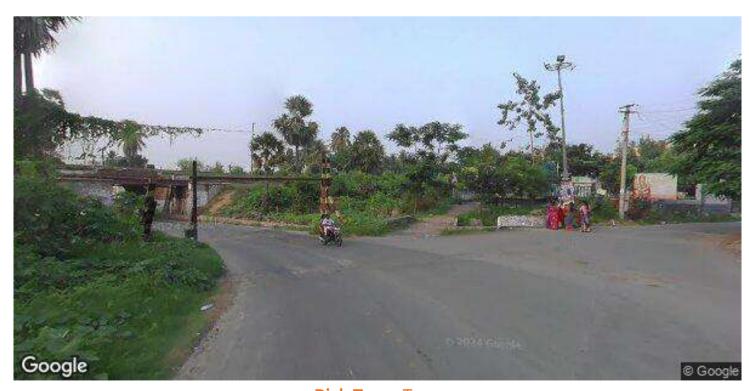
Risk Type: Turn
Risk Level: Medium

Speed Limit: 30 KM/Hr Coordinates: 11.31032, 77.70783

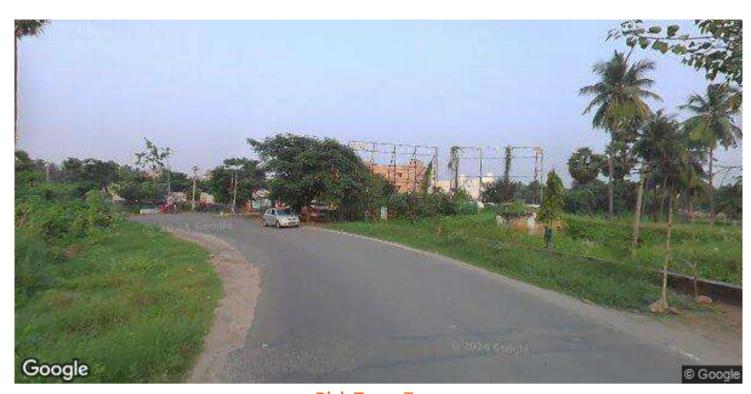
Risk Type: Turn
Risk Level: Medium
Speed Limit: 30 KM/Hr
Coordinates: 11.31003, 77.70761

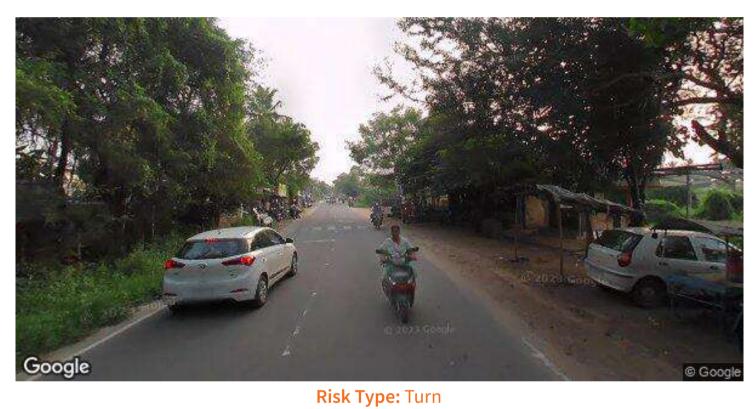
Risk Level: Medium
Speed Limit: 30 KM/Hr
Coordinates: 11.30807, 77.70415

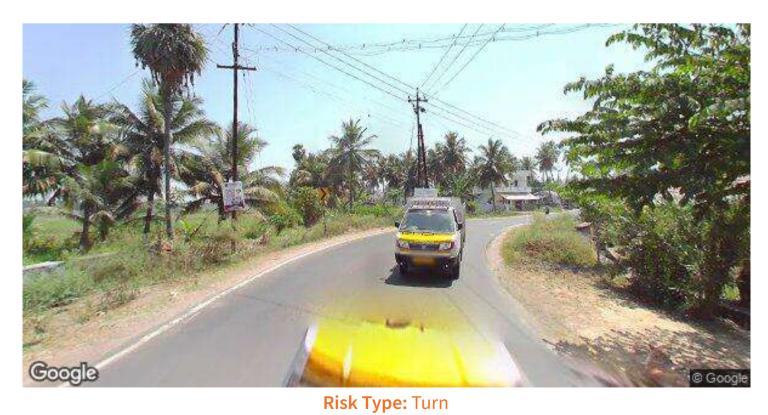
Risk Level: Medium

Speed Limit: 30 KM/Hr

Coordinates: 11.23837, 77.65729
