JOURNEY RISK MANAGEMENT (JRM) STUDY

Salem Terminal to ASHWIN AUTOMOBILES

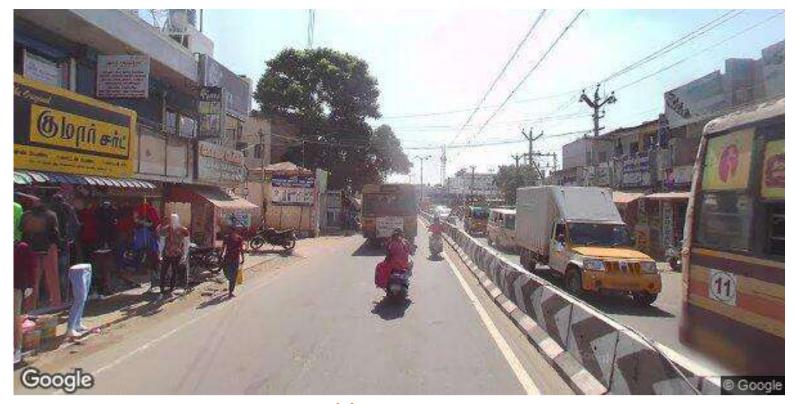
Coordinates: 11.1328729, 77.3421741

Risk Type: U-Turn
Risk Level: High
Speed Limit: 10 KM/Hr

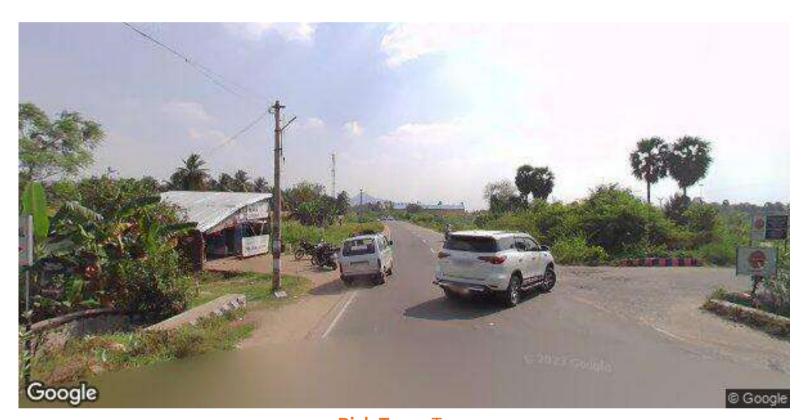
Risk Type: Turn
Risk Level: High
Speed Limit: 15 KM/Hr
Coordinates: 11.44029, 77.87544

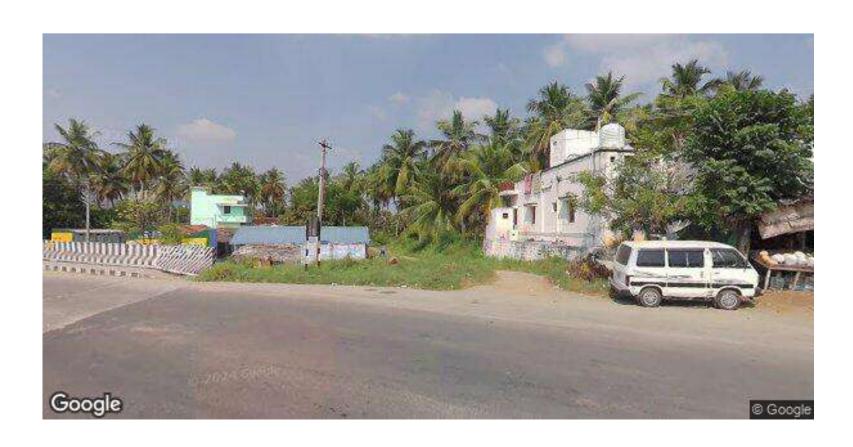
Coordinates: 11.44898, 77.87410

Risk Type: Turn
Risk Level: High
Speed Limit: 15 KM/Hr

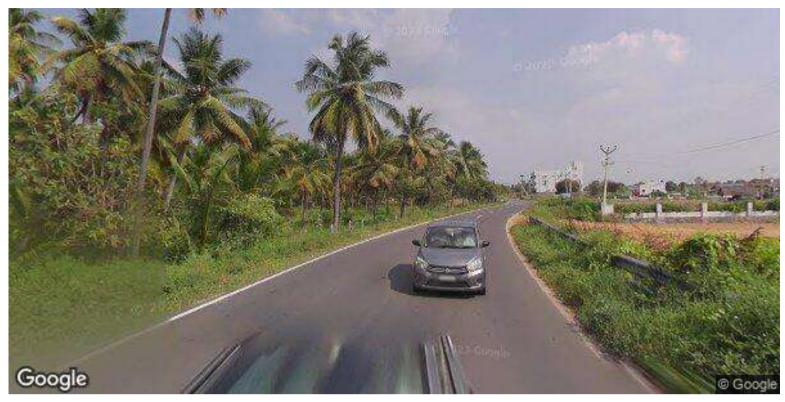
Coordinates: 11.45357, 77.85789

Risk Type: Turn
Risk Level: Medium
Speed Limit: 30 KM/Hr

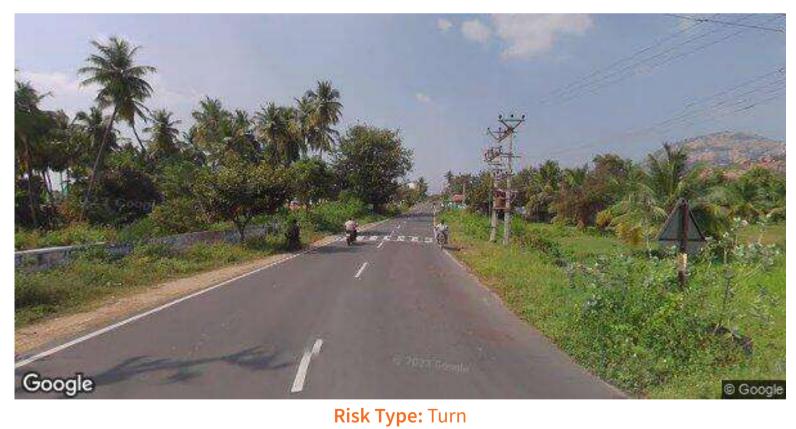
Coordinates: 11.45352, 77.85698

Risk Level: High

Speed Limit: 15 KM/Hr

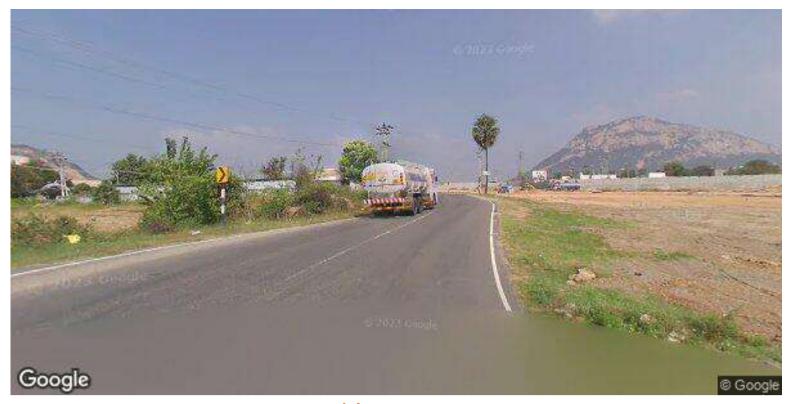
Risk Type: Turn
Risk Level: Medium
Speed Limit: 30 KM/Hr
Coordinates: 11.45847, 77.85140

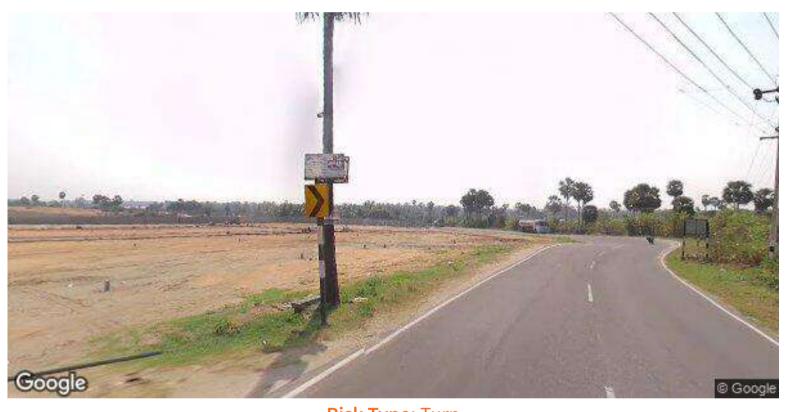
Risk Type: Turn
Risk Level: Medium
Speed Limit: 30 KM/Hr
Coordinates: 11.45898, 77.85135

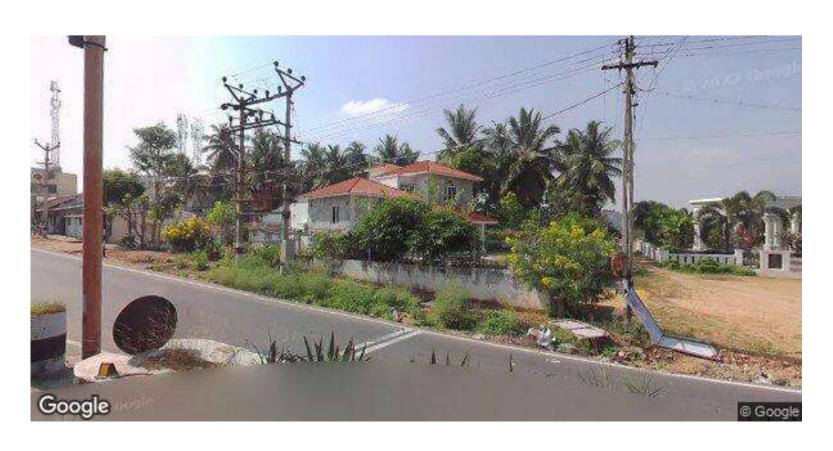
Coordinates: 11.46303, 77.84945

Risk Type: Turn
Risk Level: Medium
Speed Limit: 30 KM/Hr

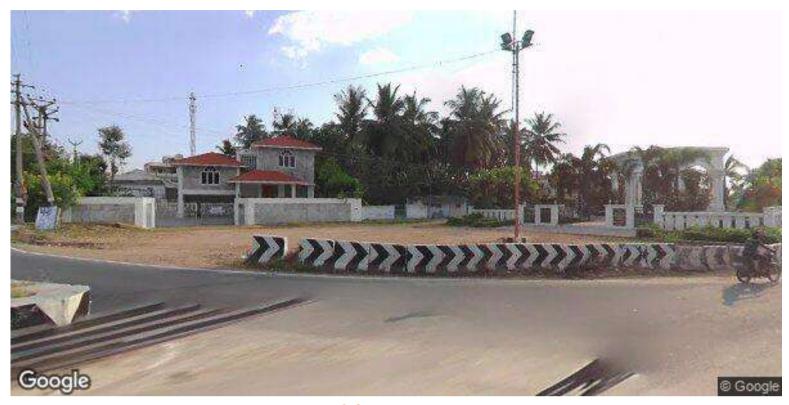
Coordinates: 11.46314, 77.84928

Risk Type: Turn
Risk Level: Medium
Speed Limit: 30 KM/Hr

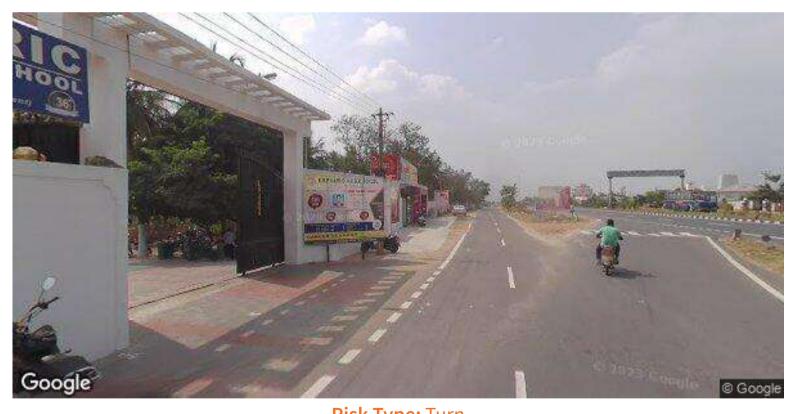
Coordinates: 11.45509, 77.81383

Risk Type: Turn
Risk Level: Medium
Speed Limit: 30 KM/Hr

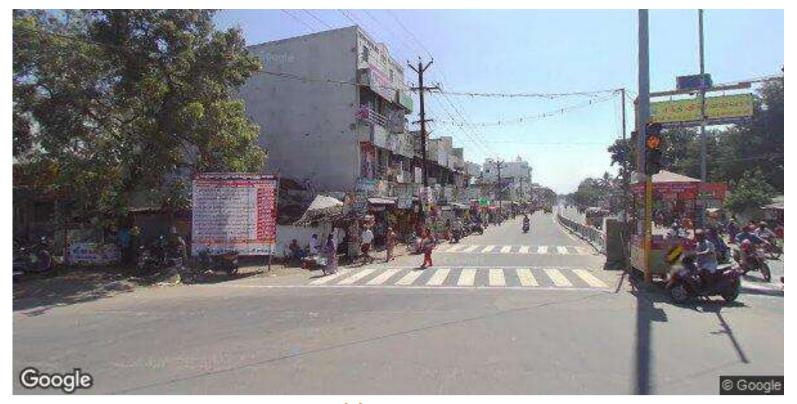
Risk Type: Turn
Risk Level: High
Speed Limit: 15 KM/Hr
Coordinates: 11.20728, 77.35914

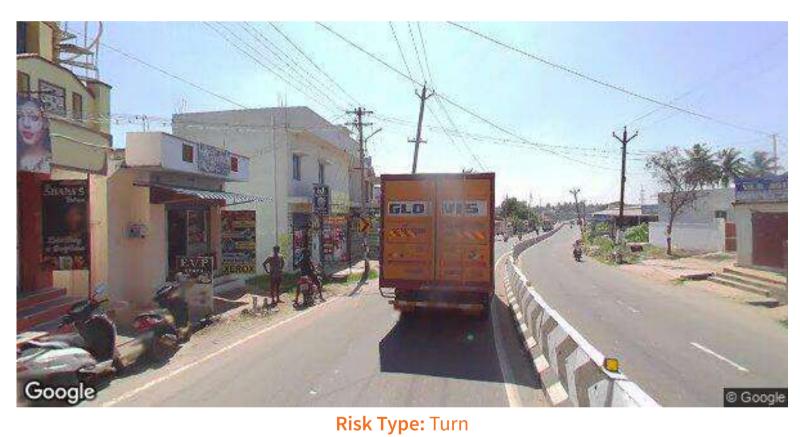
Risk Type: Turn
Risk Level: Medium
Speed Limit: 30 KM/Hr
Coordinates: 11.20246, 77.35895

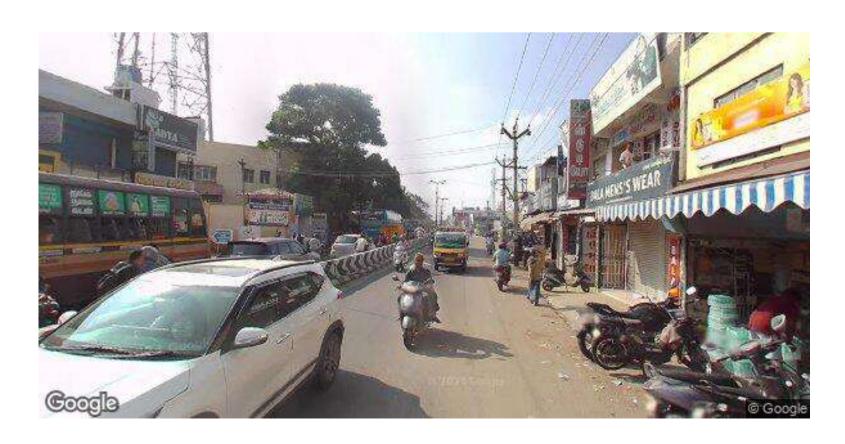
Coordinates: 11.13289, 77.34212

Risk Type: Blind Spot Risk Level: Blind Spot Speed Limit: 10 KM/Hr
