# JOURNEY RISK MANAGEMENT (JRM) STUDY

# Salem Terminal to SUMEDHA AGENCIES

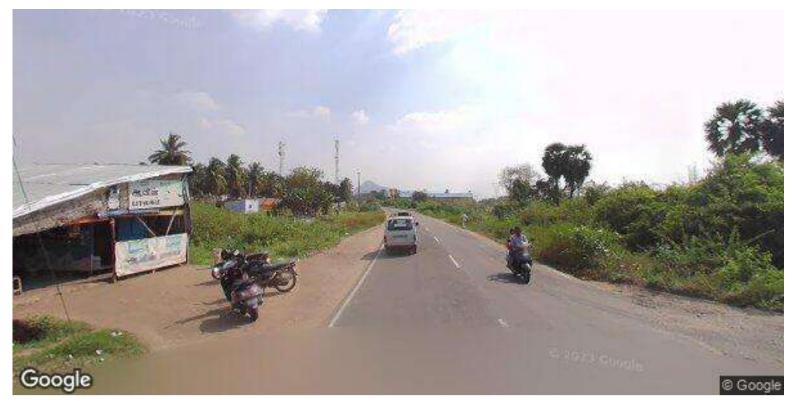
Risk Type: Turn
Risk Level: High
Speed Limit: 15 KM/Hr
Coordinates: 11.44022, 77.87546

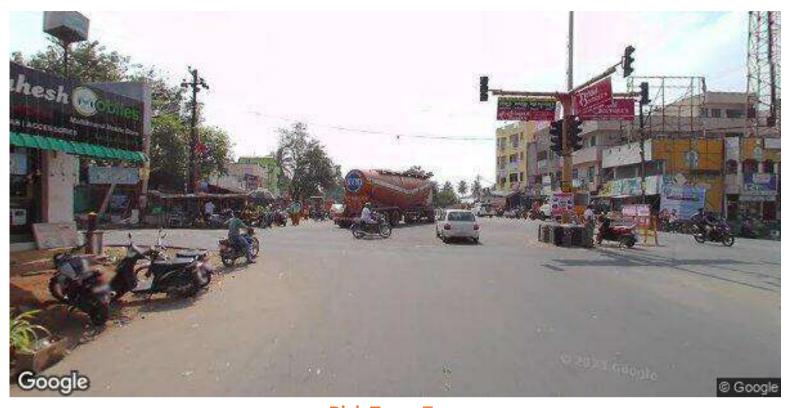
**Coordinates:** 11.36616, 77.88885

Risk Type: Turn
Risk Level: Medium
Speed Limit: 30 KM/Hr

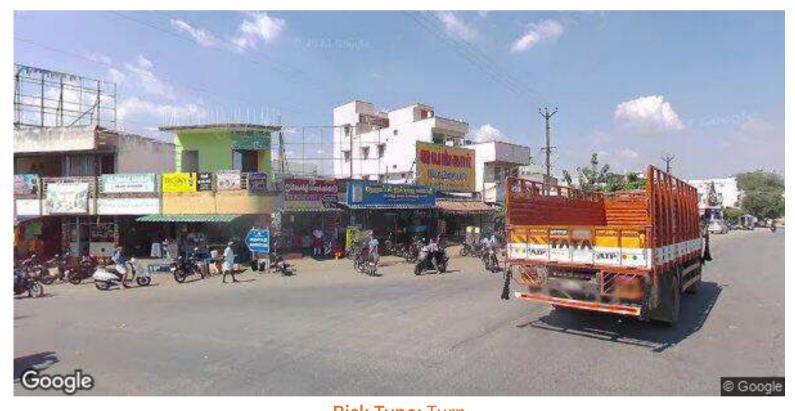
Risk Type: Turn
Risk Level: Medium
Speed Limit: 30 KM/Hr
Coordinates: 11.36602, 77.88875

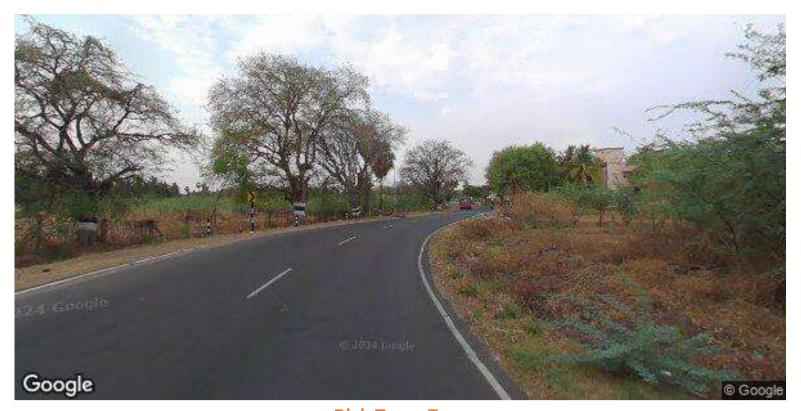
Risk Type: Turn
Risk Level: Medium
Speed Limit: 30 KM/Hr
Coordinates: 11.34067, 77.86347

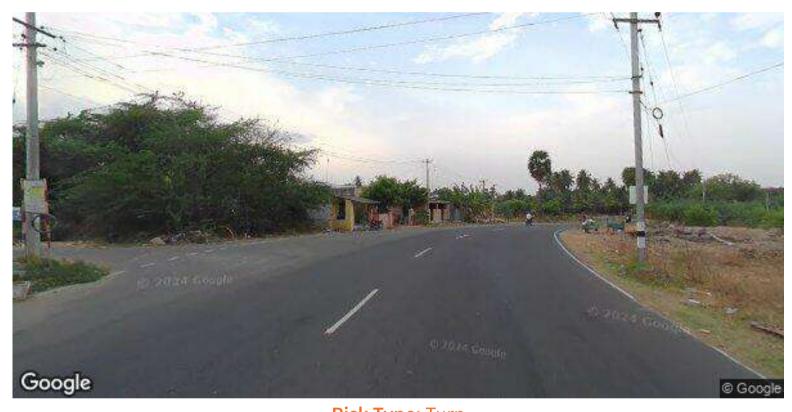
Risk Type: Turn
Risk Level: Medium
Speed Limit: 30 KM/Hr
Coordinates: 11.33854, 77.86216

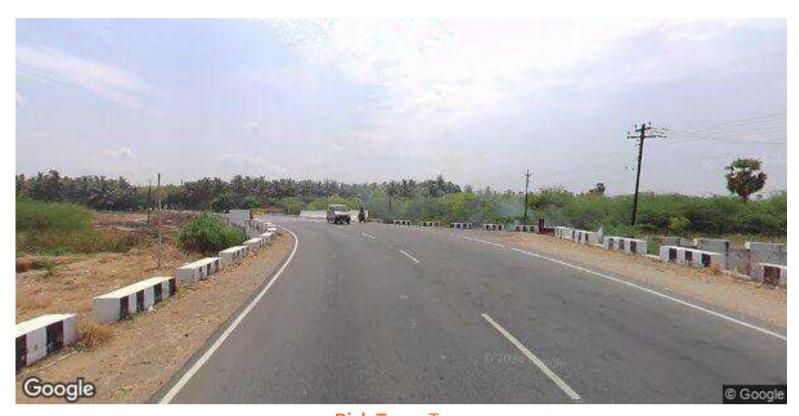
Risk Type: Turn
Risk Level: Medium
Speed Limit: 30 KM/Hr
Coordinates: 11.31746, 77.84231

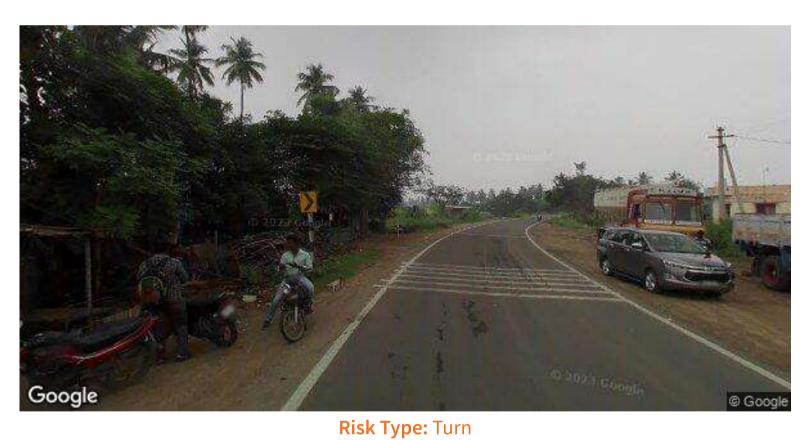
Risk Type. Turn
Risk Level: Medium
Speed Limit: 30 KM/Hr
Coordinates: 11.30951, 77.77598

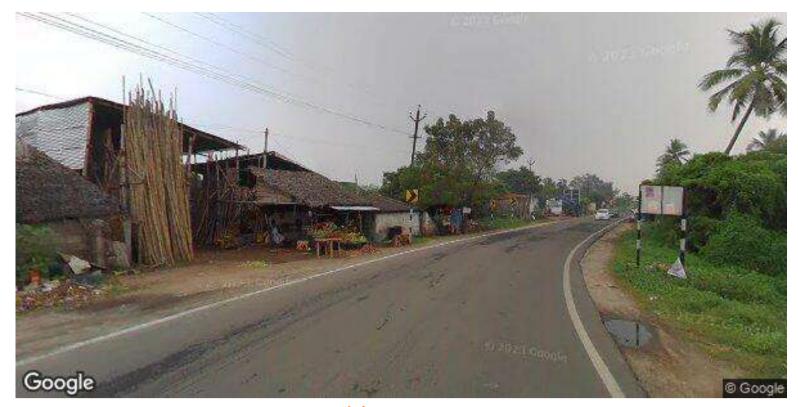
Risk Type: Turn
Risk Level: Medium
Speed Limit: 30 KM/Hr
Coordinates: 11.30968, 77.76701

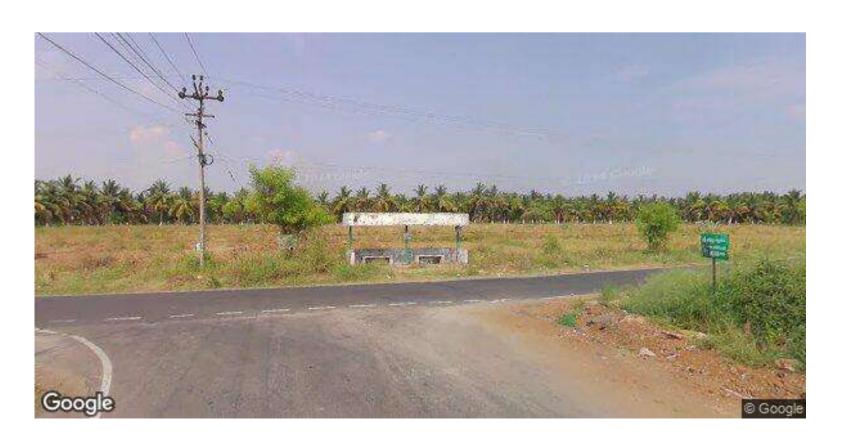
**Coordinates:** 11.29128, 77.74656

Risk Type: Turn
Risk Level: High
Speed Limit: 15 KM/Hr

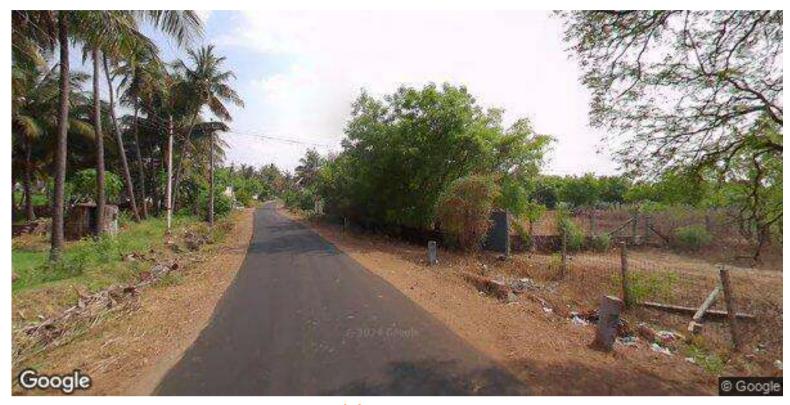
Risk Type: Turn
Risk Level: Medium
Speed Limit: 30 KM/Hr
Coordinates: 11.29051, 77.74482

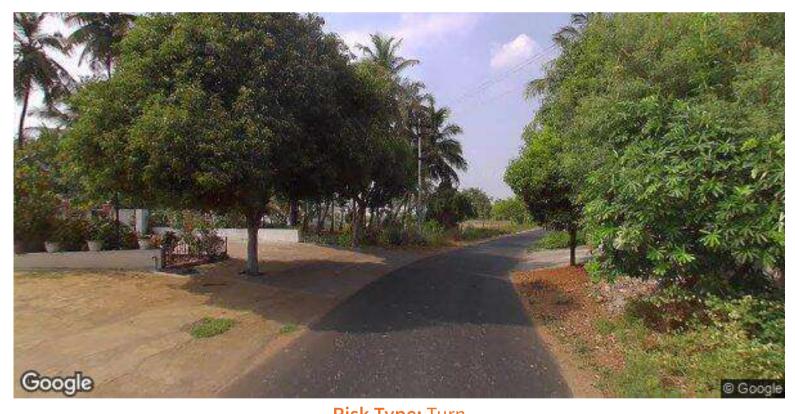
Risk Type: Turn
Risk Level: Medium
Speed Limit: 30 KM/Hr
Coordinates: 11.28859, 77.74323

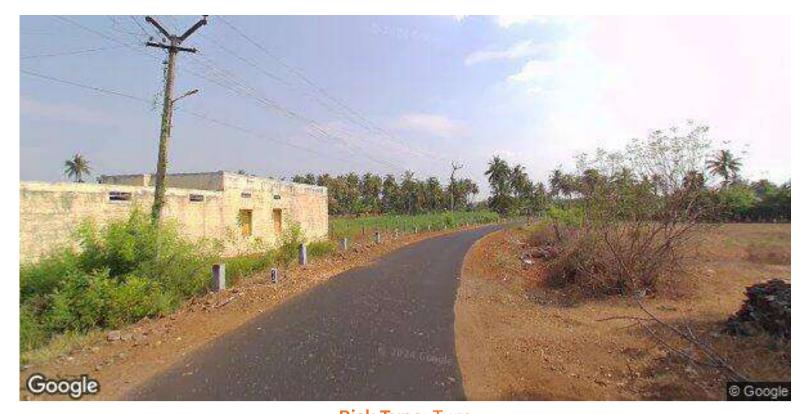
Risk Type: Turn
Risk Level: Medium
Speed Limit: 30 KM/Hr
Coordinates: 11.28588, 77.74287

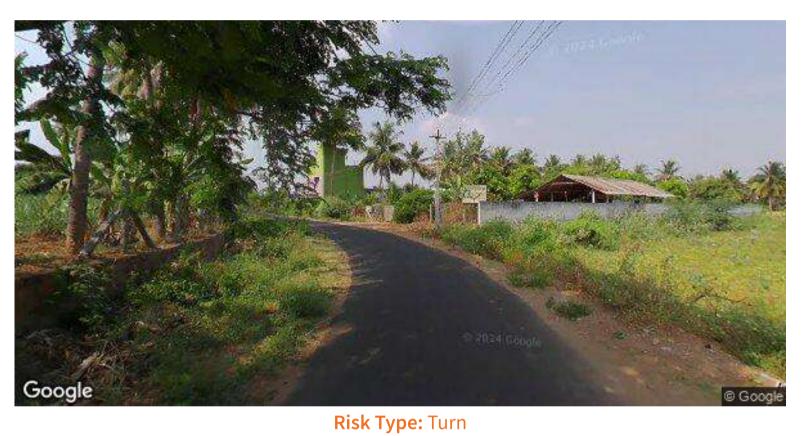
Coordinates: 11.27326, 77.72991

Risk Type: Turn

Risk Level: High

Speed Limit: 15 KM/Hr

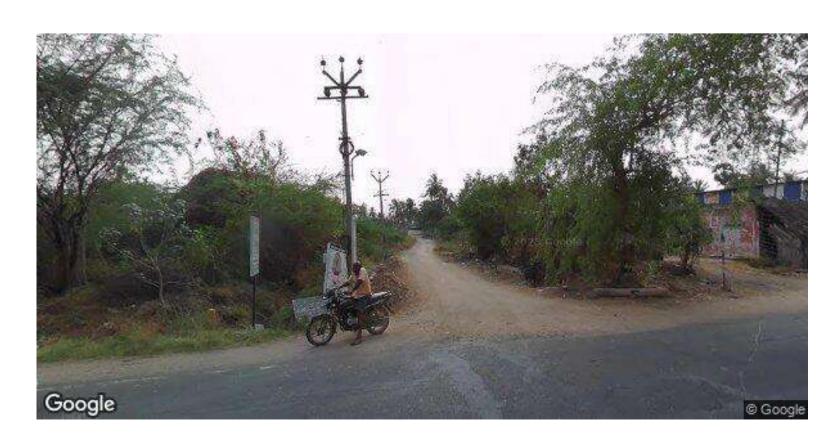
**Coordinates:** 11.27330, 77.72711

Risk Type: Blind Spot Risk Level: Blind Spot Speed Limit: 10 KM/Hr

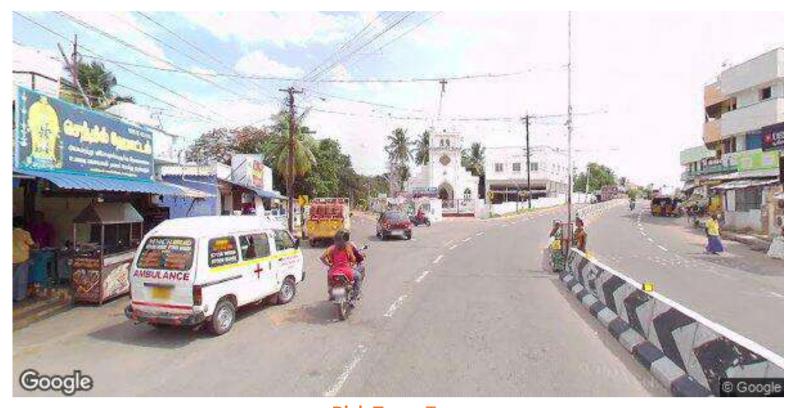
**Coordinates:** 11.23062, 77.71799

Risk Type: Turn
Risk Level: Medium
Speed Limit: 30 KM/Hr

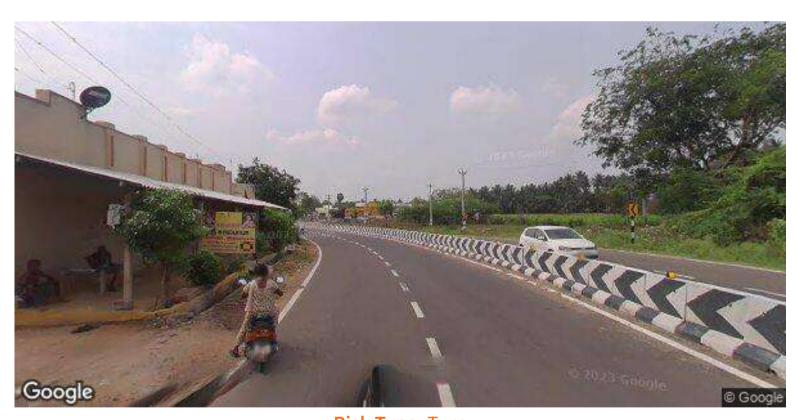
Risk Type: Turn
Risk Level: Medium
Speed Limit: 30 KM/Hr
Coordinates: 11.22395, 77.71387

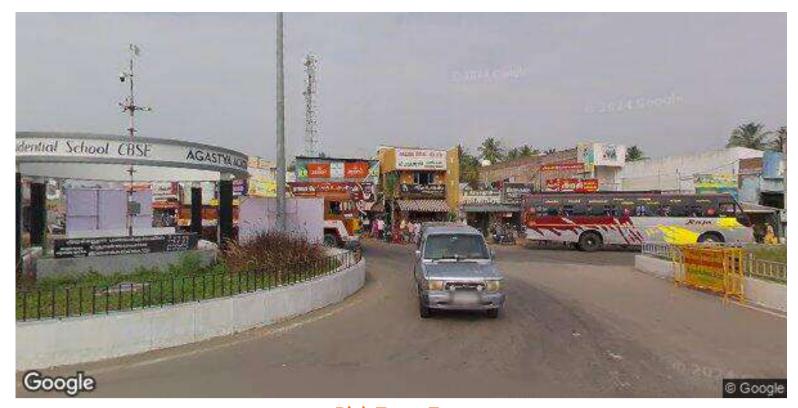
Risk Type: Turn
Risk Level: Medium
Speed Limit: 30 KM/Hr
Coordinates: 11.15951, 77.70067

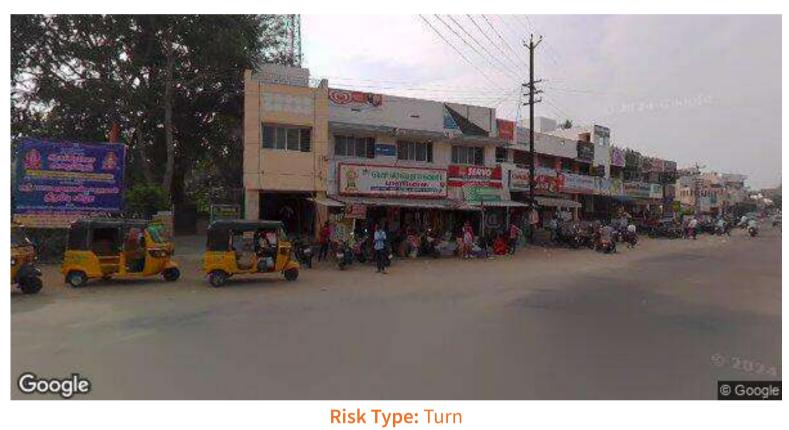
Risk Type: Turn
Risk Level: High
Speed Limit: 15 KM/Hr
Coordinates: 11.15942, 77.70068

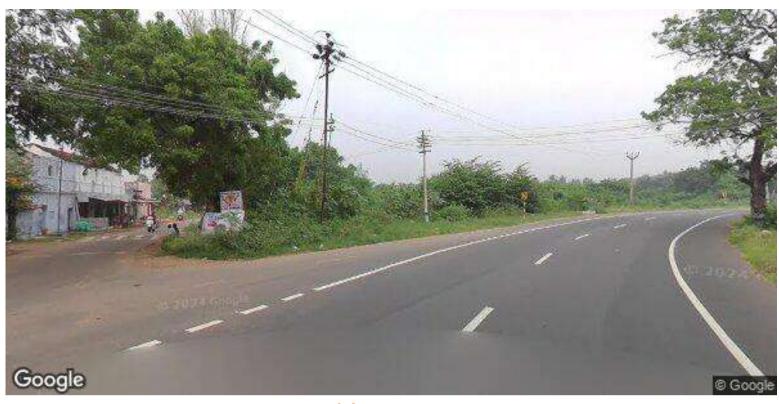
**Coordinates:** 11.11716, 77.67178

Risk Type: Turn
Risk Level: Medium
Speed Limit: 30 KM/Hr

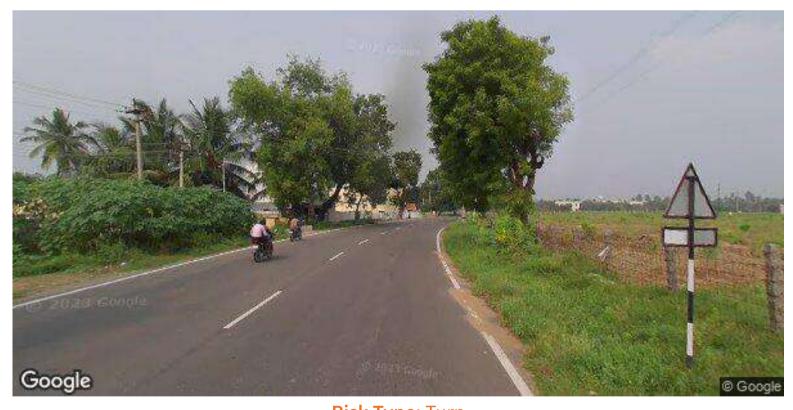
Risk Type: Turn
Risk Level: Medium
Speed Limit: 30 KM/Hr
Coordinates: 11.09494, 77.66604

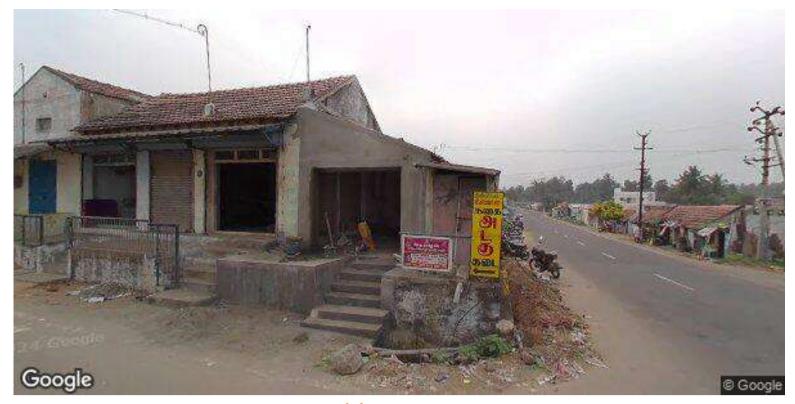
Risk Type: Turn
Risk Level: Medium
Speed Limit: 30 KM/Hr
Coordinates: 11.08499, 77.66196

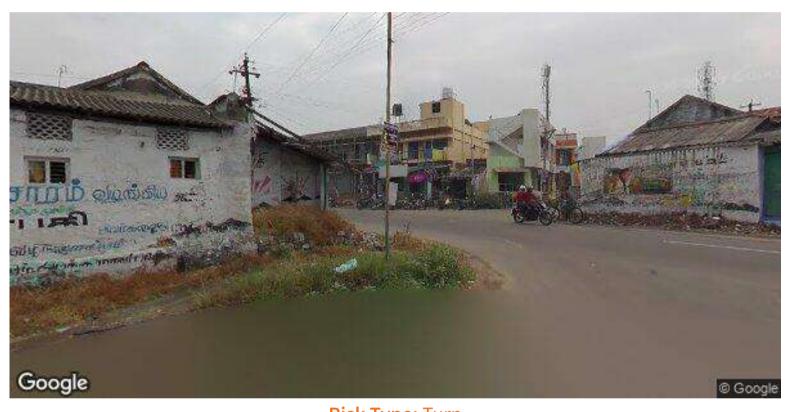
Risk Type: Turn
Risk Level: Medium
Speed Limit: 30 KM/Hr
Coordinates: 11.08497, 77.66170

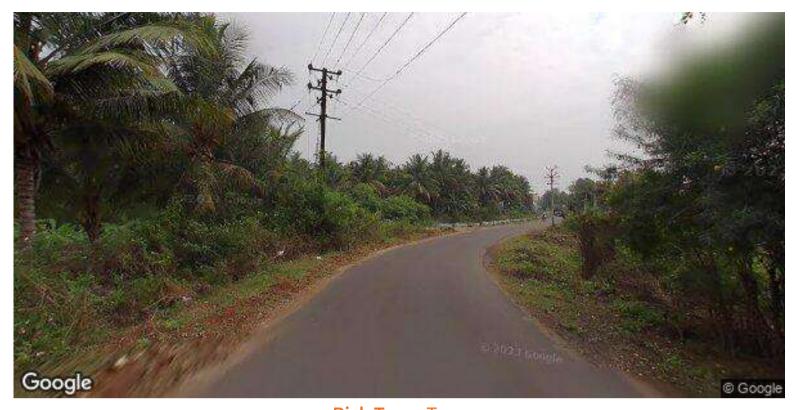
Coordinates: 11.08594, 77.65198

Risk Type: Turn
Risk Level: Medium
Speed Limit: 30 KM/Hr

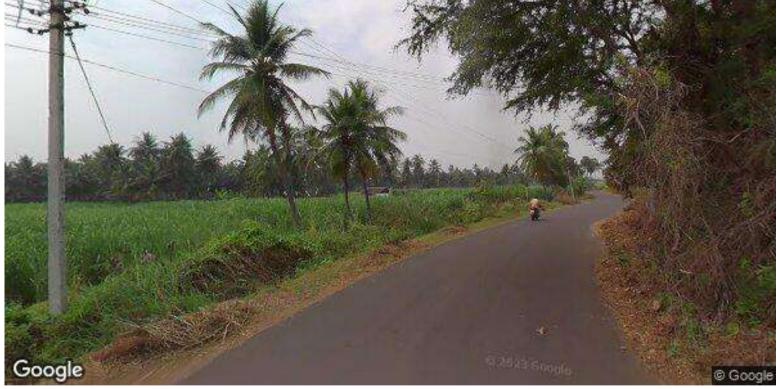
Risk Type: Turn
Risk Level: Medium
Speed Limit: 30 KM/Hr
Coordinates: 11.08501, 77.65091

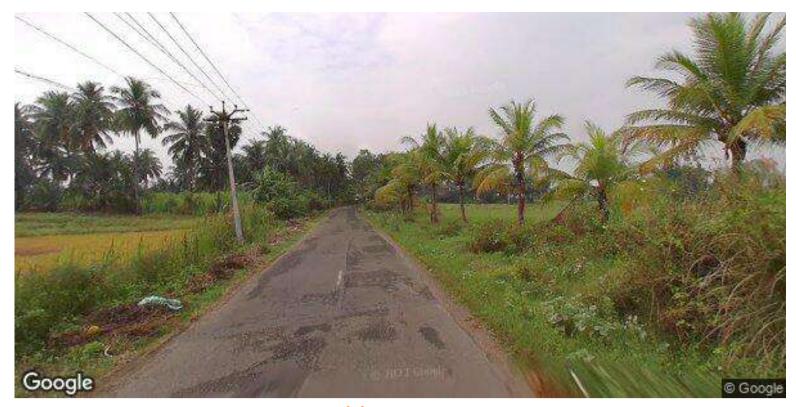
Risk Type: Turn
Risk Level: Medium
Speed Limit: 30 KM/Hr
Coordinates: 11.08411, 77.64613

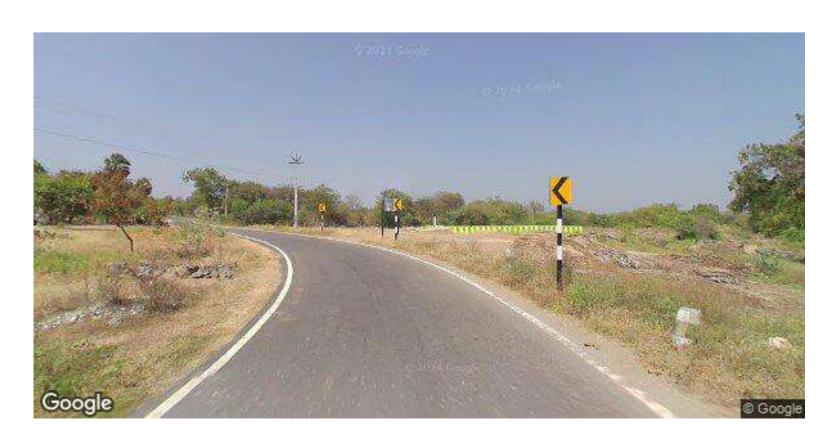
**Coordinates:** 11.08011, 77.63502

Risk Type: Turn
Risk Level: High
Speed Limit: 15 KM/Hr

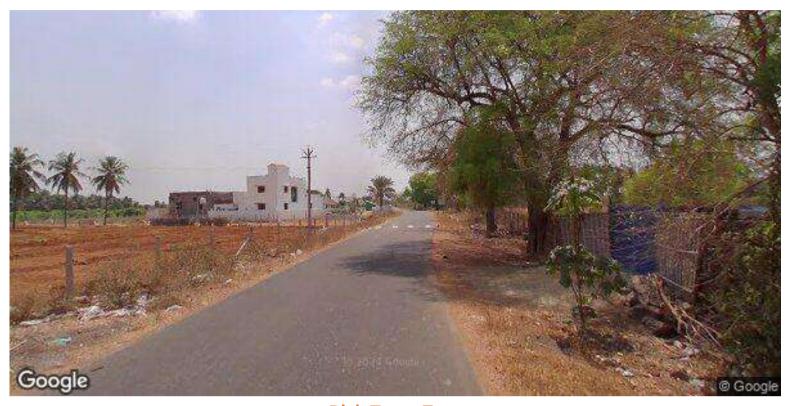
Risk Type: Turn
Risk Level: Medium
Speed Limit: 30 KM/Hr
Coordinates: 11.07494, 77.61236

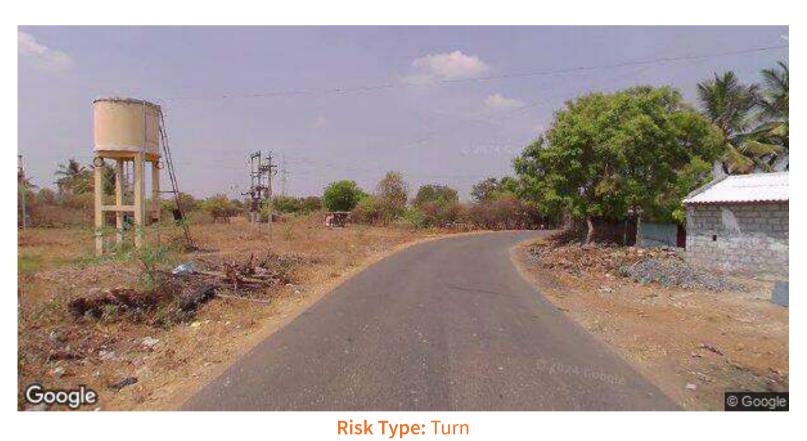
Risk Type. Turn
Risk Level: Medium
Speed Limit: 30 KM/Hr
Coordinates: 11.07378, 77.61177

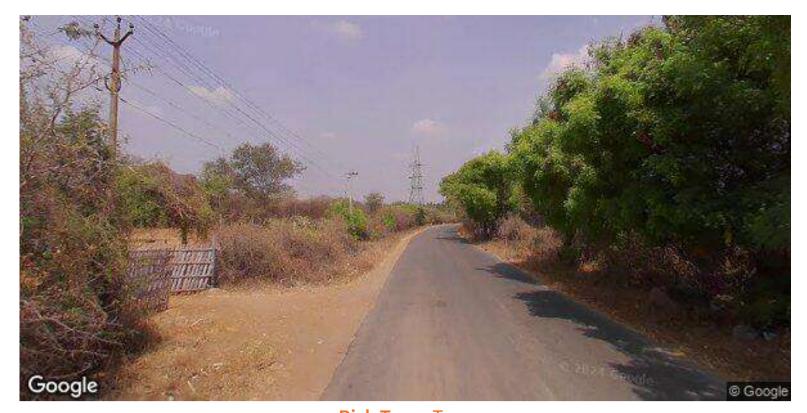
Risk Type: Turn
Risk Level: Medium
Speed Limit: 30 KM/Hr
Coordinates: 11.07352, 77.61121
