JOURNEY RISK MANAGEMENT (JRM) STUDY

IOCL Coimbatore Terminal to NGP Estate Motors Agencies

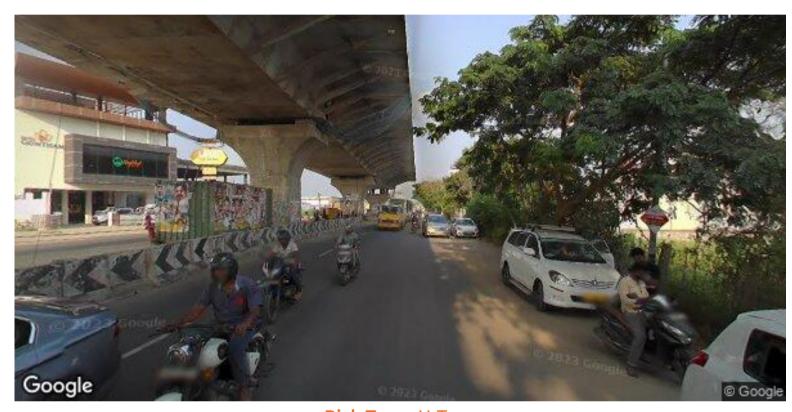
Coordinates: 11.0419501, 77.04308759999999

Risk Type: U-Turn
Risk Level: High

Speed Limit: 10 KM/Hr

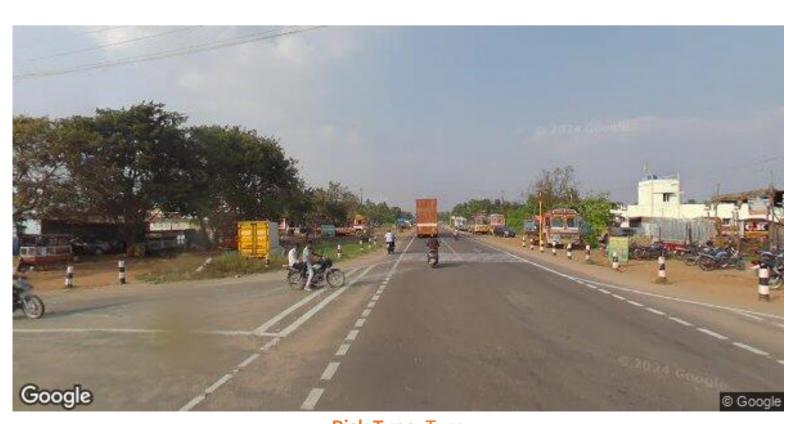
Risk Type: Turn Risk Level: High Speed Limit: 15 KM/Hr Coordinates: 11.03211, 77.07640

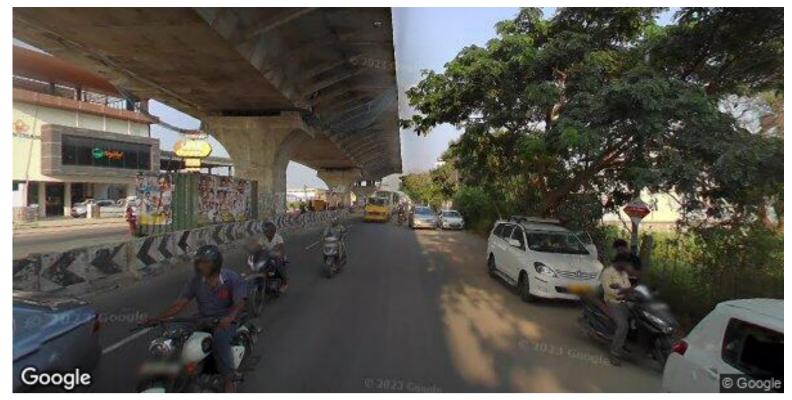
Risk Type: Turn
Risk Level: High
Speed Limit: 15 KM/Hr
Coordinates: 11.04195, 77.04309

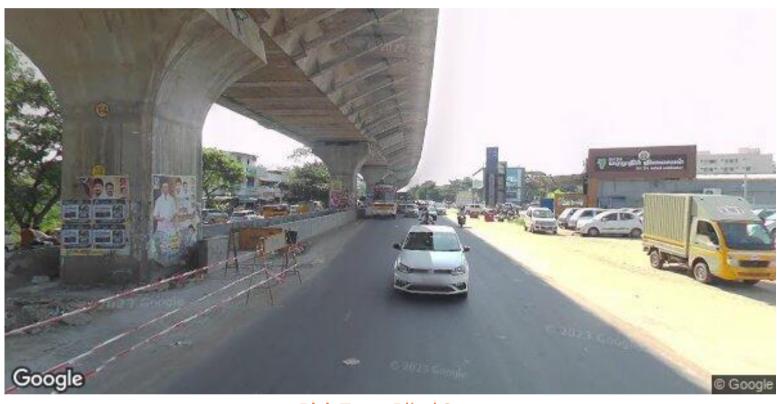
Risk Type: Blind Spot
Risk Level: Blind Spot
Speed Limit: 10 KM/Hr
Coordinates: 11.04203, 77.04303

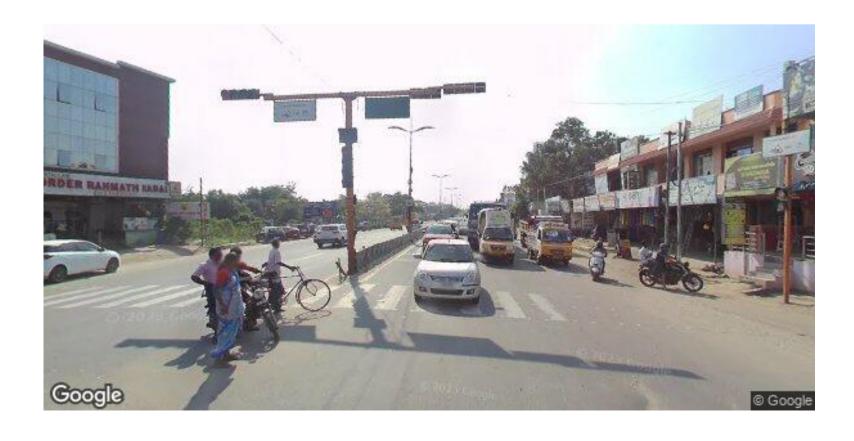
Coordinates: 11.04636, 77.05199

Risk Type: Blind Spot Risk Level: Blind Spot Speed Limit: 10 KM/Hr

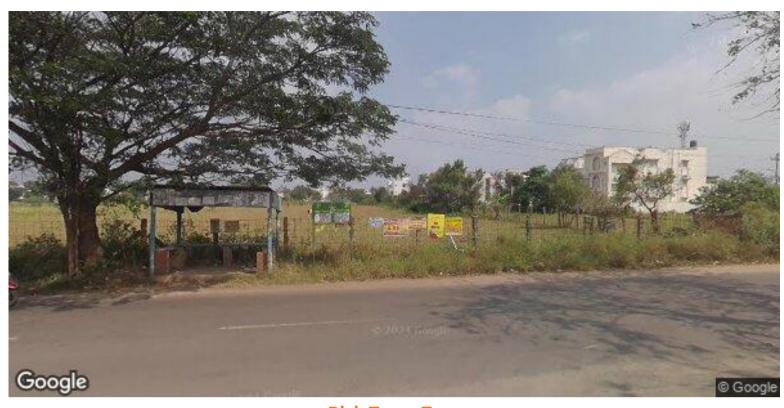
Coordinates: 11.05158, 77.04943

Risk Type: Turn
Risk Level: High
Speed Limit: 15 KM/Hr

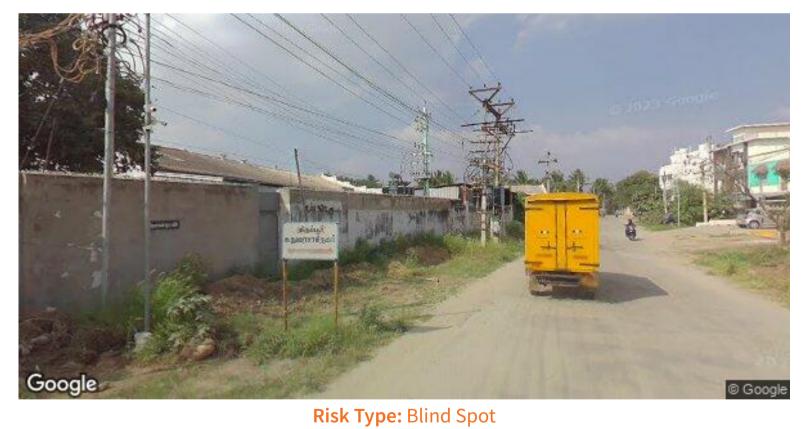
Coordinates: 11.05130, 77.04643

Risk Type: Blind Spot

Risk Level: Blind Spot

Speed Limit: 10 KM/Hr

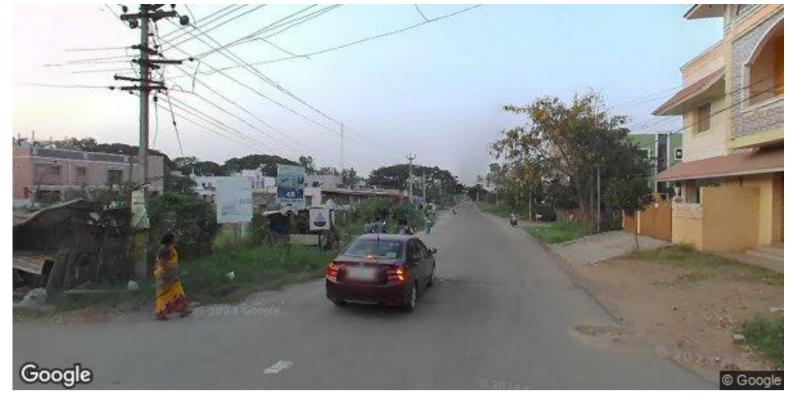
Coordinates: 11.05528, 77.04708

Risk Type: Blind Spot Risk Level: Blind Spot Speed Limit: 10 KM/Hr

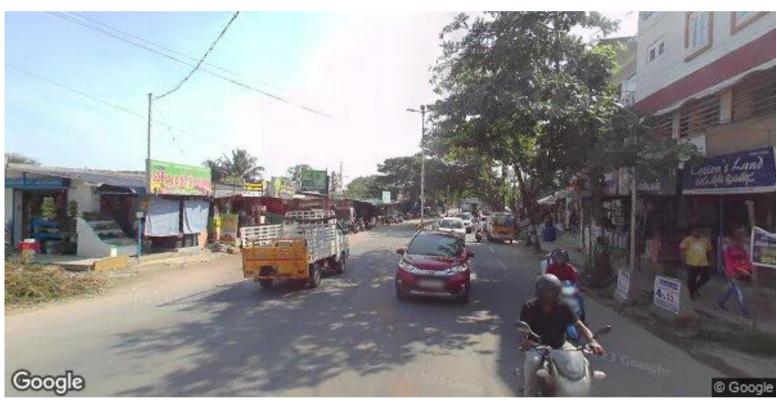
Coordinates: 11.05356, 77.03890

Risk Type: Turn
Risk Level: High
Speed Limit: 15 KM/Hr

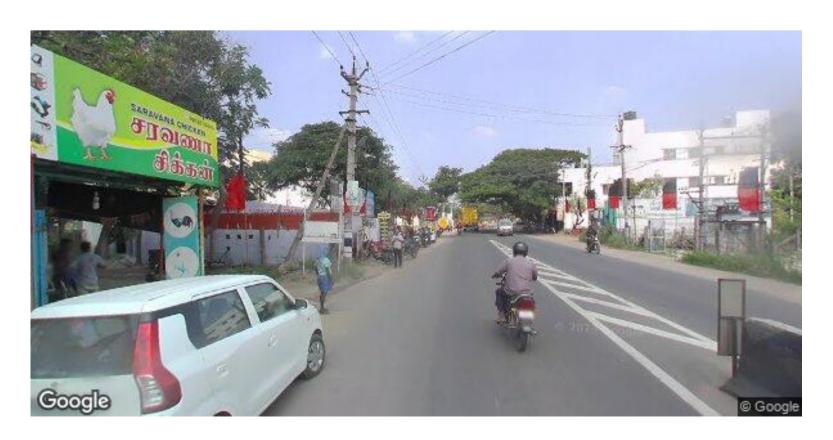
Coordinates: 11.05427, 77.03879

Risk Type: Turn
Risk Level: Medium
Speed Limit: 30 KM/Hr

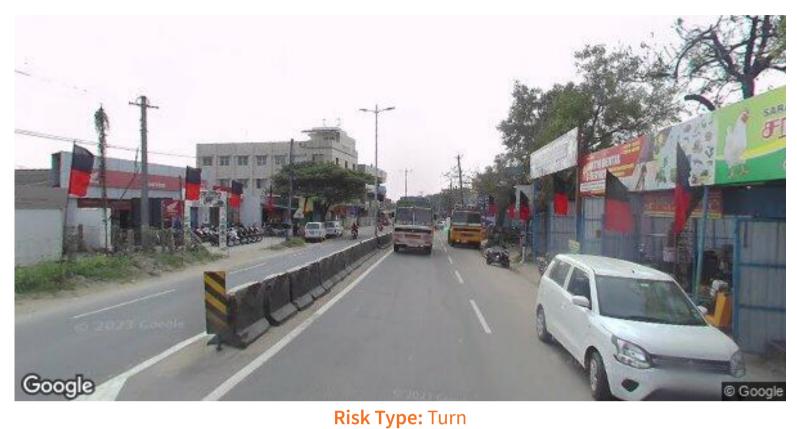
Coordinates: 11.05431, 77.03881

Risk Type: Turn
Risk Level: Medium
Speed Limit: 30 KM/Hr
