# JOURNEY RISK MANAGEMENT (JRM) STUDY

#### Salem Terminal to AKM NATARAJAN CHETTY

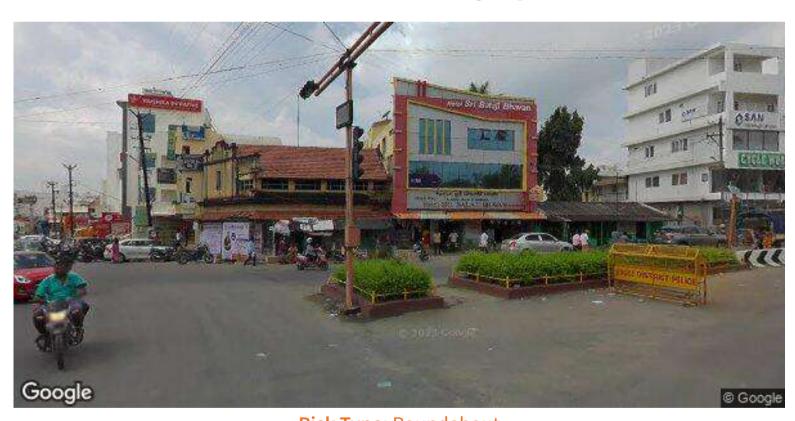
**Coordinates:** 11.27925, 77.58494

Risk Type: Roundabout
Risk Level: High

Speed Limit: 15 KM/Hr

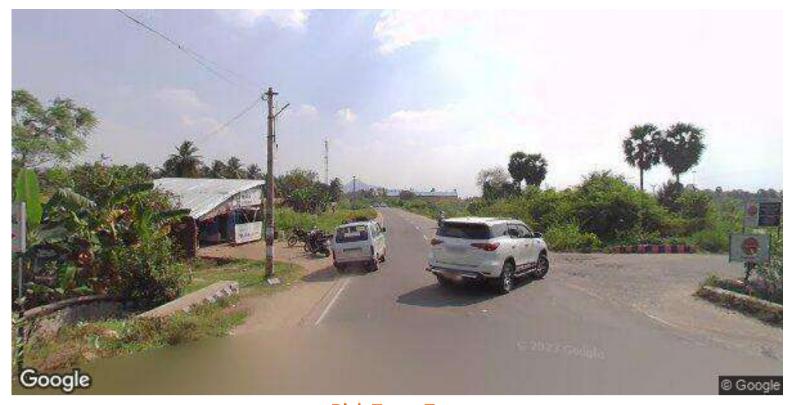
Risk Type: Turn
Risk Level: High
Speed Limit: 15 KM/Hr
Coordinates: 11.44029, 77.87544

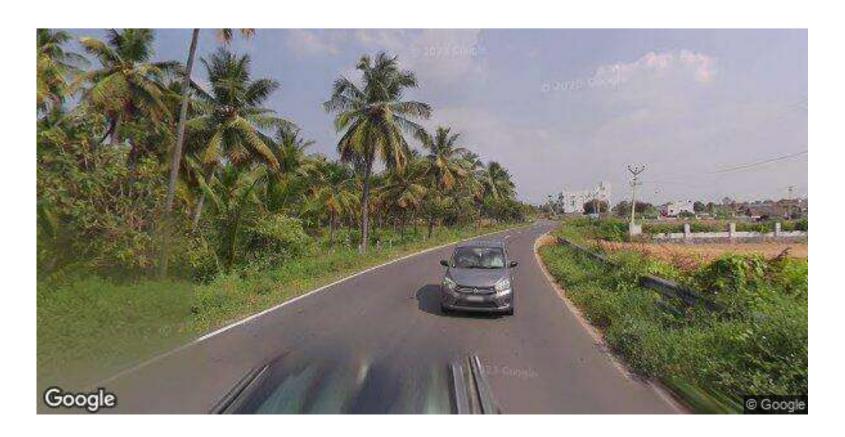
**Coordinates:** 11.45357, 77.85789

Risk Type: Turn
Risk Level: Medium
Speed Limit: 30 KM/Hr

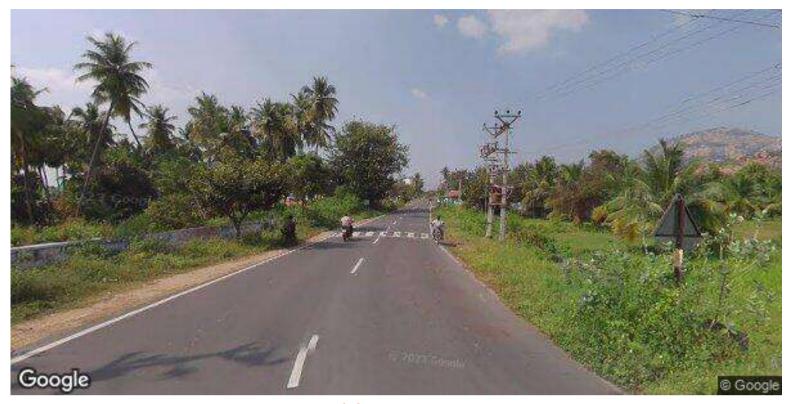
Risk Type: Turn
Risk Level: Medium
Speed Limit: 30 KM/Hr
Coordinates: 11.45352, 77.85698

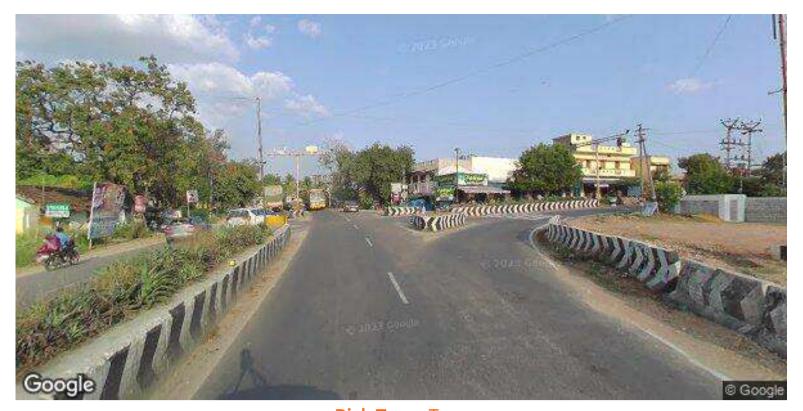
Risk Type: Turn
Risk Level: Medium
Speed Limit: 30 KM/Hr
Coordinates: 11.46318, 77.84913

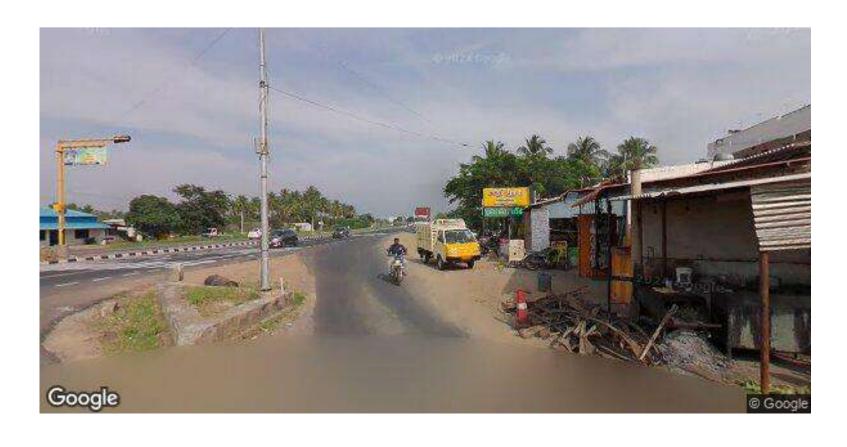
**Coordinates:** 11.29164, 77.58610

Risk Type: Turn
Risk Level: Medium
Speed Limit: 30 KM/Hr

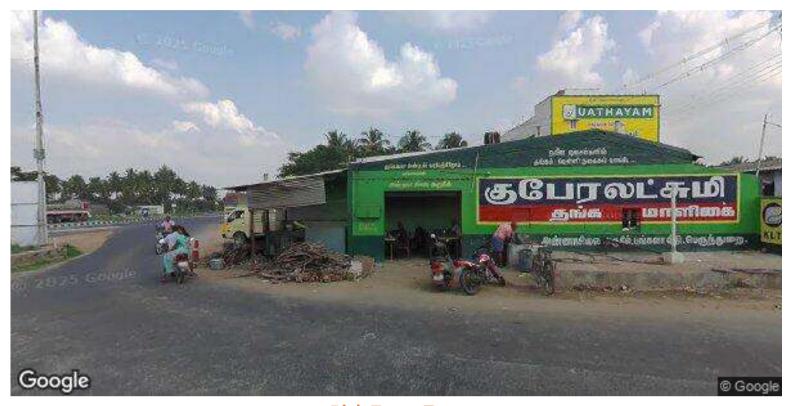
**Coordinates:** 11.29158, 77.58600

Risk Type: Turn
Risk Level: Medium
Speed Limit: 30 KM/Hr

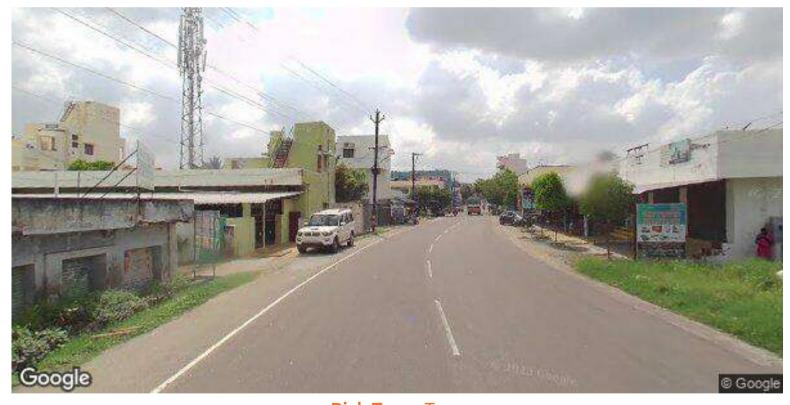
Risk Type: Turn
Risk Level: Medium
Speed Limit: 30 KM/Hr
Coordinates: 11.28223, 77.58511

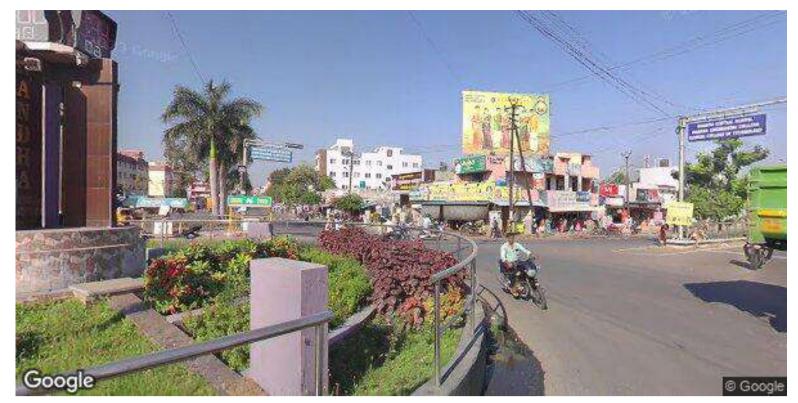
Risk Type: Turn
Risk Level: High
Speed Limit: 15 KM/Hr
Coordinates: 11.27446, 77.58267

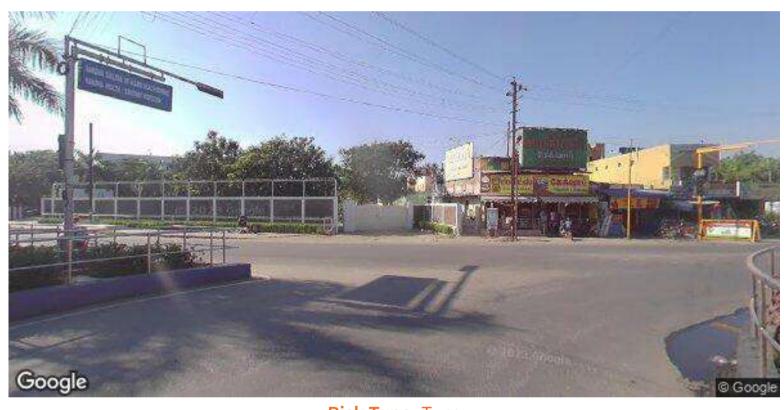
Risk Type: Turn
Risk Level: Medium
Speed Limit: 30 KM/Hr
Coordinates: 11.27446, 77.58255
