JOURNEY RISK MANAGEMENT (JRM) STUDY

IOCL Coimbatore Terminal to Shree Nanjappa & Co

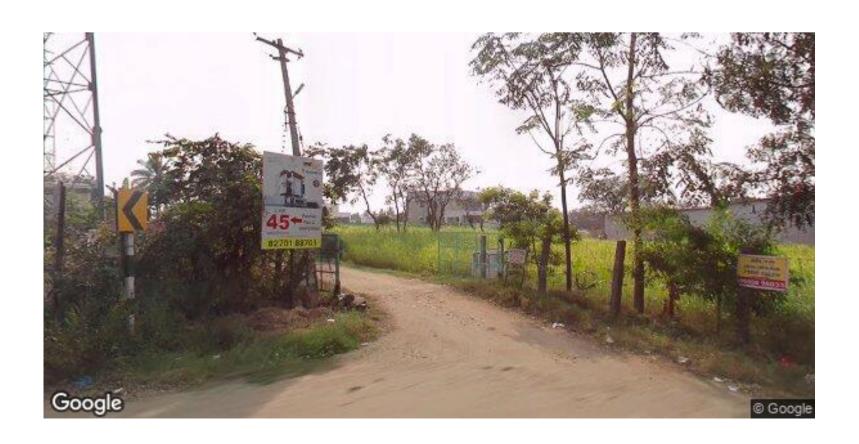
Coordinates: 11.05181, 77.07696

Risk Type: Turn
Risk Level: Medium
Speed Limit: 30 KM/Hr

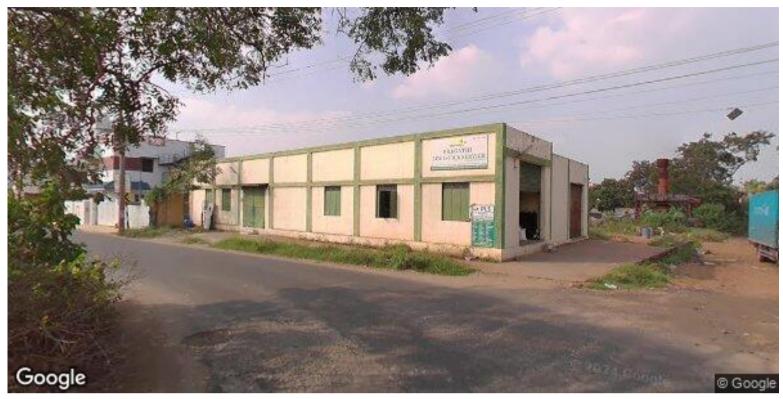
Coordinates: 11.05222, 77.07690

Risk Type: Turn
Risk Level: High
Speed Limit: 15 KM/Hr

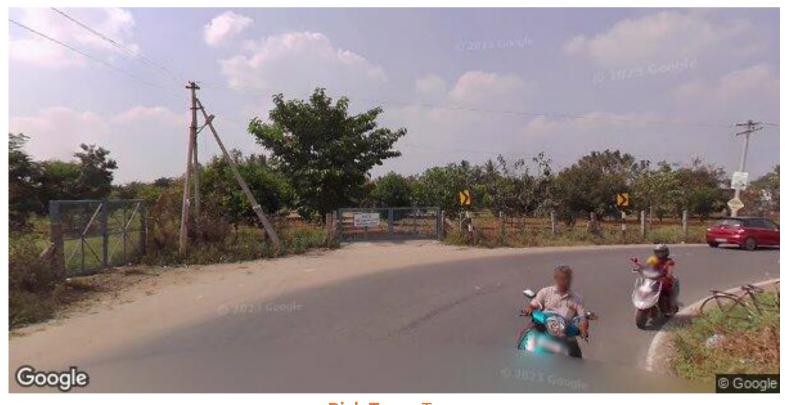
Risk Type: Turn
Risk Level: Medium
Speed Limit: 30 KM/Hr
Coordinates: 11.05343, 77.07106

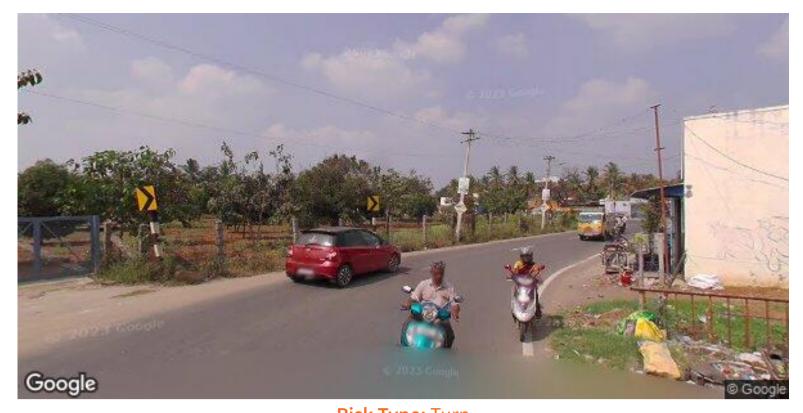
Coordinates: 11.05351, 77.07099

Risk Type: Turn
Risk Level: Medium
Speed Limit: 30 KM/Hr

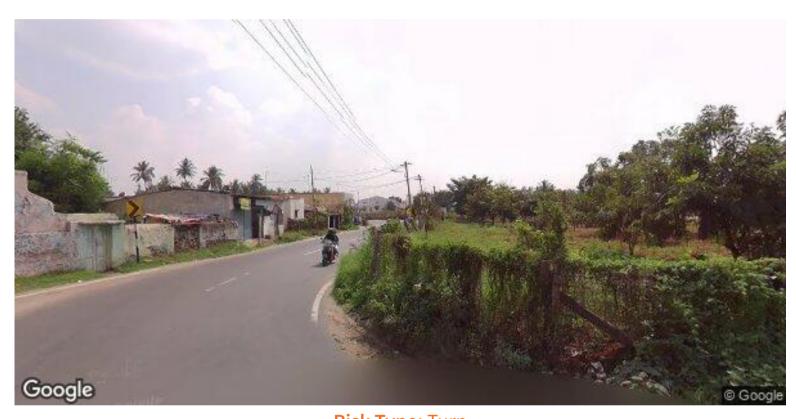
Risk Type: Turn
Risk Level: Medium
Speed Limit: 30 KM/Hr
Coordinates: 11.05411, 77.07097

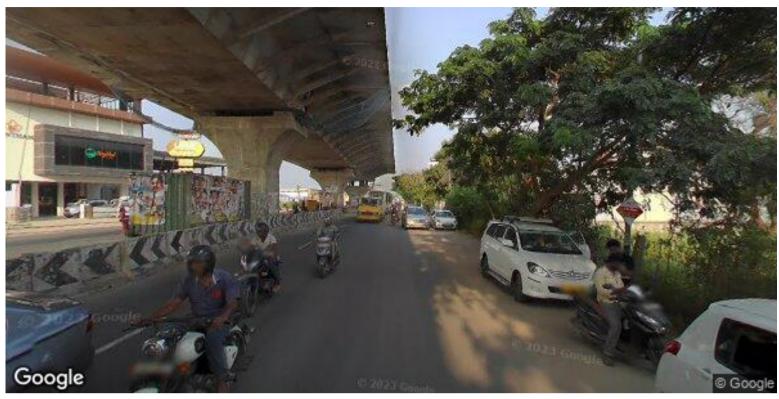
Coordinates: 11.04195, 77.04309

Risk Type: Turn
Risk Level: High
Speed Limit: 15 KM/Hr

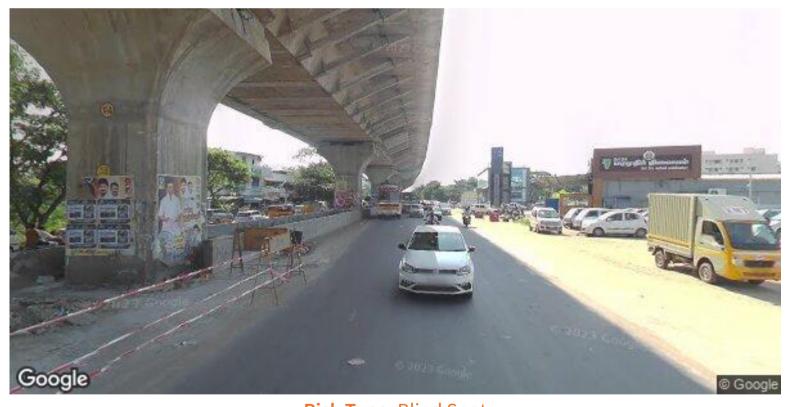
Coordinates: 11.04203, 77.04303

Risk Type: Blind Spot
Risk Level: Blind Spot
Speed Limit: 10 KM/Hr

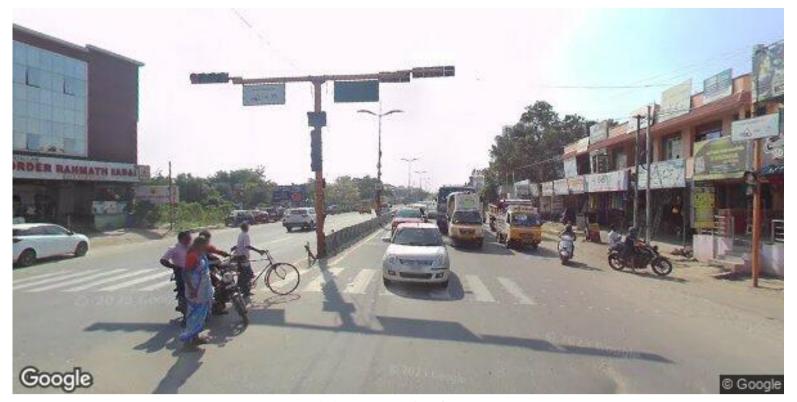
Coordinates: 11.04636, 77.05199

Risk Type: Blind Spot Risk Level: Blind Spot Speed Limit: 10 KM/Hr

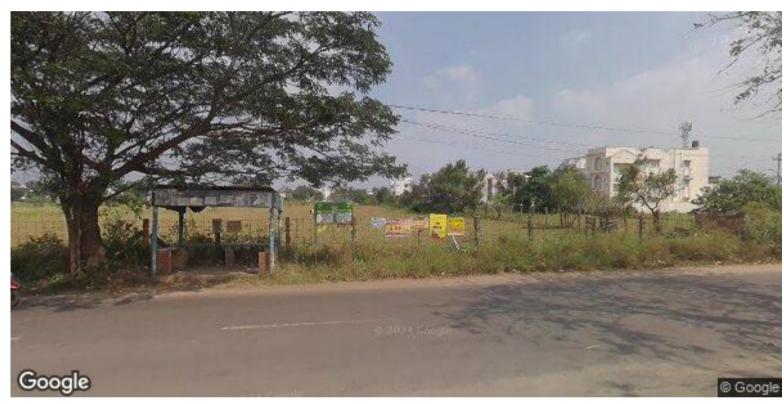
Risk Type: Turn
Risk Level: High
Speed Limit: 15 KM/Hr
Coordinates: 11.05158, 77.04943

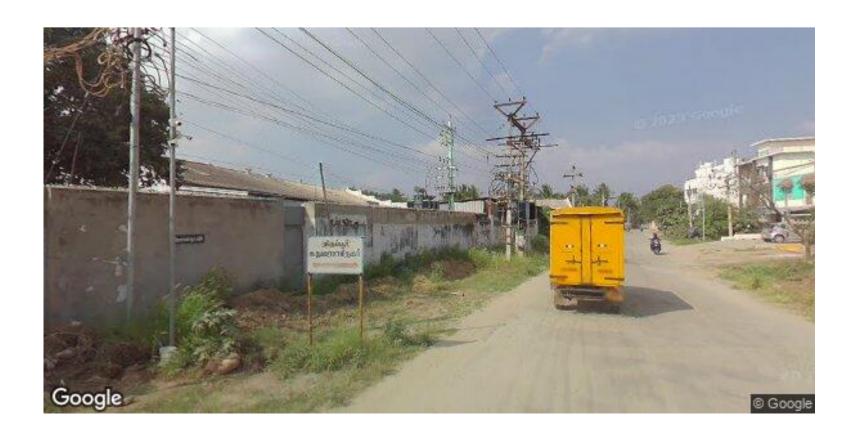
Coordinates: 11.05130, 77.04643

Risk Type: Blind Spot Risk Level: Blind Spot Speed Limit: 10 KM/Hr

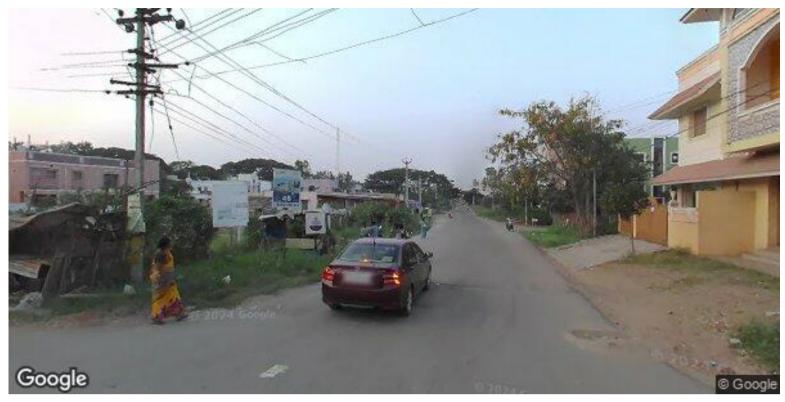
Coordinates: 11.05528, 77.04708

Risk Type: Blind Spot Risk Level: Blind Spot Speed Limit: 10 KM/Hr

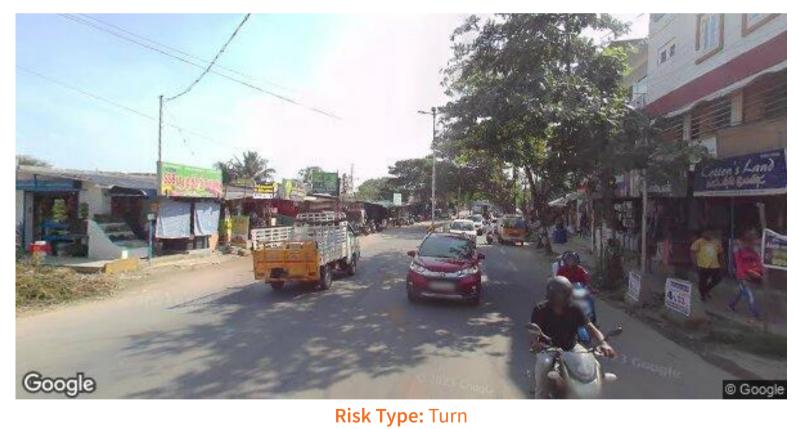
Coordinates: 11.05356, 77.03890

Risk Type: Turn
Risk Level: High
Speed Limit: 15 KM/Hr

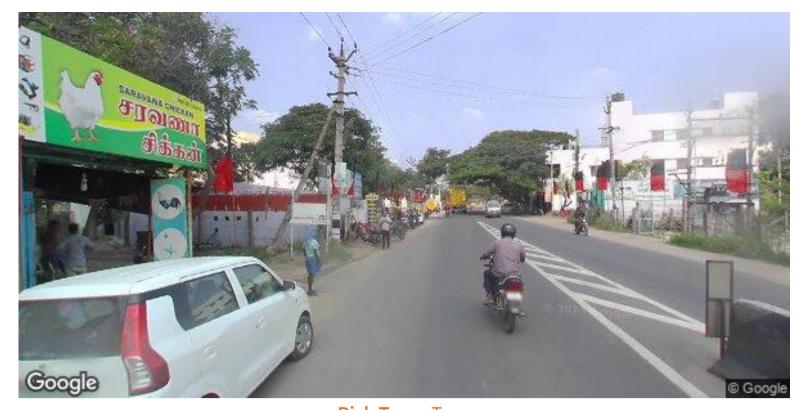
Coordinates: 11.05427, 77.03879

Risk Type: Turn
Risk Level: Medium
Speed Limit: 30 KM/Hr

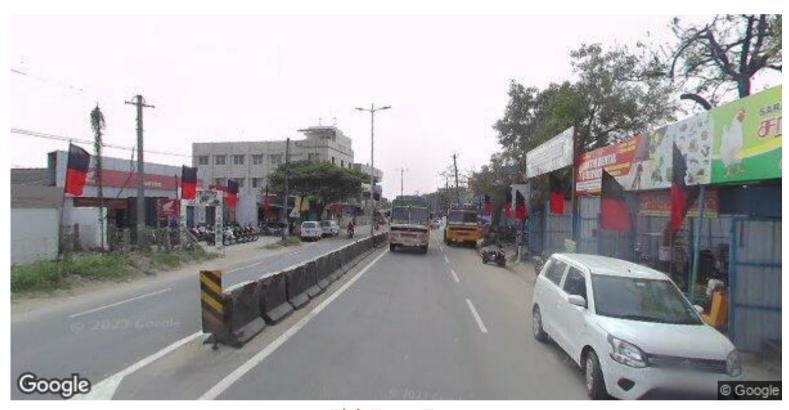
Risk Type: Turn
Risk Level: Medium
Speed Limit: 30 KM/Hr
Coordinates: 11.05431, 77.03881

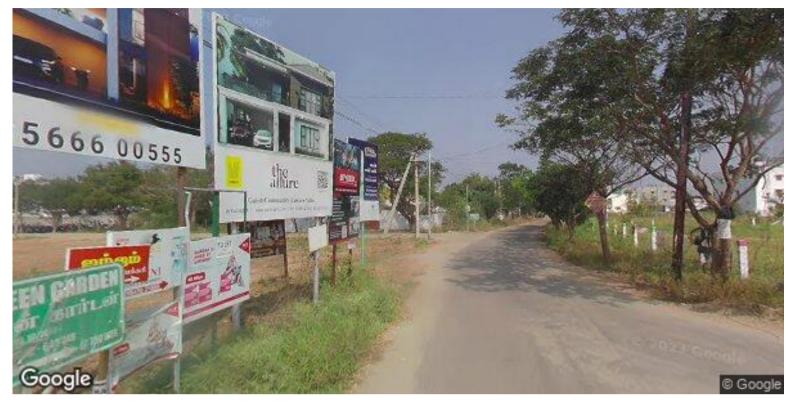
Coordinates: 11.06387, 77.03223

Risk Type: Turn
Risk Level: High
Speed Limit: 15 KM/Hr

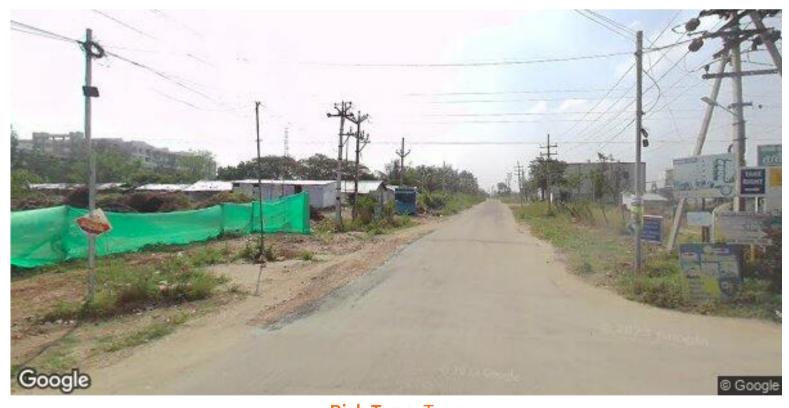
Risk Type: Turn
Risk Level: High
Speed Limit: 15 KM/Hr
Coordinates: 11.06278, 77.03213

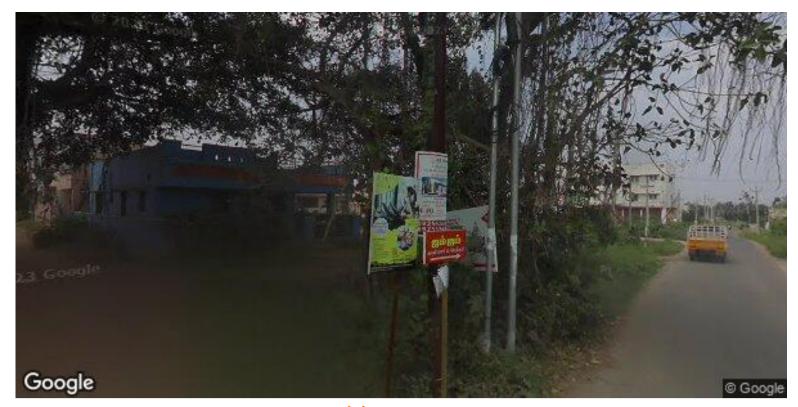
Risk Type: Turn
Risk Level: Medium
Speed Limit: 30 KM/Hr
Coordinates: 11.06262, 77.02734

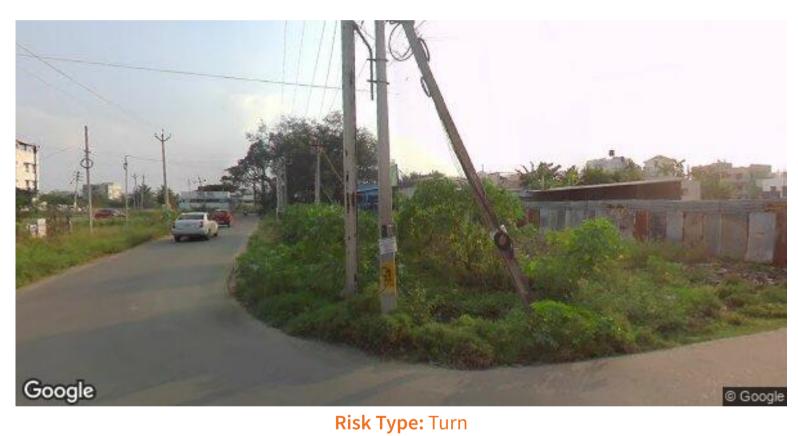
Risk Level: High
Speed Limit: 15 KM/Hr
Coordinates: 11.06325, 77.02732

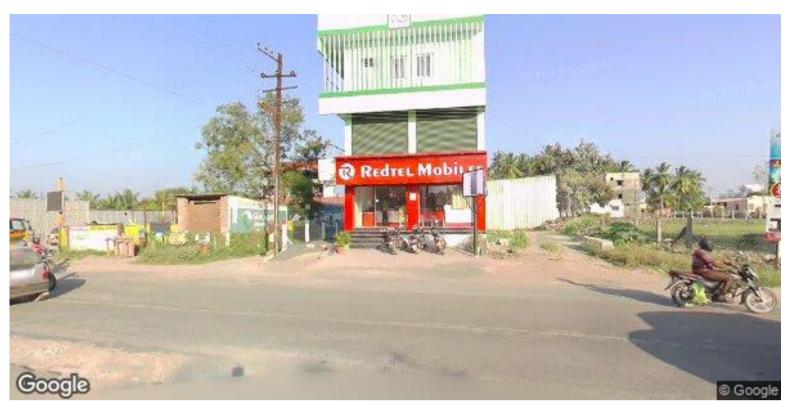
Coordinates: 11.06513, 77.01566

Risk Type: Turn
Risk Level: High
Speed Limit: 15 KM/Hr

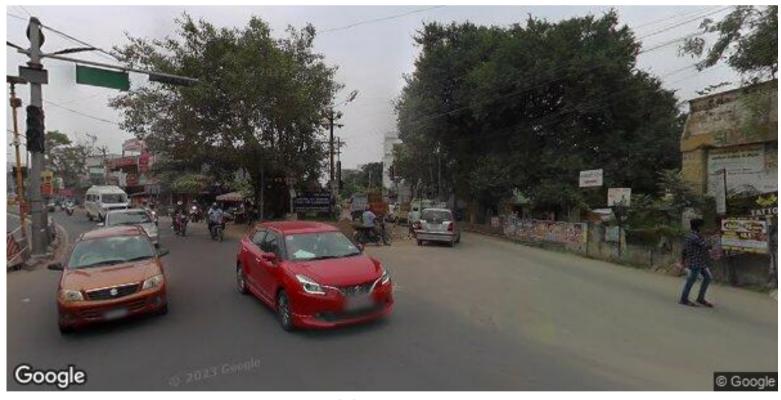
Coordinates: 11.05204, 76.99331

Risk Type: Turn
Risk Level: Medium
Speed Limit: 30 KM/Hr

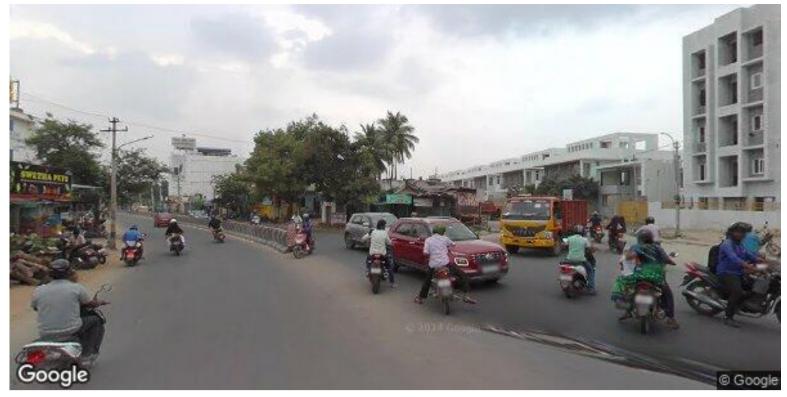
Risk Type: Turn
Risk Level: High
Speed Limit: 15 KM/Hr
Coordinates: 11.05126, 76.99153

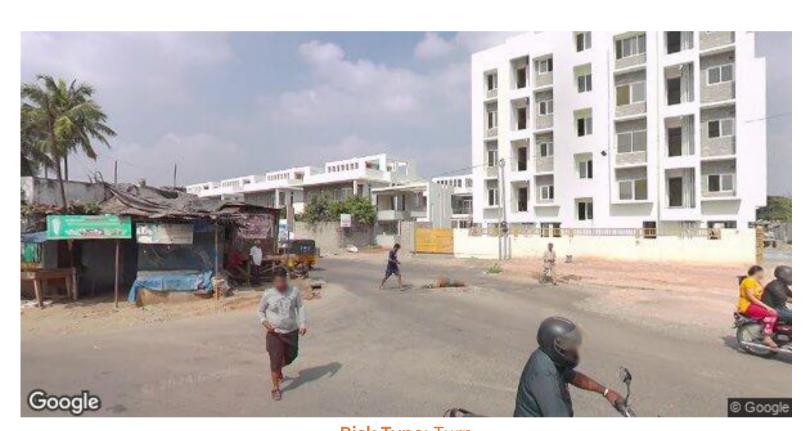
Risk Type: Turn
Risk Level: Medium
Speed Limit: 30 KM/Hr
Coordinates: 11.05138, 76.99143

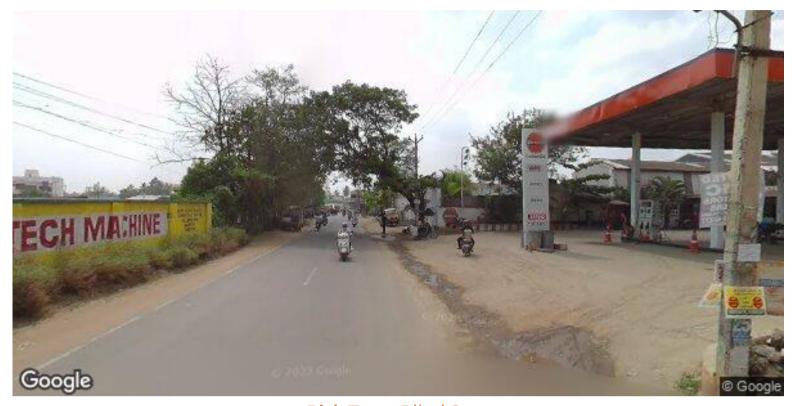
Coordinates: 11.05132, 76.98368

Risk Type: Blind Spot Risk Level: Blind Spot Speed Limit: 10 KM/Hr
