JOURNEY RISK MANAGEMENT (JRM) STUDY

Salem Terminal To SRI CHELLANDI AMMAN AGENCIES

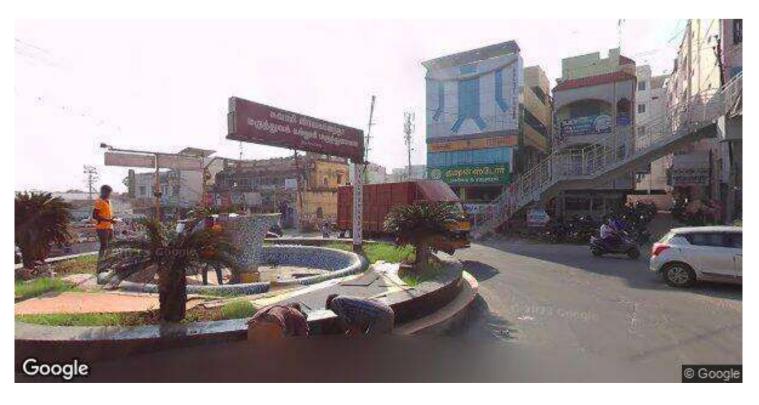
Coordinates: 11.38395, 77.89480

Risk Type: Roundabout
Risk Level: High
Speed Limit: 15 KM/Hr

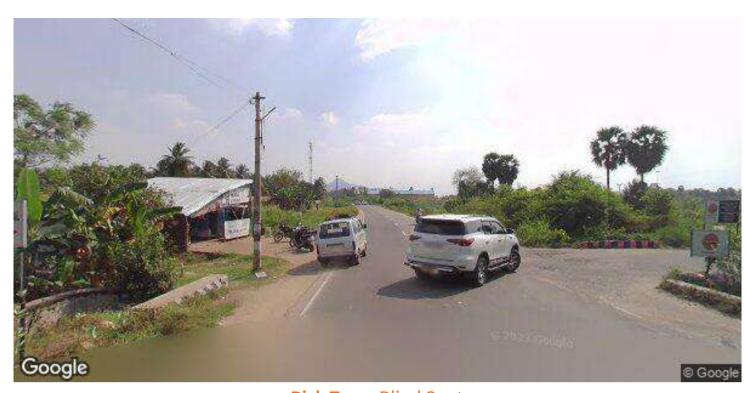
Risk Type: Blind Spot
Risk Level: Blind Spot
Speed Limit: 10 KM/Hr
Coordinates: 11.44029, 77.87544

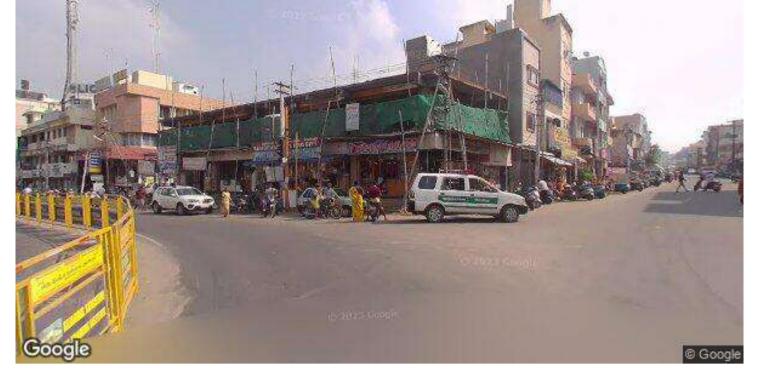
Risk Type: Turn
Risk Level: High
Speed Limit: 15 KM/Hr
Coordinates: 11.37868, 77.89498

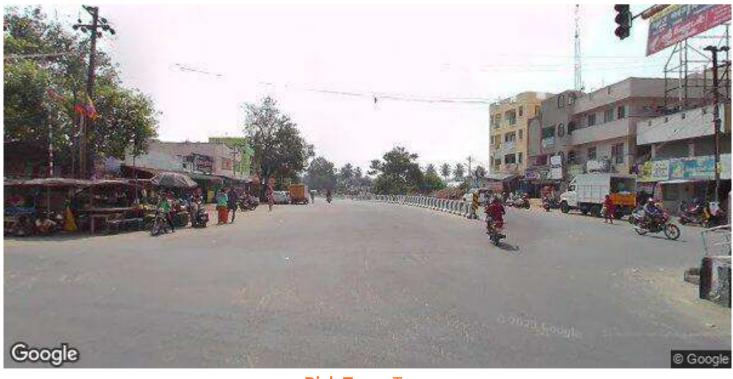
Risk Type: Turn Risk Level: High Speed Limit: 15 KM/Hr Coordinates: 11.36604, 77.88887

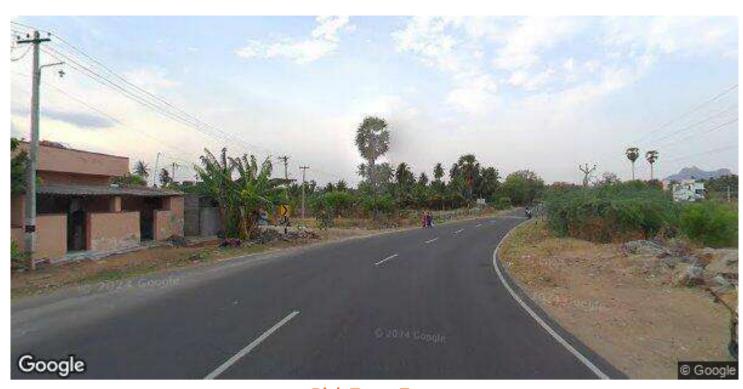
Risk Type: Turn
Risk Level: Medium
Speed Limit: 30 KM/Hr
Coordinates: 11.33882, 77.86218

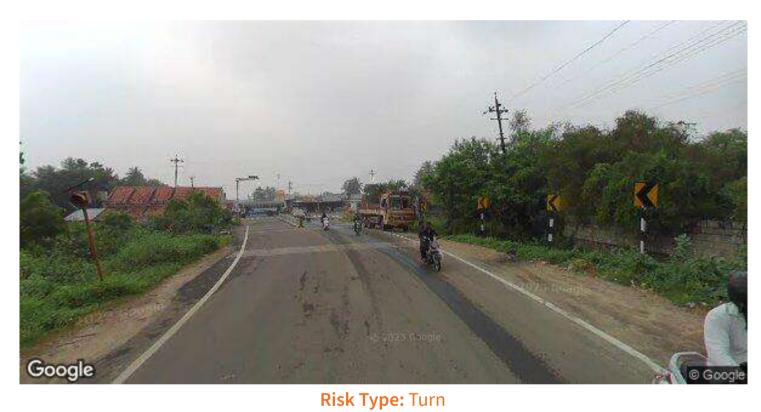
Risk Level: Medium
Speed Limit: 30 KM/Hr
Coordinates: 11.30970, 77.76705

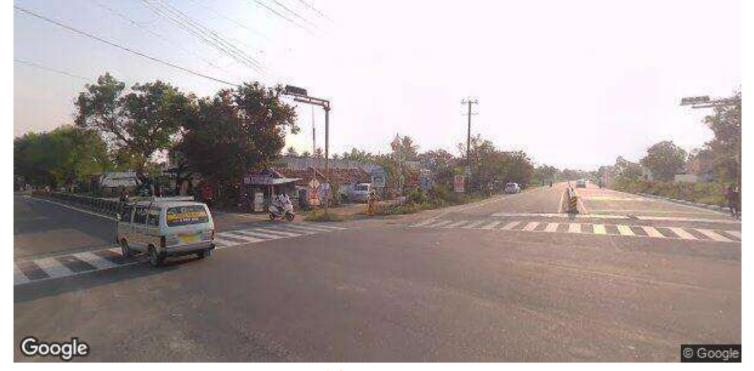
Risk Type: Turn
Risk Level: High
Speed Limit: 15 KM/Hr
Coordinates: 11.29899, 77.75806

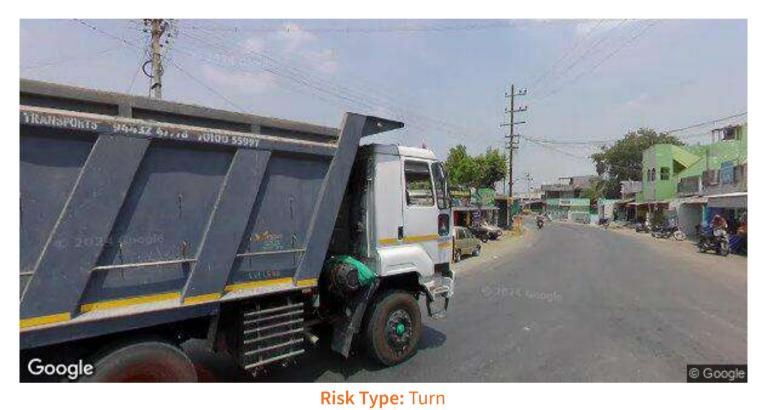
Risk Level: Medium
Speed Limit: 30 KM/Hr
Coordinates: 11.18959, 77.77076

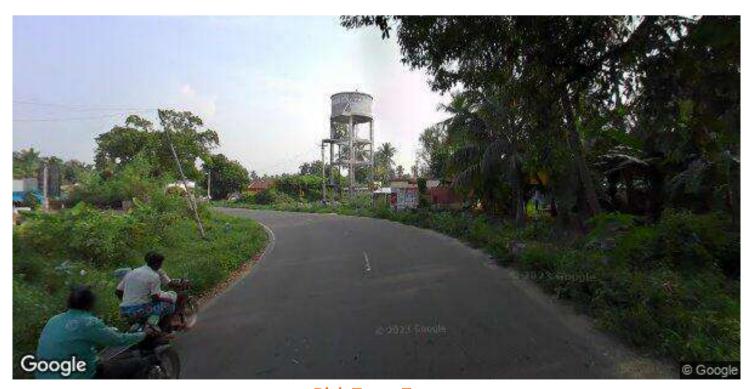
Risk Type: Turn
Risk Level: Medium

Speed Limit: 30 KM/Hr Coordinates: 11.16421, 77.77364

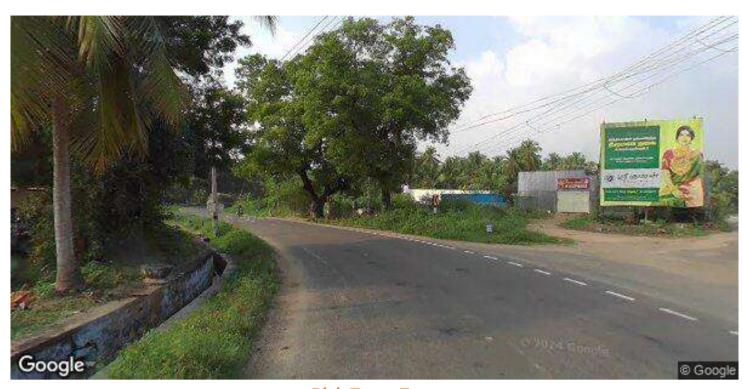
Risk Type: Turn
Risk Level: Medium
Speed Limit: 30 KM/Hr
Coordinates: 11.16357, 77.77434

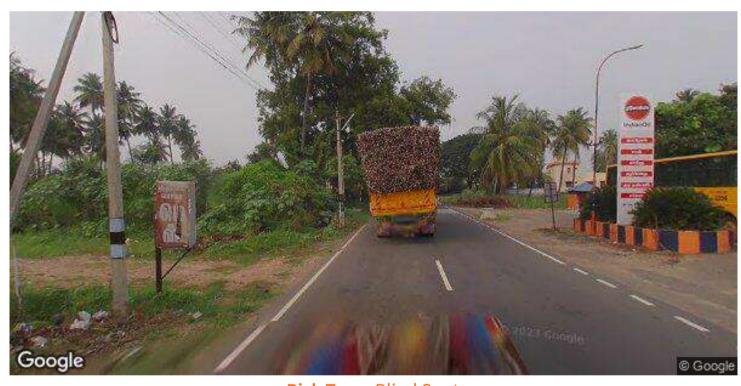
Risk Type: Blind Spot
Risk Level: Blind Spot
Speed Limit: 10 KM/Hr
Coordinates: 11.11427, 77.75261

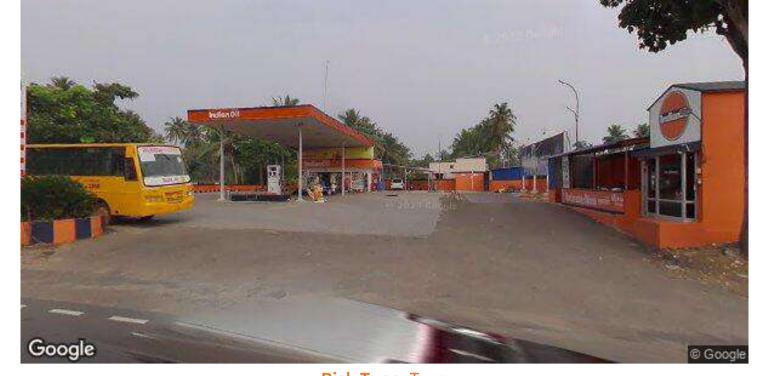
Risk Type: Turn
Risk Level: Medium
Speed Limit: 30 KM/Hr
Coordinates: 11.11424, 77.75282

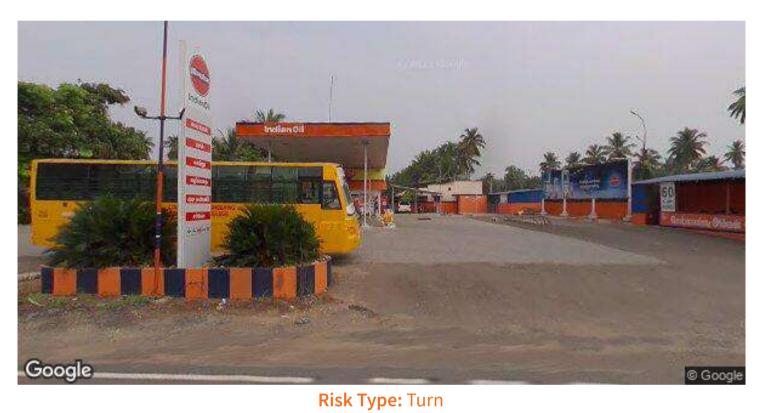
Risk Type. Turn
Risk Level: High
Speed Limit: 15 KM/Hr
Coordinates: 11.11428, 77.75288
