JOURNEY RISK MANAGEMENT (JRM) STUDY

Salem Terminal To SRI GARUDA AGENCY

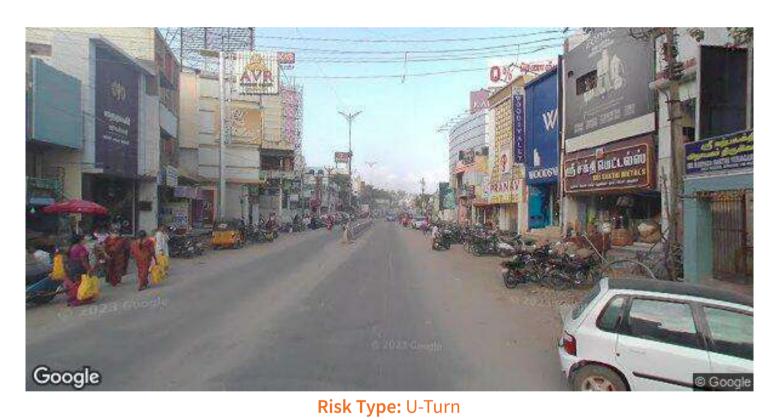
Risk Level: High
Speed Limit: 10 KM/Hr

Coordinates: 11.3453211, 77.7304652

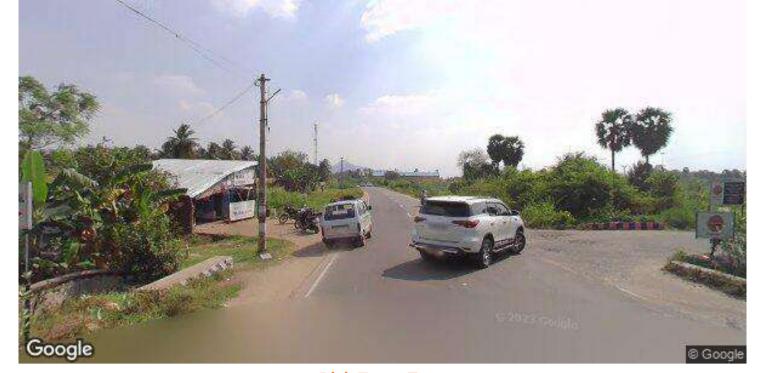
Risk Type: Turn
Risk Level: High
Speed Limit: 15 KM/Hr
Coordinates: 11.44029, 77.87544

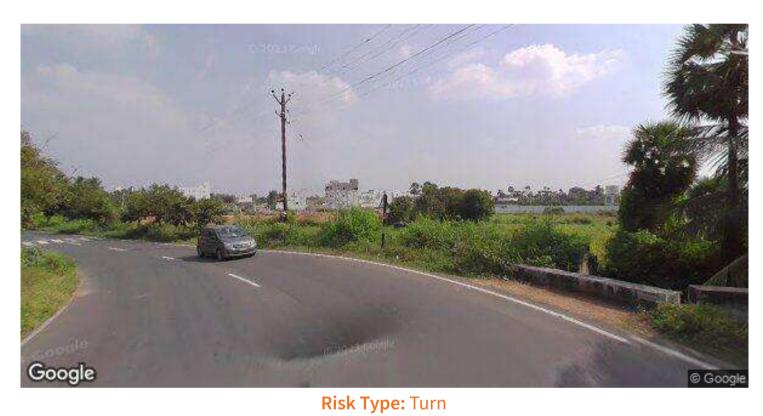
Risk Level: High
Speed Limit: 15 KM/Hr
Coordinates: 11.45350, 77.85700

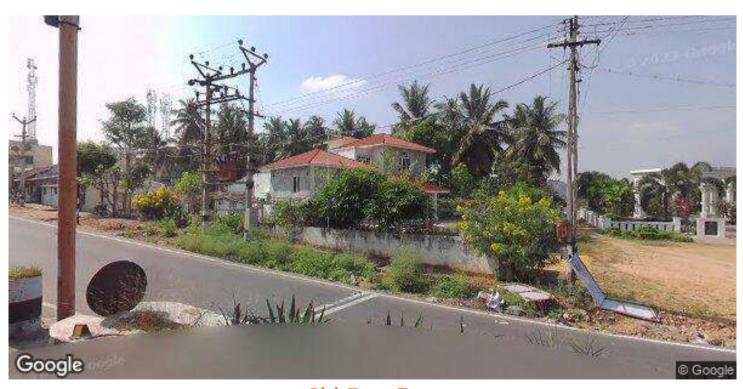
Risk Type: Turn
Risk Level: Medium

Speed Limit: 30 KM/Hr Coordinates: 11.46303, 77.84945

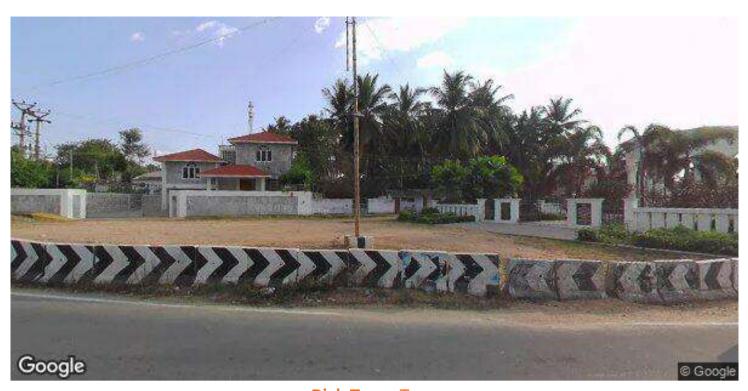
Risk Type: Turn
Risk Level: Medium
Speed Limit: 30 KM/Hr
Coordinates: 11.46316, 77.84921

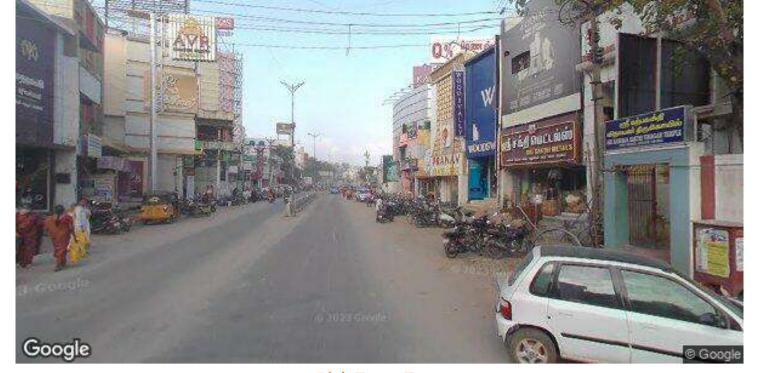
Risk Type: Turn
Risk Level: High
Speed Limit: 15 KM/Hr
Coordinates: 11.34532, 77.73047

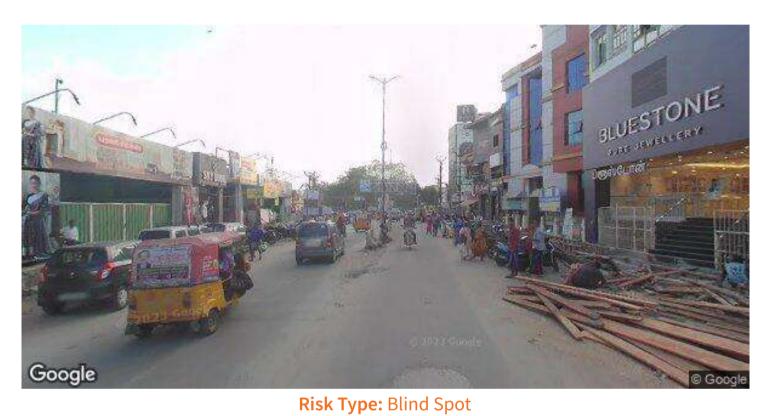
Risk Level: Blind Spot
Speed Limit: 10 KM/Hr
Coordinates: 11.34535, 77.73036

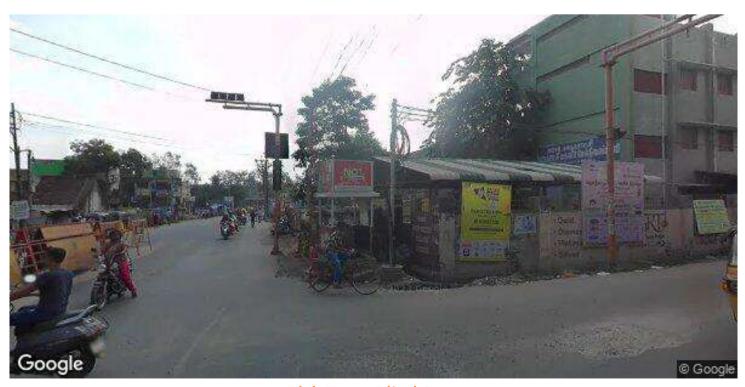
Risk Type: Blind Spot Risk Level: Blind Spot Speed Limit: 10 KM/Hr Coordinates: 11.34964, 77.73257

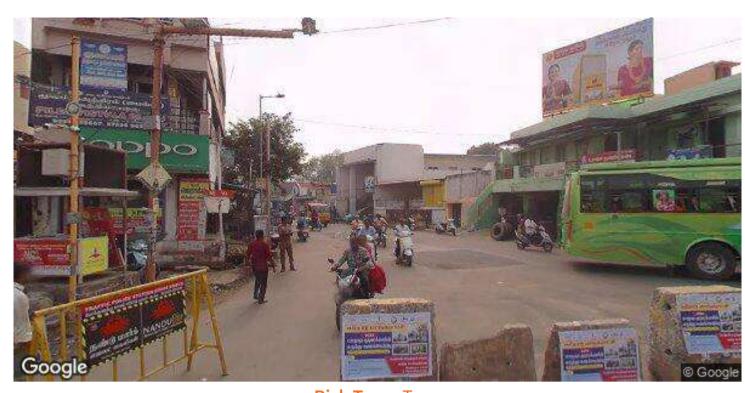
Risk Type: Turn
Risk Level: High
Speed Limit: 15 KM/Hr
Coordinates: 11.35072, 77.72261

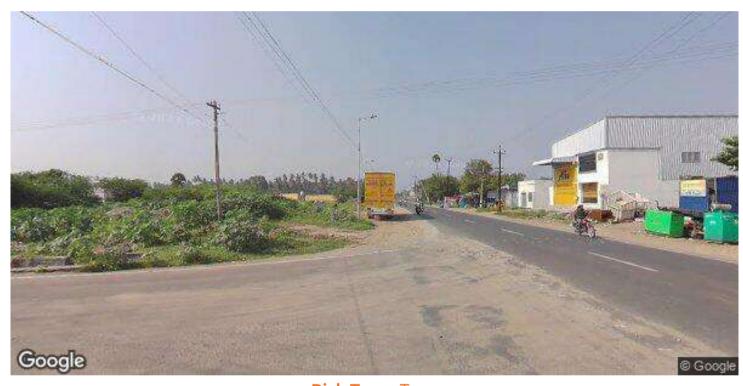
Risk Type: Turn
Risk Level: High
Speed Limit: 15 KM/Hr
Coordinates: 11.37396, 77.70396

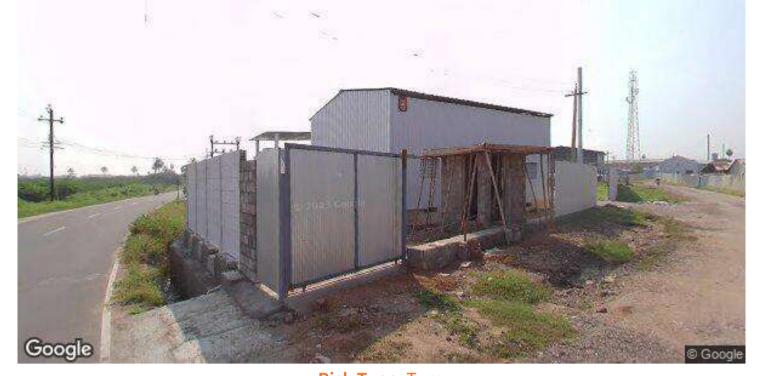
Risk Type: Turn
Risk Level: Medium
Speed Limit: 30 KM/Hr
Coordinates: 11.37301, 77.70207

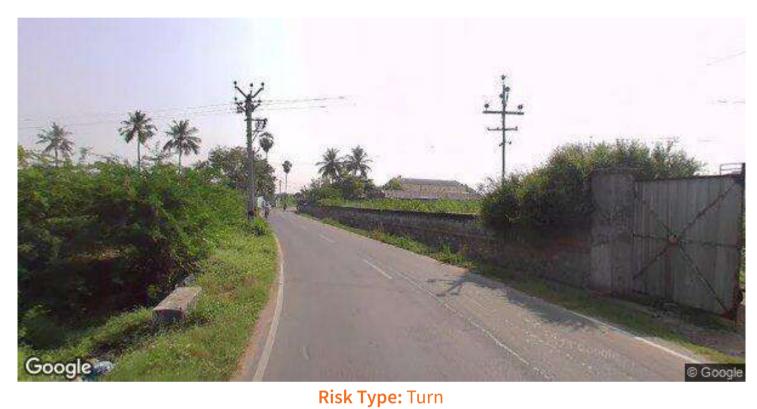
Risk Level: Medium
Speed Limit: 30 KM/Hr
Coordinates: 11.37050, 77.70035

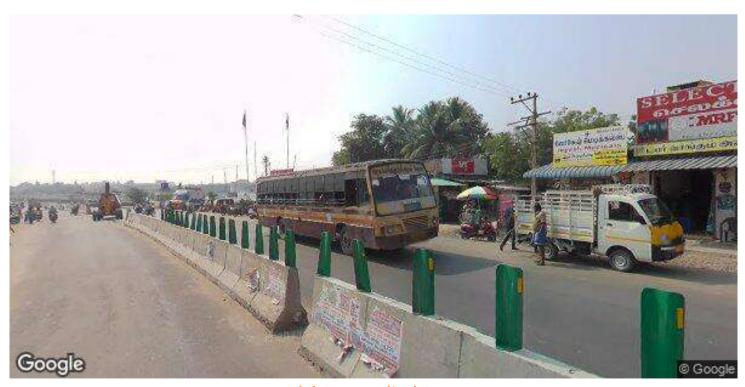
Risk Type: Blind Spot Risk Level: Blind Spot Speed Limit: 10 KM/Hr Coordinates: 11.36676, 77.69652

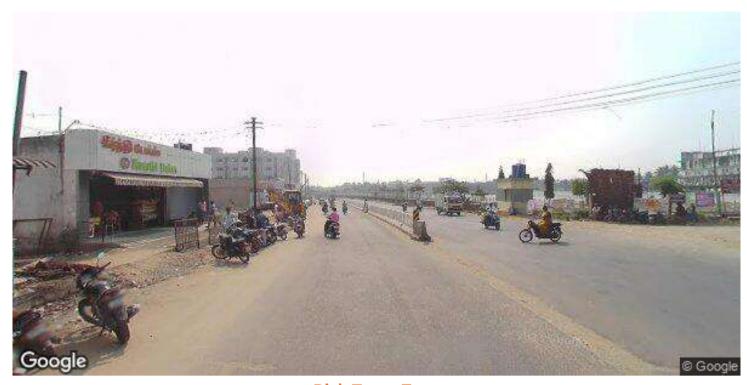
Risk Type: Turn
Risk Level: High
Speed Limit: 15 KM/Hr
Coordinates: 11.36638, 77.69678

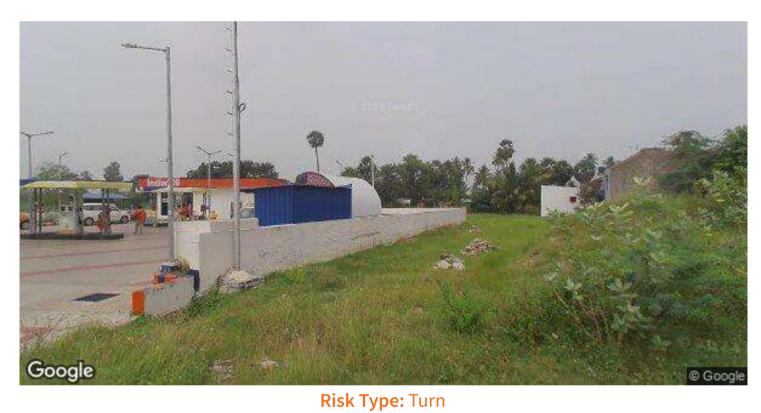
Risk Level: Medium
Speed Limit: 30 KM/Hr
Coordinates: 11.36067, 77.67336

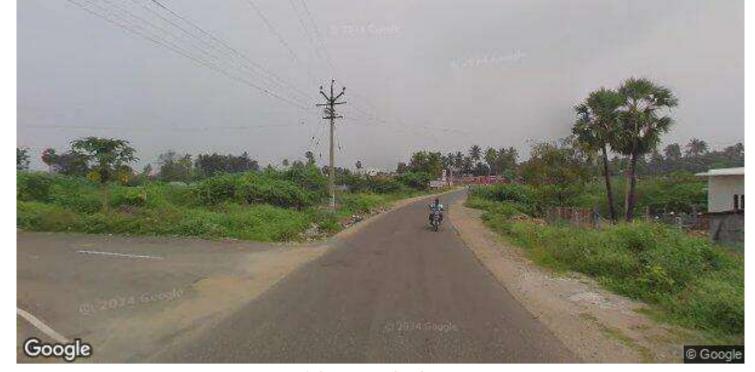
Risk Type: Blind Spot
Risk Level: Blind Spot
Speed Limit: 10 KM/Hr

Coordinates: 11.36054, 77.67198
