JOURNEY RISK MANAGEMENT (JRM) STUDY

IOCL Coimbatore Terminal to Gounder And Co

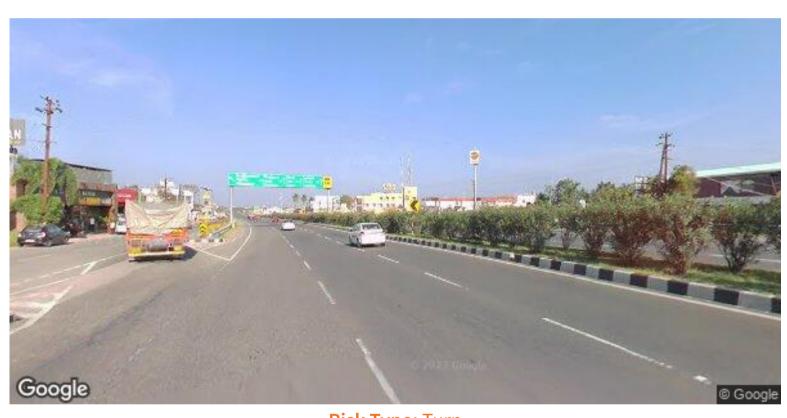
Risk Type: Turn
Risk Level: Medium
Speed Limit: 30 KM/Hr
Coordinates: 11.10499, 77.17299

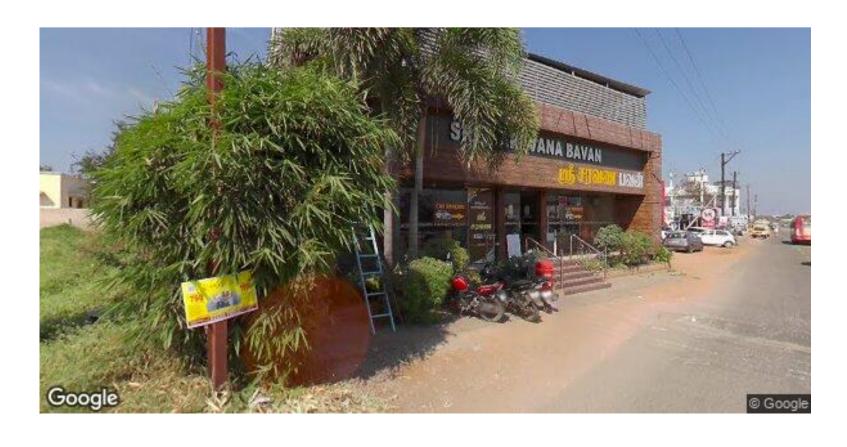
Coordinates: 11.10527, 77.17318

Risk Type: Turn
Risk Level: Medium
Speed Limit: 30 KM/Hr

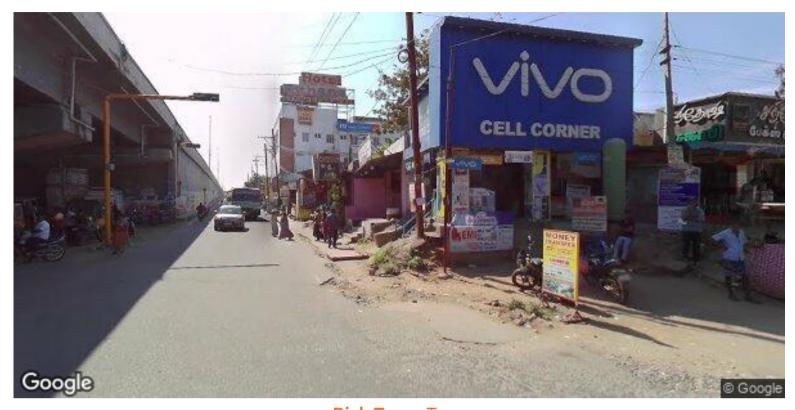
Risk Type: Turn
Risk Level: High
Speed Limit: 15 KM/Hr
Coordinates: 11.10777, 77.17700

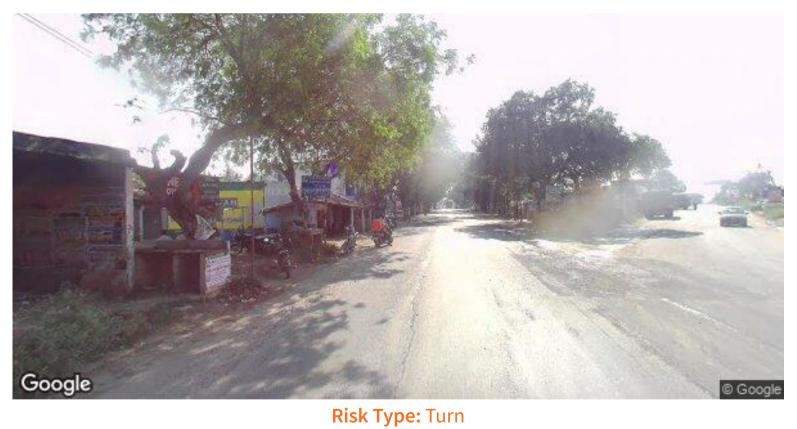
Risk Level: Medium
Speed Limit: 30 KM/Hr
Coordinates: 11.22872, 77.12009

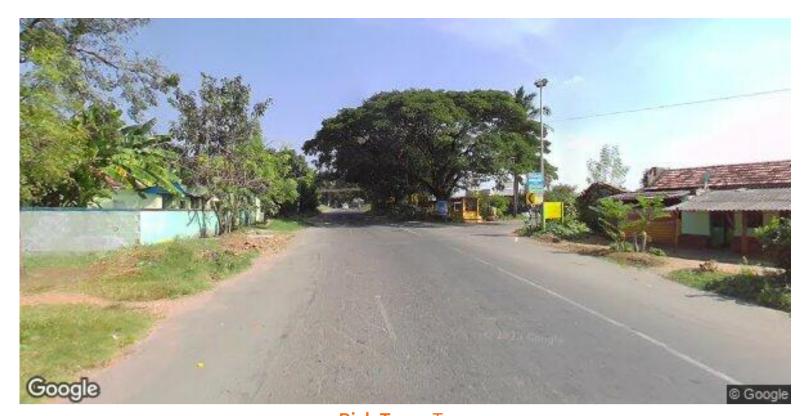
Coordinates: 11.25609, 77.04276

Risk Type: Turn
Risk Level: Medium
Speed Limit: 30 KM/Hr
