JOURNEY RISK MANAGEMENT (JRM) STUDY

IOCL Coimbatore Terminal to Sri Skanda Agencies Unit II

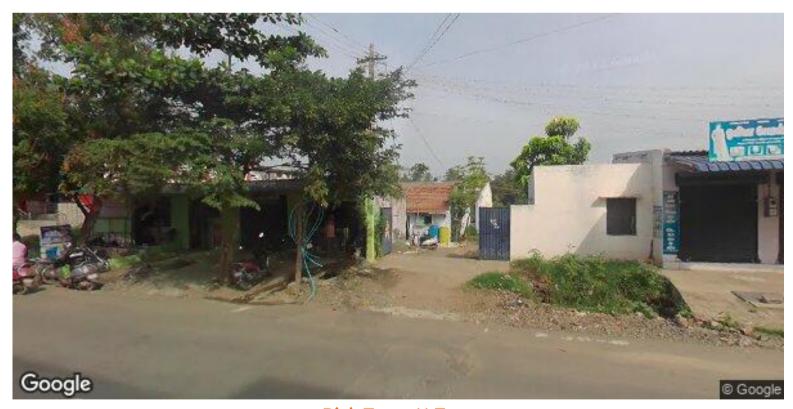
Coordinates: 11.1409643, 77.3164038

Risk Type: U-Turn
Risk Level: High
Speed Limit: 10 KM/Hr

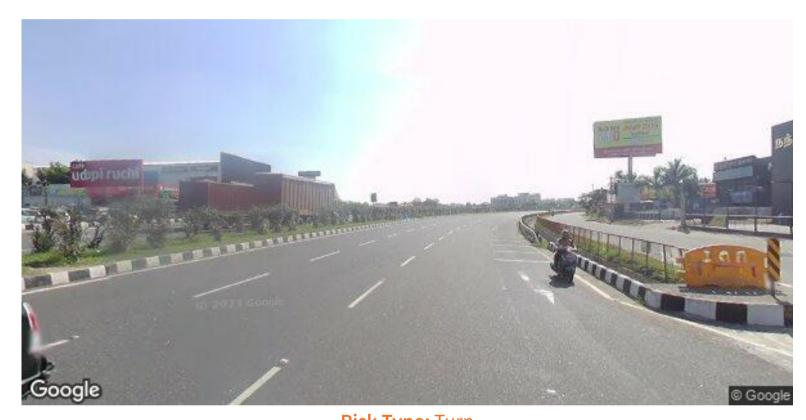
Risk Type: Turn
Risk Level: High
Speed Limit: 15 KM/Hr
Coordinates: 11.17756, 77.28350

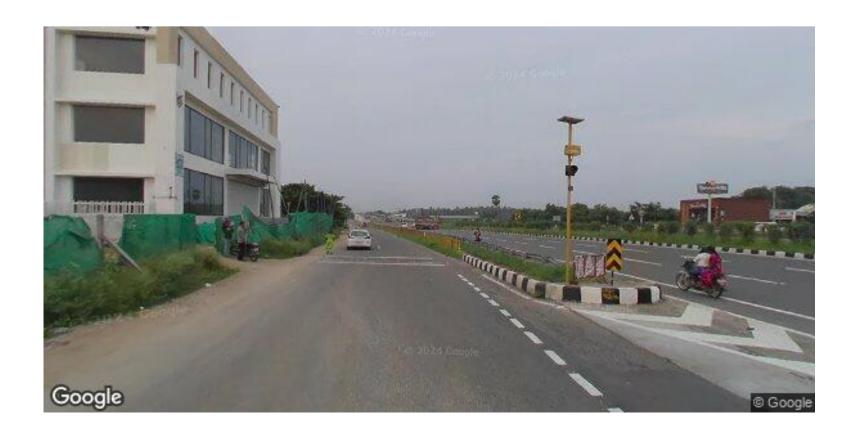
Coordinates: 11.17771, 77.28339

Risk Type: Turn
Risk Level: High
Speed Limit: 15 KM/Hr

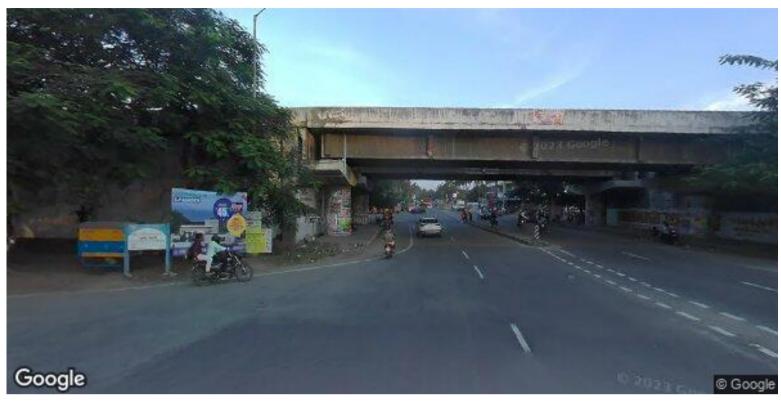
Coordinates: 11.18268, 77.28468

Risk Type: Blind Spot
Risk Level: Blind Spot
Speed Limit: 10 KM/Hr

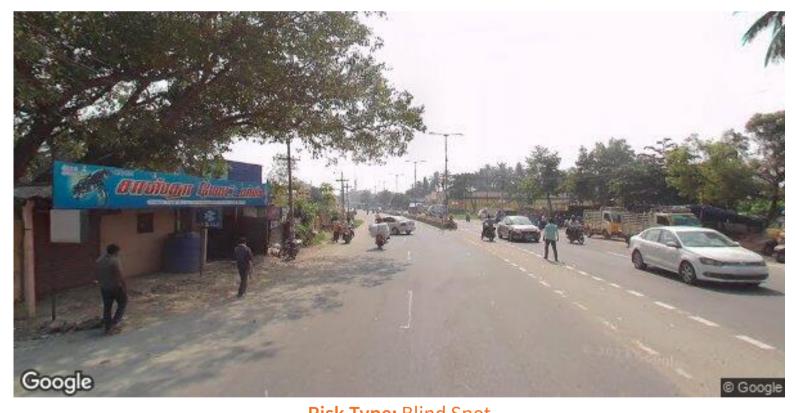
Coordinates: 11.14859, 77.31337

Risk Type: Blind Spot
Risk Level: Blind Spot
Speed Limit: 10 KM/Hr

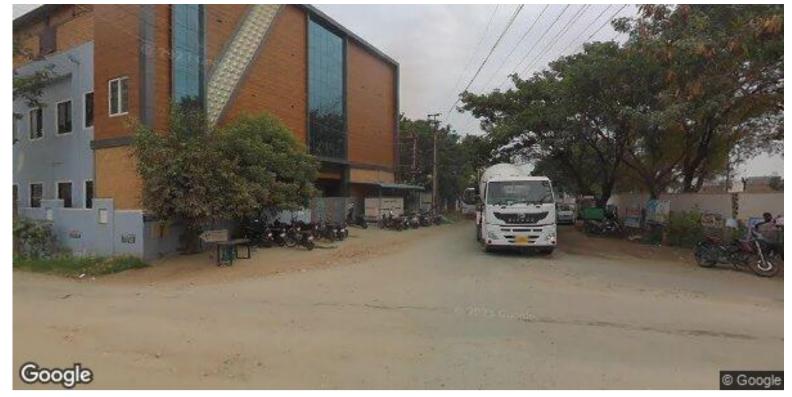
Coordinates: 11.14698, 77.30948

Risk Type: Blind Spot Risk Level: Blind Spot Speed Limit: 10 KM/Hr

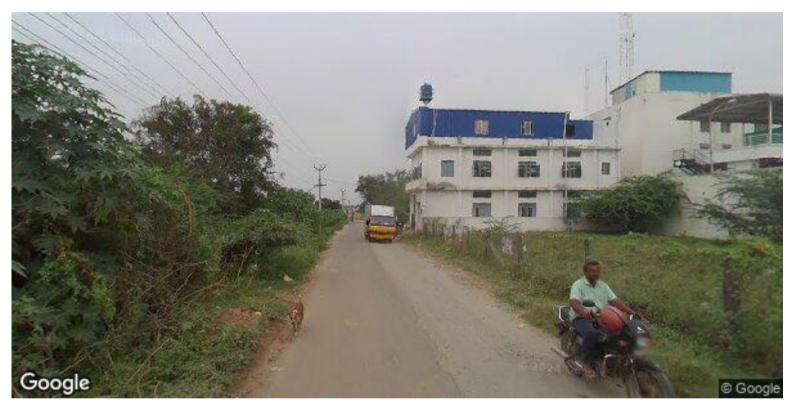
Risk Type: Blind Spot
Risk Level: Blind Spot
Speed Limit: 10 KM/Hr
Coordinates: 11.14782, 77.30965

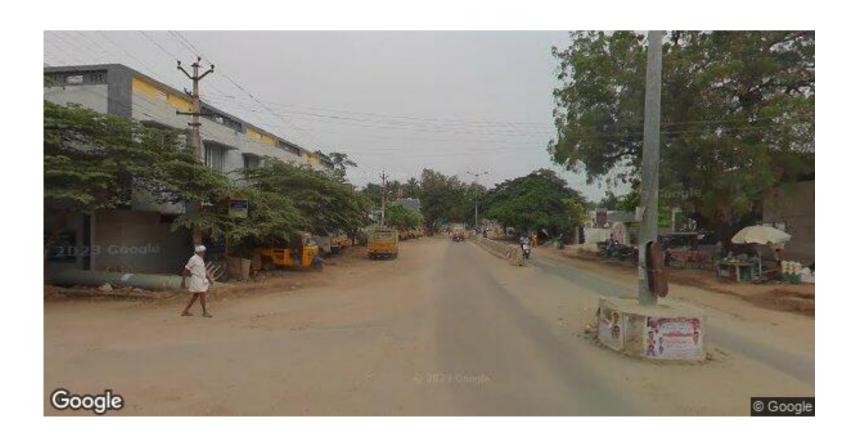
Coordinates: 11.14086, 77.30953

Risk Type: Turn
Risk Level: High
Speed Limit: 15 KM/Hr

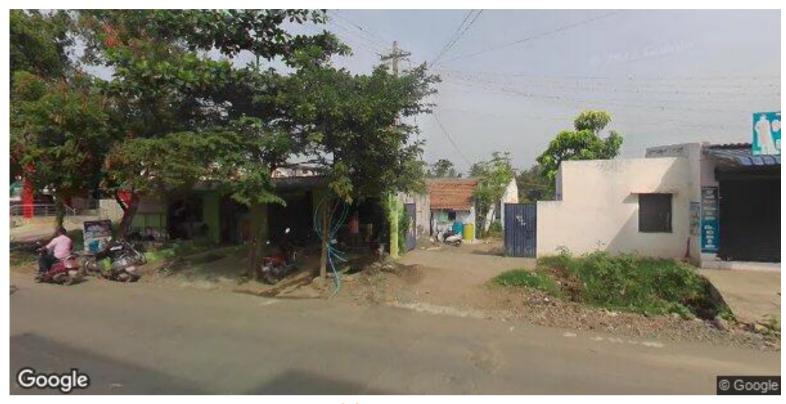
Coordinates: 11.14096, 77.31640

Risk Type: Turn
Risk Level: High
Speed Limit: 15 KM/Hr

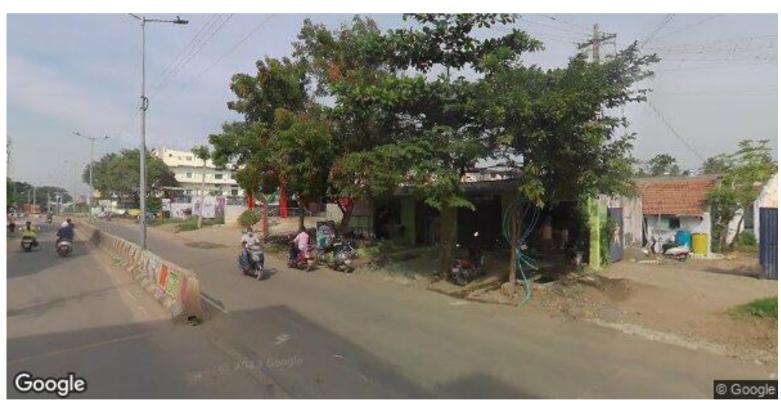
Coordinates: 11.14091, 77.31641

Risk Type: Blind Spot
Risk Level: Blind Spot
Speed Limit: 10 KM/Hr
