JOURNEY RISK MANAGEMENT (JRM) STUDY

IOCL Coimbatore Terminal to R K T Trading Co

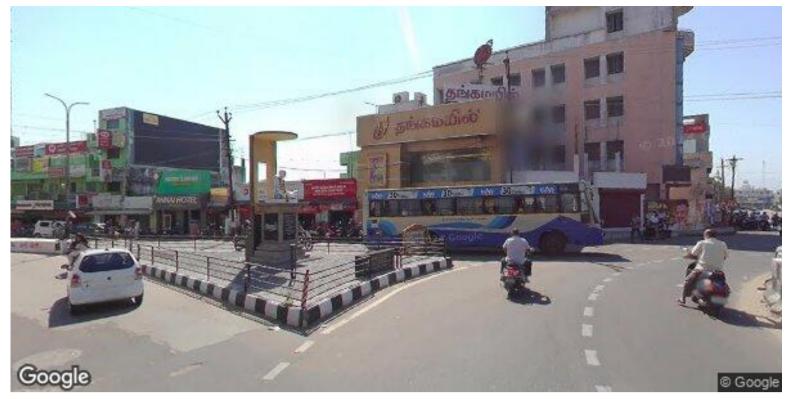
Coordinates: 10.66197, 77.00818

Risk Type: Roundabout
Risk Level: High
Speed Limit: 15 KM/Hr

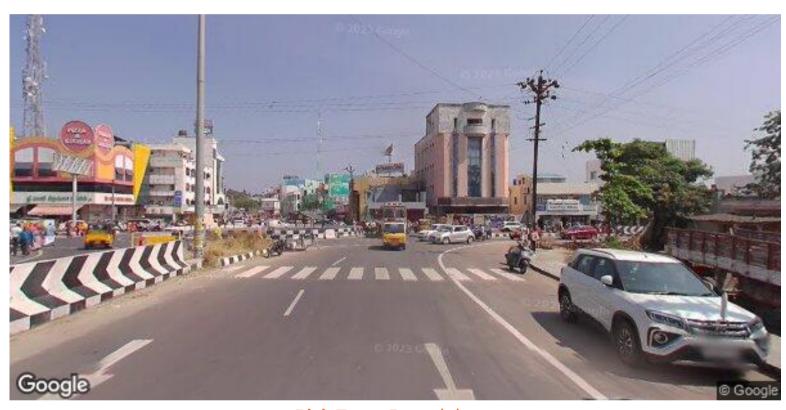
Risk Type: Roundabout
Risk Level: High
Speed Limit: 15 KM/Hr
Coordinates: 10.66176, 77.00771

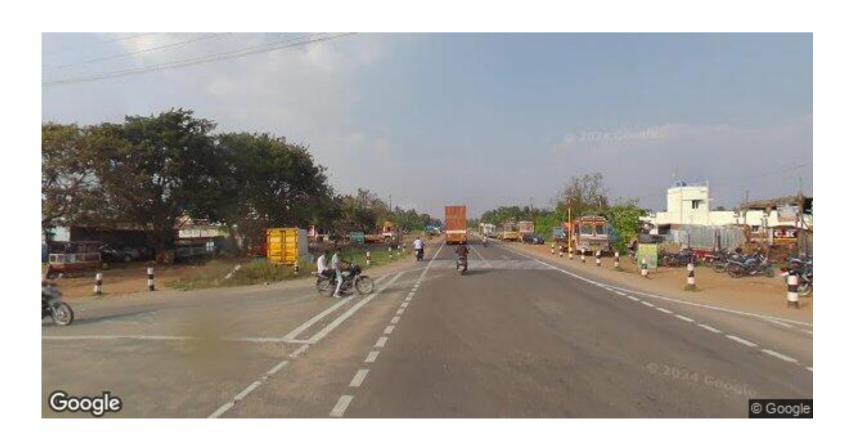
Coordinates: 11.03211, 77.07640

Risk Type: Blind Spot Risk Level: Blind Spot Speed Limit: 10 KM/Hr

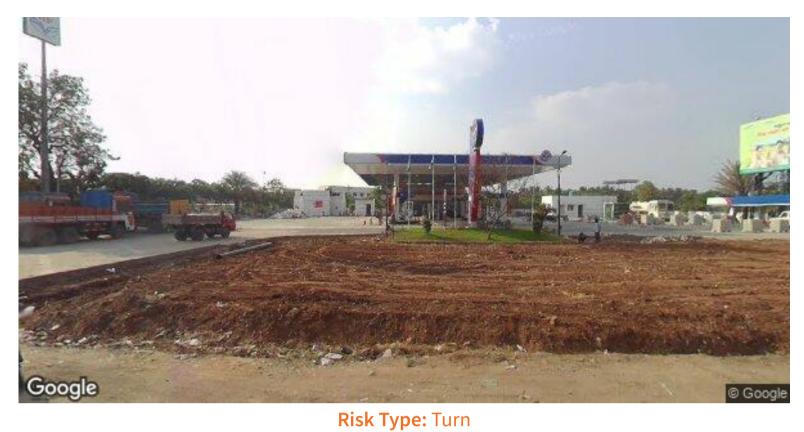
Risk Type: Turn
Risk Level: Medium
Speed Limit: 30 KM/Hr
Coordinates: 11.00873, 77.07114

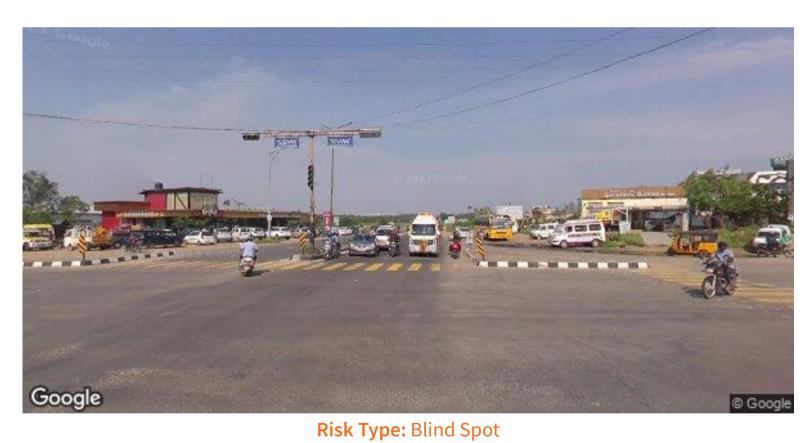
Coordinates: 10.91785, 76.98617

Risk Type: Blind Spot

Risk Level: Blind Spot

Speed Limit: 10 KM/Hr

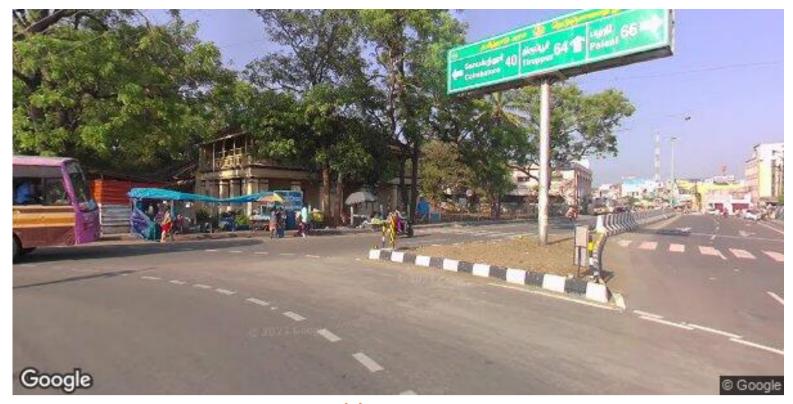
Risk Type: Turn
Risk Level: Medium
Speed Limit: 30 KM/Hr
Coordinates: 10.66172, 77.00697

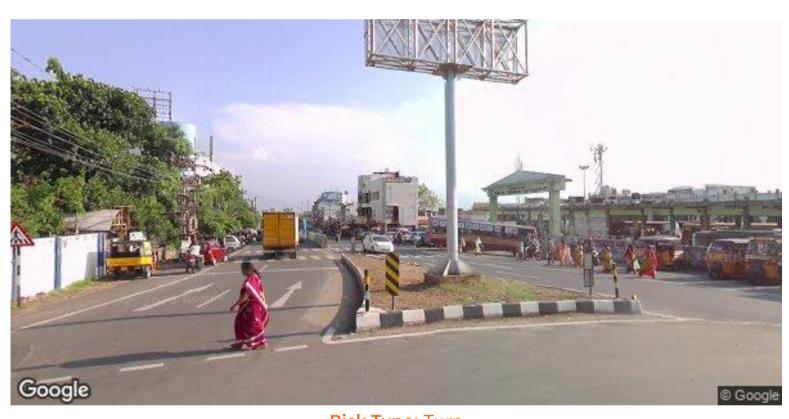
Risk Type: Turn
Risk Level: Medium
Speed Limit: 30 KM/Hr
Coordinates: 10.66167, 77.00688

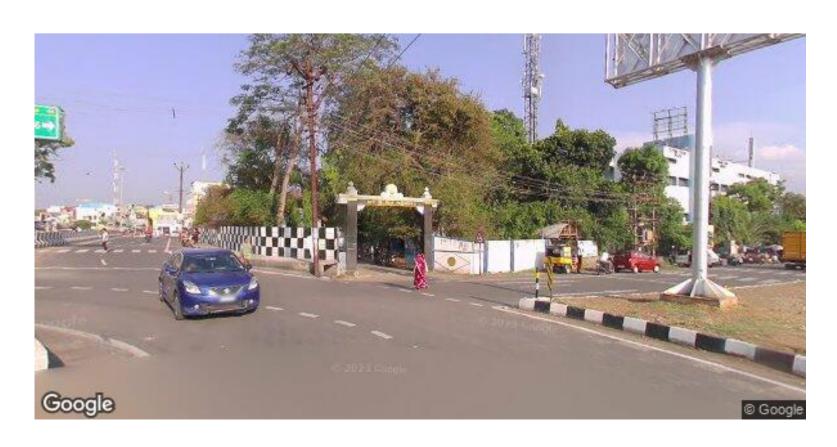
Coordinates: 10.66168, 77.00681

Risk Type: Turn
Risk Level: Medium
Speed Limit: 30 KM/Hr

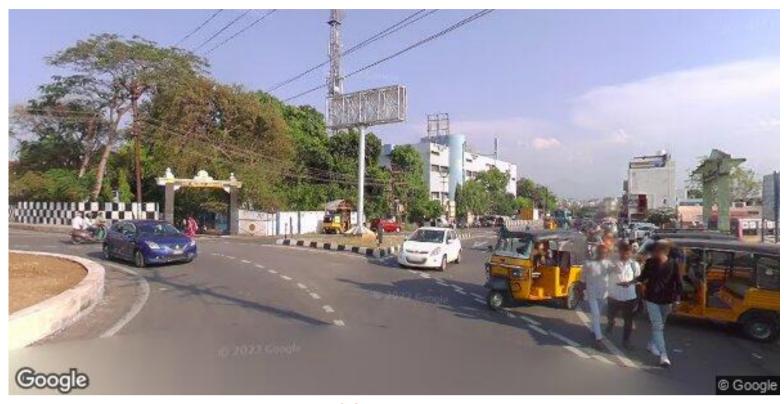
Risk Type: Turn
Risk Level: Medium
Speed Limit: 30 KM/Hr
Coordinates: 10.66175, 77.00674

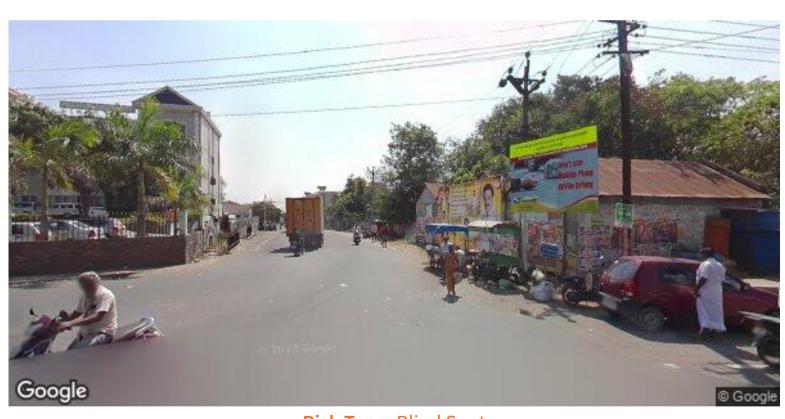
Coordinates: 10.66318, 77.00202

Risk Type: Blind Spot Risk Level: Blind Spot Speed Limit: 10 KM/Hr

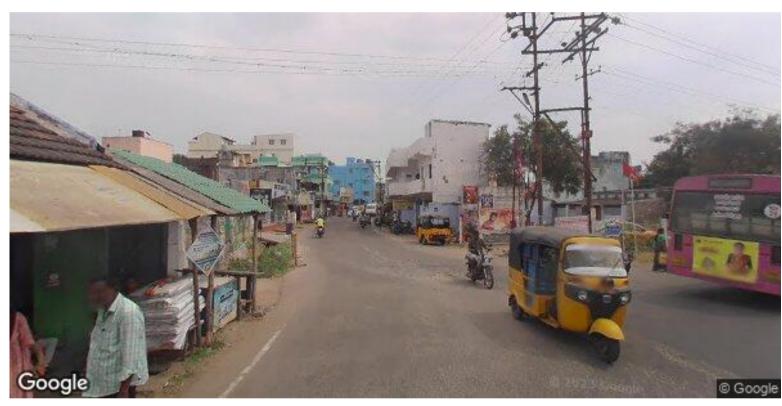
Coordinates: 10.66026, 77.00309

Risk Type: Turn
Risk Level: High
Speed Limit: 15 KM/Hr
