JOURNEY RISK MANAGEMENT (JRM) STUDY

Salem Terminal to SRI VELAVAN AGENCY

Route Safety Analysis for CVQF+23W, Sangagiri to 531, Erode-Chennimalai Rd, Senathipathipalayam, Erode

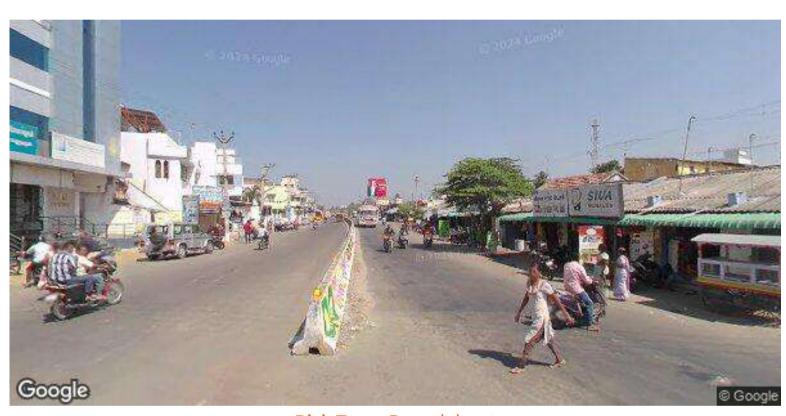
Coordinates: 11.37086, 77.74828

Risk Type: Roundabout
Risk Level: High
Speed Limit: 15 KM/Hr

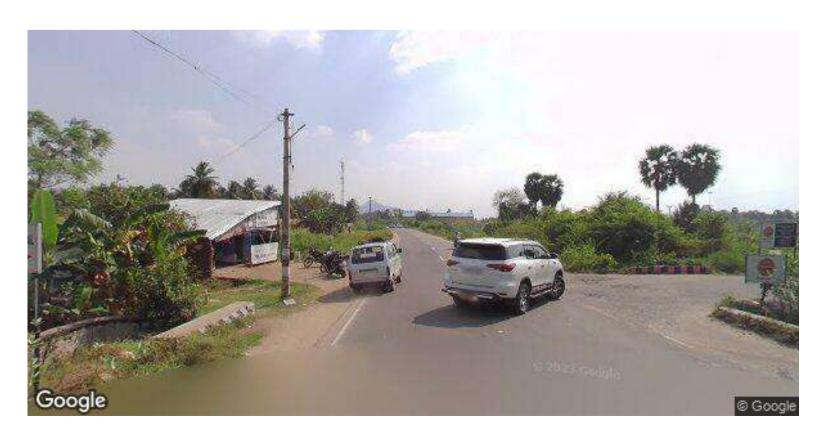
Coordinates: 11.44029, 77.87544

Risk Type: Turn
Risk Level: High
Speed Limit: 15 KM/Hr

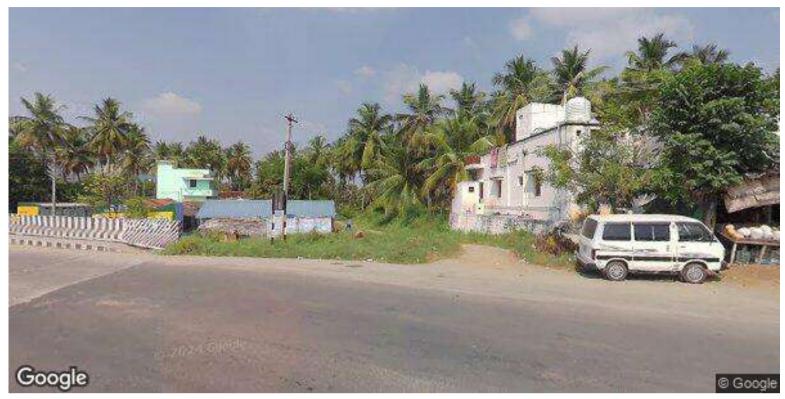
Coordinates: 11.44898, 77.87410

Risk Type: Turn
Risk Level: Medium
Speed Limit: 30 KM/Hr

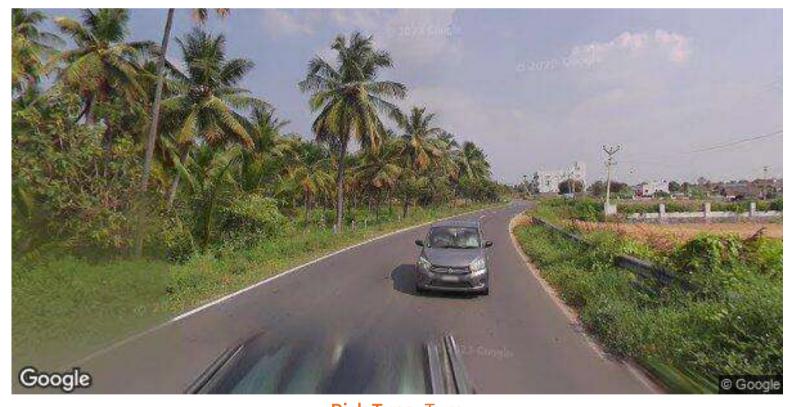
Risk Type: Turn
Risk Level: Medium
Speed Limit: 30 KM/Hr
Coordinates: 11.45357, 77.85789

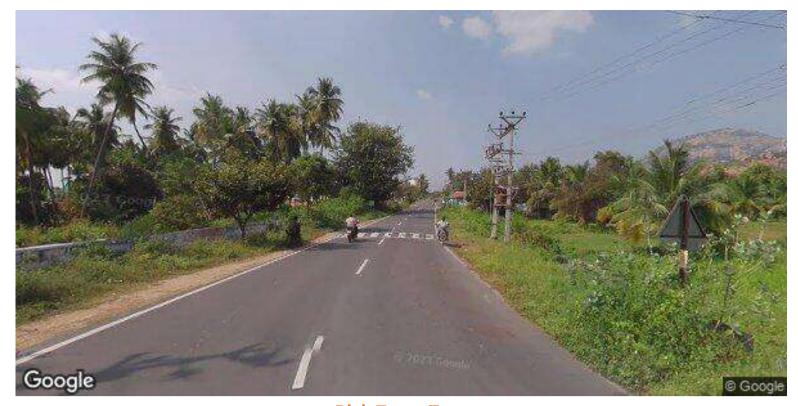
Risk Type: Turn
Risk Level: Medium
Speed Limit: 30 KM/Hr
Coordinates: 11.45352, 77.85698

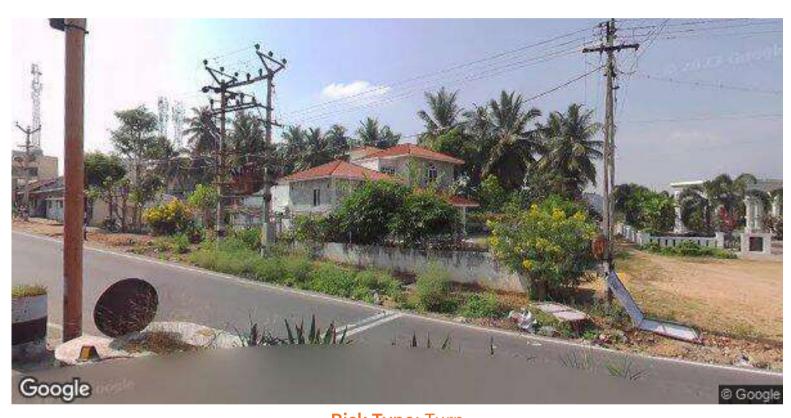
Risk Type: Turn
Risk Level: Medium
Speed Limit: 30 KM/Hr
Coordinates: 11.46303, 77.84945

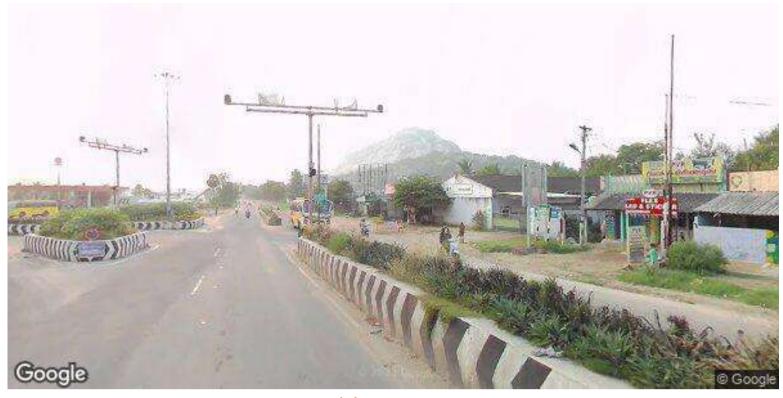
Risk Type: Turn
Risk Level: Medium
Speed Limit: 30 KM/Hr
Coordinates: 11.46312, 77.84886

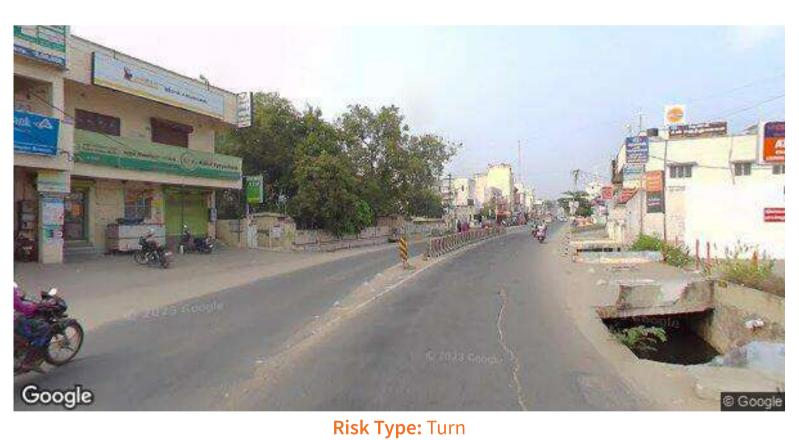
Risk Type. Turn
Risk Level: Medium
Speed Limit: 30 KM/Hr
Coordinates: 11.36622, 77.74789

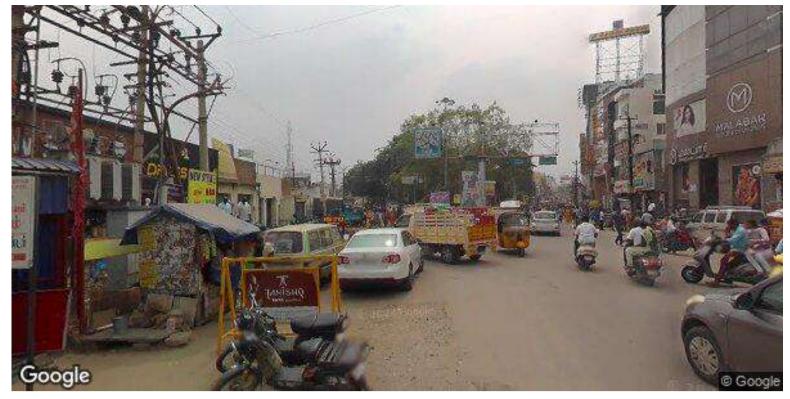
Risk Type: Turn
Risk Level: Medium
Speed Limit: 30 KM/Hr
Coordinates: 11.34493, 77.73032

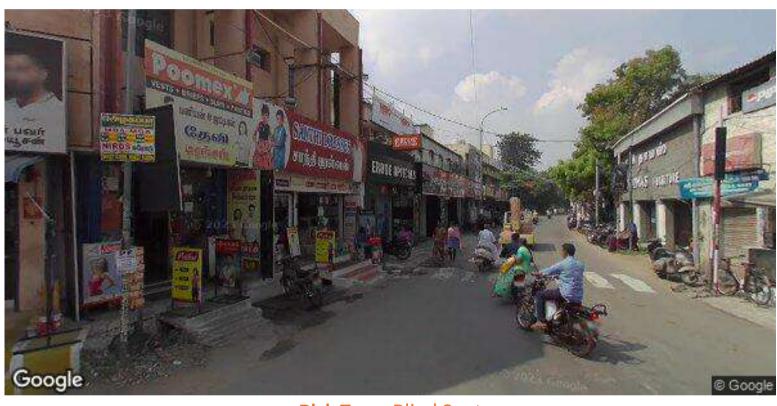
Risk Type: Blind Spot
Risk Level: Blind Spot
Speed Limit: 10 KM/Hr
Coordinates: 11.33920, 77.72902

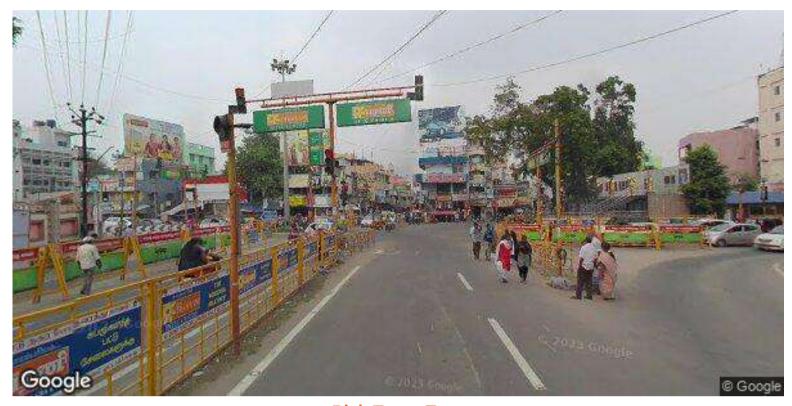
Coordinates: 11.33890, 77.72637

Risk Type: Turn
Risk Level: High
Speed Limit: 15 KM/Hr

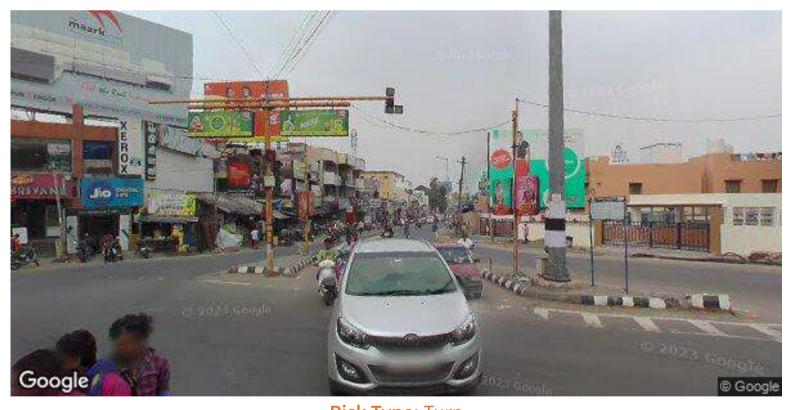
Risk Type: Turn
Risk Level: Medium
Speed Limit: 30 KM/Hr
Coordinates: 11.33095, 77.72748

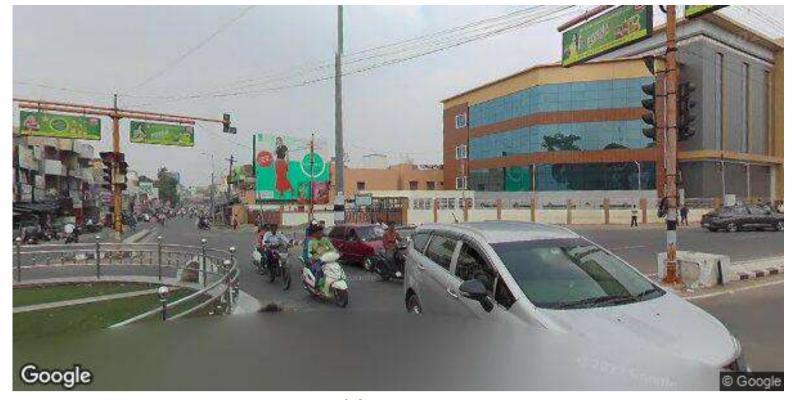
Risk Type: Turn
Risk Level: High
Speed Limit: 15 KM/Hr
Coordinates: 11.33090, 77.72748

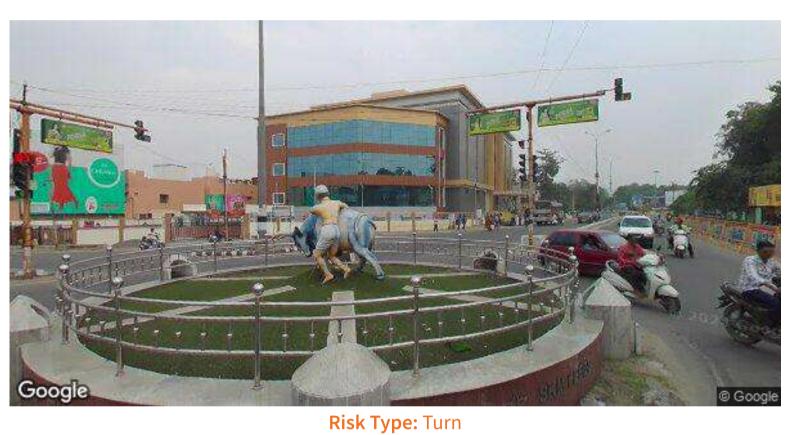
Risk Type: Turn
Risk Level: Medium
Speed Limit: 30 KM/Hr
Coordinates: 11.33084, 77.72742

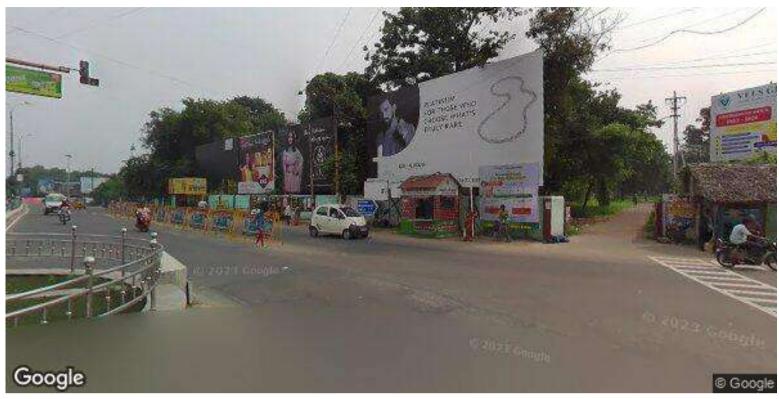
Coordinates: 11.33084, 77.72731

Risk Type: Turn
Risk Level: High
Speed Limit: 15 KM/Hr

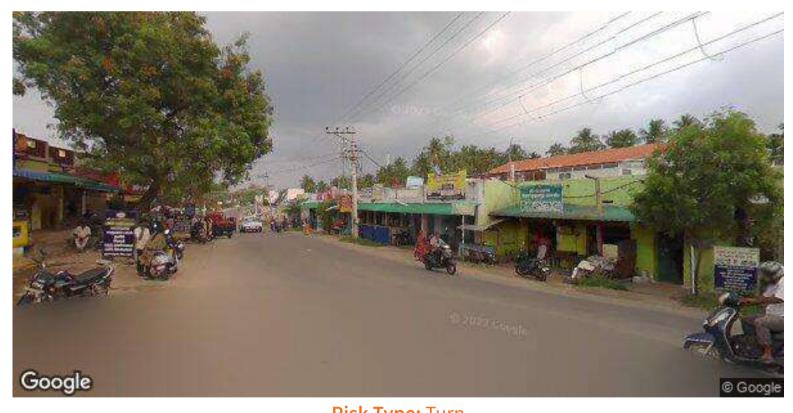
Coordinates: 11.31172, 77.70715

Risk Type: Turn
Risk Level: High
Speed Limit: 15 KM/Hr

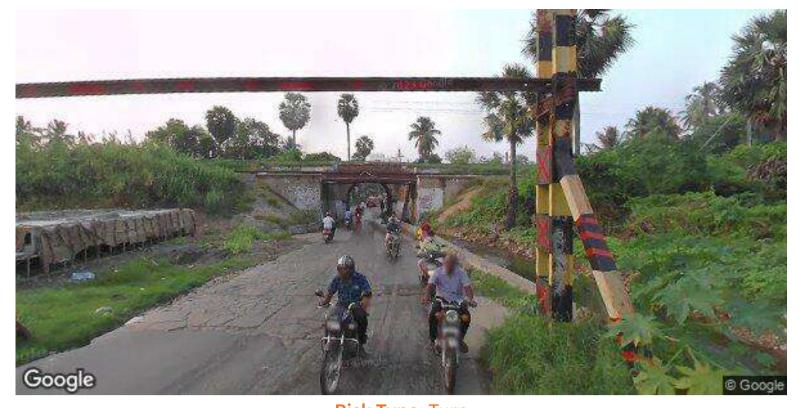
Risk Type: Turn
Risk Level: Medium
Speed Limit: 30 KM/Hr
Coordinates: 11.31050, 77.70781

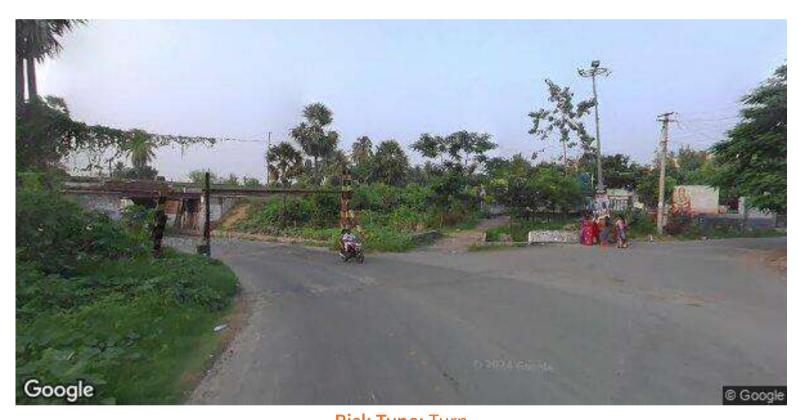
Risk Type: Turn
Risk Level: Medium
Speed Limit: 30 KM/Hr
Coordinates: 11.31032, 77.70783

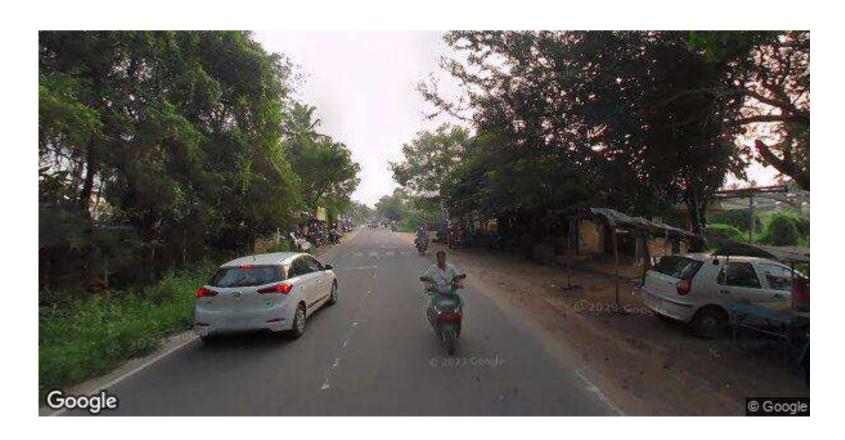
Coordinates: 11.30807, 77.70415

24	Turn	Medium	11.30807, 77.70415	30 KM/Hr
