# JOURNEY RISK MANAGEMENT (JRM) STUDY

# Salem Terminal to SRI RAGAVENDRA FUELS

Route Safety Analysis: CVQF+23W, Sangagiri to 3MCR+RG Keetapalayam

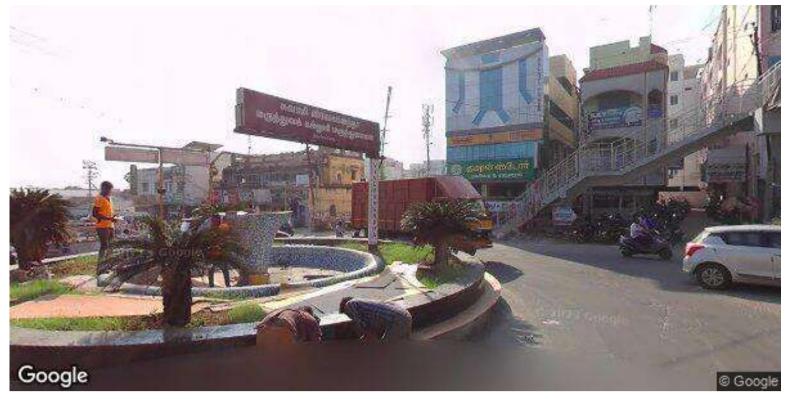
**Coordinates:** 11.38395, 77.89480

| | Risk Type | Risk Level | Coordinates | Speed Limit |
|---|---|---|---|---|
| 0 | Roundabout | High | 11.38395, 77.89480 | 15 KM/Hr |

Risk Type: Roundabout
Risk Level: High
Speed Limit: 15 KM/Hr

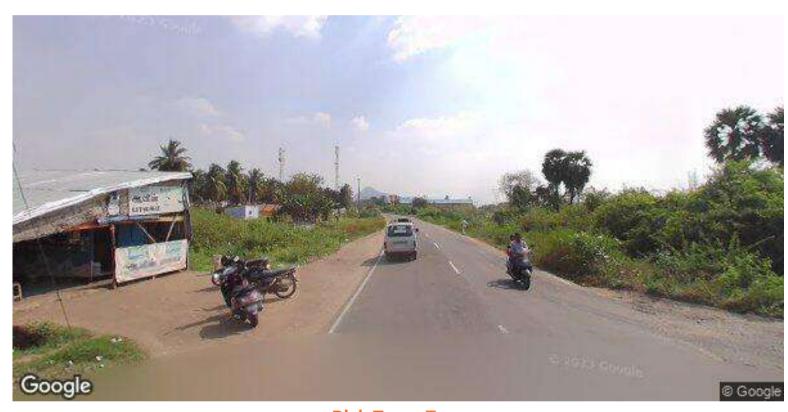
| | Risk Type | Risk Level | Coordinates | Speed Limit |
|---|---|---|---|---|
| 3 | Turn | High | 11.44022, 77.87546 | 15 KM/Hr |

Risk Type: Turn
Risk Level: High
Speed Limit: 15 KM/Hr
Coordinates: 11.44022, 77.87546

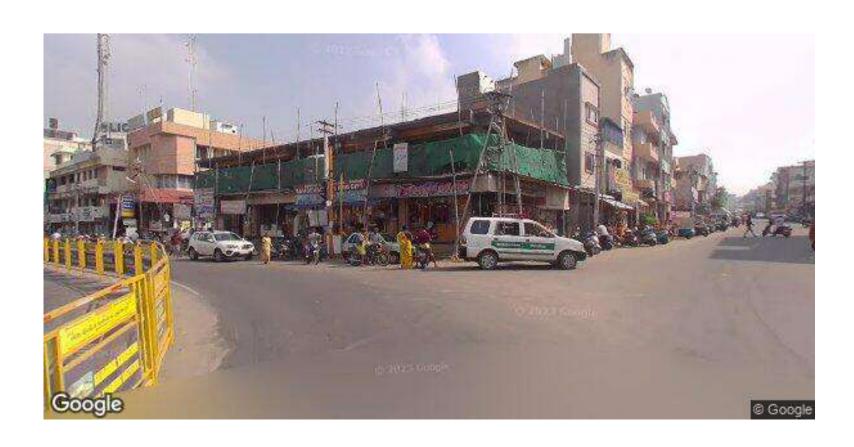
**Coordinates:** 11.37868, 77.89498

| | Risk Type | Risk Level | Coordinates | Speed Limit |
|---|---|---|---|---|
| 4 | Turn | High | 11.37868, 77.89498 | 15 KM/Hr |

Risk Type: Turn
Risk Level: High
Speed Limit: 15 KM/Hr

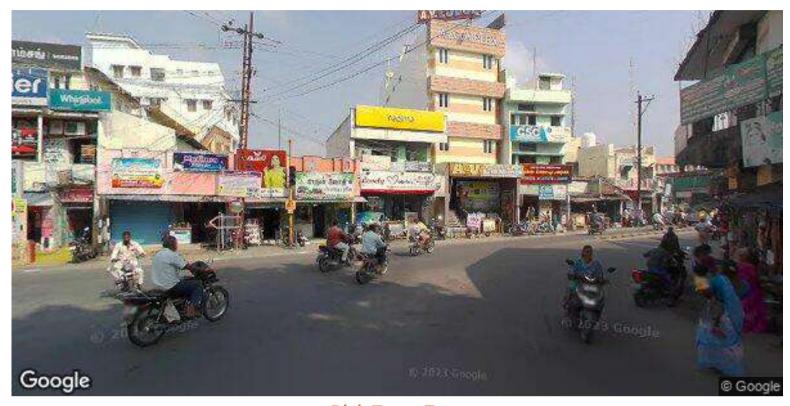
**Coordinates:** 11.37842, 77.89452

| | Risk Type | Risk Level | Coordinates | Speed Limit |
|---|---|---|---|---|
| 5 | Turn | Medium | 11.37842, 77.89452 | 30 KM/Hr |

Risk Type: Turn
Risk Level: Medium
Speed Limit: 30 KM/Hr

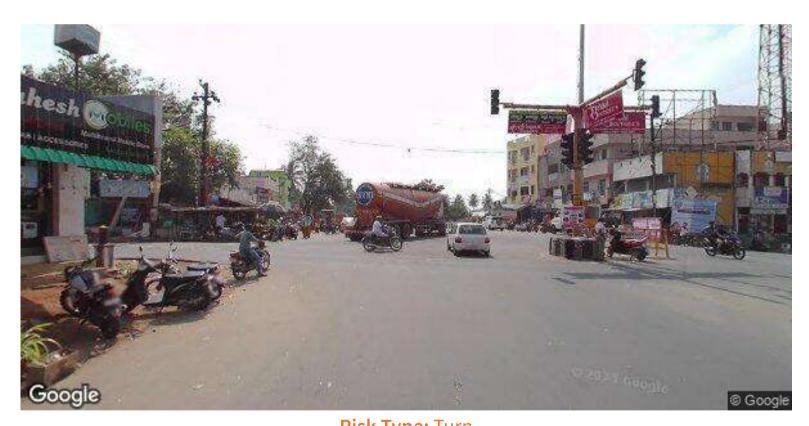
**Coordinates:** 11.36616, 77.88885

| | Risk Type | Risk Level | Coordinates | Speed Limit |
|---|---|---|---|---|
| 6 | Turn | Medium | 11.36616, 77.88885 | 30 KM/Hr |

Risk Type: Turn
Risk Level: Medium
Speed Limit: 30 KM/Hr

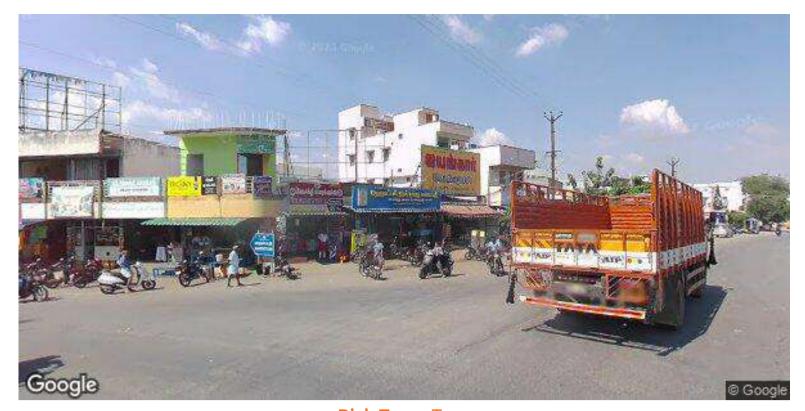
**Coordinates:** 11.36602, 77.88875

| | Risk Type | Risk Level | Coordinates | Speed Limit |
|---|---|---|---|---|
| 7 | Turn | Medium | 11.36602, 77.88875 | 30 KM/Hr |

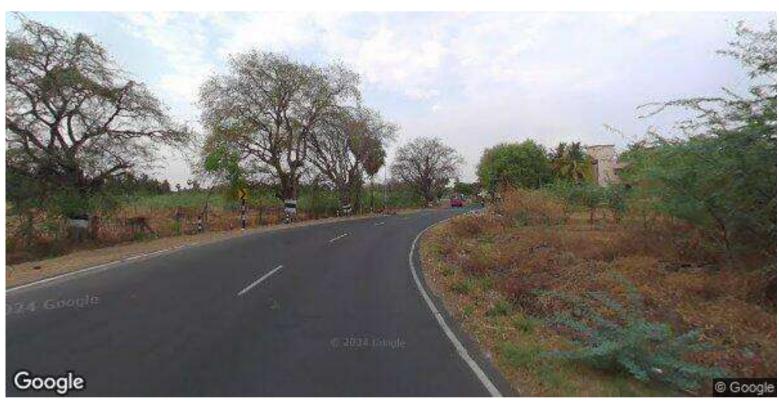
| | Risk Type | Risk Level | Coordinates | Speed Limit |
|---|---|---|---|---|
| 8 | Turn | Medium | 11.34067, 77.86347 | 30 KM/Hr |

Risk Type: Turn
Risk Level: Medium
Speed Limit: 30 KM/Hr
Coordinates: 11.34067, 77.86347

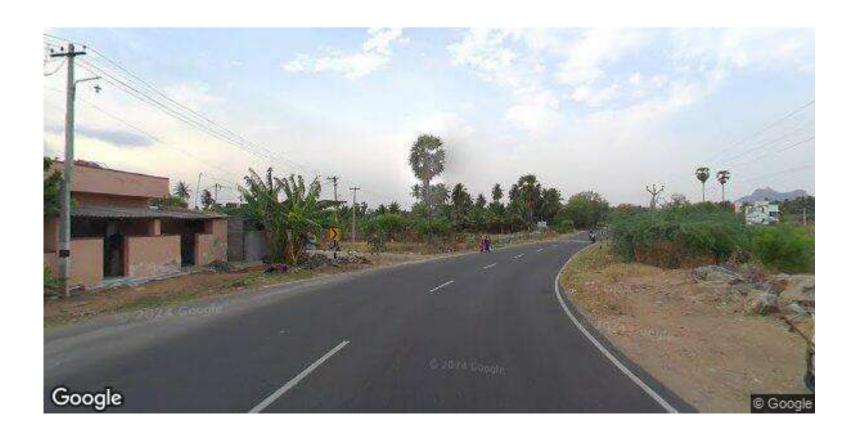
**Coordinates:** 11.33882, 77.86218

| | Risk Type | Risk Level | Coordinates | Speed Limit |
|---|---|---|---|---|
| 9 | Turn | Medium | 11.33882, 77.86218 | 30 KM/Hr |

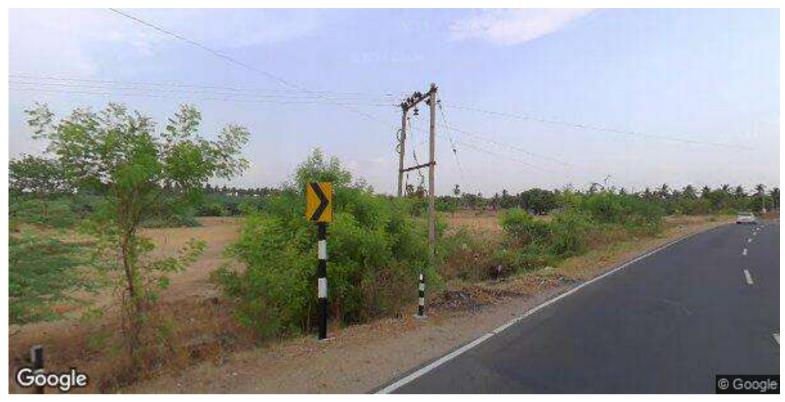
| | Risk Type | Risk Level | Coordinates | Speed Limit |
|---|---|---|---|---|
| 10 | Turn | Medium | 11.33778, 77.86236 | 30 KM/Hr |

Risk Type: Turn
Risk Level: Medium
Speed Limit: 30 KM/Hr
Coordinates: 11.33778, 77.86236

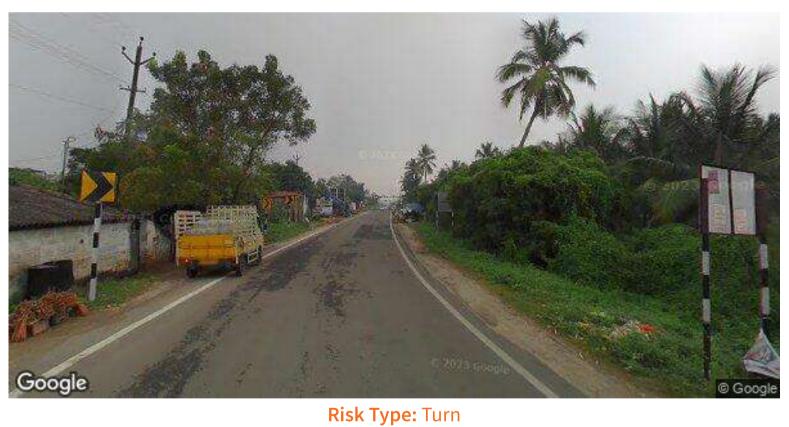
| | Risk Type | Risk Level | Coordinates | Speed Limit |
|---|---|---|---|---|
| 11 | Turn | Medium | 11.30973, 77.76712 | 30 KM/Hr |

Risk Type: Turn
Risk Level: Medium
Speed Limit: 30 KM/Hr
Coordinates: 11.30973, 77.76712

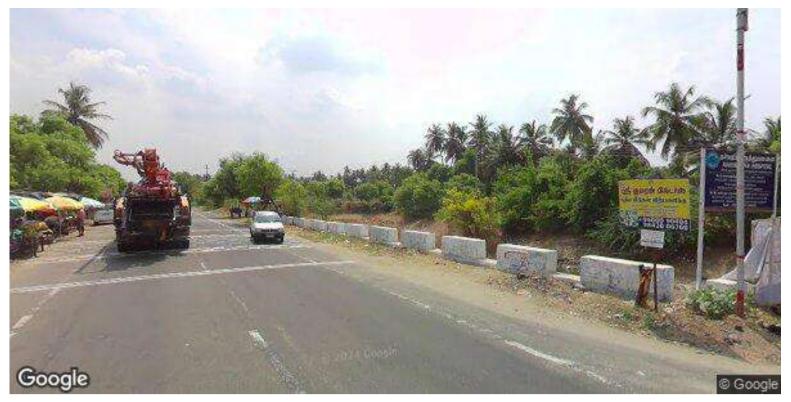
| | Risk Type | Risk Level | Coordinates | Speed Limit |
|---|---|---|---|---|
| 12 | Turn | High | 11.29490, 77.74685 | 15 KM/Hr |

Risk Type: Turn
Risk Level: High
Speed Limit: 15 KM/Hr
Coordinates: 11.29490, 77.74685

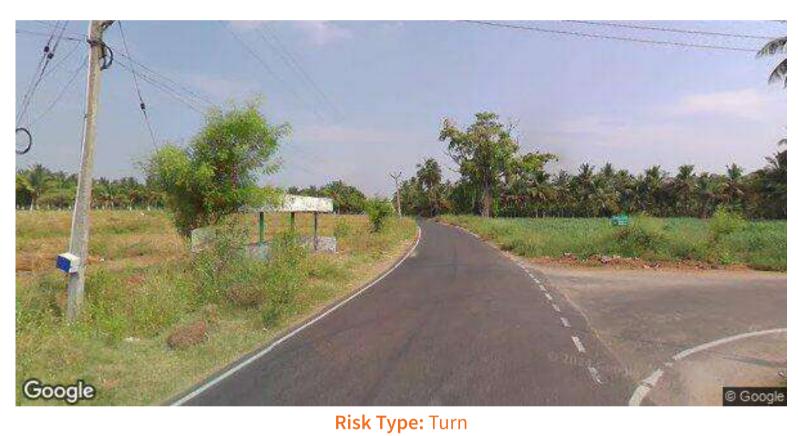
| | Risk Type | Risk Level | Coordinates | Speed Limit |
|---|---|---|---|---|
| 13 | Turn | High | 11.29141, 77.74662 | 15 KM/Hr |

Risk Type: Turn
Risk Level: High
Speed Limit: 15 KM/Hr
Coordinates: 11.29141, 77.74662

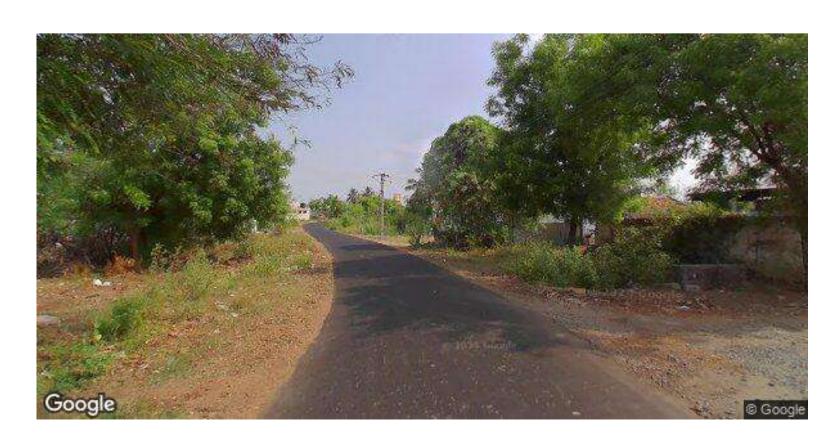
**Coordinates:** 11.28844, 77.74319

| | Risk Type | Risk Level | Coordinates | Speed Limit |
|---|---|---|---|---|
| 14 | Turn | Medium | 11.28844, 77.74319 | 30 KM/Hr |

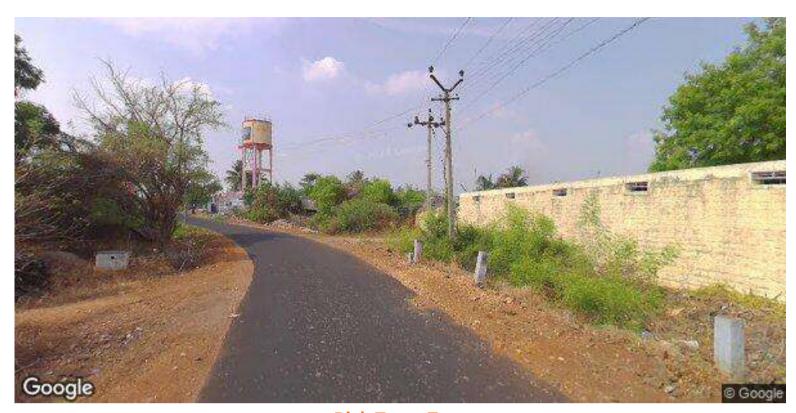
| | Risk Type | Risk Level | Coordinates | Speed Limit |
|---|---|---|---|---|
| 15 | Turn | Medium | 11.28573, 77.74281 | 30 KM/Hr |

Risk Type: Turn
Risk Level: Medium
Speed Limit: 30 KM/Hr
Coordinates: 11.28573, 77.74281

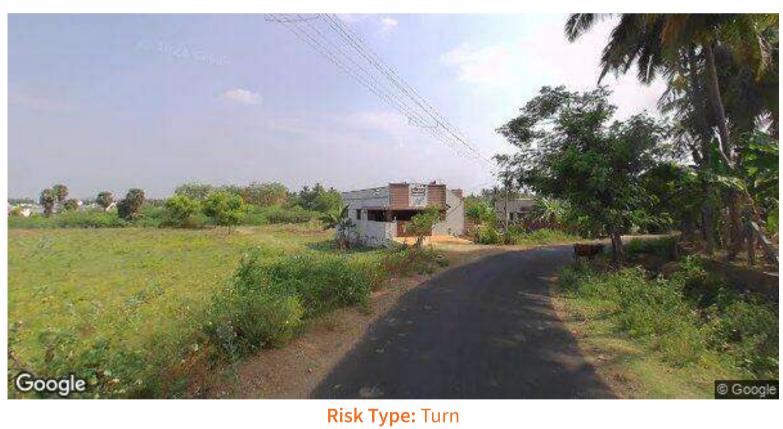
| | Risk Type | Risk Level | Coordinates | Speed Limit |
|---|---|---|---|---|
| 16 | Turn | Medium | 11.27336, 77.72999 | 30 KM/Hr |

Risk Type. Turn
Risk Level: Medium
Speed Limit: 30 KM/Hr
Coordinates: 11.27336, 77.72999

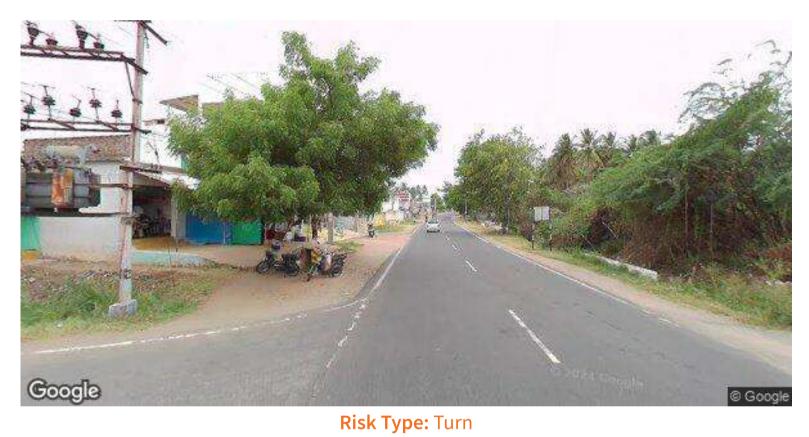
| | Risk Type | Risk Level | Coordinates | Speed Limit |
|---|---|---|---|---|
| 18 | Turn | High | 11.27328, 77.72705 | 15 KM/Hr |

Risk Level: High
Speed Limit: 15 KM/Hr
Coordinates: 11.27328, 77.72705

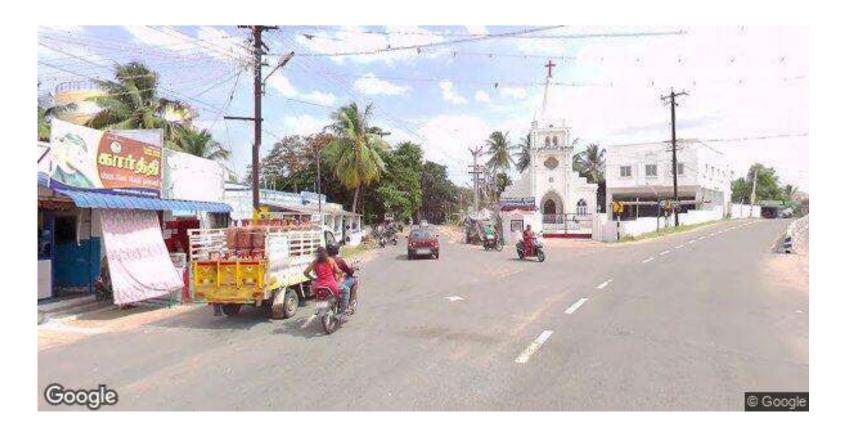
**Coordinates:** 11.23054, 77.71796

| | Risk Type | Risk Level | Coordinates | Speed Limit |
|---|---|---|---|---|
| 19 | Turn | Medium | 11.23054, 77.71796 | 30 KM/Hr |

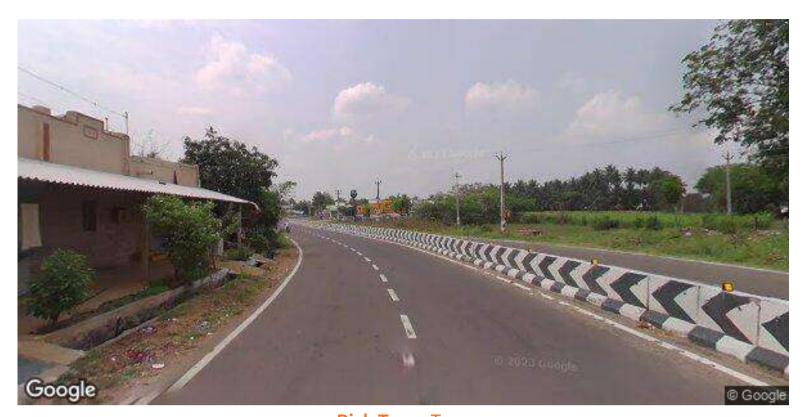
| | Risk Type | Risk Level | Coordinates | Speed Limit |
|---|---|---|---|---|
| 20 | Turn | Medium | 11.22387, 77.71385 | 30 KM/Hr |

Risk Type: Turn
Risk Level: Medium
Speed Limit: 30 KM/Hr
Coordinates: 11.22387, 77.71385

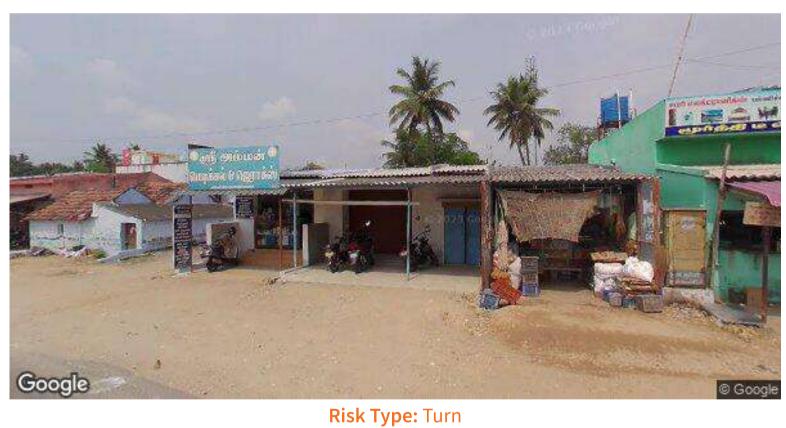
| | Risk Type | Risk Level | Coordinates | Speed Limit |
|---|---|---|---|---|
| 21 | Turn | Medium | 11.20776, 77.70916 | 30 KM/Hr |

Risk Type. Turn
Risk Level: Medium
Speed Limit: 30 KM/Hr
Coordinates: 11.20776, 77.70916

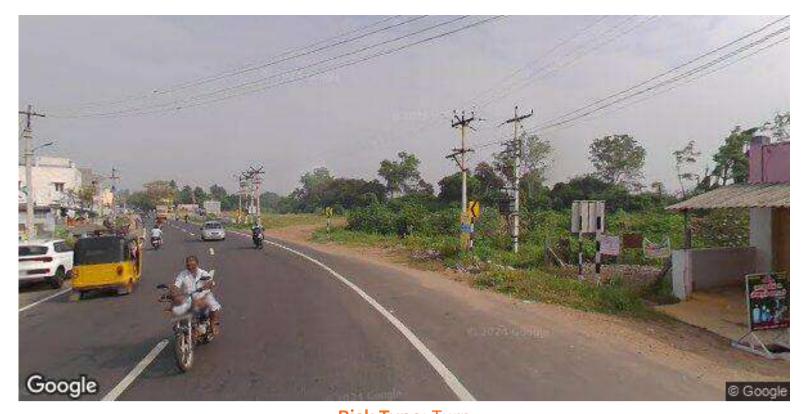
| | Risk Type | Risk Level | Coordinates | Speed Limit |
|---|---|---|---|---|
| 22 | Turn | Medium | 11.16078, 77.70122 | 30 KM/Hr |

Risk Type: Turn
Risk Level: Medium
Speed Limit: 30 KM/Hr
Coordinates: 11.16078, 77.70122

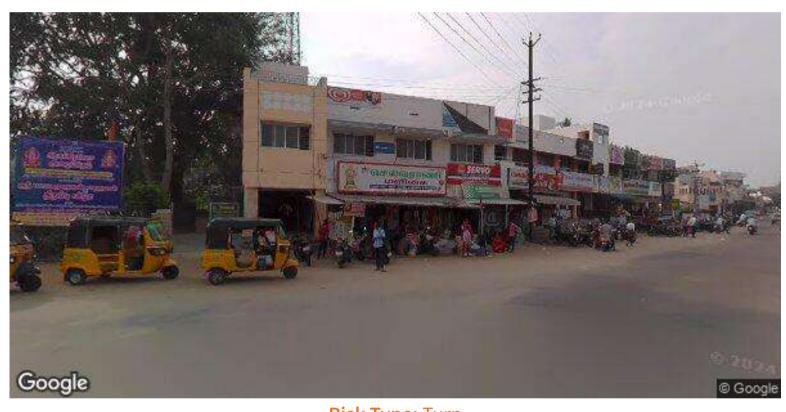
| | Risk Type | Risk Level | Coordinates | Speed Limit |
|---|---|---|---|---|
| 23 | Turn | High | 11.15942, 77.70068 | 15 KM/Hr |

Risk Type: Turn
Risk Level: High
Speed Limit: 15 KM/Hr
Coordinates: 11.15942, 77.70068

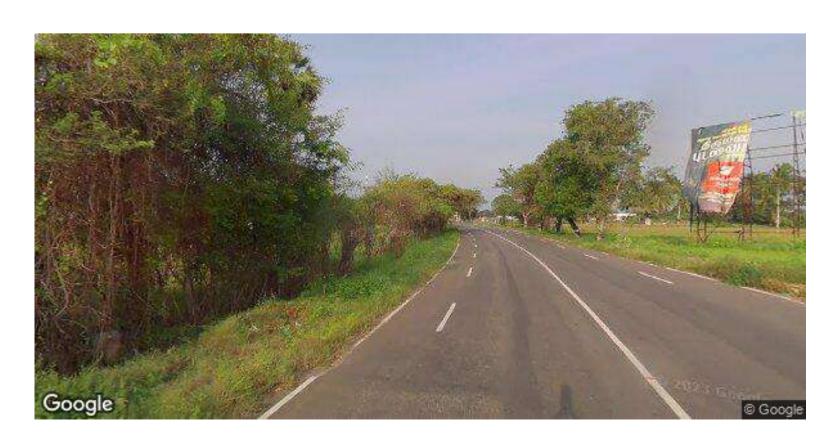
**Coordinates:** 11.11932, 77.67786

| | Risk Type | Risk Level | Coordinates | Speed Limit |
|---|---|---|---|---|
| 24 | Turn | Medium | 11.11932, 77.67786 | 30 KM/Hr |

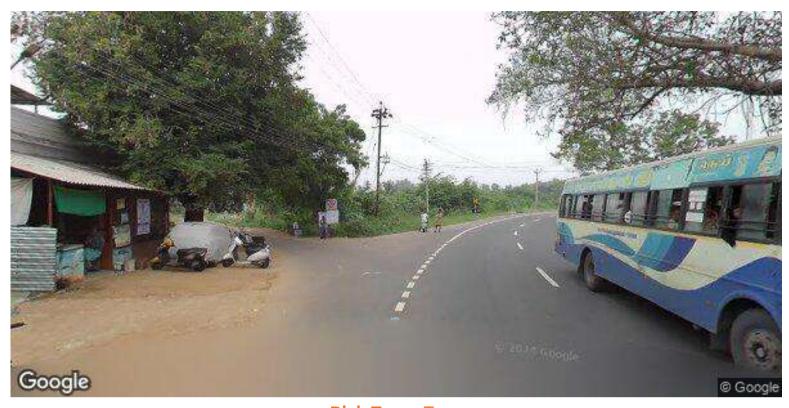
| | Risk Type | Risk Level | Coordinates | Speed Limit |
|---|---|---|---|---|
| 25 | Turn | Medium | 11.11710, 77.67175 | 30 KM/Hr |

Risk Type: Turn
Risk Level: Medium
Speed Limit: 30 KM/Hr
Coordinates: 11.11710, 77.67175

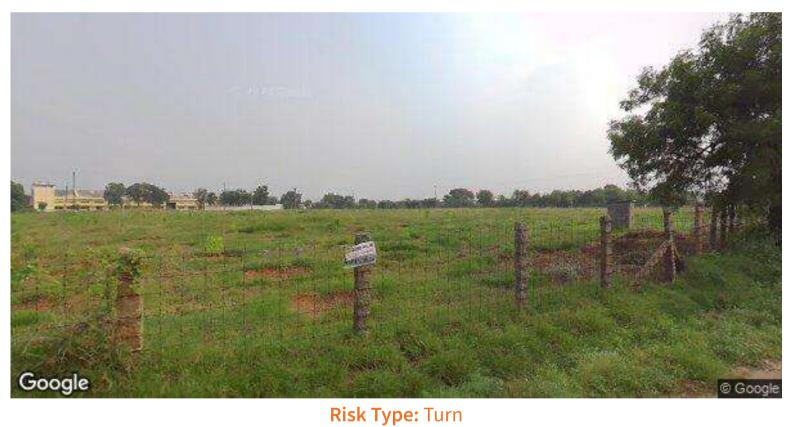
| | Risk Type | Risk Level | Coordinates | Speed Limit |
|---|---|---|---|---|
| 26 | Turn | Medium | 11.09491, 77.66603 | 30 KM/Hr |

Risk Type: Turn
Risk Level: Medium
Speed Limit: 30 KM/Hr
Coordinates: 11.09491, 77.66603

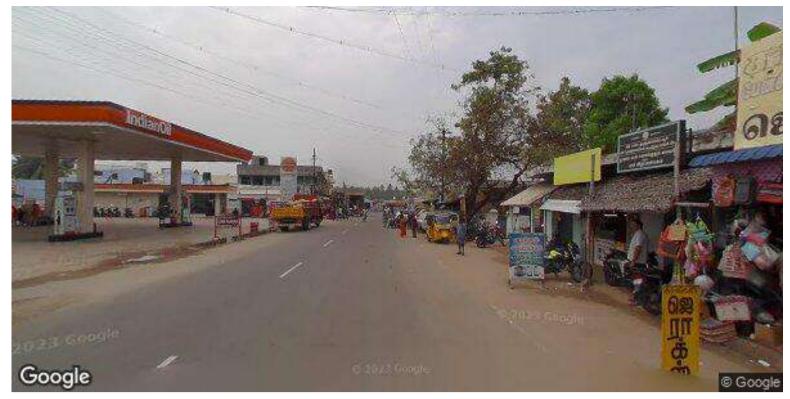
**Coordinates:** 11.08565, 77.66268

| | Risk Type | Risk Level | Coordinates | Speed Limit |
|---|---|---|---|---|
| 27 | Blind Spot | Blind Spot | 11.08565, 77.66268 | 10 KM/Hr |

Risk Type: Blind Spot Risk Level: Blind Spot Speed Limit: 10 KM/Hr

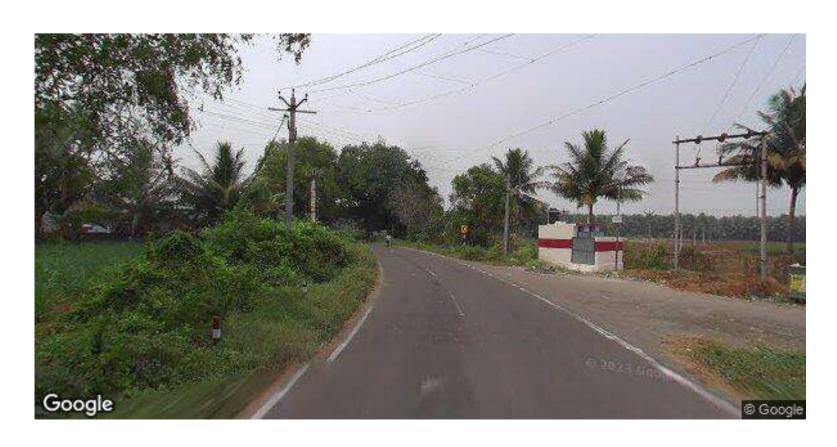
**Coordinates:** 11.08165, 77.68830

| | Risk Type | Risk Level | Coordinates | Speed Limit |
|---|---|---|---|---|
| 29 | Turn | Medium | 11.08165, 77.68830 | 30 KM/Hr |

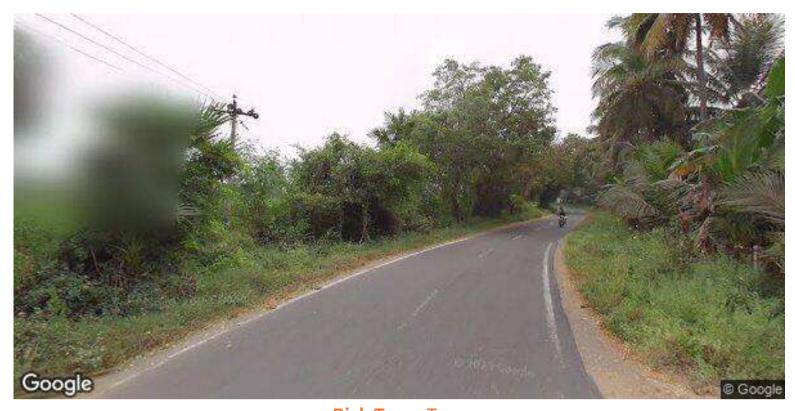
| | Risk Type | Risk Level | Coordinates | Speed Limit |
|---|---|---|---|---|
| 30 | Turn | Medium | 11.07800, 77.68953 | 30 KM/Hr |

Risk Type: Turn
Risk Level: Medium
Speed Limit: 30 KM/Hr
Coordinates: 11.07800, 77.68953

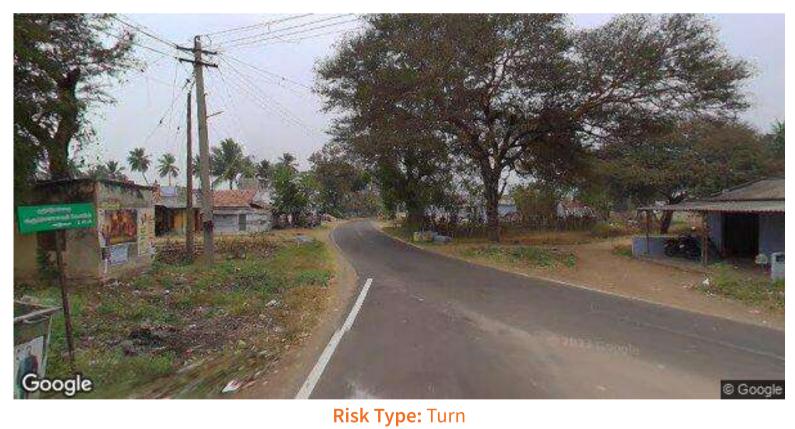
| | Risk Type | Risk Level | Coordinates | Speed Limit |
|---|---|---|---|---|
| 31 | Turn | High | 11.07327, 77.68855 | 15 KM/Hr |

Risk Level: High
Speed Limit: 15 KM/Hr
Coordinates: 11.07327, 77.68855

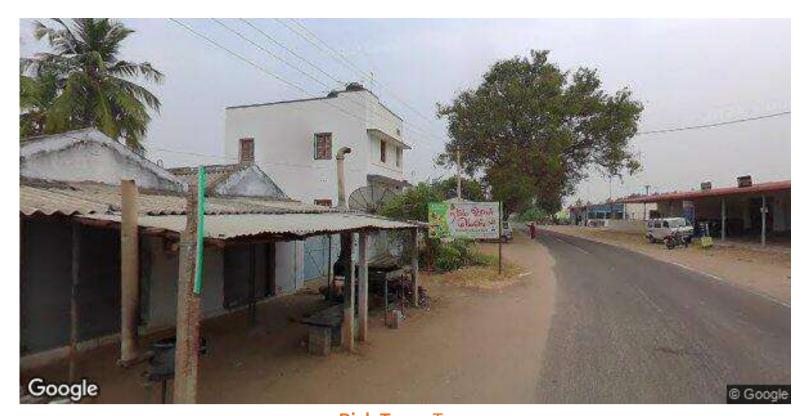
**Coordinates:** 11.07301, 77.68877

| | Risk Type | Risk Level | Coordinates | Speed Limit |
|---|---|---|---|---|
| 32 | Turn | Medium | 11.07301, 77.68877 | 30 KM/Hr |
