JOURNEY RISK MANAGEMENT (JRM) STUDY

IOCL Coimbatore Terminal to Sri Ramakrishna Fuels

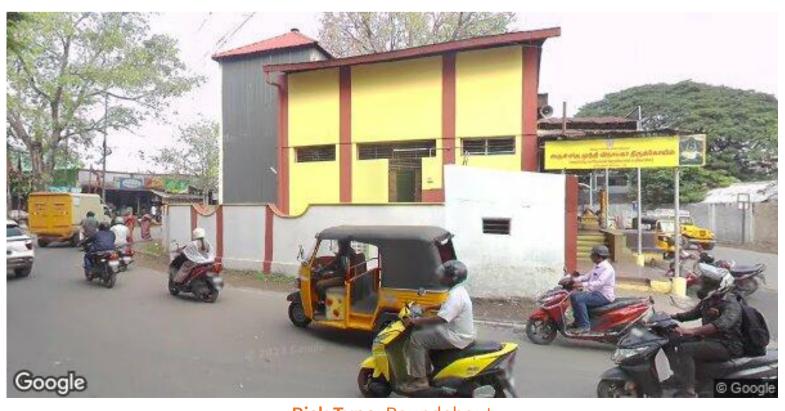
Risk Type: Roundabout
Risk Level: High

Speed Limit: 15 KM/Hr Coordinates: 11.00410, 76.99311

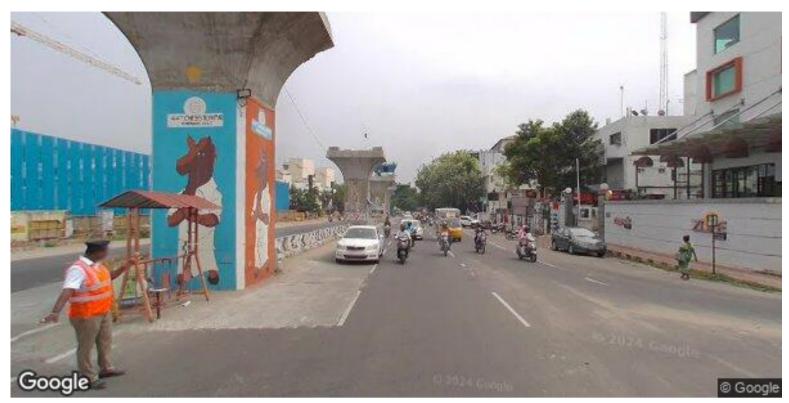
Risk Type: U-Turn
Risk Level: High
Speed Limit: 10 KM/Hr

Coordinates: 11.011602, 76.9841897

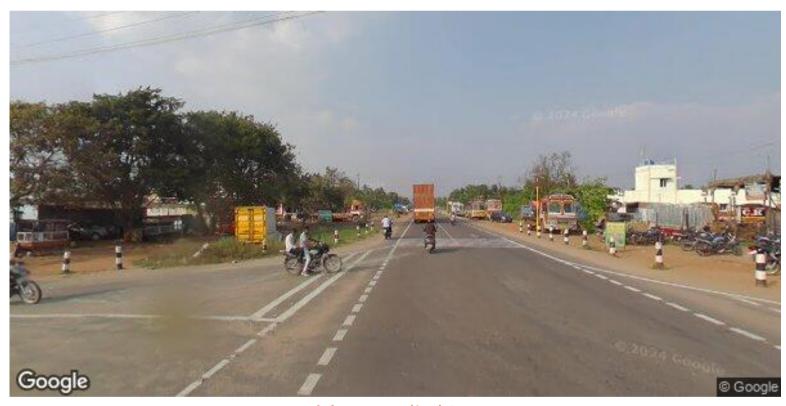
Risk Type: Blind Spot
Risk Level: Blind Spot
Speed Limit: 10 KM/Hr

Coordinates: 11.03211, 77.07640

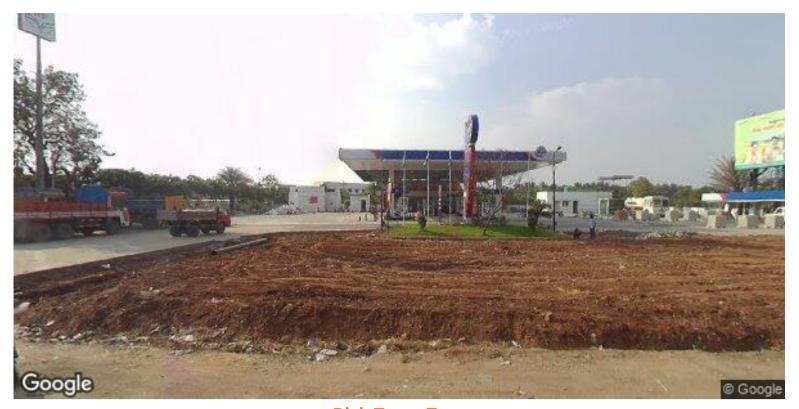
Risk Type: Turn
Risk Level: Medium
Speed Limit: 30 KM/Hr
Coordinates: 11.00873, 77.07114

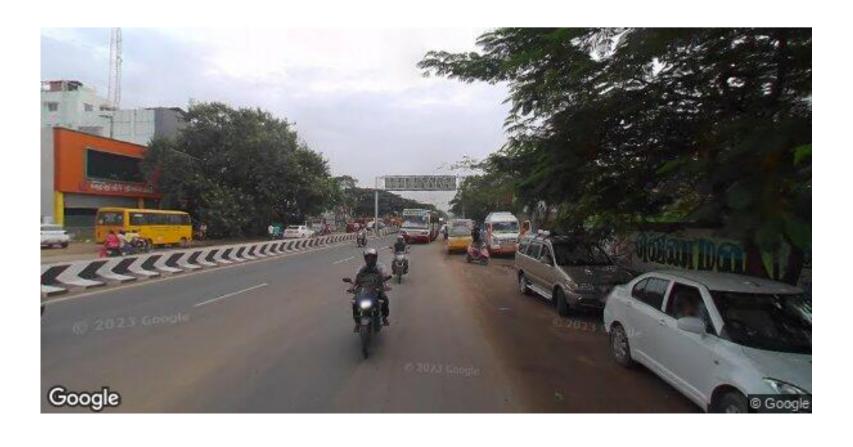
Risk Type: Turn
Risk Level: Medium
Speed Limit: 30 KM/Hr

Coordinates: 10.99678, 77.00653

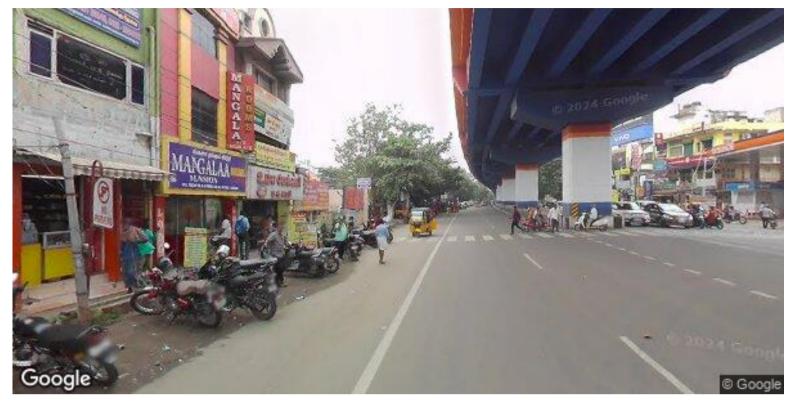
Risk Type: Turn
Risk Level: High
Speed Limit: 15 KM/Hr

Coordinates: 10.99699, 76.99565

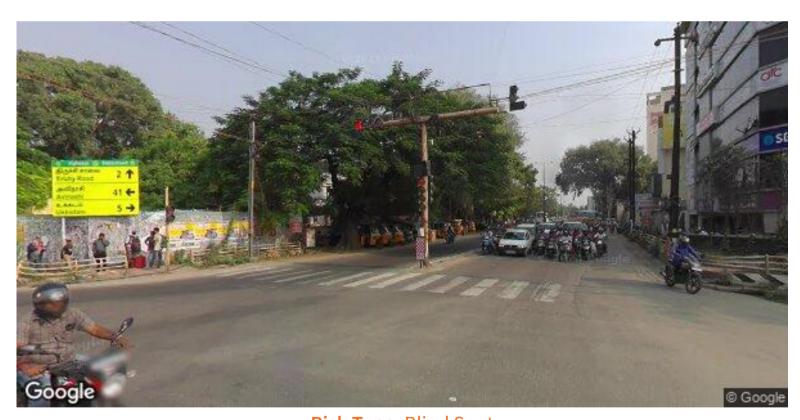
Risk Type: Blind Spot
Risk Level: Blind Spot
Speed Limit: 10 KM/Hr

Coordinates: 11.01285, 76.98611

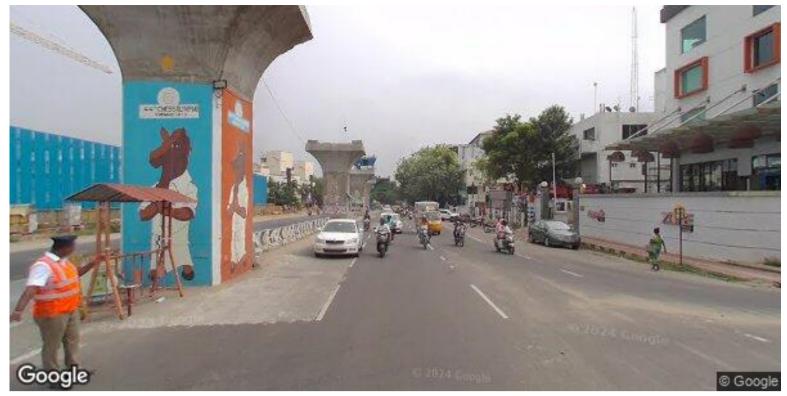
Risk Type: Turn
Risk Level: High
Speed Limit: 15 KM/Hr
Coordinates: 11.01160, 76.98419

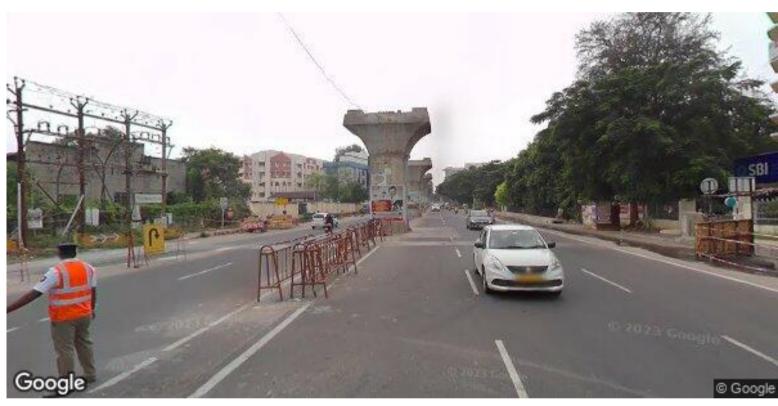
Risk Type: Blind Spot
Risk Level: Blind Spot
Speed Limit: 10 KM/Hr
Coordinates: 11.01176, 76.98410

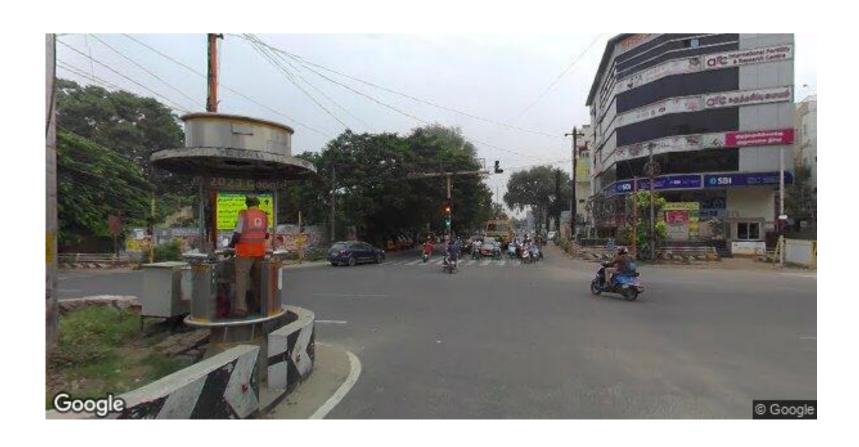
Risk Type: Turn
Risk Level: High
Speed Limit: 15 KM/Hr

Coordinates: 11.01298, 76.98601

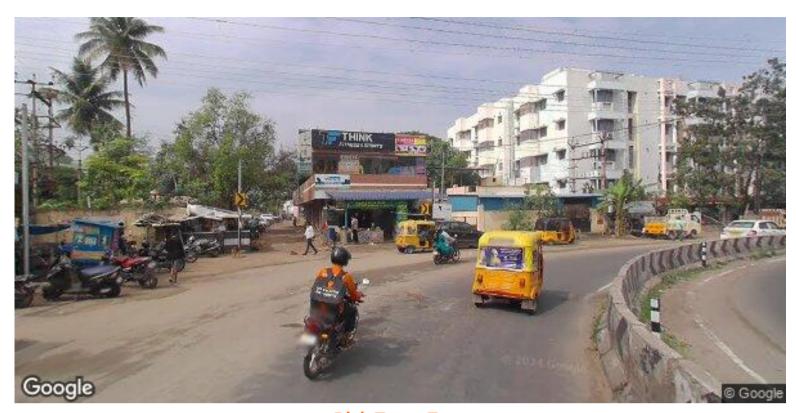
Risk Type: Turn
Risk Level: Medium
Speed Limit: 30 KM/Hr
Coordinates: 11.01367, 76.97915

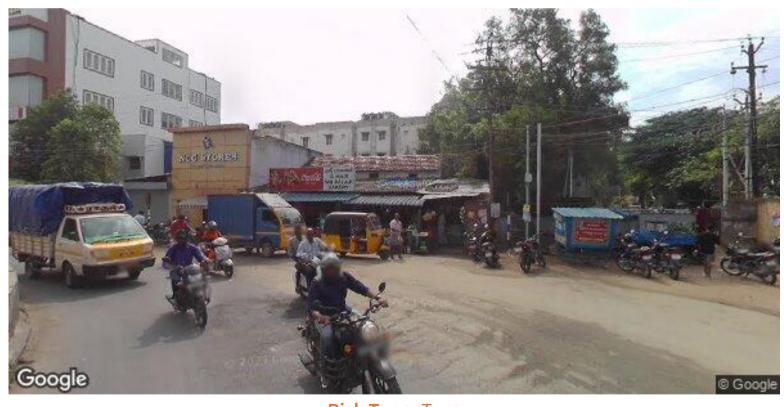
Risk Type: Turn
Risk Level: Medium
Speed Limit: 30 KM/Hr
Coordinates: 11.01374, 76.97905

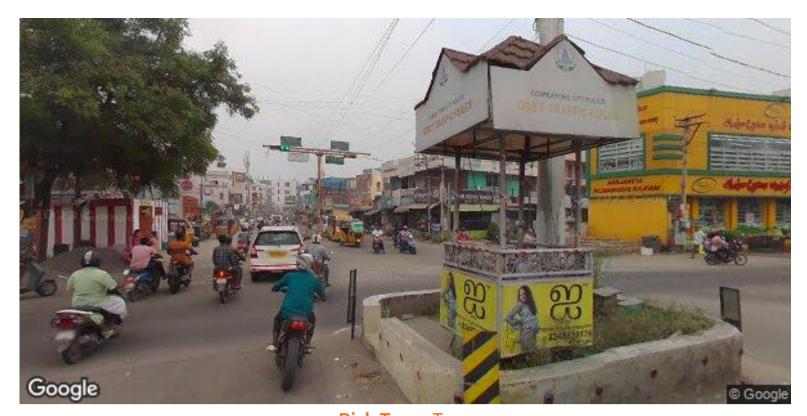
Risk Type: Turn
Risk Level: High
Speed Limit: 15 KM/Hr
Coordinates: 11.01671, 76.97732
