JOURNEY RISK MANAGEMENT (JRM) STUDY

Salem Terminal to ARUL MURUGAN AGENCIES

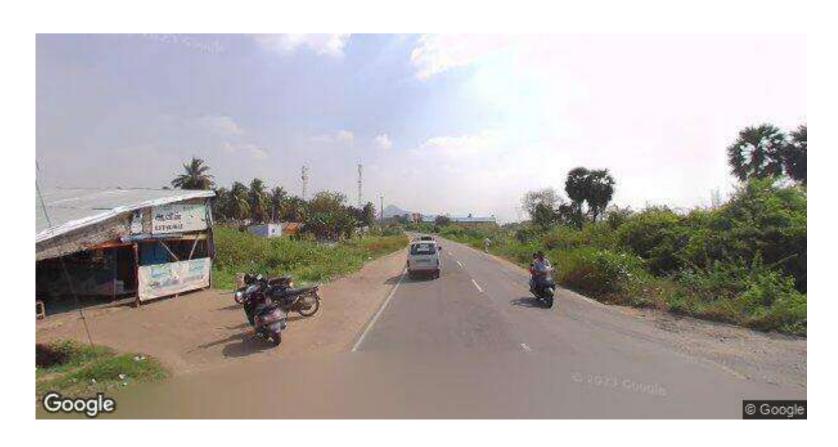
Coordinates: 11.44022, 77.87546

Risk Type: Turn
Risk Level: High
Speed Limit: 15 KM/Hr

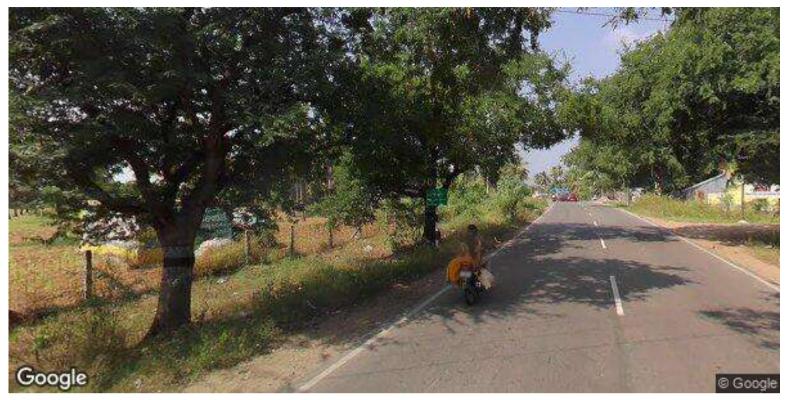
Risk Type: Turn
Risk Level: Medium
Speed Limit: 30 KM/Hr
Coordinates: 11.43107, 77.88171

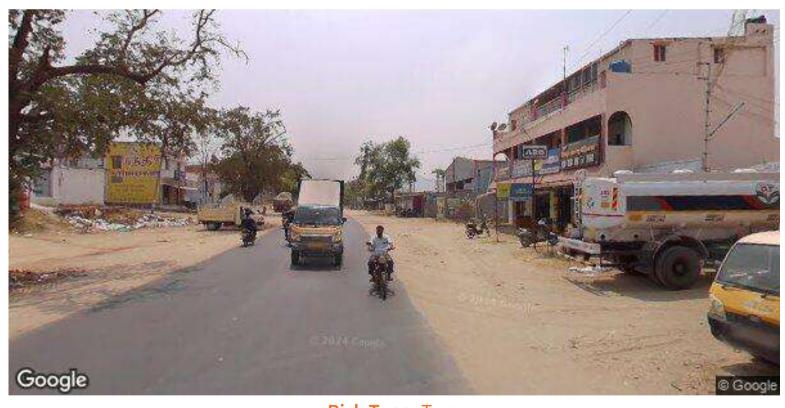
Risk Type: Turn
Risk Level: Medium
Speed Limit: 30 KM/Hr
Coordinates: 11.39976, 77.88382

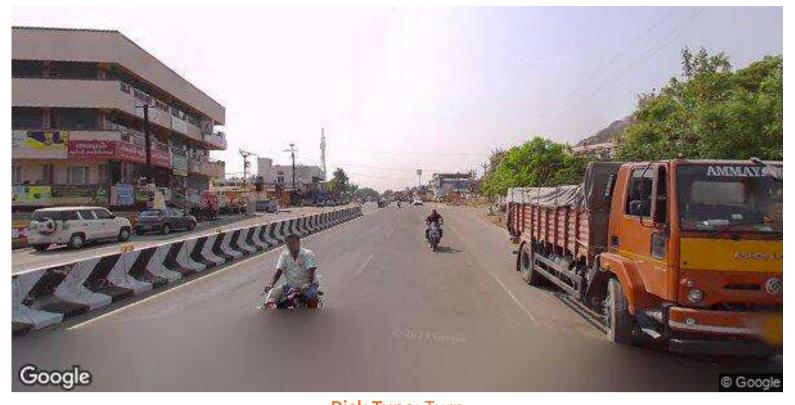
Risk Type: Turn
Risk Level: Medium
Speed Limit: 30 KM/Hr
Coordinates: 11.39690, 77.88852

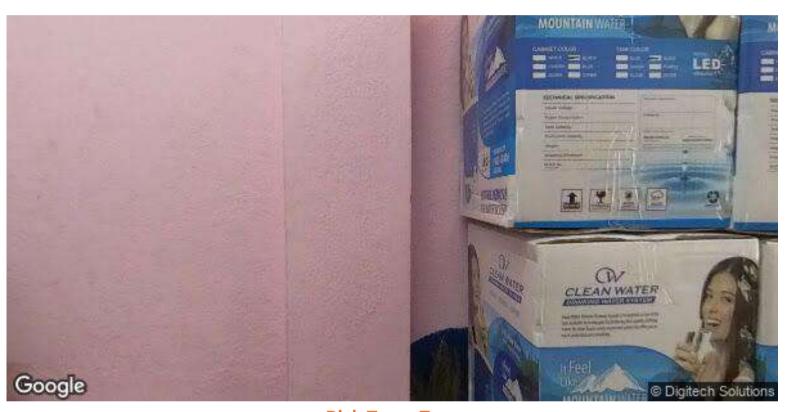
Coordinates: 11.37862, 77.89530

Risk Type: Turn
Risk Level: High
Speed Limit: 15 KM/Hr

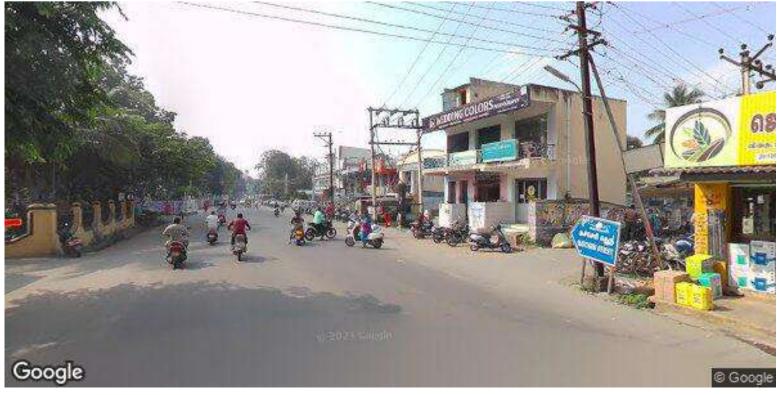
Coordinates: 11.37820, 77.89447

Risk Type: Turn
Risk Level: High
Speed Limit: 15 KM/Hr

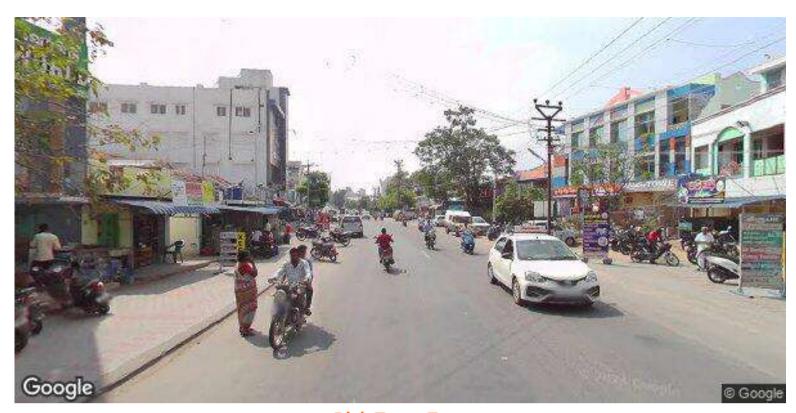
Coordinates: 11.36919, 77.88934

Risk Type: Turn
Risk Level: Medium
Speed Limit: 30 KM/Hr

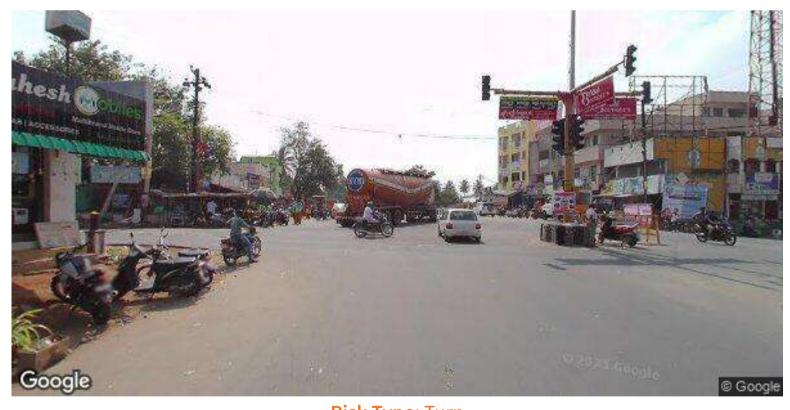
Risk Type: Turn
Risk Level: Medium
Speed Limit: 30 KM/Hr
Coordinates: 11.36616, 77.88885

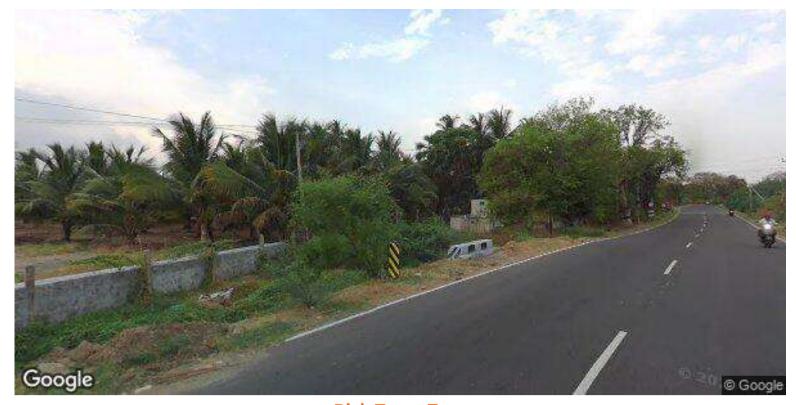
Risk Type: Turn
Risk Level: Medium
Speed Limit: 30 KM/Hr
Coordinates: 11.33949, 77.86263

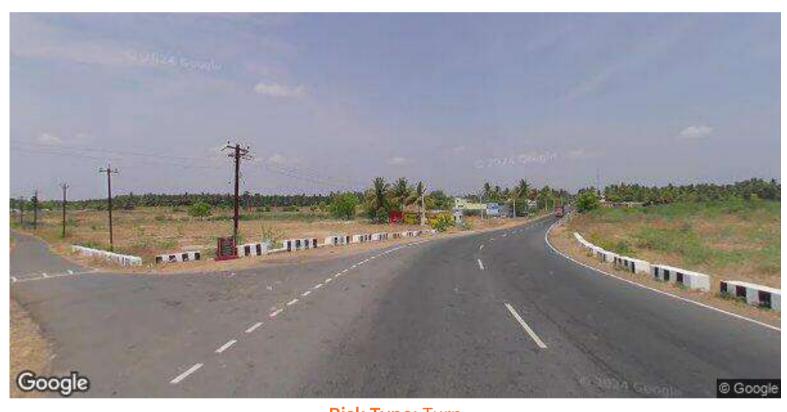
Risk Type: Turn
Risk Level: Medium
Speed Limit: 30 KM/Hr
Coordinates: 11.31752, 77.84260

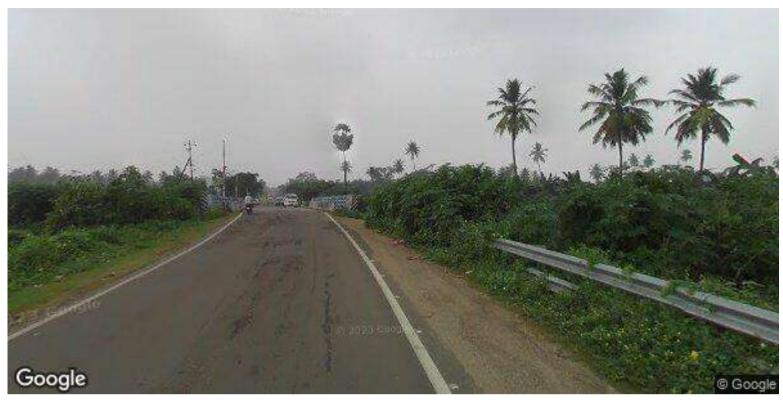
Coordinates: 11.31115, 77.77102

Risk Type: Turn
Risk Level: Medium
Speed Limit: 30 KM/Hr

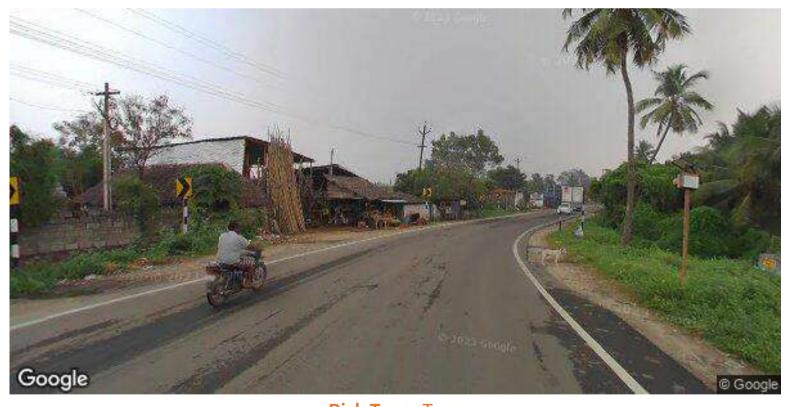
Coordinates: 11.30963, 77.76695

Risk Type: Turn
Risk Level: Medium
Speed Limit: 30 KM/Hr

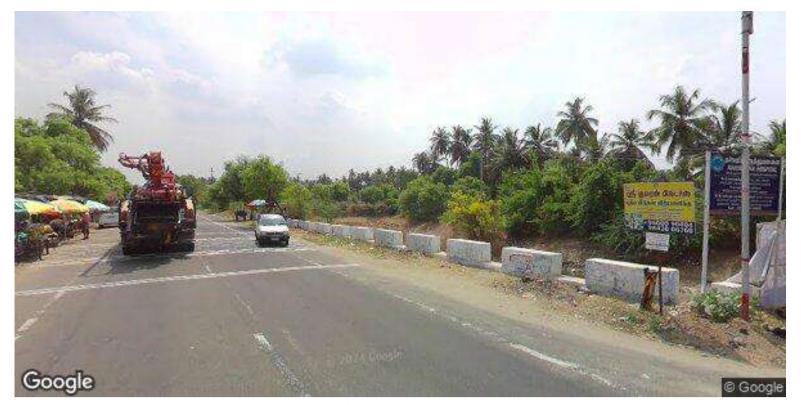
Risk Type: Turn
Risk Level: High
Speed Limit: 15 KM/Hr
Coordinates: 11.29490, 77.74685

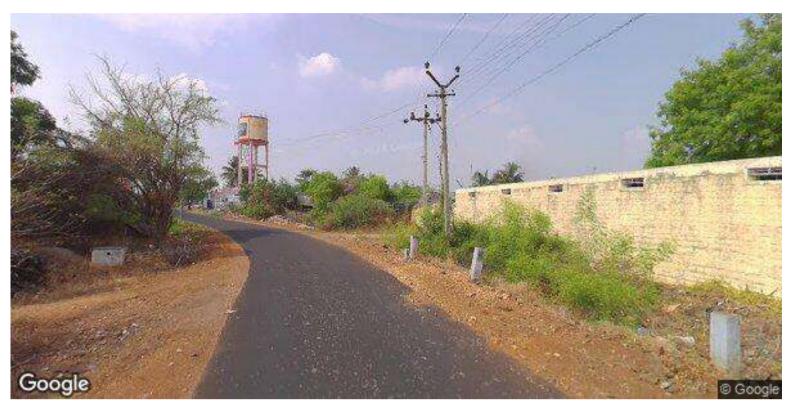
Risk Type: Turn
Risk Level: Medium
Speed Limit: 30 KM/Hr
Coordinates: 11.28573, 77.74281

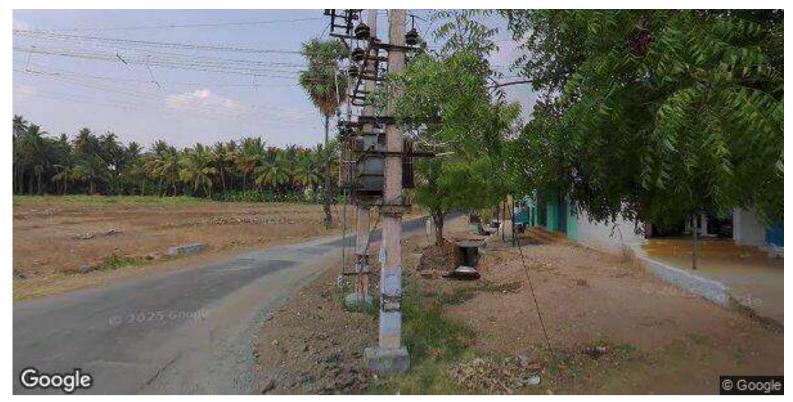
Risk Type: Blind Spot
Risk Level: Blind Spot
Speed Limit: 10 KM/Hr
Coordinates: 11.27330, 77.72715

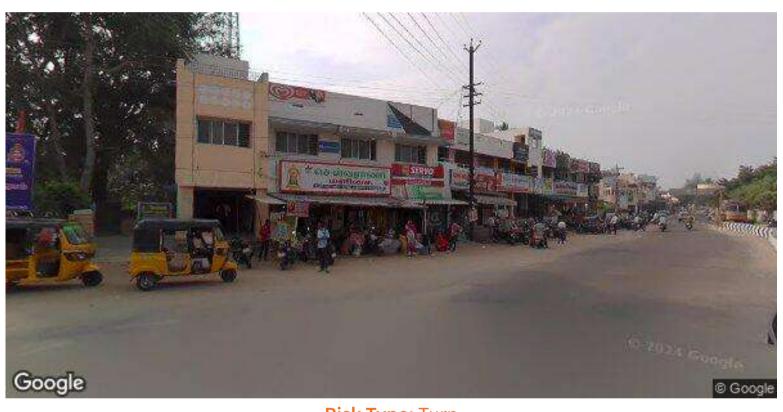
Risk Type: Turn
Risk Level: Medium
Speed Limit: 30 KM/Hr
Coordinates: 11.15944, 77.70068

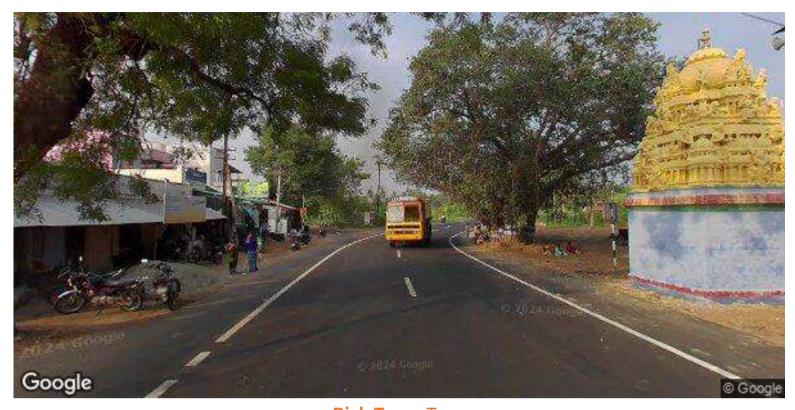
Coordinates: 11.11683, 77.67168

Risk Type: Turn
Risk Level: High
Speed Limit: 15 KM/Hr

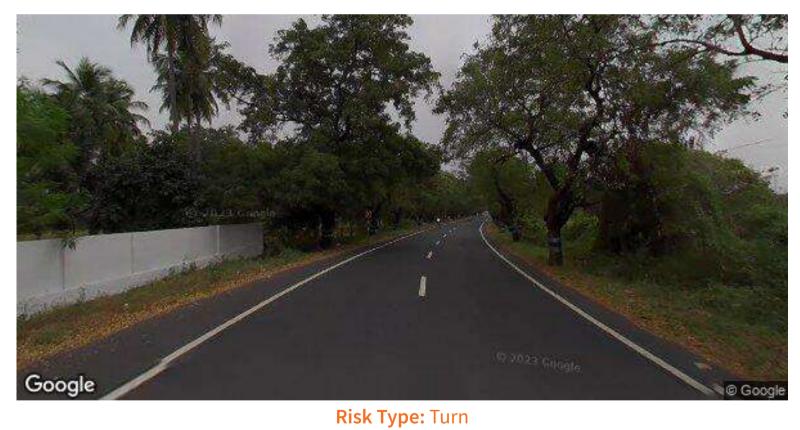
Risk Level: Medium
Speed Limit: 30 KM/Hr
Coordinates: 11.10481, 77.67060

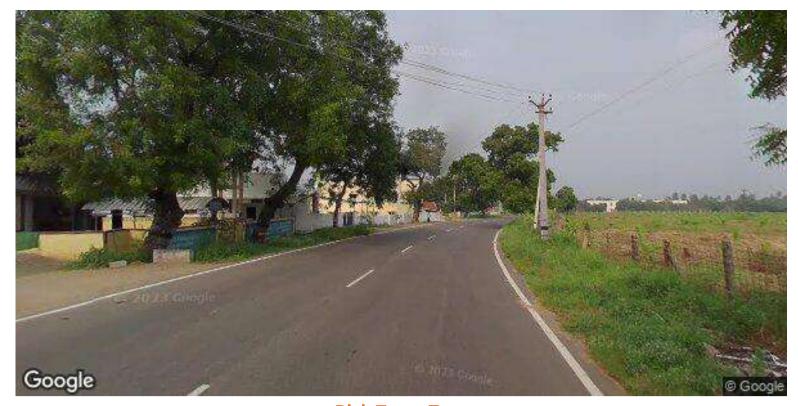
Risk Type: Turn
Risk Level: Medium
Speed Limit: 30 KM/Hr
Coordinates: 11.09509, 77.66612

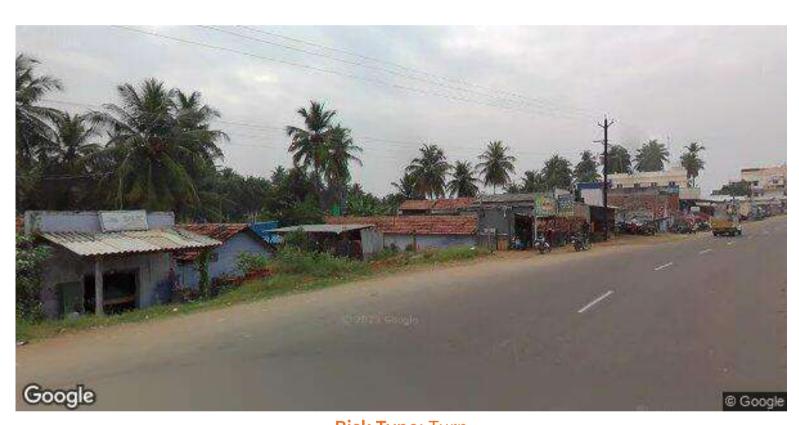
Risk Type: Turn
Risk Level: Medium
Speed Limit: 30 KM/Hr
Coordinates: 11.08730, 77.66436

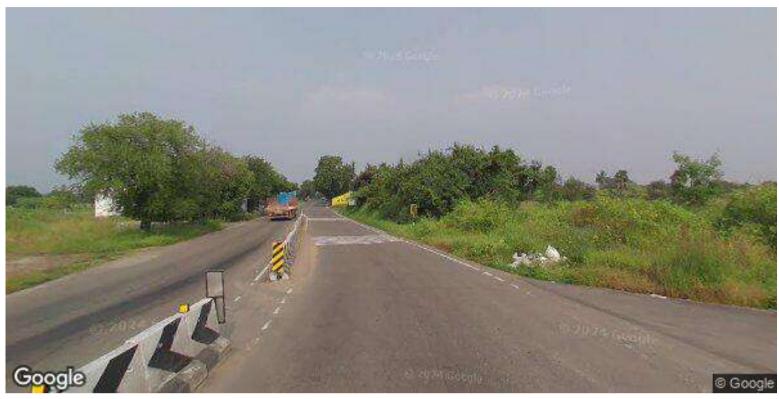
Coordinates: 11.06189, 77.63943

Risk Type: Turn
Risk Level: High
Speed Limit: 15 KM/Hr

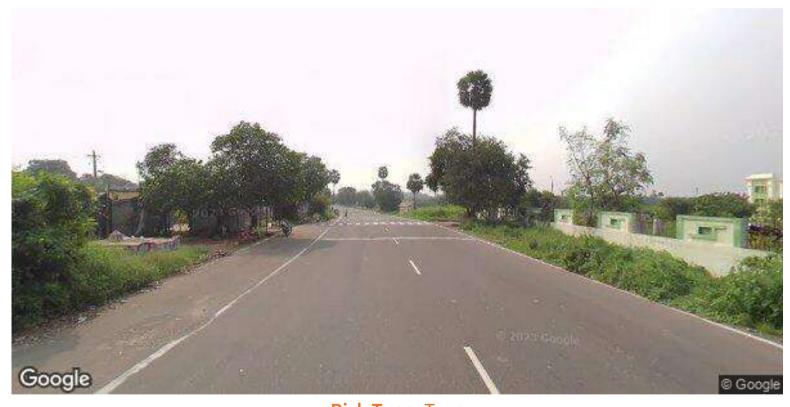
Risk Type: Turn
Risk Level: Medium
Speed Limit: 30 KM/Hr
Coordinates: 11.06183, 77.63626

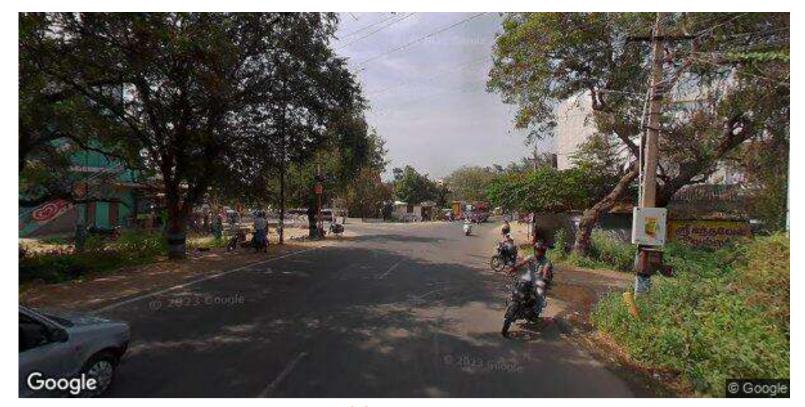
Risk Type: Turn
Risk Level: Medium
Speed Limit: 30 KM/Hr
Coordinates: 11.00852, 77.56992

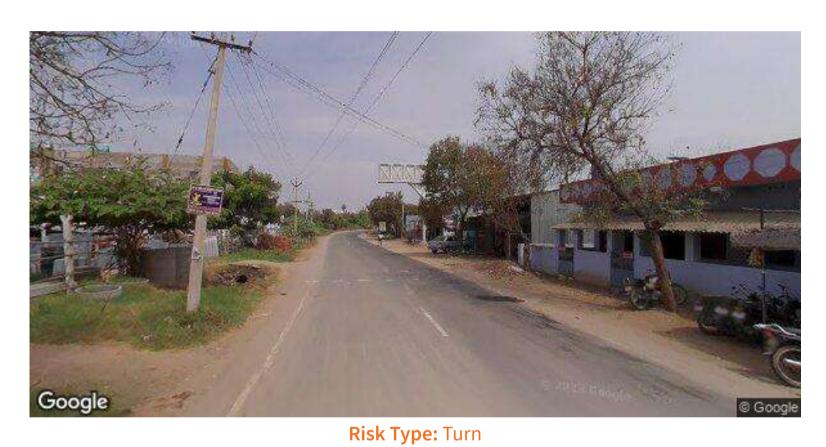
Risk Level: High
Speed Limit: 15 KM/Hr
Coordinates: 11.00090, 77.56888

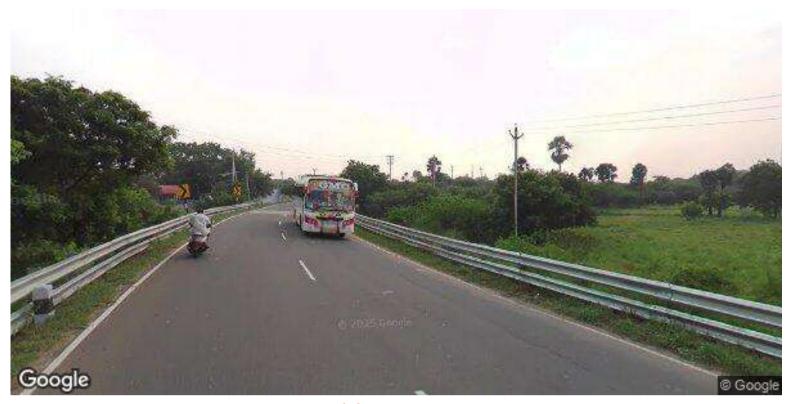
Coordinates: 10.94764, 77.54709

Risk Type: Turn
Risk Level: Medium
Speed Limit: 30 KM/Hr

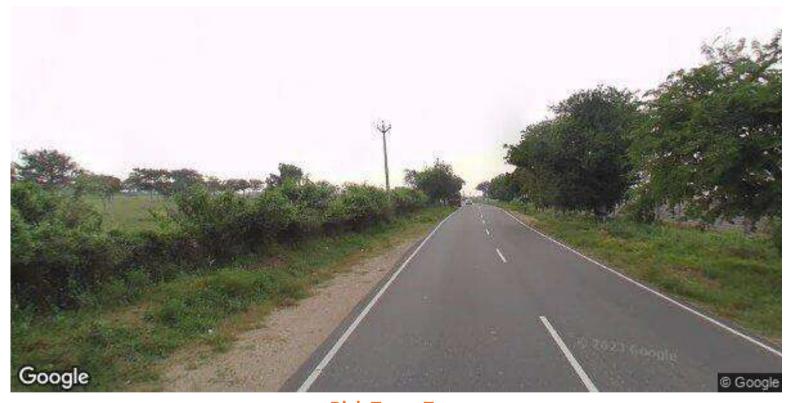
Coordinates: 10.93853, 77.53921

Risk Type: Turn
Risk Level: Medium
Speed Limit: 30 KM/Hr

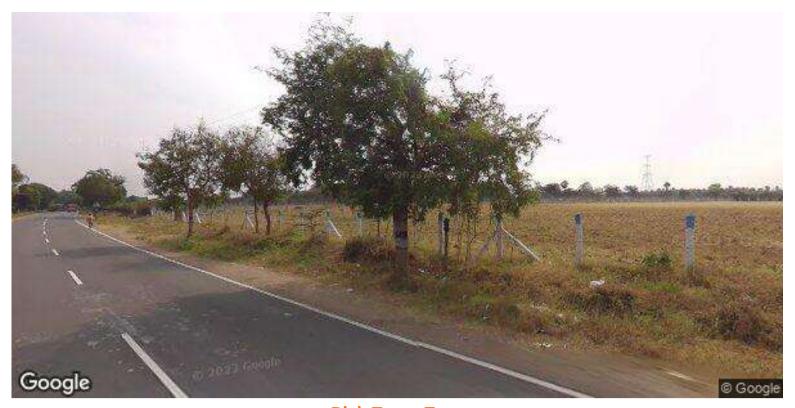
Risk Type: Turn
Risk Level: Medium
Speed Limit: 30 KM/Hr
Coordinates: 10.93794, 77.53764

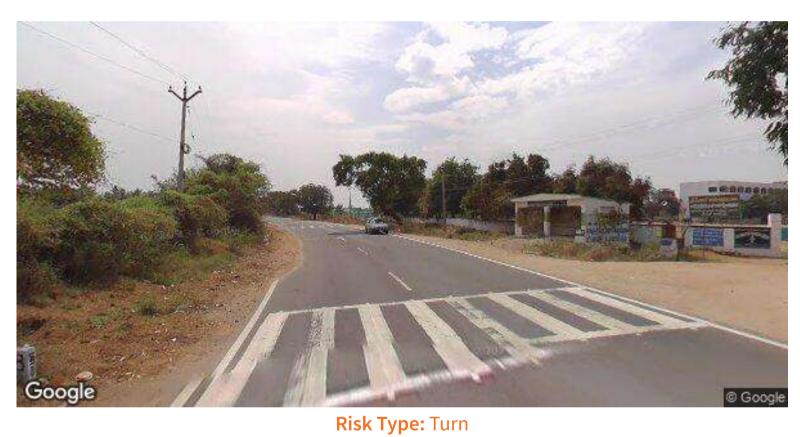
Risk Type: Turn
Risk Level: High
Speed Limit: 15 KM/Hr
Coordinates: 10.93006, 77.53262

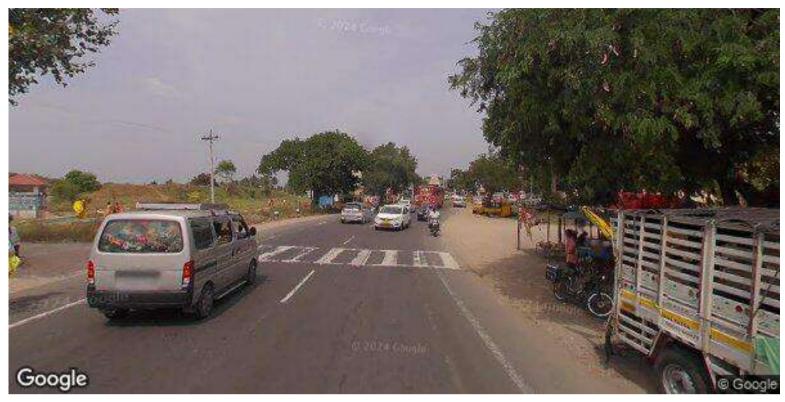
Coordinates: 10.89172, 77.52640

Risk Type: Turn
Risk Level: Medium
Speed Limit: 30 KM/Hr

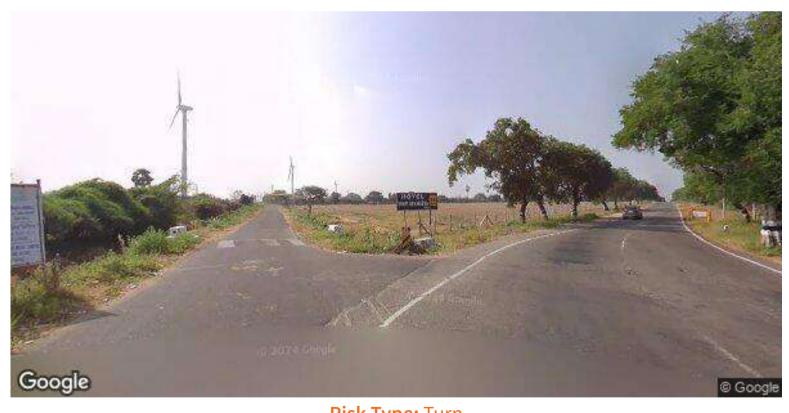
Coordinates: 10.83409, 77.52932

Risk Type: Turn
Risk Level: Medium
Speed Limit: 30 KM/Hr

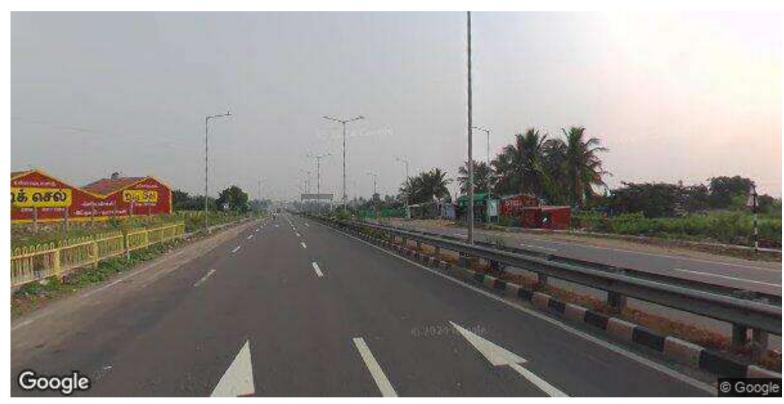
Risk Type: Turn
Risk Level: Medium
Speed Limit: 30 KM/Hr
Coordinates: 10.77580, 77.50724

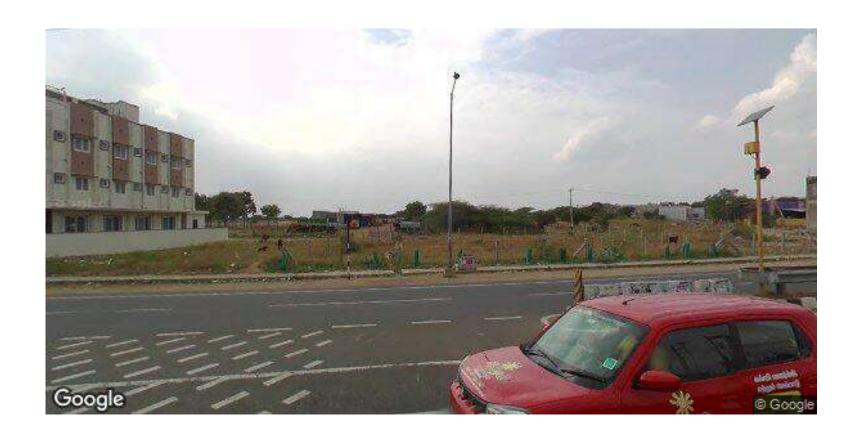
Coordinates: 10.75791, 77.51938

Risk Type: Turn
Risk Level: High
Speed Limit: 15 KM/Hr

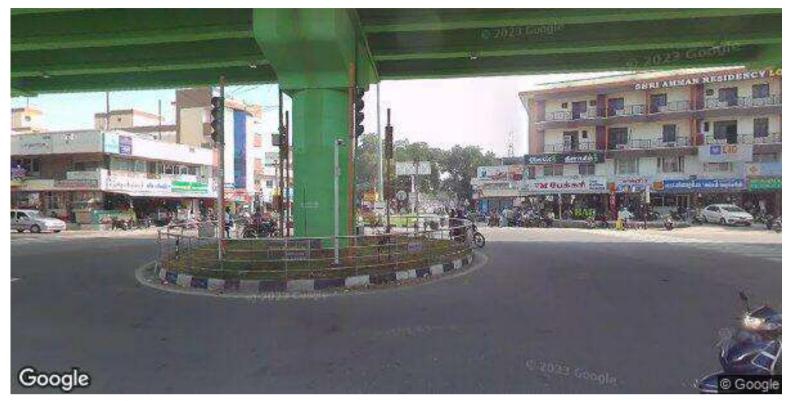
Coordinates: 10.73533, 77.51739

Risk Type: Turn
Risk Level: High
Speed Limit: 15 KM/Hr

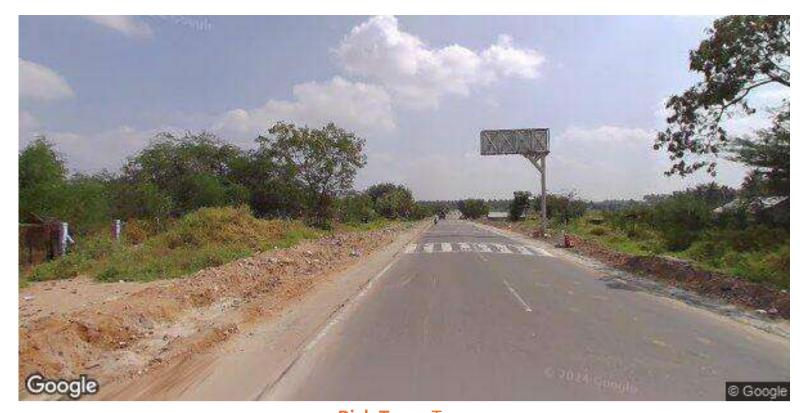
Risk Type: Turn
Risk Level: Medium
Speed Limit: 30 KM/Hr
Coordinates: 10.68901, 77.28244

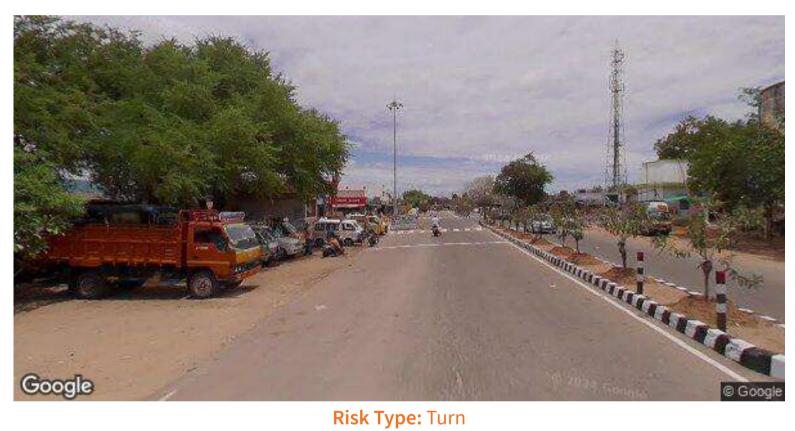
Coordinates: 10.68872, 77.28115

Risk Type: Turn

Risk Level: High

Speed Limit: 15 KM/Hr

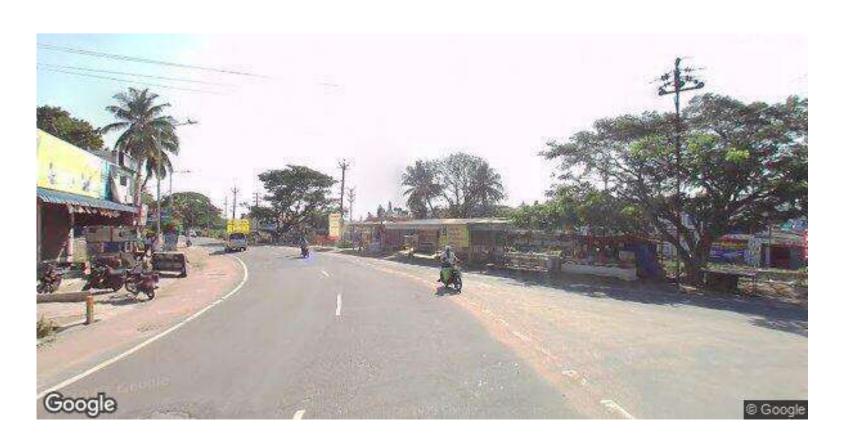
Coordinates: 10.59566, 77.24559

Risk Type: Turn
Risk Level: High
Speed Limit: 15 KM/Hr

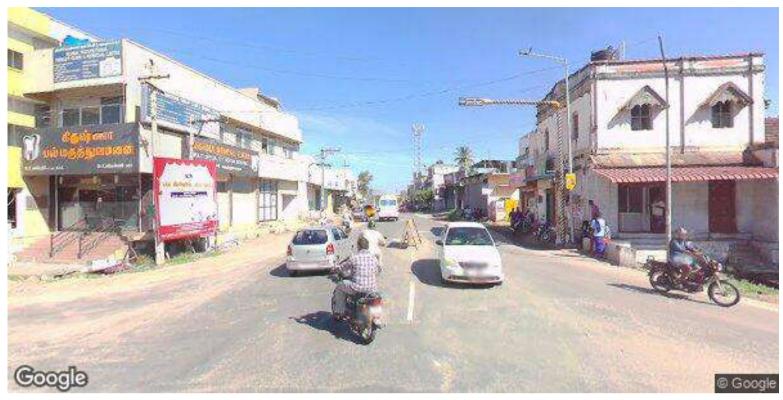
Coordinates: 10.58828, 77.24496

Risk Type: Turn
Risk Level: High
Speed Limit: 15 KM/Hr

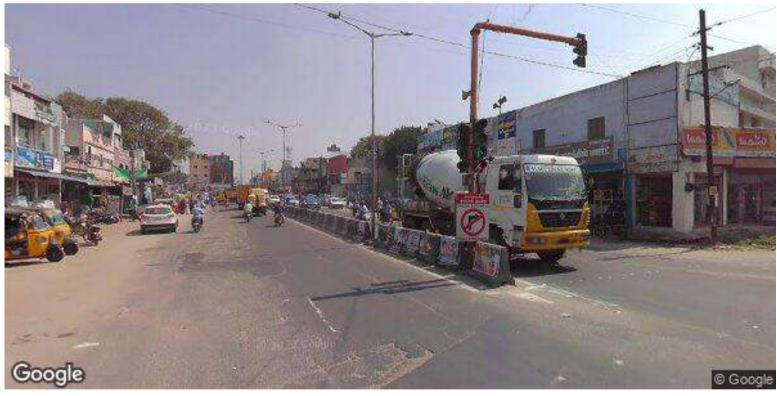
Coordinates: 10.58797, 77.24603

Risk Type: Blind Spot
Risk Level: Blind Spot
Speed Limit: 10 KM/Hr

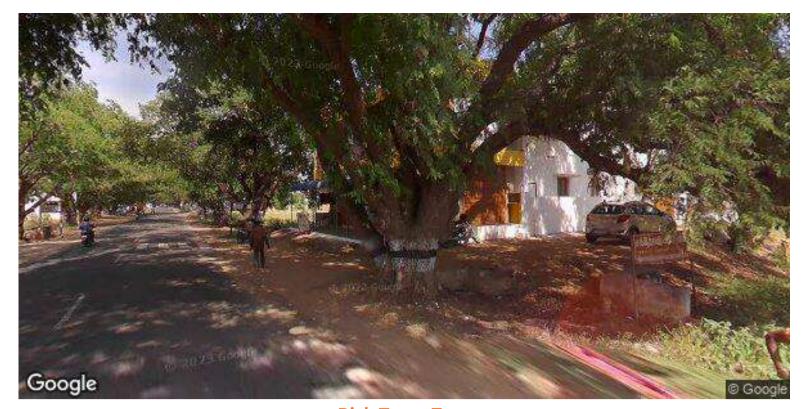
Risk Type: Turn
Risk Level: Medium
Speed Limit: 30 KM/Hr
Coordinates: 10.53874, 77.22421

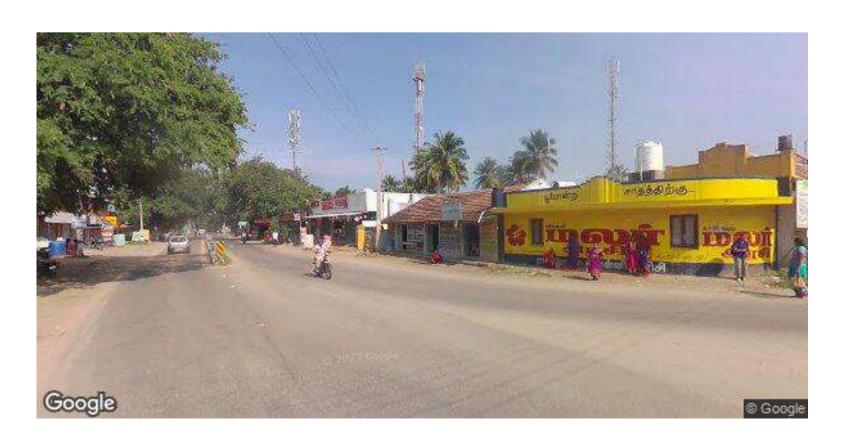
Coordinates: 10.53104, 77.22003

Risk Type: Blind Spot Risk Level: Blind Spot Speed Limit: 10 KM/Hr

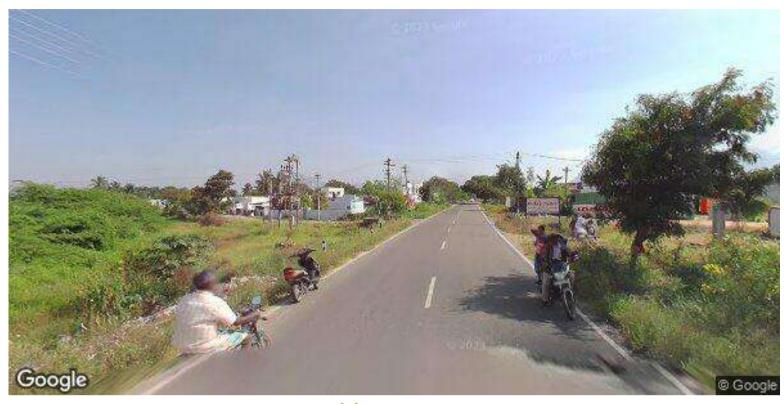
Risk Type: Turn
Risk Level: Medium
Speed Limit: 30 KM/Hr
Coordinates: 10.52368, 77.22684

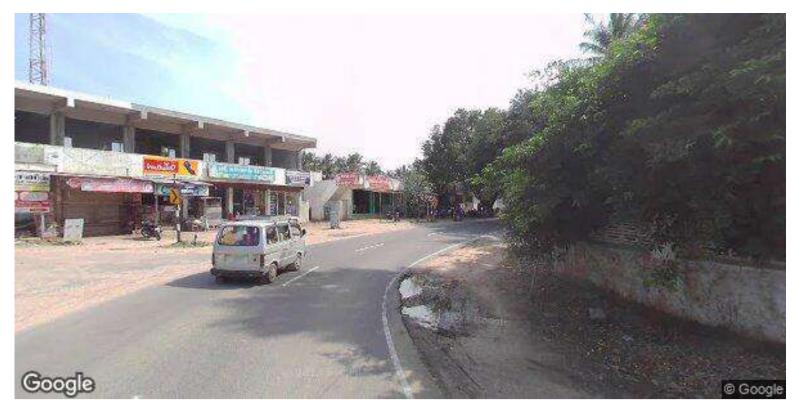
Coordinates: 10.49231, 77.24037

Risk Type: Turn
Risk Level: High
Speed Limit: 15 KM/Hr
