# JOURNEY RISK MANAGEMENT (JRM) STUDY

#### Salem Terminal to SRI UDAYAGIRI FUELS KSK

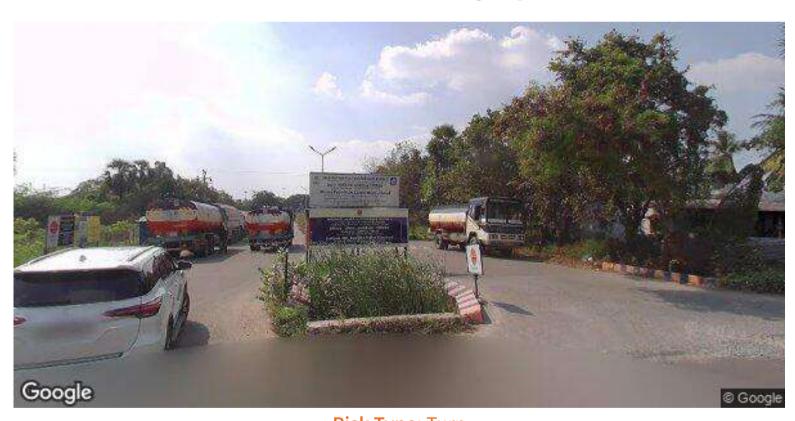
Risk Type: Turn Risk Level: High

Speed Limit: 15 KM/Hr Coordinates: 11.44024, 77.87528

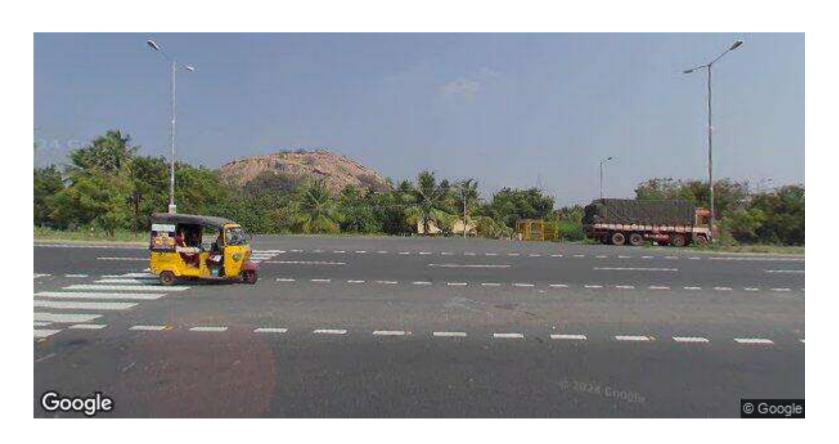
Risk Type: Turn Risk Level: Medium Speed Limit: 30 KM/Hr

**Coordinates:** 11.45085, 77.77020

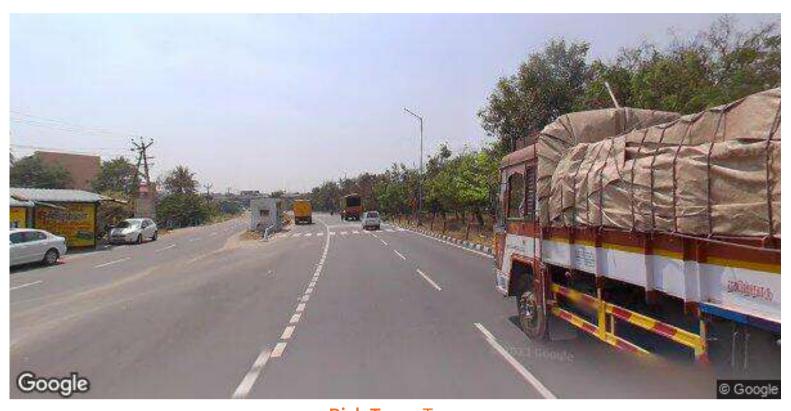
Risk Type: Turn Risk Level: Medium Speed Limit: 30 KM/Hr **Coordinates:** 11.43165, 77.67734

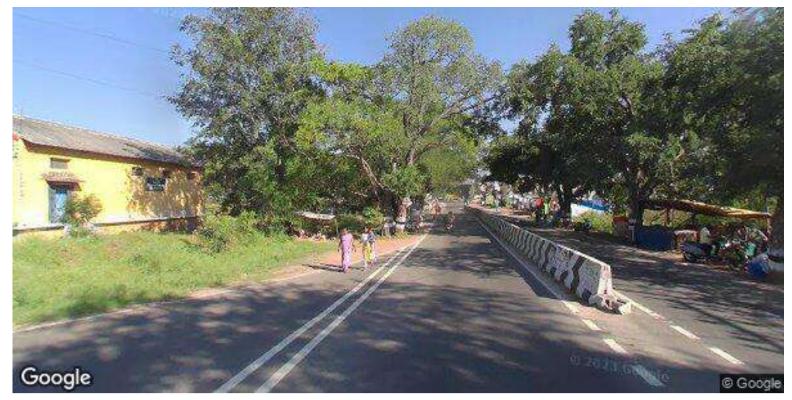
Risk Type: Blind Spot Risk Level: Blind Spot Speed Limit: 10 KM/Hr

**Coordinates:** 11.28189, 77.56929

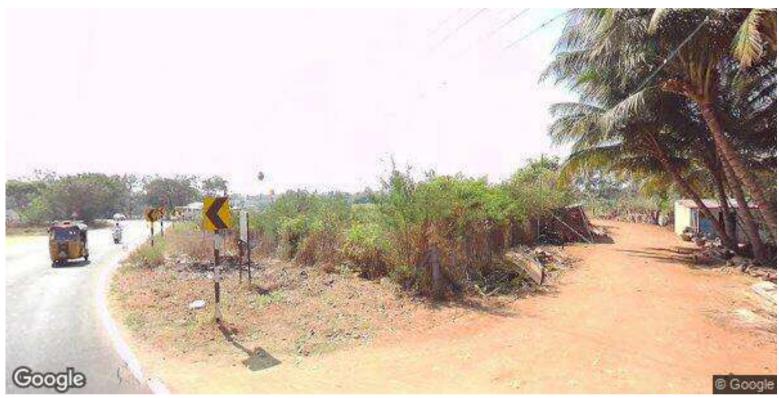
Risk Type: Turn
Risk Level: Medium
Speed Limit: 30 KM/Hr
Coordinates: 11.29281, 77.53814

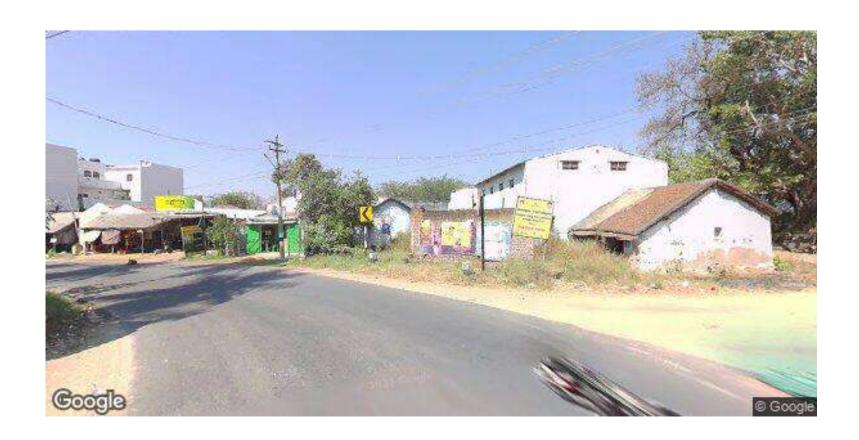
Risk Type: Turn
Risk Level: High
Speed Limit: 15 KM/Hr

**Coordinates:** 11.29251, 77.53037

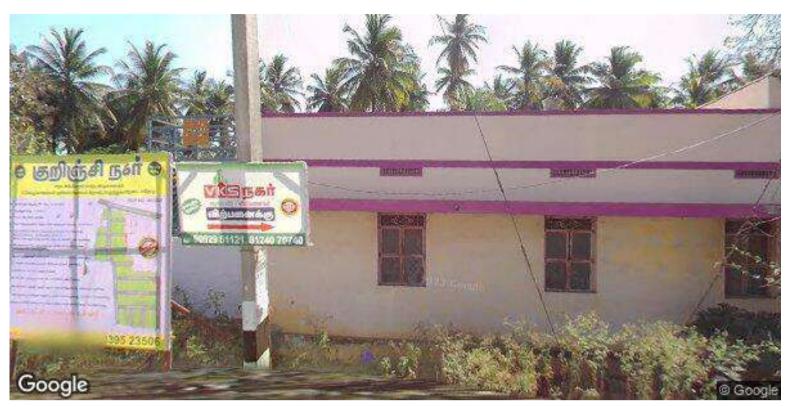
Risk Type: Turn
Risk Level: Medium
Speed Limit: 30 KM/Hr

**Coordinates:** 11.29192, 77.52990

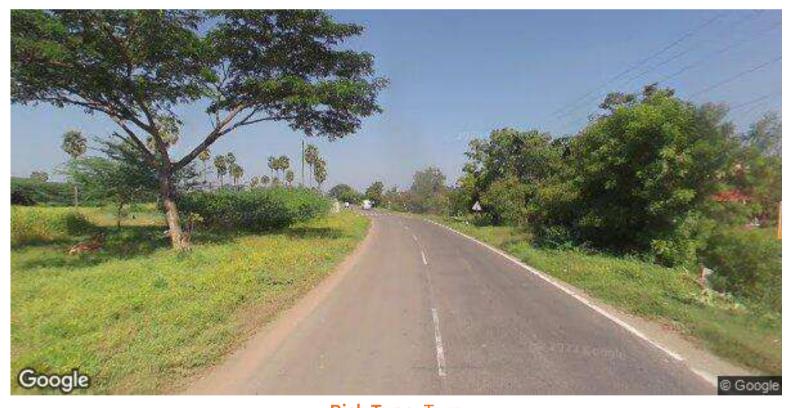
Risk Type: Turn
Risk Level: Medium
Speed Limit: 30 KM/Hr
Coordinates: 11.27393, 77.42230

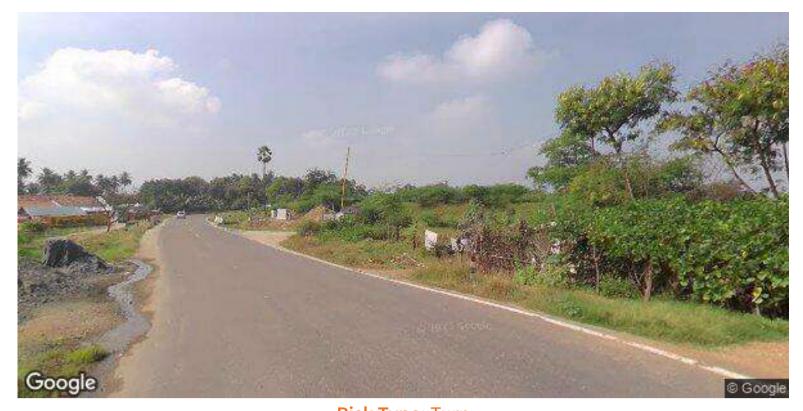
Risk Type: Turn
Risk Level: Medium
Speed Limit: 30 KM/Hr
Coordinates: 11.27378, 77.41973

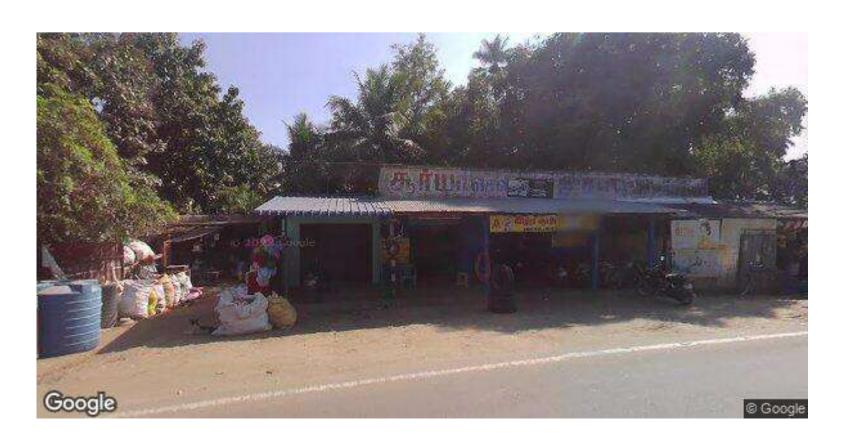
Risk Type: Turn
Risk Level: Medium
Speed Limit: 30 KM/Hr

**Coordinates:** 11.27254, 77.41851

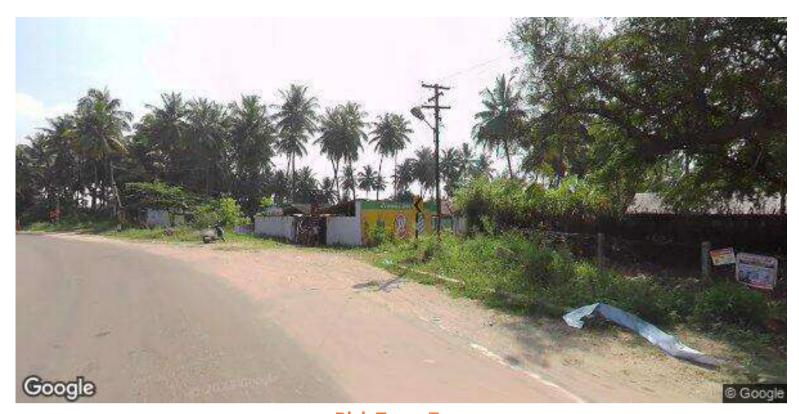
Risk Type: Turn
Risk Level: Medium
Speed Limit: 30 KM/Hr
Coordinates: 11.27228, 77.41323

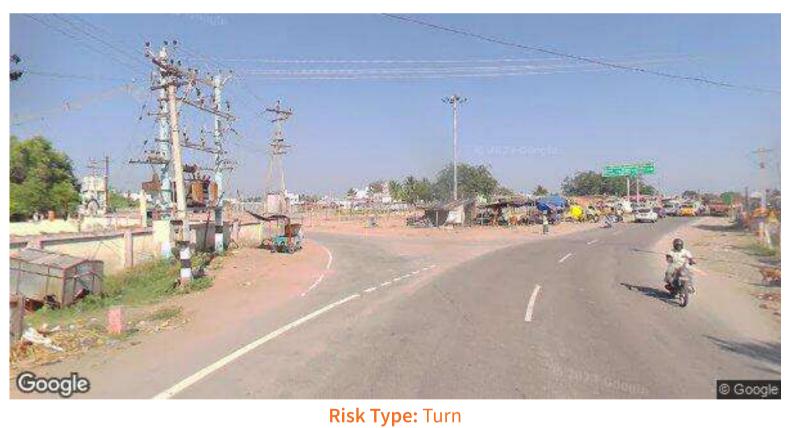
Risk Level: Medium
Speed Limit: 30 KM/Hr
Coordinates: 11.27353, 77.40862

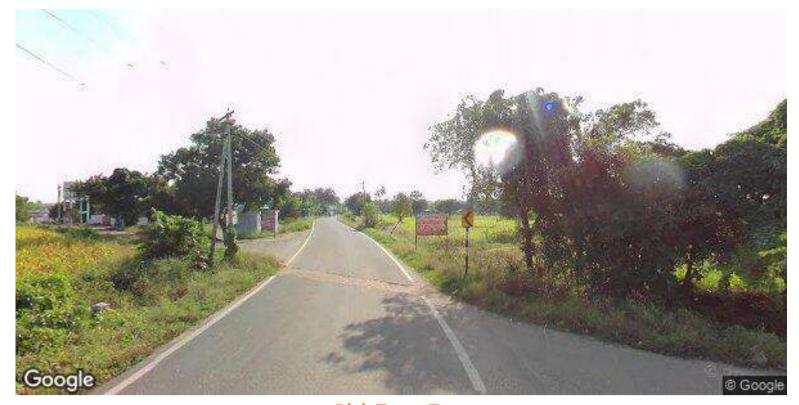
Risk Type: Turn
Risk Level: High
Speed Limit: 15 KM/Hr
Coordinates: 11.27057, 77.38574

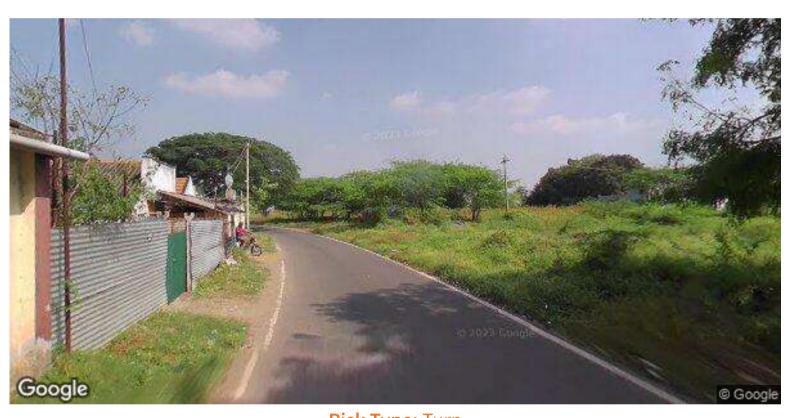
Risk Type: Turn
Risk Level: Medium
Speed Limit: 30 KM/Hr
Coordinates: 11.26001, 77.36845

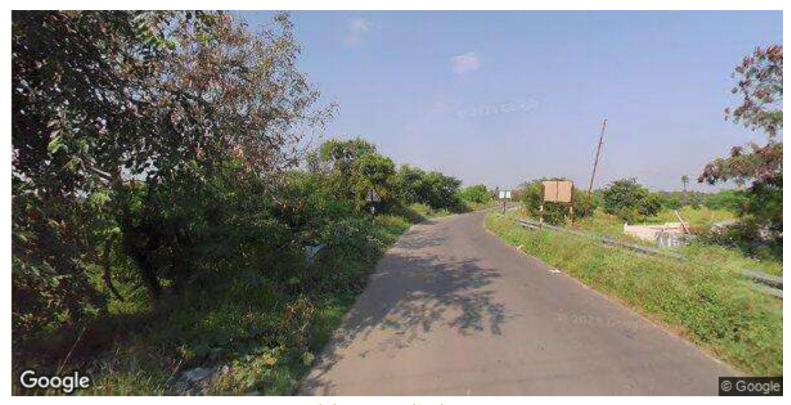
Risk Type: Blind Spot Risk Level: Blind Spot Speed Limit: 10 KM/Hr

**Coordinates:** 11.25985, 77.36605

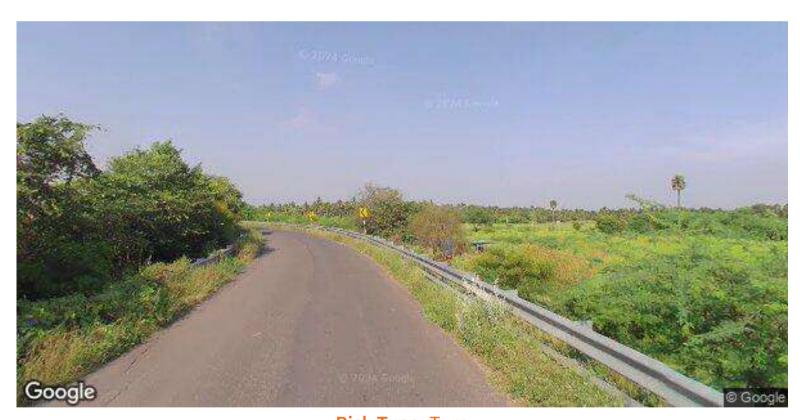
Risk Type: Turn
Risk Level: Medium
Speed Limit: 30 KM/Hr

**Coordinates:** 11.26055, 77.36646

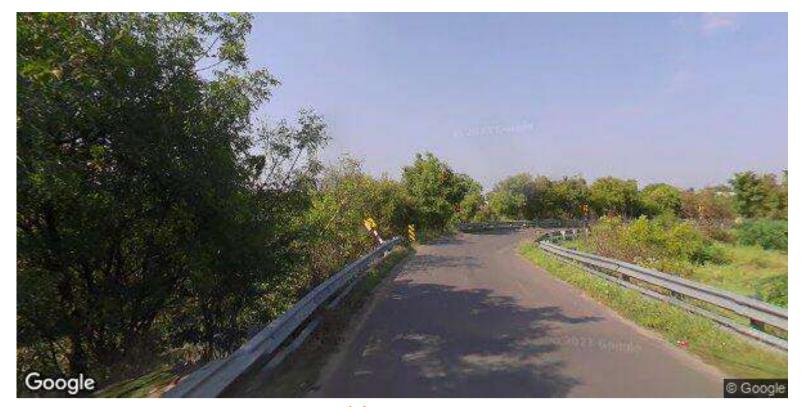
Risk Type: Turn
Risk Level: Medium
Speed Limit: 30 KM/Hr
Coordinates: 11.26413, 77.36636

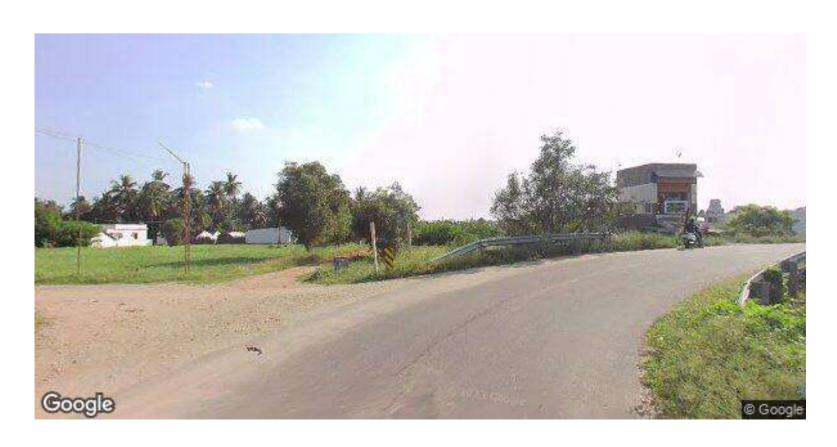
Risk Type: Blind Spot Risk Level: Blind Spot Speed Limit: 10 KM/Hr

**Coordinates:** 11.26487, 77.36723

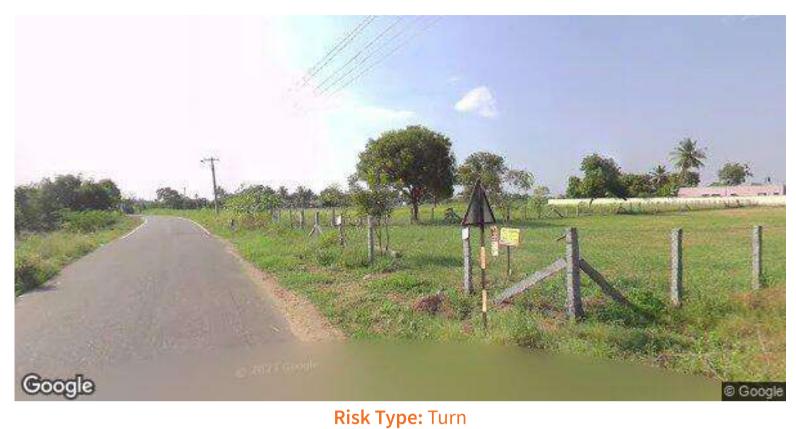
Risk Type: Turn

Risk Level: High

Speed Limit: 15 KM/Hr

Coordinates: 11.26516, 77.36707

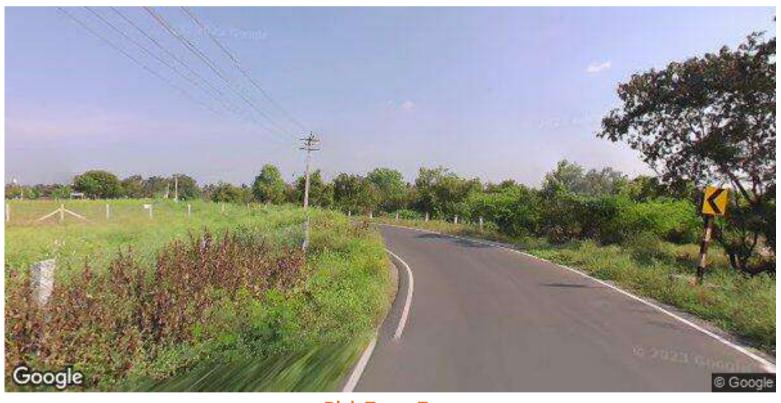
Risk Type: Turn
Risk Level: High
Speed Limit: 15 KM/Hr
Coordinates: 11.26513, 77.36557

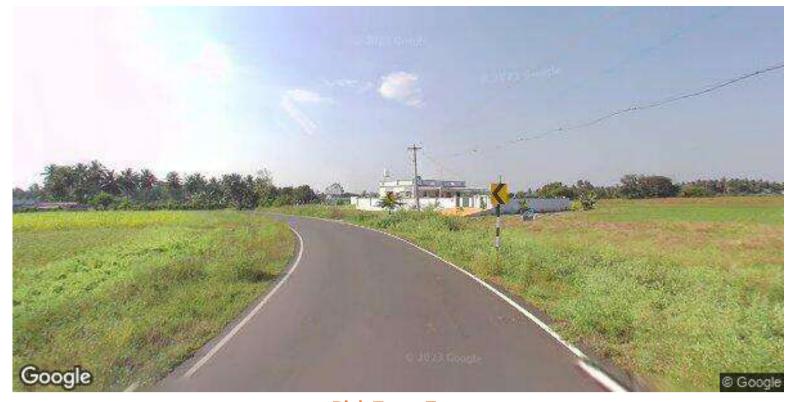
Risk Type: Turn
Risk Level: Medium
Speed Limit: 30 KM/Hr

**Coordinates:** 11.26796, 77.36396

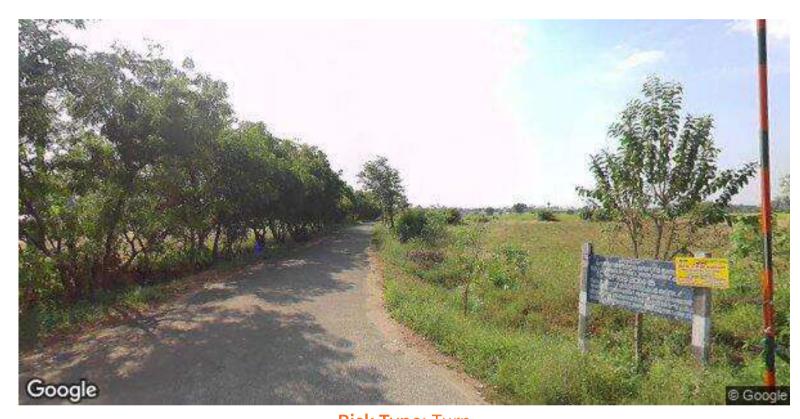
Risk Type: Turn
Risk Level: High
Speed Limit: 15 KM/Hr
Coordinates: 11.27740, 77.35788

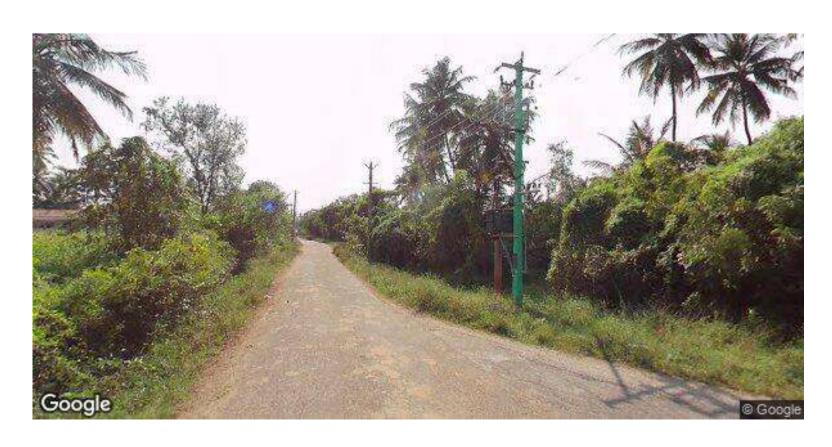
Risk Type: Blind Spot Risk Level: Blind Spot Speed Limit: 10 KM/Hr

**Coordinates:** 11.27682, 77.34555

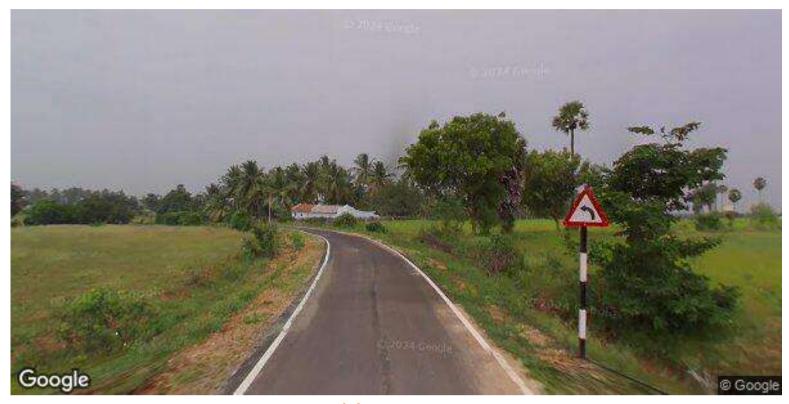
Risk Type: Turn
Risk Level: Medium
Speed Limit: 30 KM/Hr

**Coordinates:** 11.28158, 77.34302

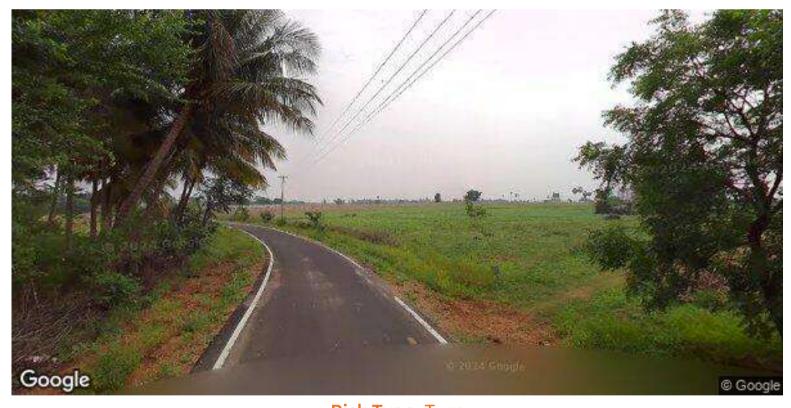
Risk Type: Turn
Risk Level: Medium
Speed Limit: 30 KM/Hr

**Coordinates:** 11.28239, 77.33843

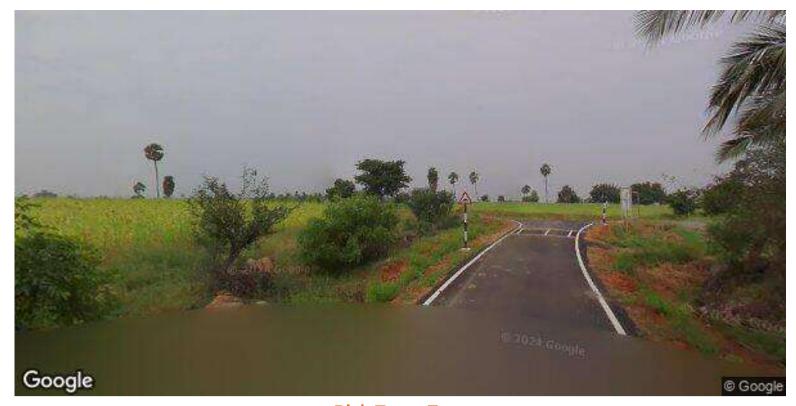
Risk Type: Turn
Risk Level: Medium
Speed Limit: 30 KM/Hr
Coordinates: 11.28317, 77.33761

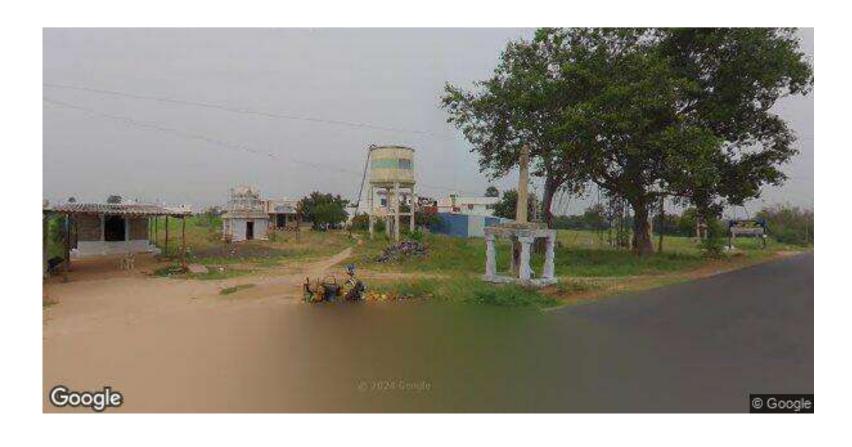
Risk Type: Blind Spot Risk Level: Blind Spot Speed Limit: 10 KM/Hr

**Coordinates:** 11.28369, 77.33267

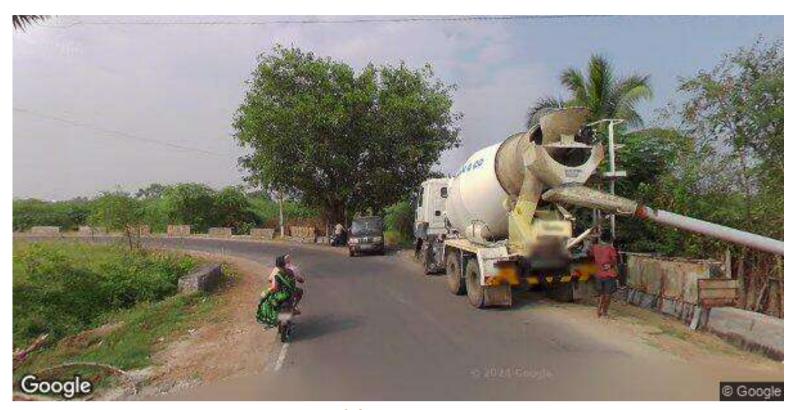
Risk Type: Turn
Risk Level: Medium
Speed Limit: 30 KM/Hr
Coordinates: 11.28760, 77.33292

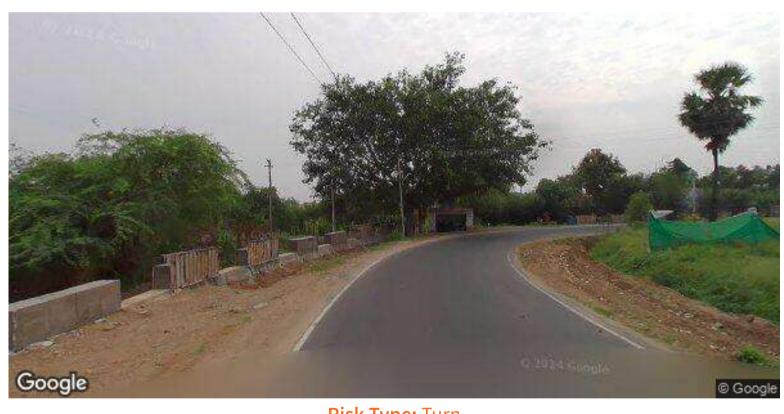
Risk Type: Turn
Risk Level: Medium
Speed Limit: 30 KM/Hr
Coordinates: 11.28784, 77.33263

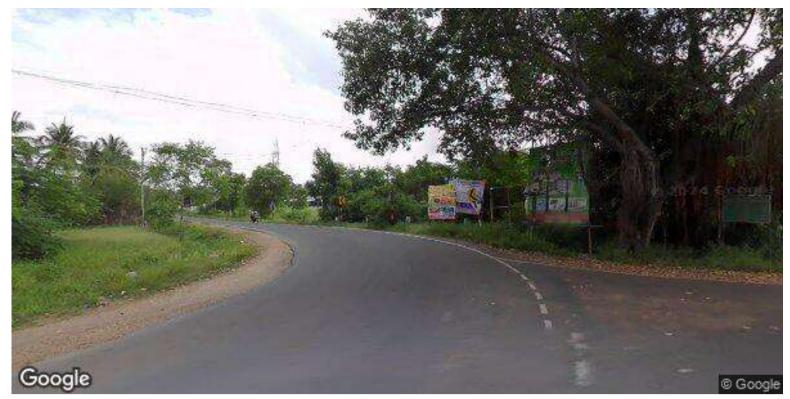
Risk Type: Turn
Risk Level: High
Speed Limit: 15 KM/Hr

**Coordinates:** 11.28799, 77.32982

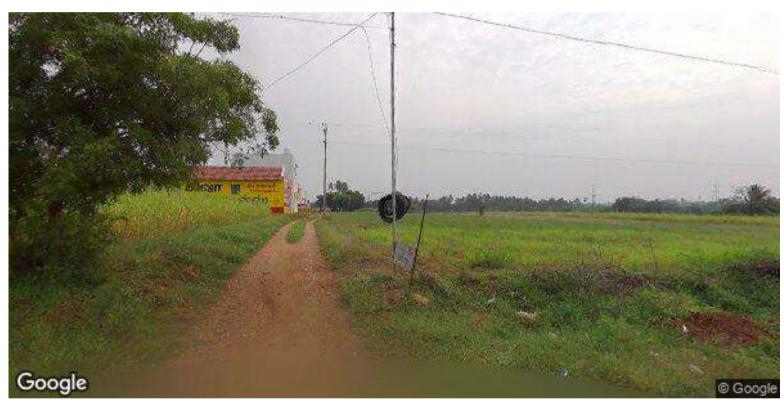
Risk Type: Turn
Risk Level: High
Speed Limit: 15 KM/Hr

**Coordinates:** 11.29047, 77.32961
