JOURNEY RISK MANAGEMENT (JRM) STUDY

IOCL Coimbatore Terminal to TNSTC Sathy CBE Div

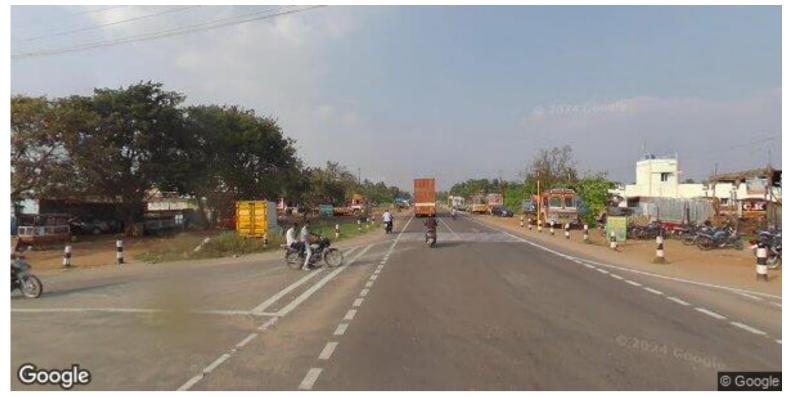
Risk Type: Turn Risk Level: High Speed Limit: 15 KM/Hr **Coordinates:** 11.03211, 77.07640

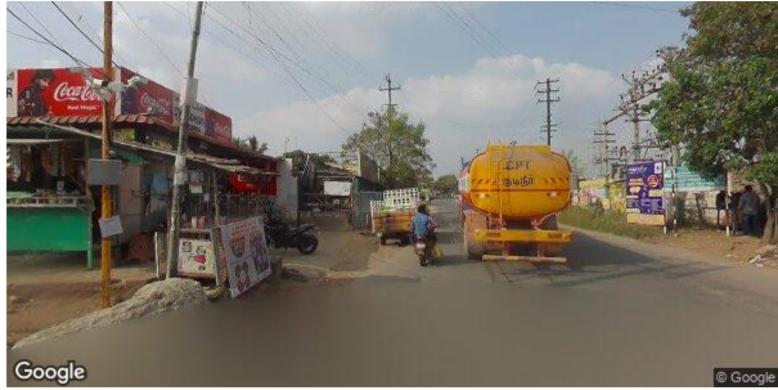
Risk Type: Turn Risk Level: High Speed Limit: 15 KM/Hr **Coordinates:** 11.08298, 77.12274

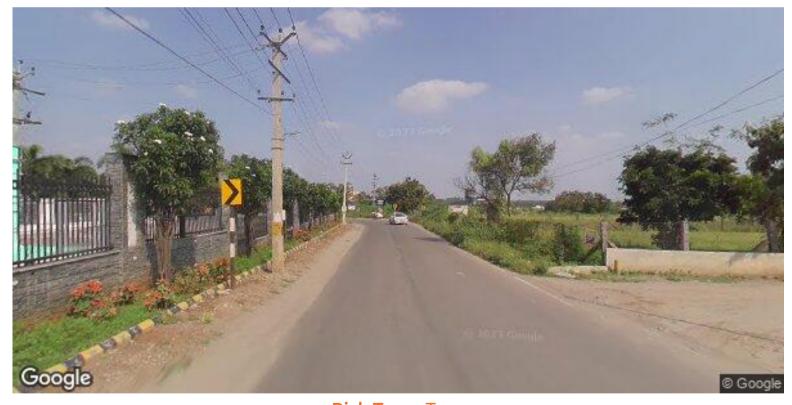
Coordinates: 11.10456, 77.13099

Risk Type: Turn
Risk Level: High
Speed Limit: 15 KM/Hr

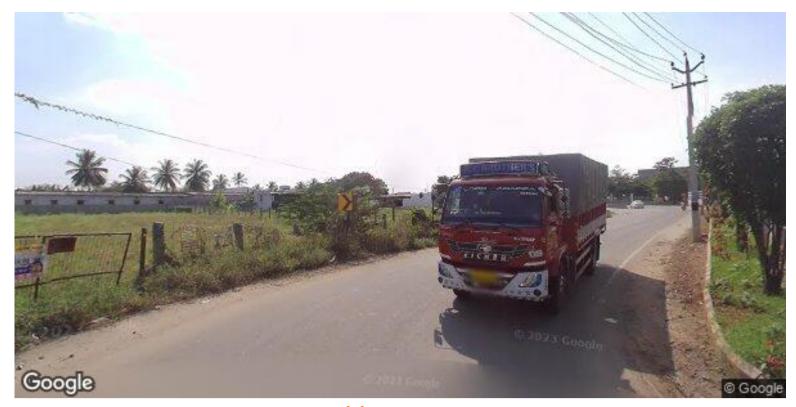
Risk Type: Turn
Risk Level: Medium
Speed Limit: 30 KM/Hr
Coordinates: 11.10504, 77.13143

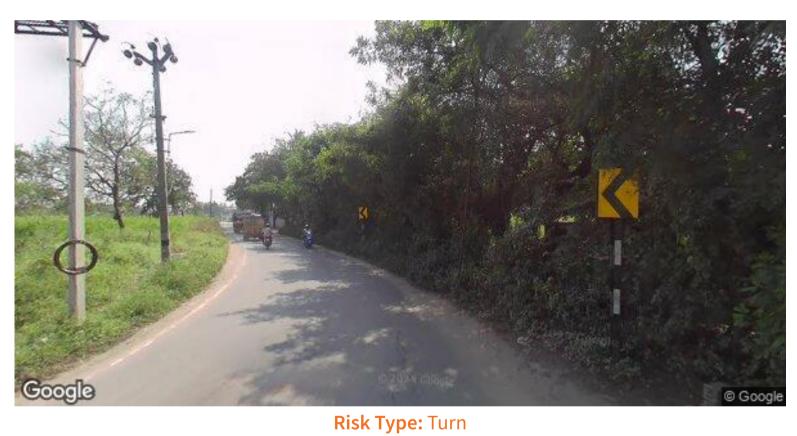
Risk Type: Turn
Risk Level: High
Speed Limit: 15 KM/Hr
Coordinates: 11.10521, 77.13189

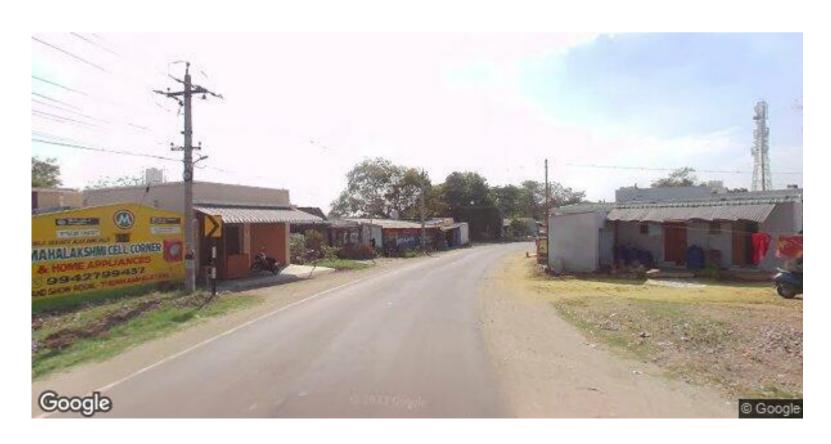
Risk Level: High
Speed Limit: 15 KM/Hr
Coordinates: 11.10855, 77.13210

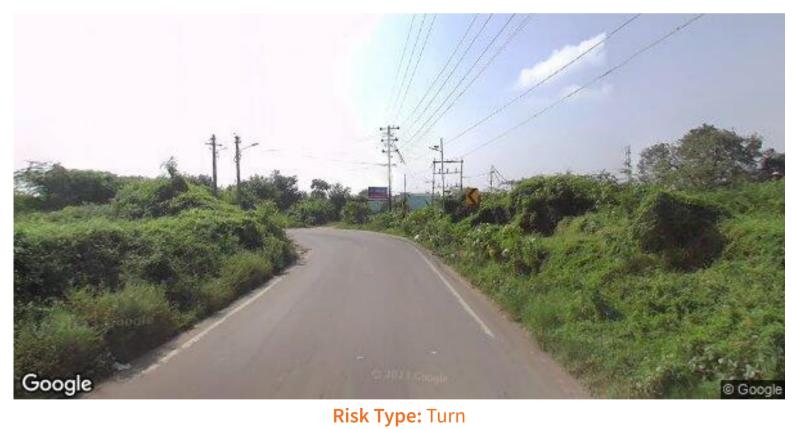
Risk Type: Turn
Risk Level: High
Speed Limit: 15 KM/Hr
Coordinates: 11.11024, 77.13351

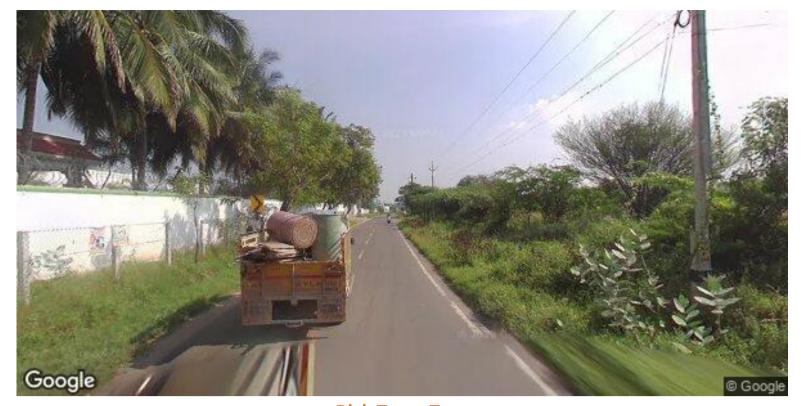
Risk Level: Medium
Speed Limit: 30 KM/Hr
Coordinates: 11.11094, 77.13301

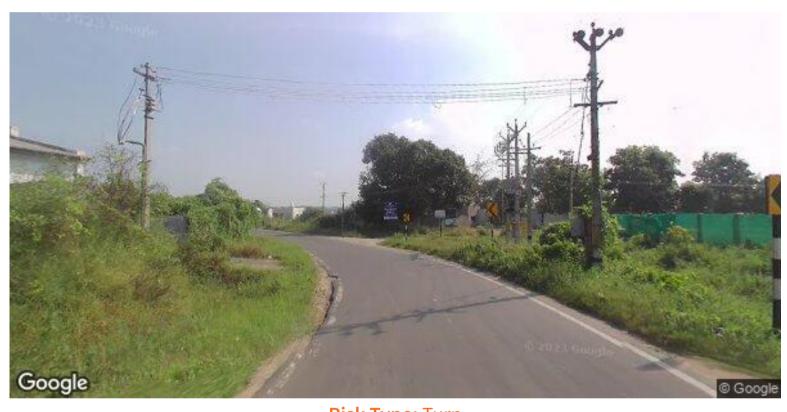
Risk Type: Turn
Risk Level: Medium
Speed Limit: 30 KM/Hr
Coordinates: 11.12179, 77.13475

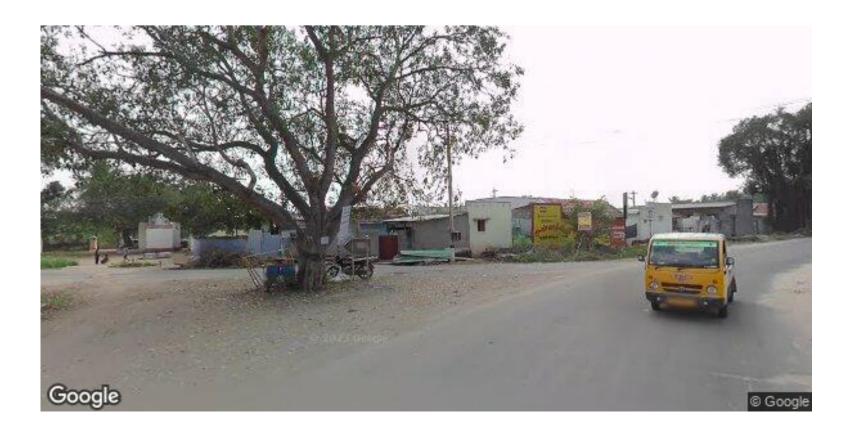
Risk Type: Turn
Risk Level: Medium
Speed Limit: 30 KM/Hr
Coordinates: 11.12295, 77.13756

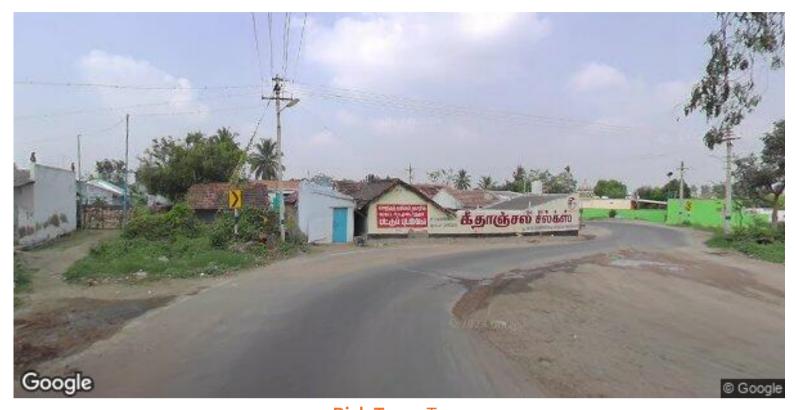
Coordinates: 11.12966, 77.13932

Risk Type: Turn
Risk Level: High
Speed Limit: 15 KM/Hr

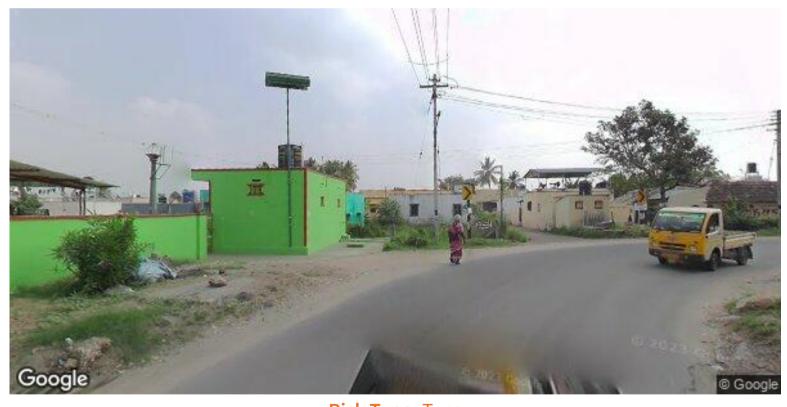
Risk Type: Turn
Risk Level: Medium
Speed Limit: 30 KM/Hr
Coordinates: 11.12977, 77.13912

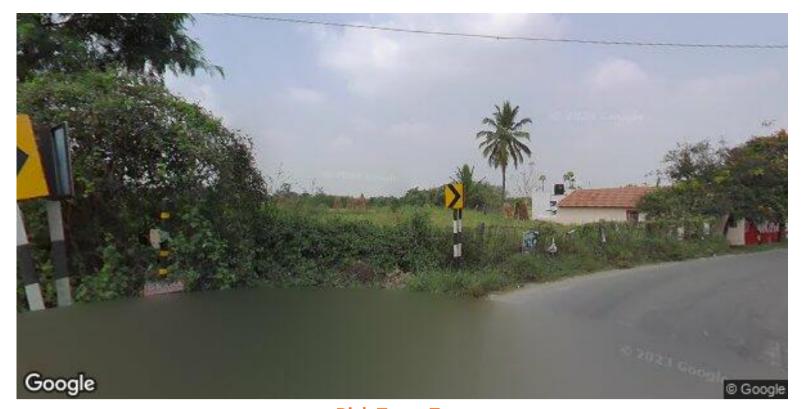
Risk Type: Turn
Risk Level: High
Speed Limit: 15 KM/Hr
Coordinates: 11.13017, 77.13878

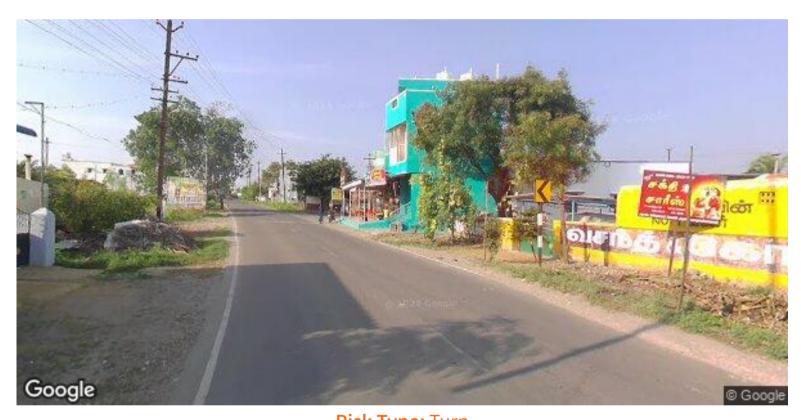
Risk Type: Turn
Risk Level: High
Speed Limit: 15 KM/Hr
Coordinates: 11.13016, 77.13845

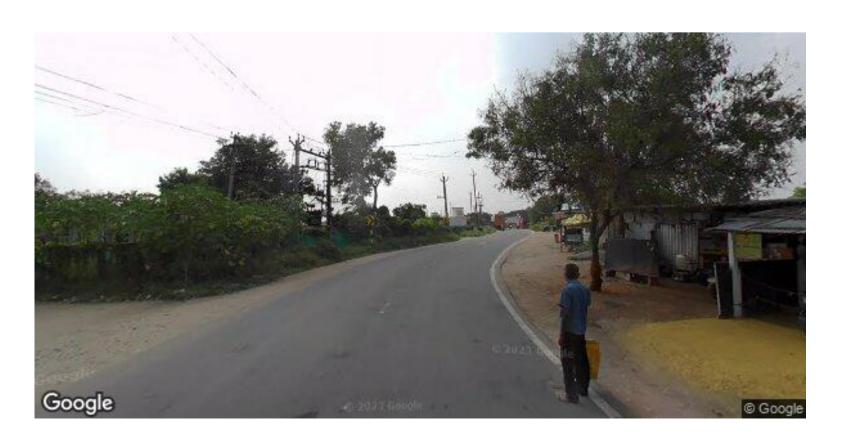
Risk Type: Turn
Risk Level: Medium
Speed Limit: 30 KM/Hr
Coordinates: 11.13333, 77.13837

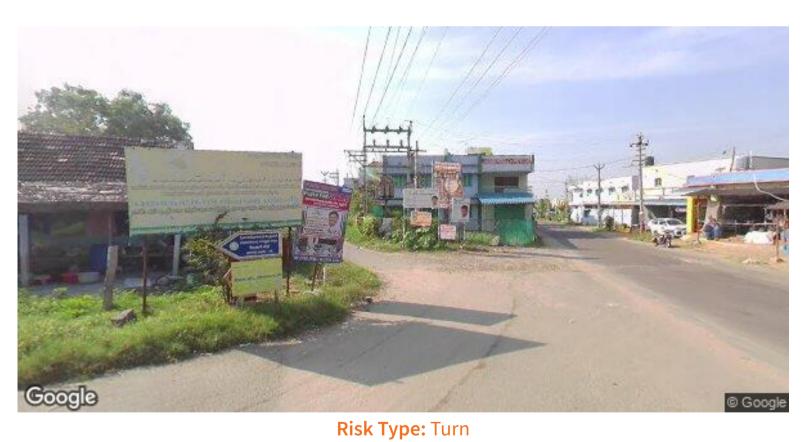
Risk Type: Blind Spot
Risk Level: Blind Spot
Speed Limit: 10 KM/Hr
Coordinates: 11.14431, 77.13584

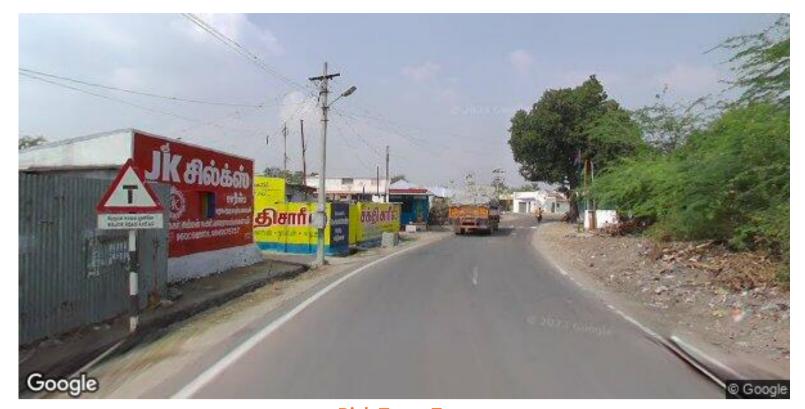
Risk Level: Medium
Speed Limit: 30 KM/Hr
Coordinates: 11.14404, 77.13127

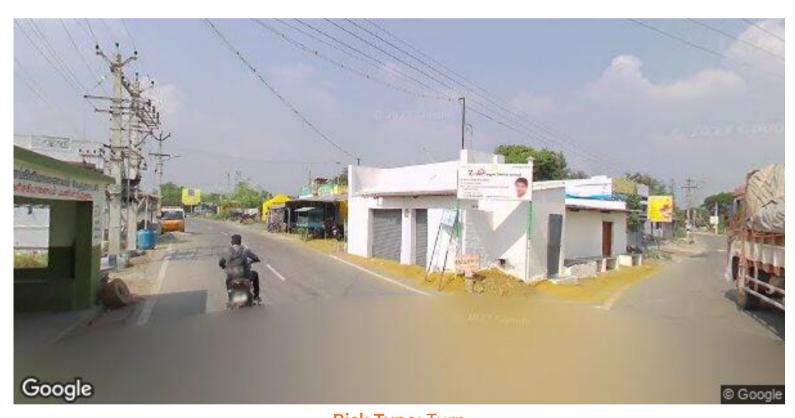
Risk Type: Turn
Risk Level: Medium
Speed Limit: 30 KM/Hr
Coordinates: 11.14576, 77.12599

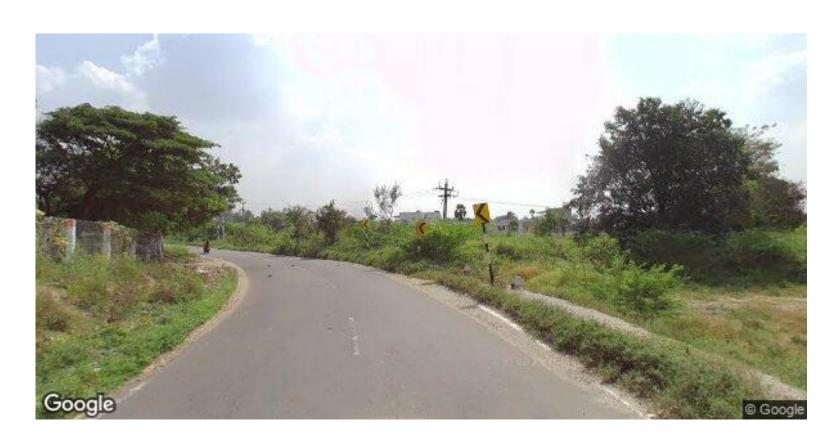
Risk Type: Turn
Risk Level: Medium
Speed Limit: 30 KM/Hr
Coordinates: 11.14602, 77.12554

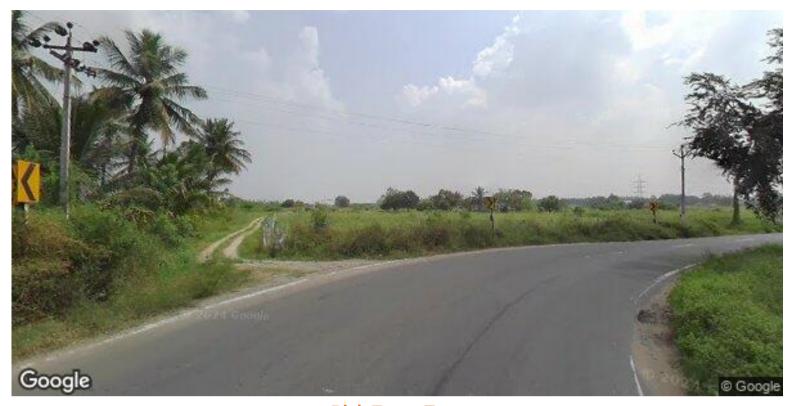
Coordinates: 11.14937, 77.12182

Risk Type: Turn
Risk Level: High
Speed Limit: 15 KM/Hr

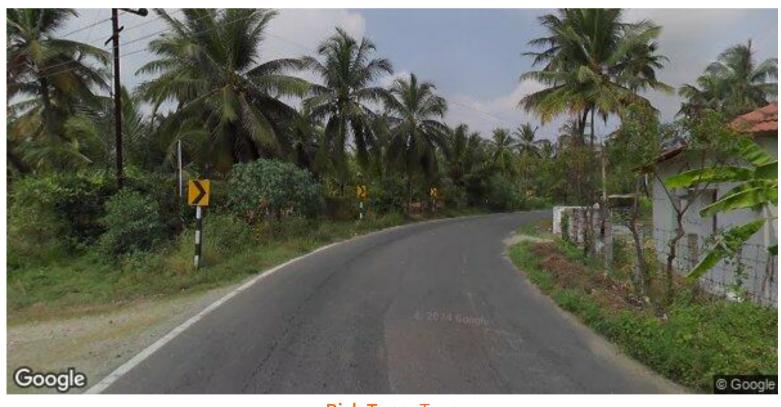
Risk Type: Turn
Risk Level: High
Speed Limit: 15 KM/Hr
Coordinates: 11.15275, 77.12071

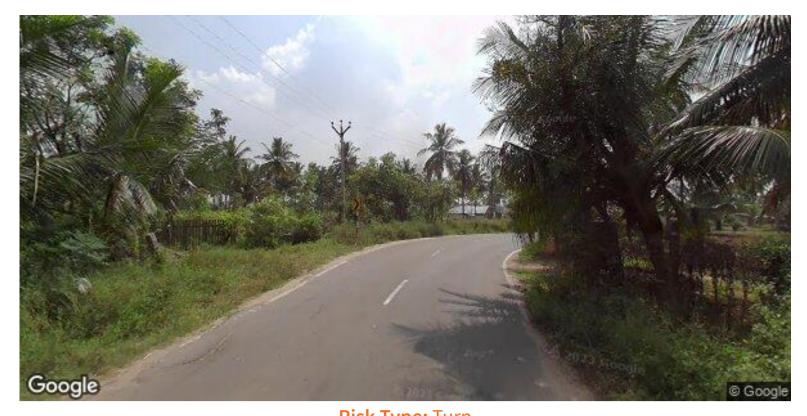
Risk Type: Turn
Risk Level: High
Speed Limit: 15 KM/Hr
Coordinates: 11.15285, 77.12042

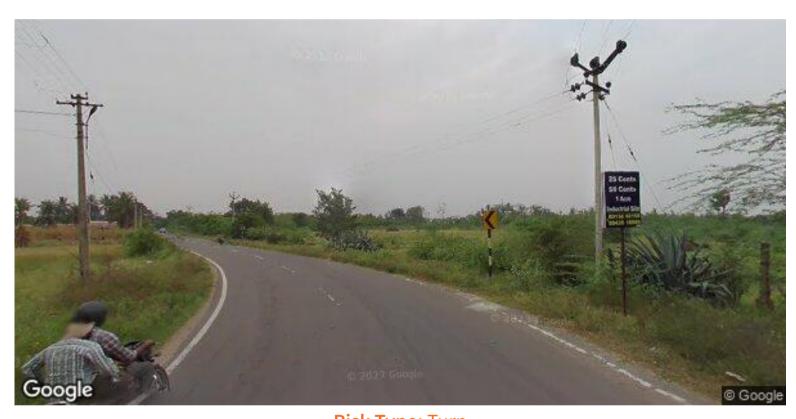
Risk Type: Turn
Risk Level: Medium
Speed Limit: 30 KM/Hr
Coordinates: 11.15408, 77.12021

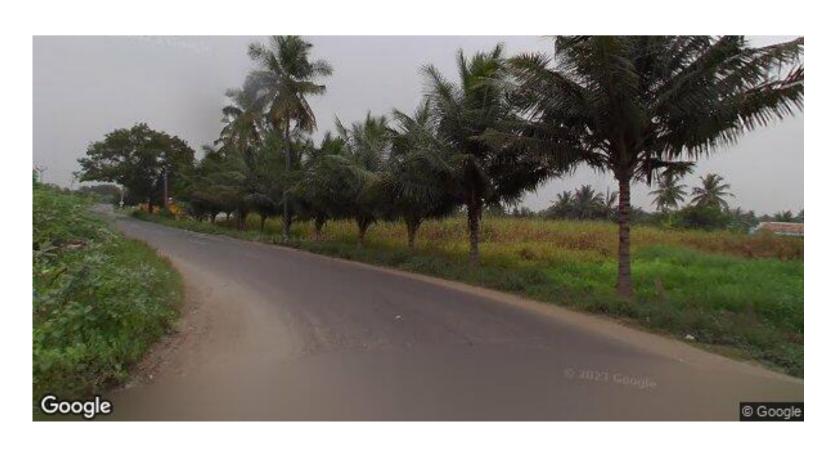
Risk Type: Turn
Risk Level: Medium
Speed Limit: 30 KM/Hr
Coordinates: 11.15604, 77.11805

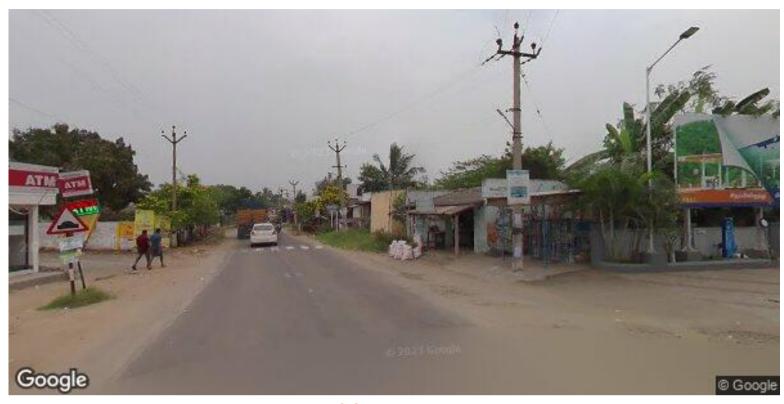
Coordinates: 11.15619, 77.11569

Risk Type: Turn
Risk Level: High
Speed Limit: 15 KM/Hr

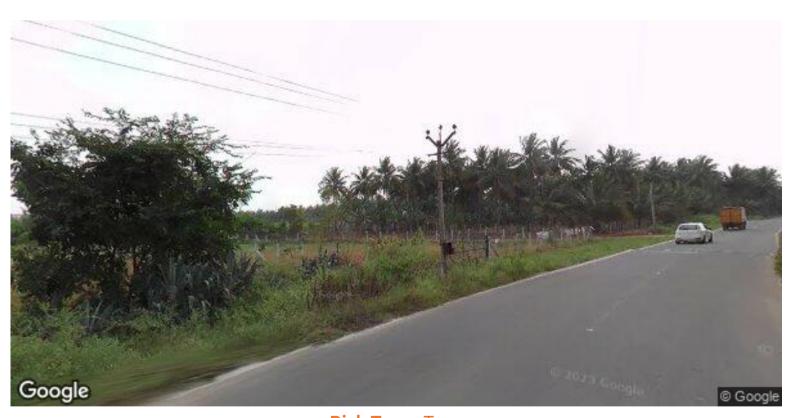
Risk Type: Turn
Risk Level: Medium
Speed Limit: 30 KM/Hr
Coordinates: 11.16078, 77.11422

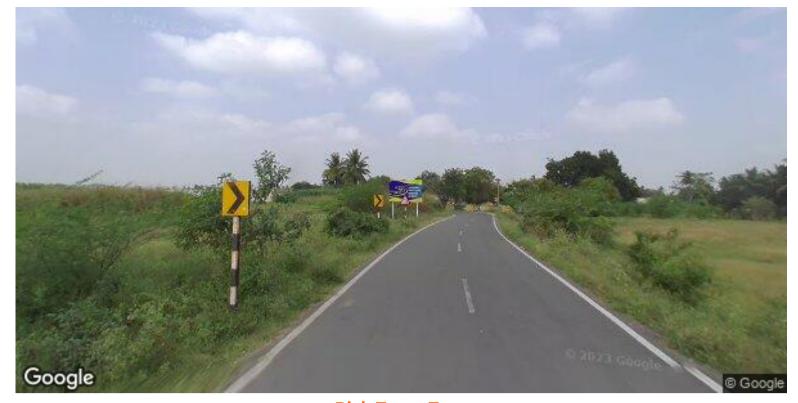
Risk Type: Turn
Risk Level: High
Speed Limit: 15 KM/Hr
Coordinates: 11.16693, 77.11381

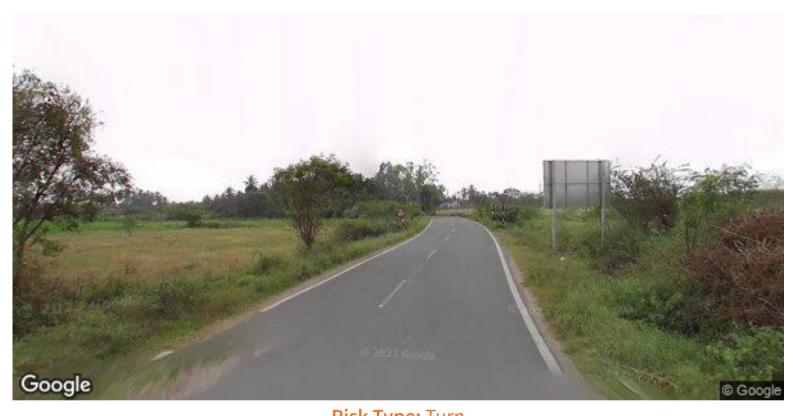
Risk Type: Turn
Risk Level: Medium
Speed Limit: 30 KM/Hr
Coordinates: 11.16744, 77.11212

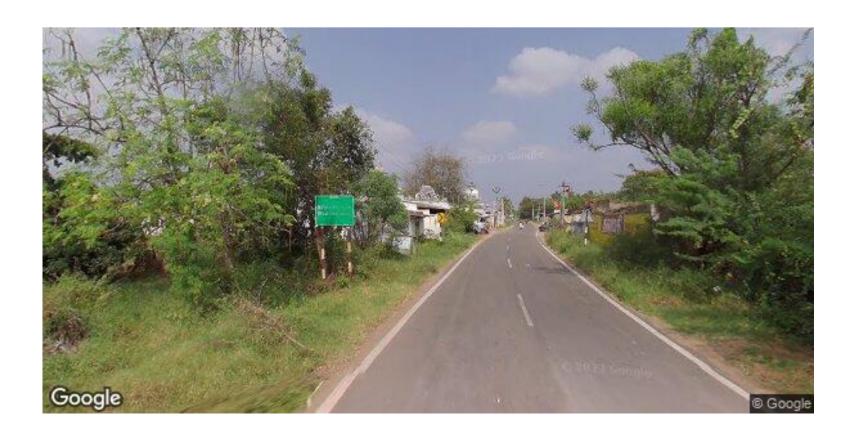
Risk Type: Turn
Risk Level: Medium
Speed Limit: 30 KM/Hr
Coordinates: 11.16789, 77.11187

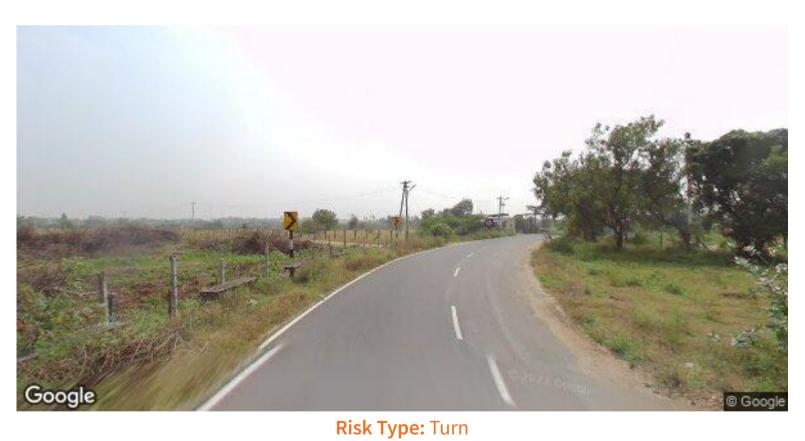
Risk Type: Turn
Risk Level: Medium
Speed Limit: 30 KM/Hr
Coordinates: 11.17312, 77.10864

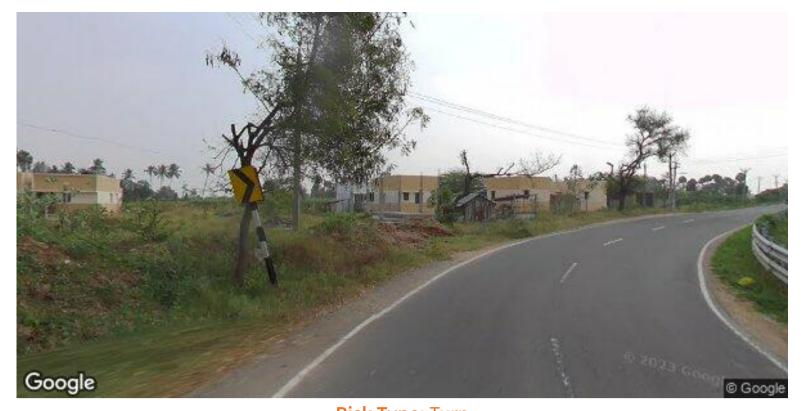
Risk Type: Turn
Risk Level: High
Speed Limit: 15 KM/Hr
Coordinates: 11.19791, 77.10874

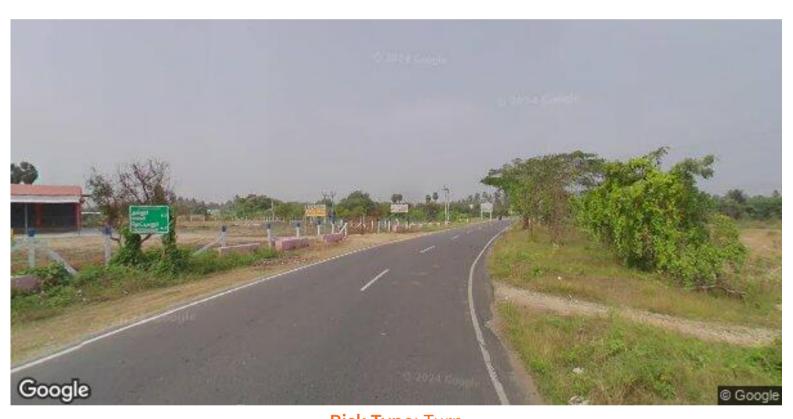
Risk Type: Turn
Risk Level: High
Speed Limit: 15 KM/Hr
Coordinates: 11.20658, 77.10414

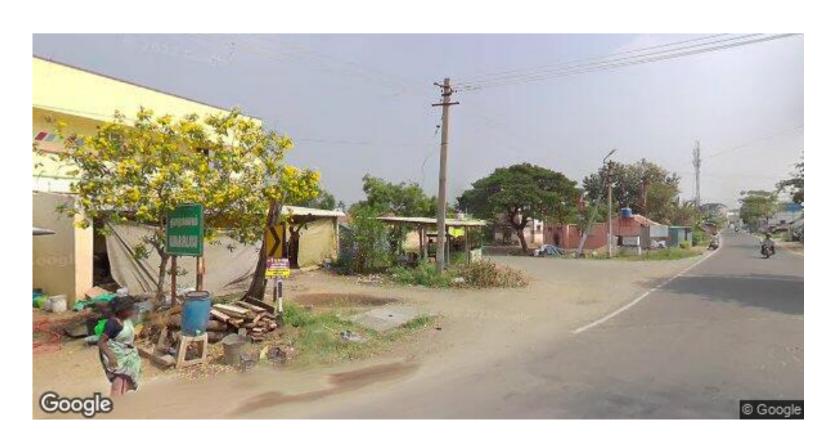
Risk Type: Turn
Risk Level: Medium
Speed Limit: 30 KM/Hr
Coordinates: 11.20702, 77.10300

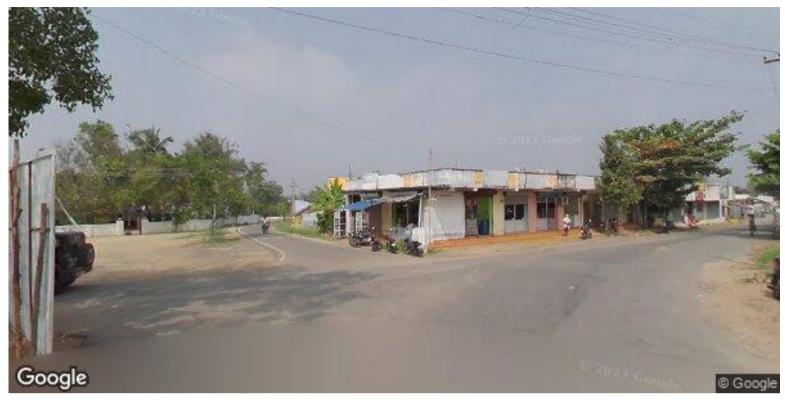
Coordinates: 11.21497, 77.10243

Risk Type: Turn
Risk Level: High
Speed Limit: 15 KM/Hr

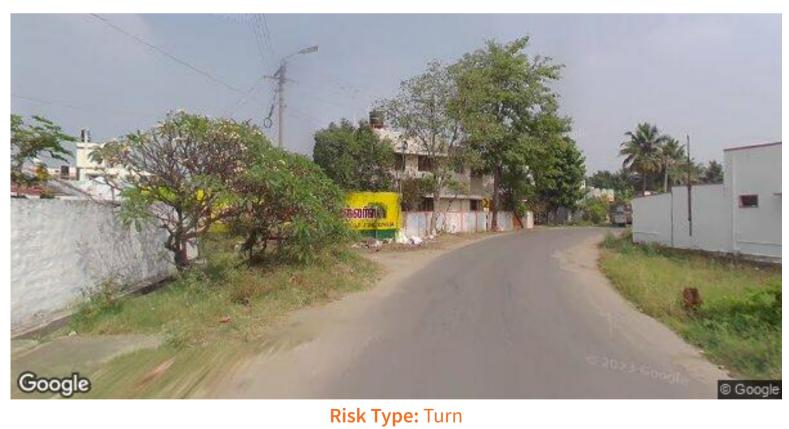
Risk Type: Blind Spot
Risk Level: Blind Spot
Speed Limit: 10 KM/Hr
Coordinates: 11.21522, 77.10162

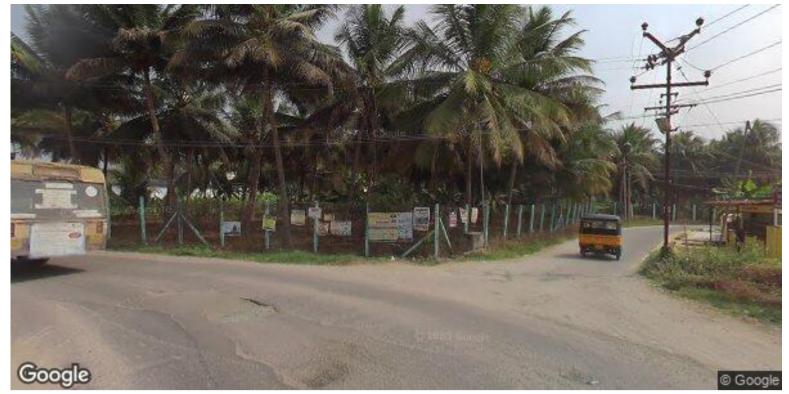
Risk Type: Turn
Risk Level: High
Speed Limit: 15 KM/Hr
Coordinates: 11.22823, 77.10600

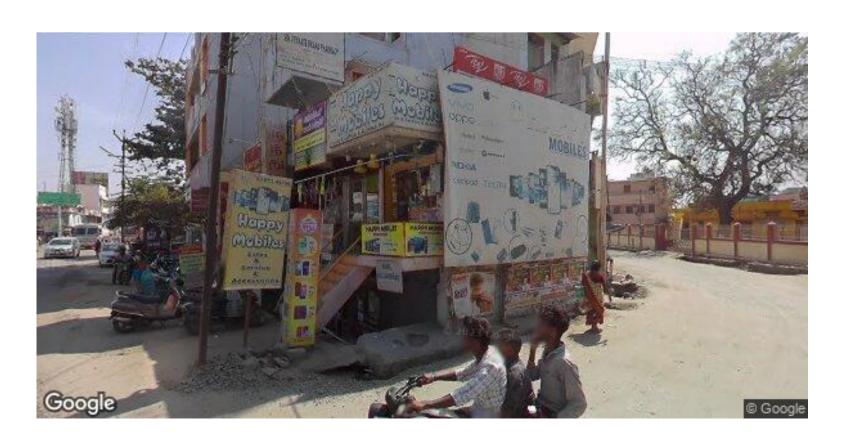
Risk Type: Turn
Risk Level: Medium
Speed Limit: 30 KM/Hr
Coordinates: 11.23306, 77.10441

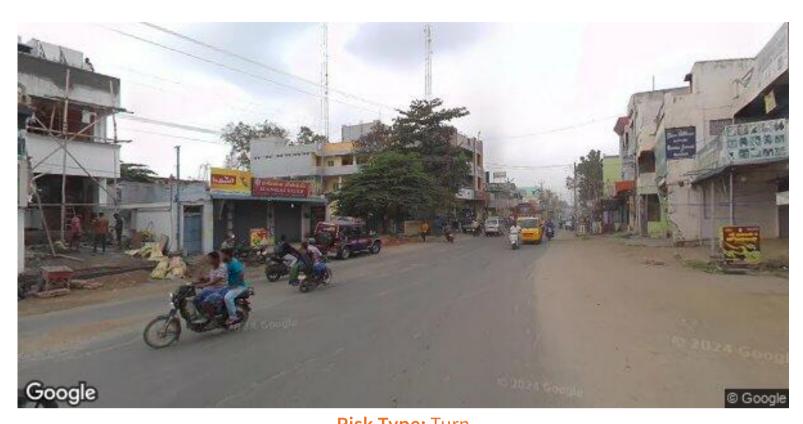
Coordinates: 11.23316, 77.10440

Risk Type: Blind Spot
Risk Level: Blind Spot
Speed Limit: 10 KM/Hr

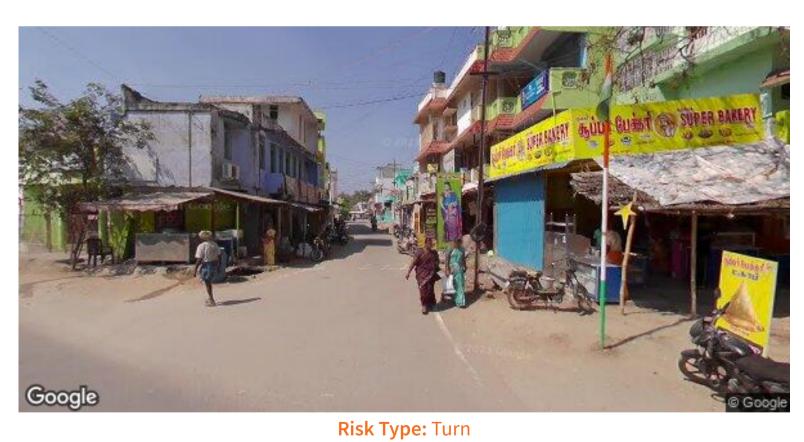
Risk Type: Turn
Risk Level: Medium
Speed Limit: 30 KM/Hr
Coordinates: 11.23317, 77.10504

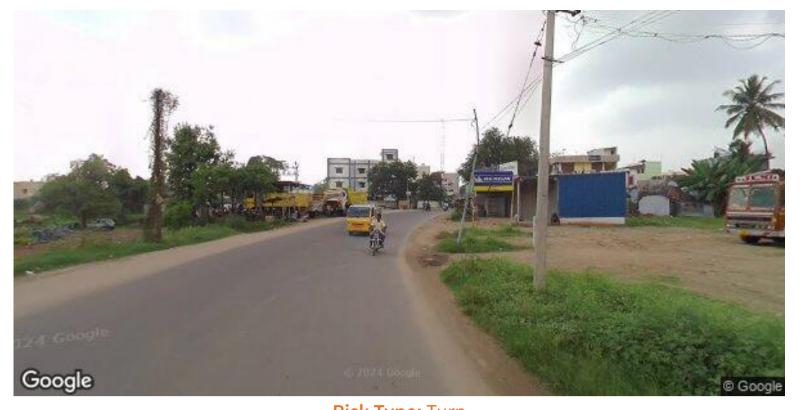
Risk Level: Medium
Speed Limit: 30 KM/Hr
Coordinates: 11.23356, 77.10594

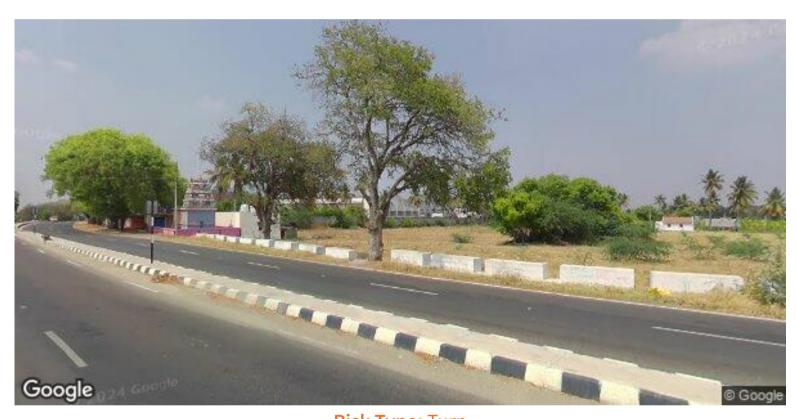
Risk Type: Turn
Risk Level: Medium
Speed Limit: 30 KM/Hr
Coordinates: 11.23578, 77.10737

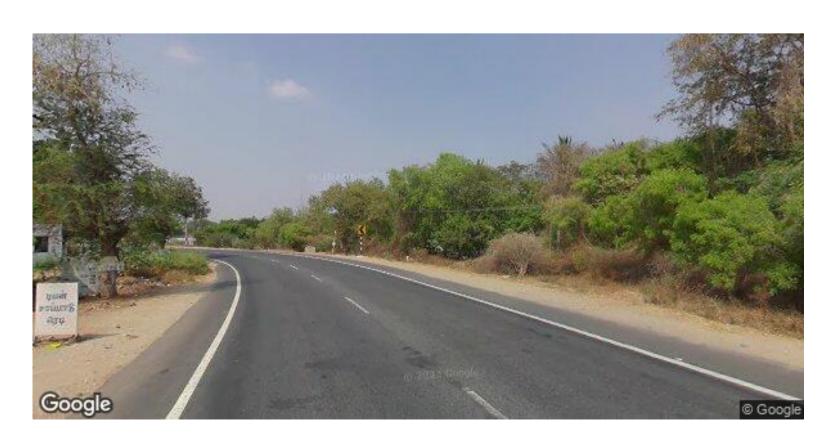
Risk Type: Turn
Risk Level: Medium
Speed Limit: 30 KM/Hr
Coordinates: 11.27860, 77.12093

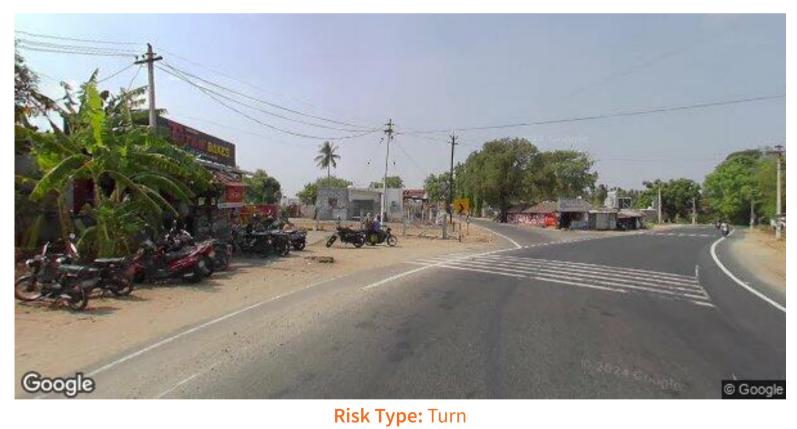
Coordinates: 11.29626, 77.12833

Risk Type: Turn
Risk Level: Medium
Speed Limit: 30 KM/Hr

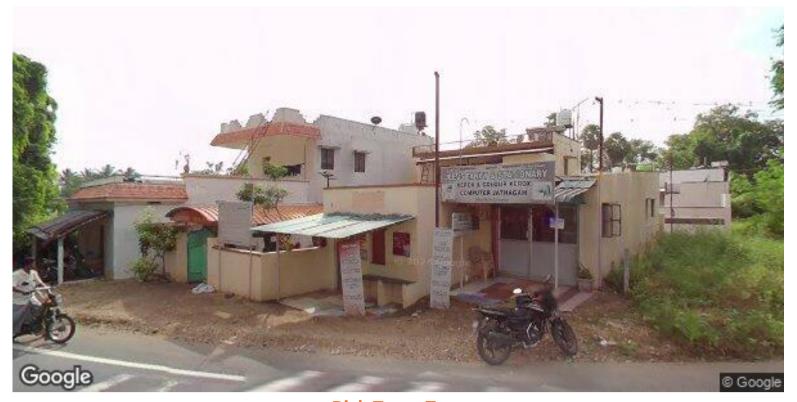
Coordinates: 11.29733, 77.12809

Risk Type: Turn
Risk Level: High
Speed Limit: 15 KM/Hr

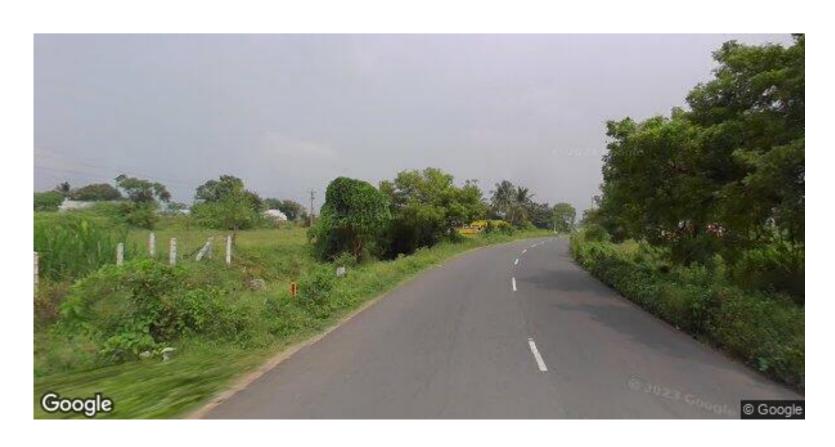
Risk Type: Turn
Risk Level: Medium
Speed Limit: 30 KM/Hr
Coordinates: 11.29846, 77.13026

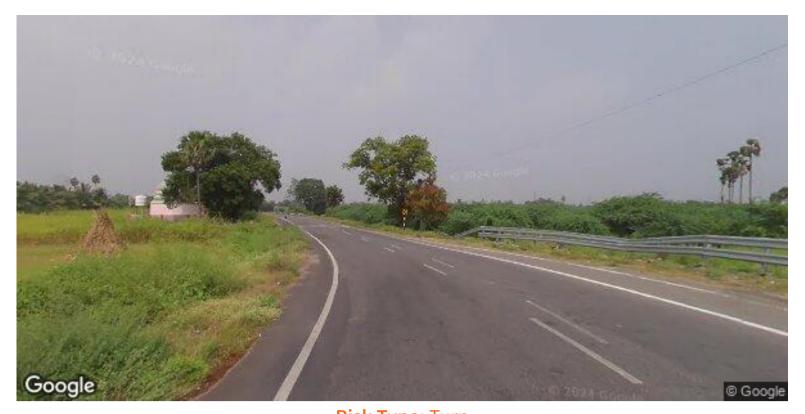
Risk Type. Turn
Risk Level: Medium
Speed Limit: 30 KM/Hr
Coordinates: 11.34917, 77.16622

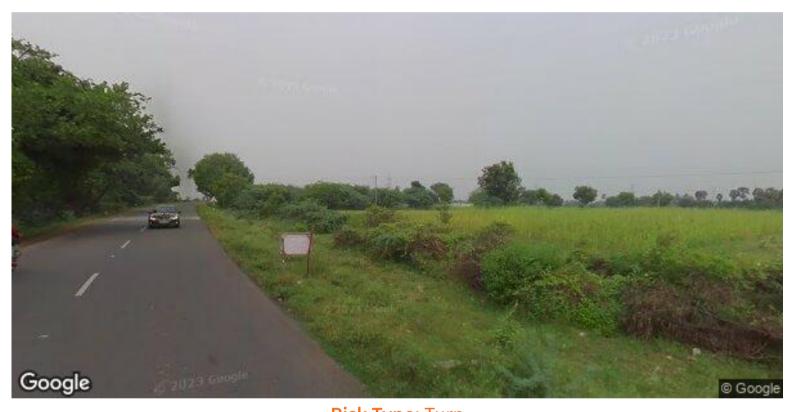
Risk Type: Turn
Risk Level: Medium
Speed Limit: 30 KM/Hr
Coordinates: 11.38755, 77.17810

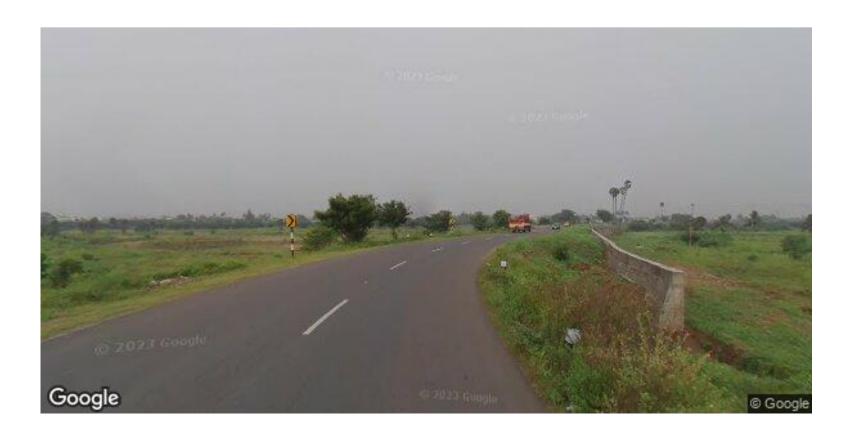
Risk Type: Turn
Risk Level: Medium
Speed Limit: 30 KM/Hr
Coordinates: 11.39072, 77.17785

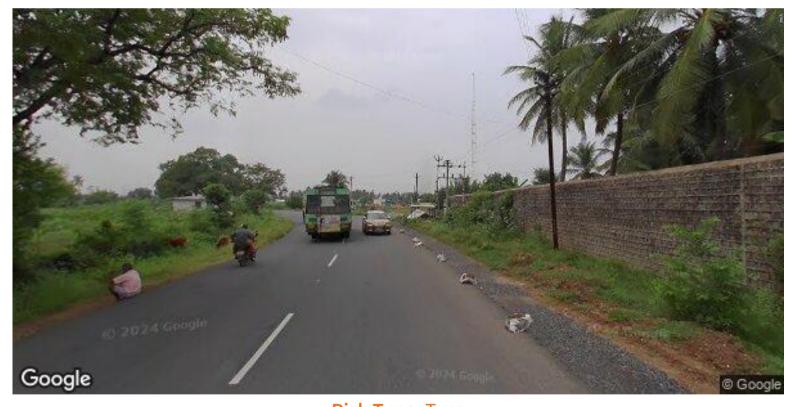
Coordinates: 11.39567, 77.18065

Risk Type: Turn
Risk Level: Medium
Speed Limit: 30 KM/Hr

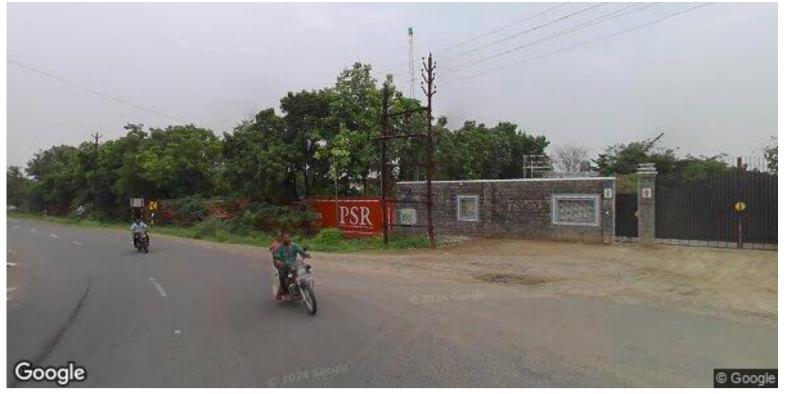
Risk Type: Turn
Risk Level: High
Speed Limit: 15 KM/Hr
Coordinates: 11.39993, 77.18889

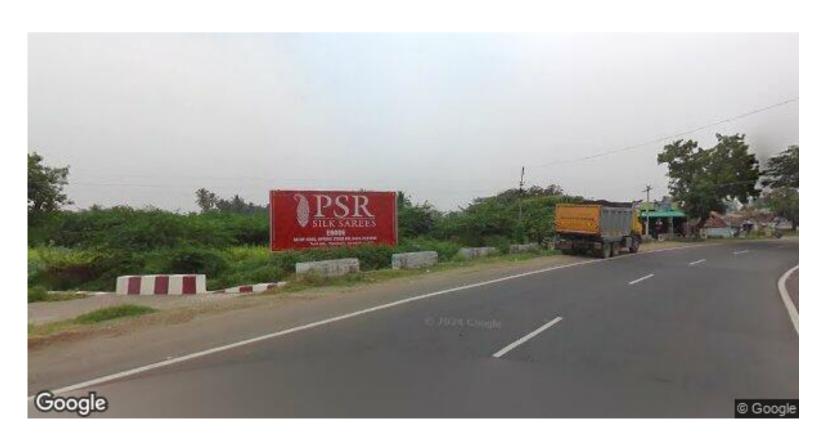
Risk Level: High
Speed Limit: 15 KM/Hr
Coordinates: 11.40343, 77.19017

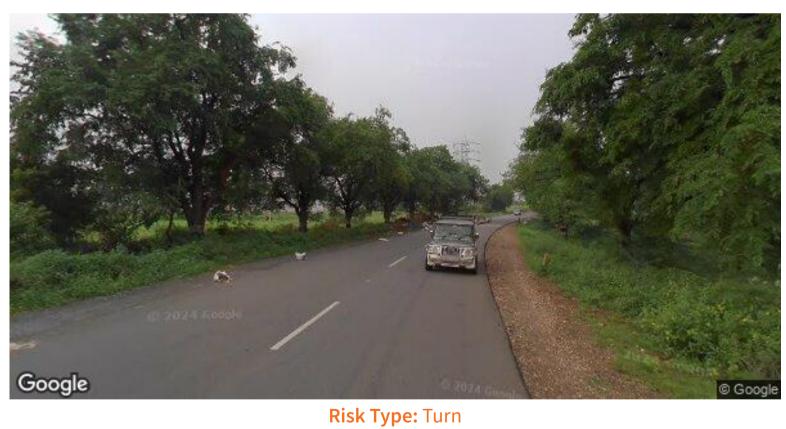
Risk Type: Turn
Risk Level: Medium
Speed Limit: 30 KM/Hr
Coordinates: 11.41995, 77.19489

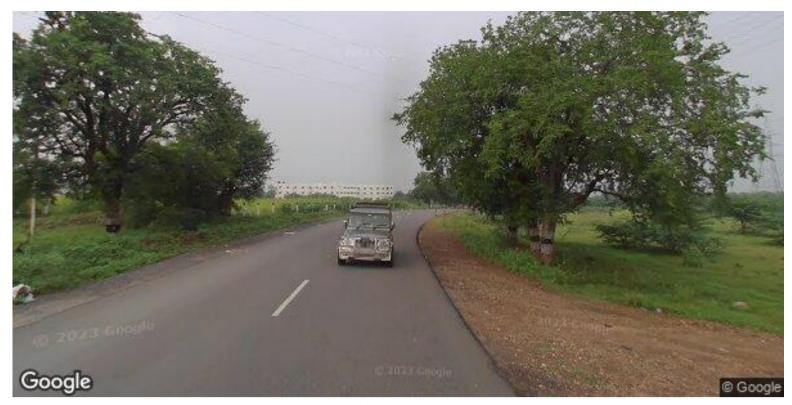
Risk Type. Turn
Risk Level: Medium
Speed Limit: 30 KM/Hr
Coordinates: 11.42116, 77.19387

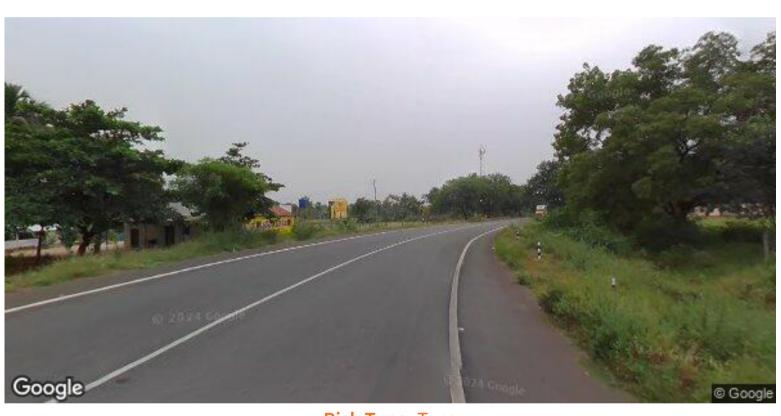
Risk Type: Turn
Risk Level: Medium
Speed Limit: 30 KM/Hr
Coordinates: 11.42213, 77.19390

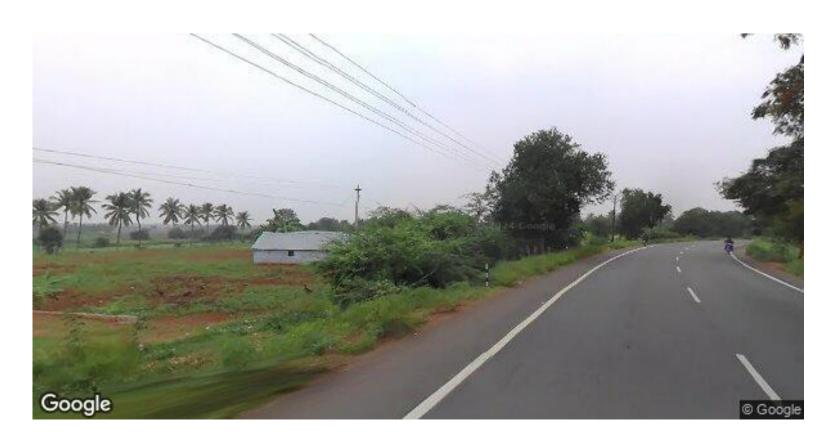
Risk Type: Turn
Risk Level: Medium
Speed Limit: 30 KM/Hr
Coordinates: 11.43270, 77.20219

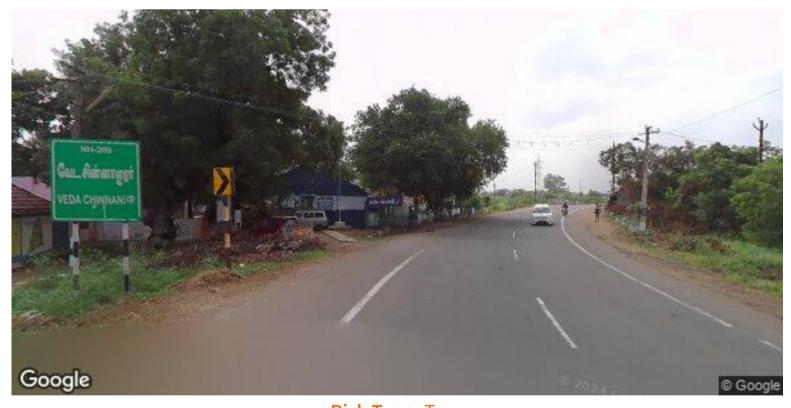
Coordinates: 11.44181, 77.20796

Risk Type: Turn
Risk Level: Medium
Speed Limit: 30 KM/Hr

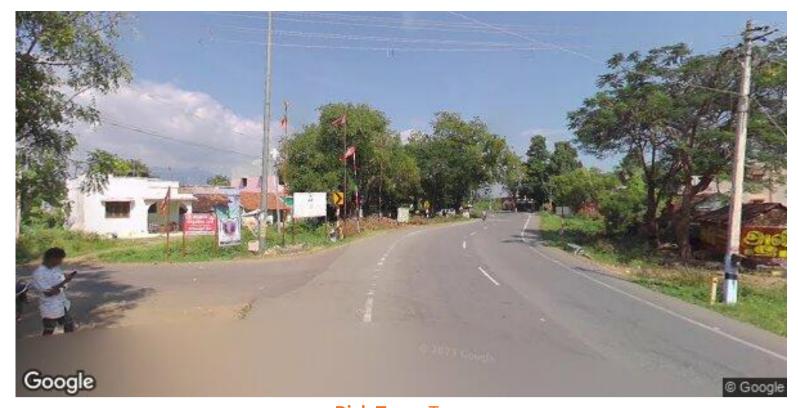
Risk Type: Turn
Risk Level: Medium
Speed Limit: 30 KM/Hr
Coordinates: 11.45128, 77.21536

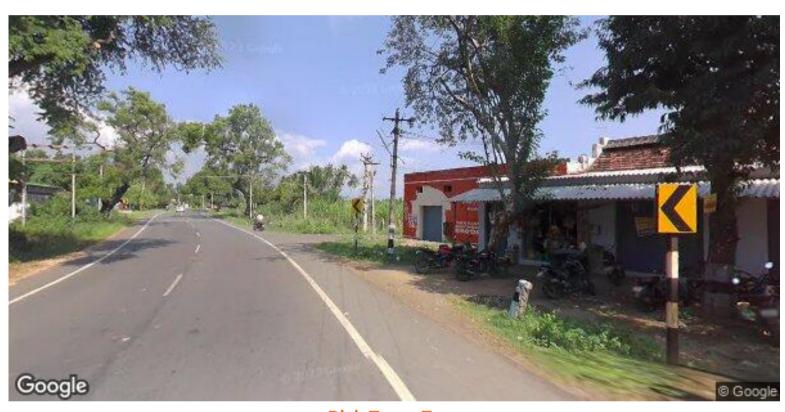
Risk Type: Turn
Risk Level: Medium
Speed Limit: 30 KM/Hr
Coordinates: 11.46199, 77.21848
