JOURNEY RISK MANAGEMENT (JRM) STUDY

Salem Terminal to ANTHIYUR THAVITTUPALAYAM LORRY

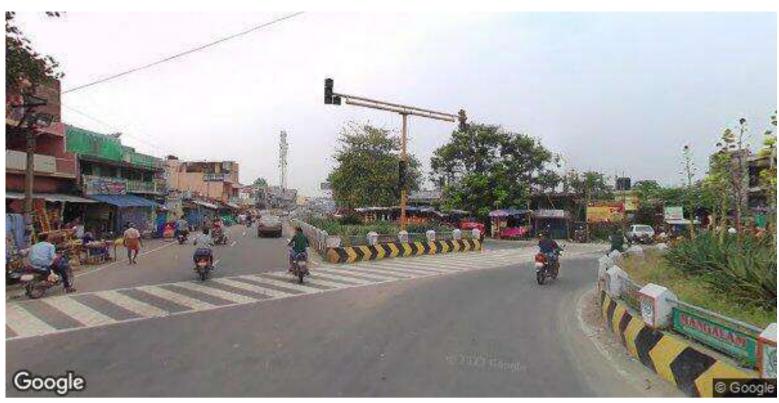
Coordinates: 11.57607, 77.58841

Risk Type: Roundabout
Risk Level: High
Speed Limit: 15 KM/Hr

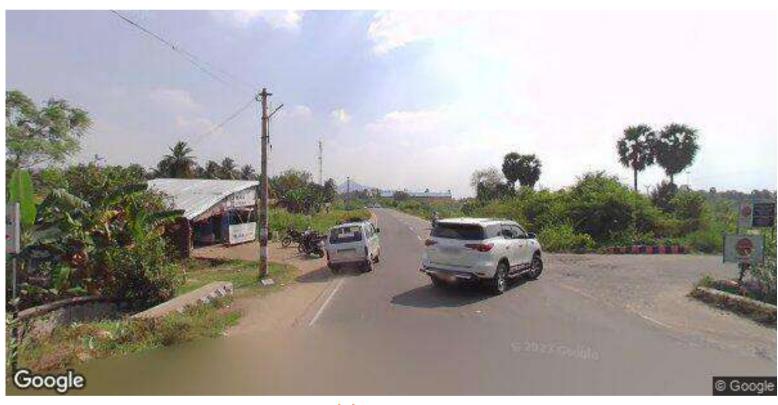
Risk Type: Turn
Risk Level: High
Speed Limit: 15 KM/Hr
Coordinates: 11.44029, 77.87544

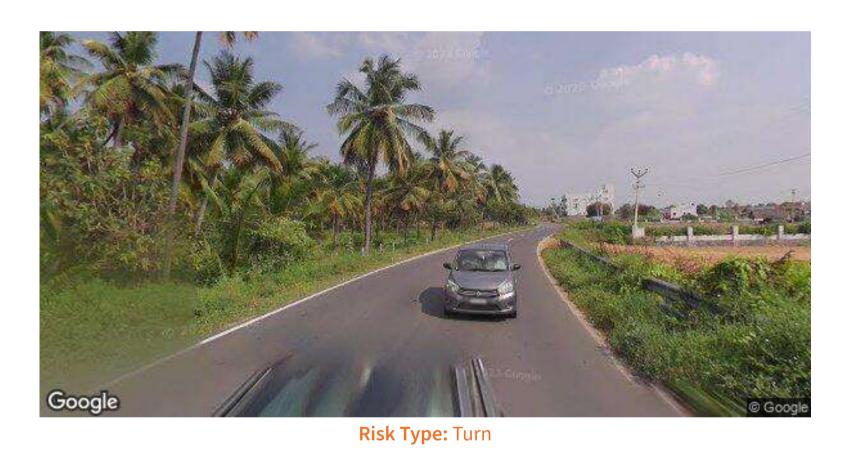
Speed Limit: 30 KM/Hr Coordinates: 11.45357, 77.85789

Risk Level: Medium

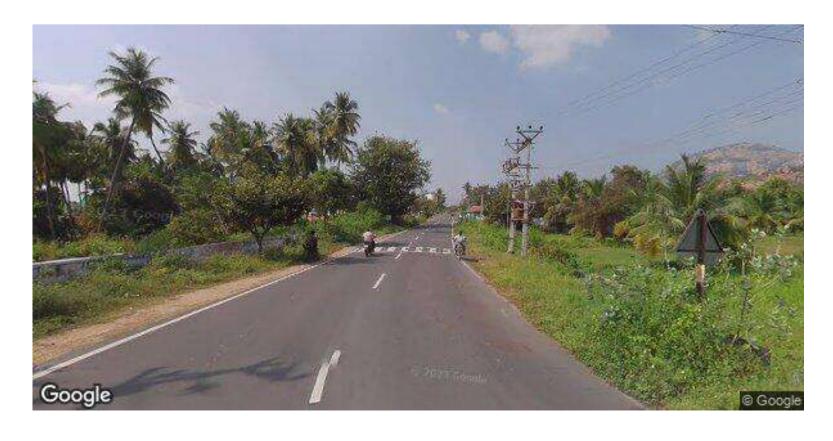
Coordinates: 11.45352, 77.85698

Risk Type: Turn
Risk Level: Medium
Speed Limit: 30 KM/Hr

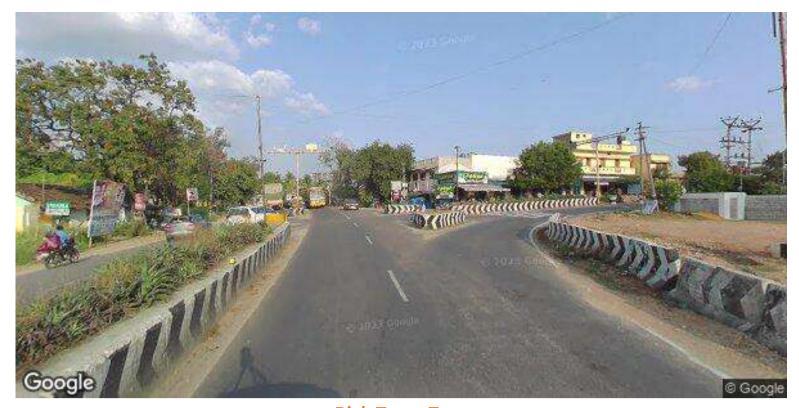
Risk Type: Turn
Risk Level: Medium
Speed Limit: 30 KM/Hr
Coordinates: 11.46318, 77.84913

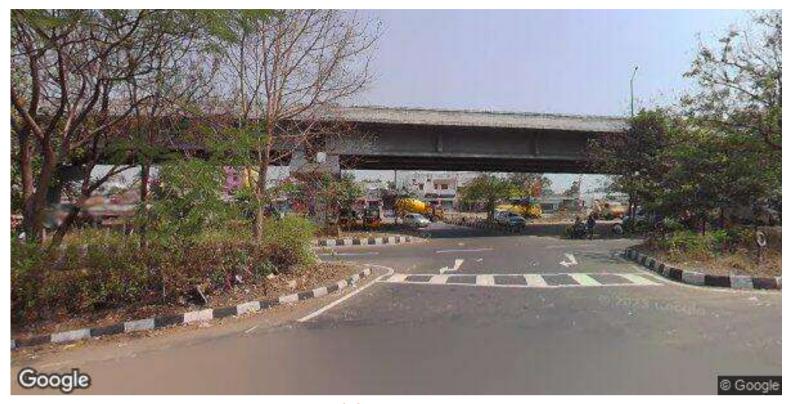
Coordinates: 11.43026, 77.67525

Risk Type: Turn
Risk Level: High
Speed Limit: 15 KM/Hr

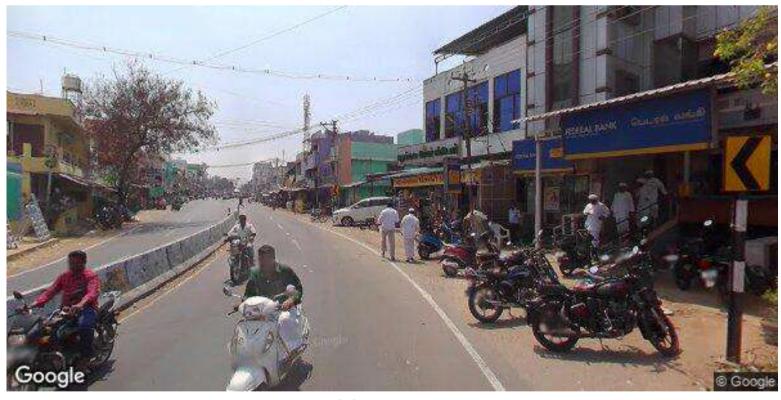
Risk Type: Turn
Risk Level: Medium
Speed Limit: 30 KM/Hr
Coordinates: 11.43769, 77.67810

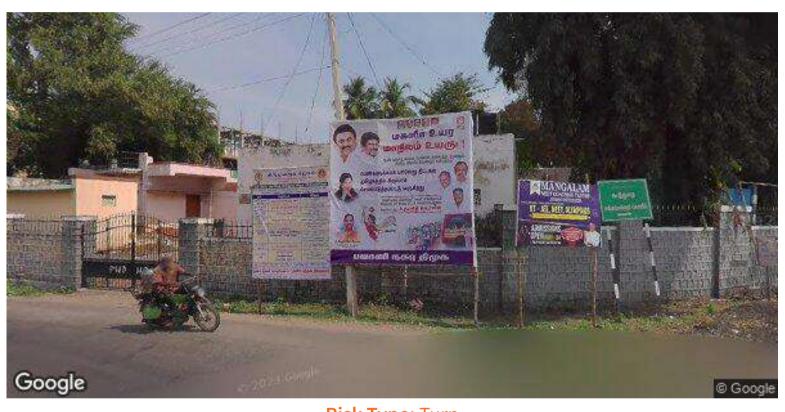
Risk Type: Turn
Risk Level: Medium
Speed Limit: 30 KM/Hr
Coordinates: 11.43871, 77.68228

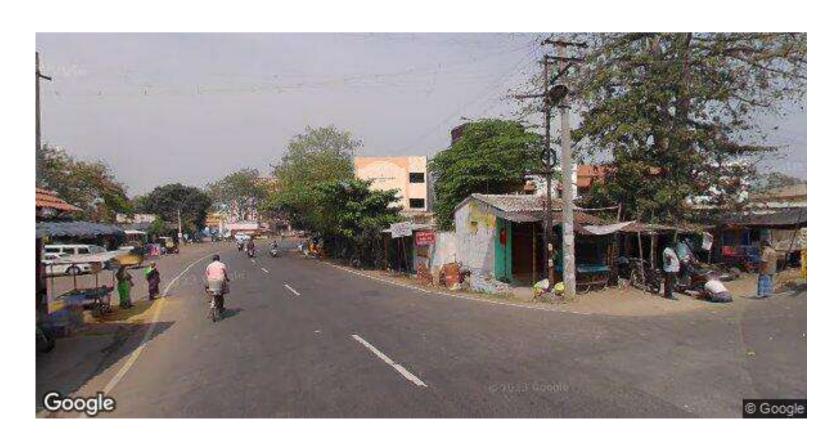
Coordinates: 11.43965, 77.68224

Risk Type: Turn
Risk Level: Medium
Speed Limit: 30 KM/Hr

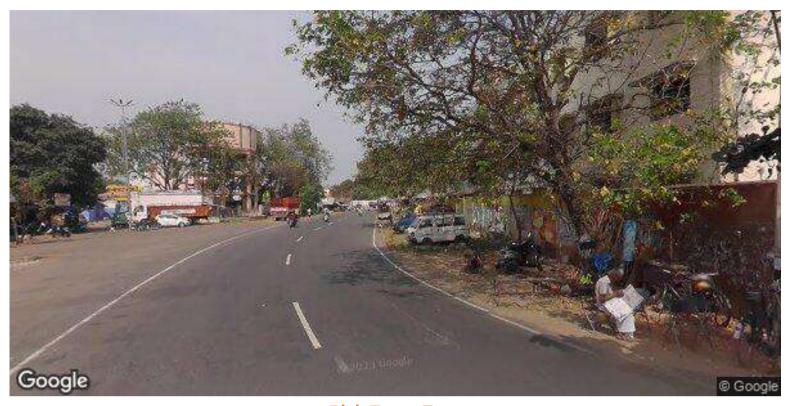
Coordinates: 11.43997, 77.68198

Risk Type: Turn
Risk Level: Medium
Speed Limit: 30 KM/Hr

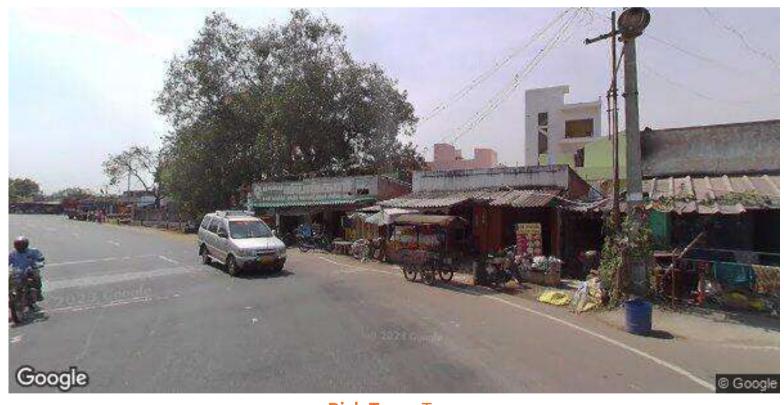
Coordinates: 11.44105, 77.68187

Risk Type: Turn
Risk Level: High
Speed Limit: 15 KM/Hr

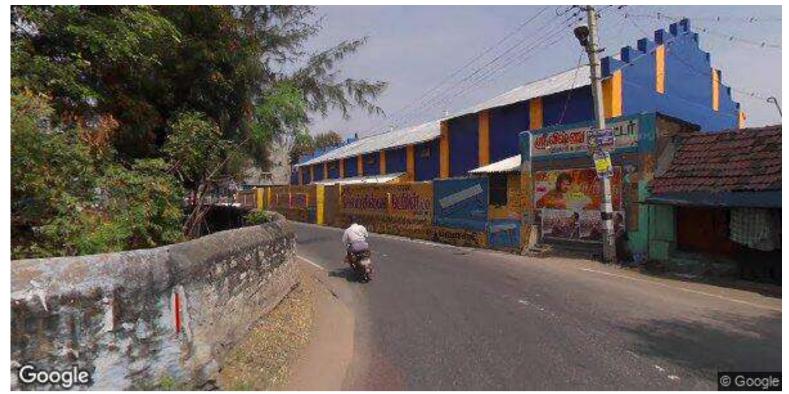
Risk Type: Turn
Risk Level: High
Speed Limit: 15 KM/Hr
Coordinates: 11.44119, 77.68217

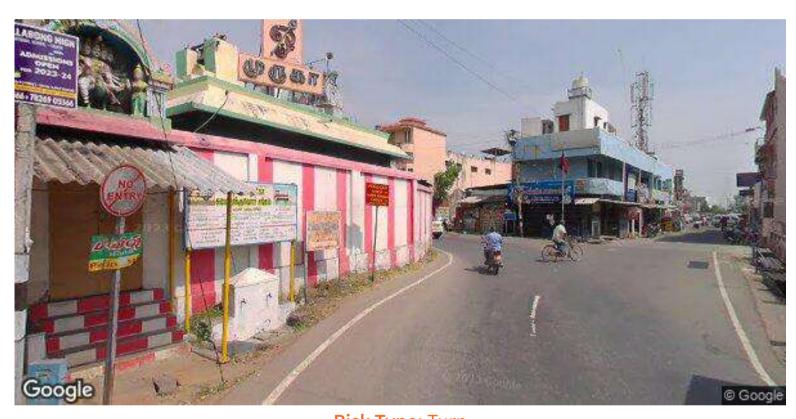
Risk Type: Turn
Risk Level: Medium
Speed Limit: 30 KM/Hr
Coordinates: 11.44295, 77.68261

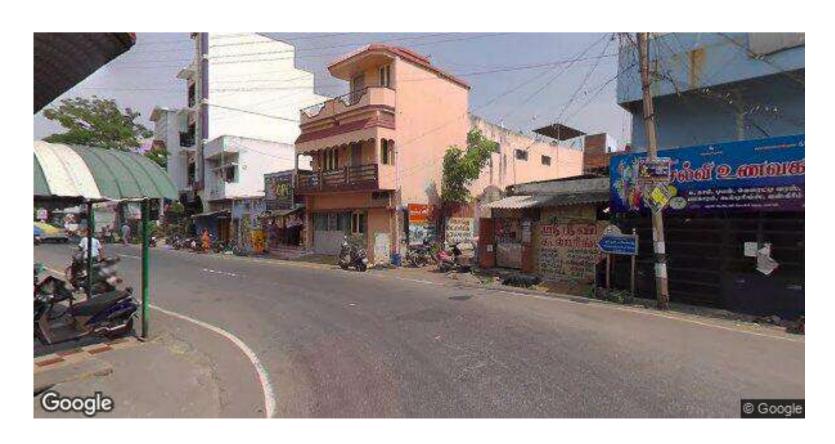
Coordinates: 11.44300, 77.68275

Risk Type: Turn
Risk Level: High
Speed Limit: 15 KM/Hr

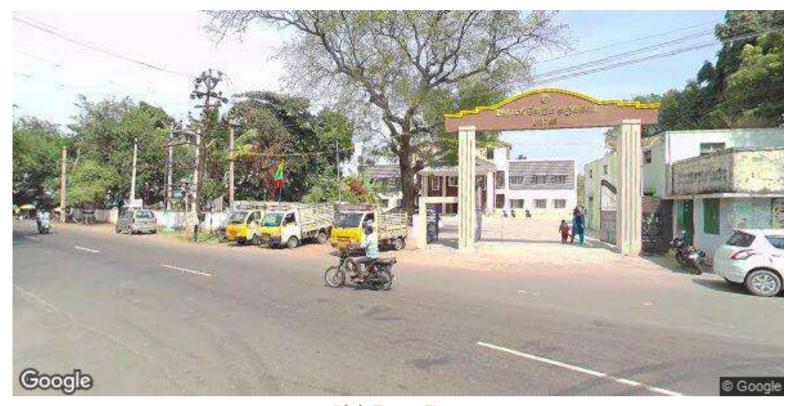
Risk Type: Turn
Risk Level: High
Speed Limit: 15 KM/Hr
Coordinates: 11.44853, 77.68331

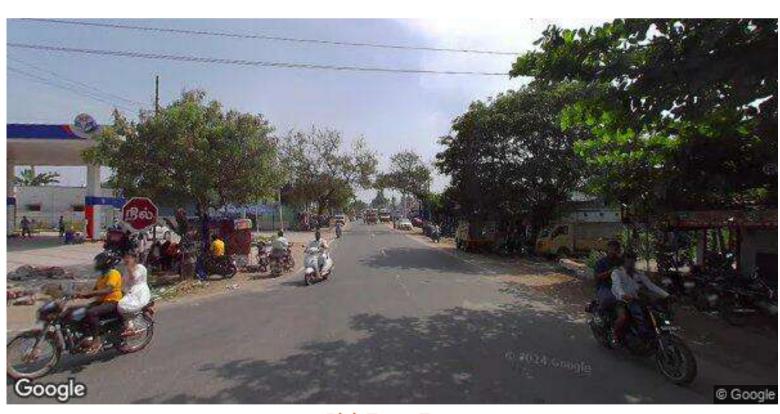
Risk Type: Turn
Risk Level: High
Speed Limit: 15 KM/Hr
Coordinates: 11.45649, 77.67621

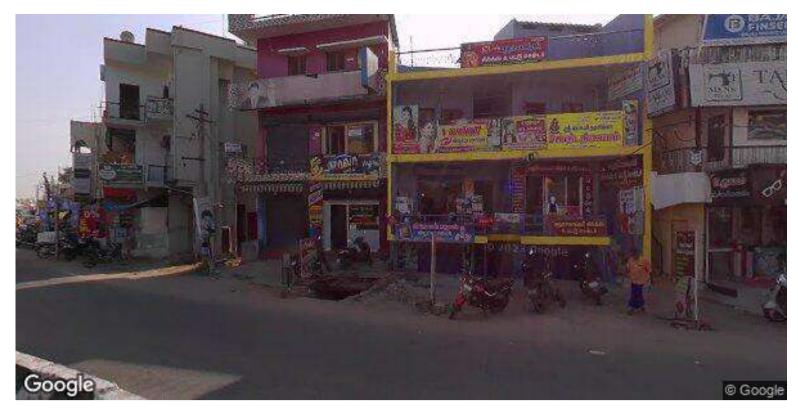
Risk Type: Turn
Risk Level: Medium
Speed Limit: 30 KM/Hr
Coordinates: 11.57510, 77.58991
