JOURNEY RISK MANAGEMENT (JRM) STUDY

IOCL Coimbatore Terminal to Arul Murugan Fuels

Route Safety Analysis Report

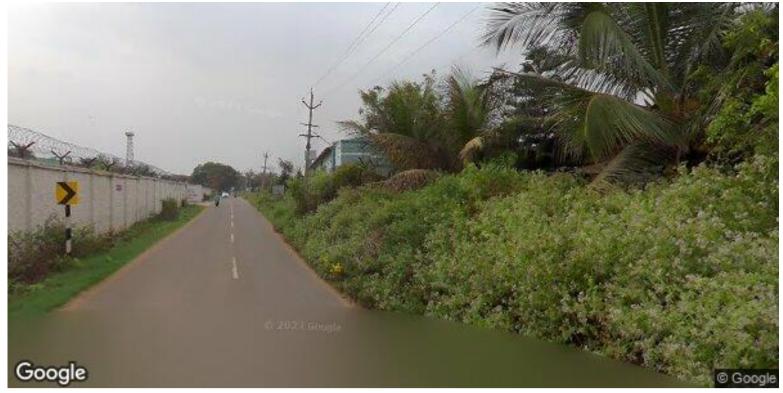
Coordinates: 11.03174, 77.08443

Risk Type: Turn
Risk Level: High
Speed Limit: 15 KM/Hr

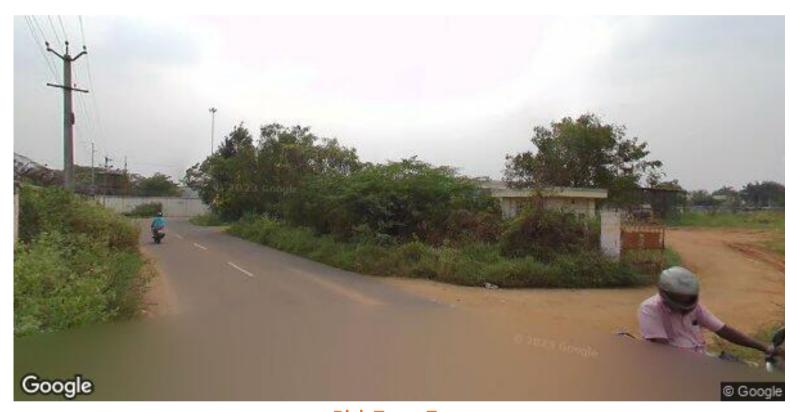
Risk Type: Turn
Risk Level: High
Speed Limit: 15 KM/Hr
Coordinates: 11.03231, 77.08448

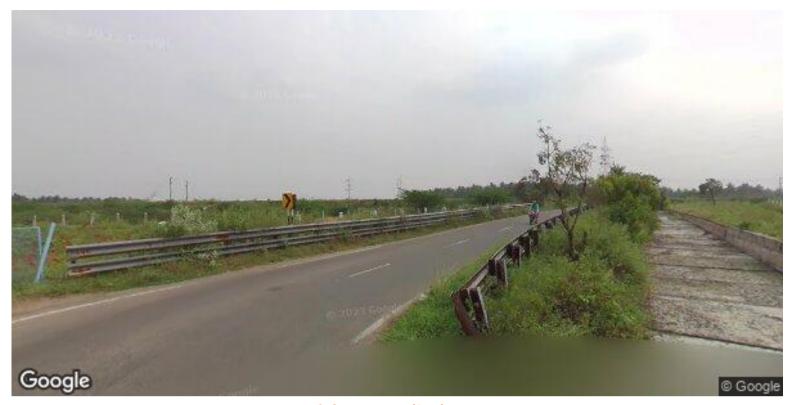
Risk Type: Blind Spot
Risk Level: Blind Spot
Speed Limit: 10 KM/Hr
Coordinates: 11.03364, 77.08947

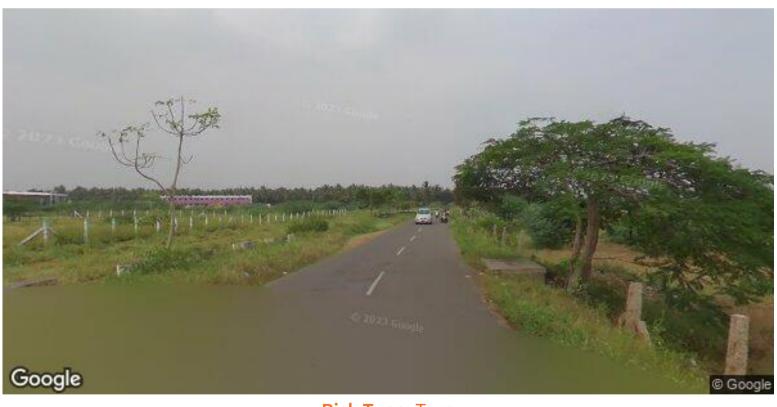
Risk Type: Turn
Risk Level: Medium
Speed Limit: 30 KM/Hr
Coordinates: 11.03279, 77.08941

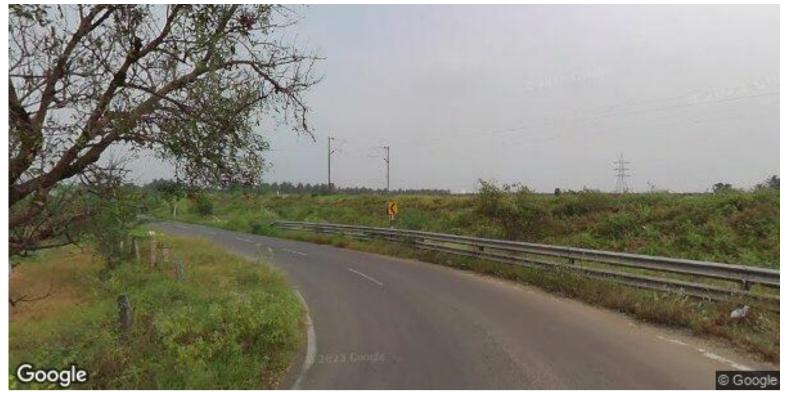
Risk Type: Turn
Risk Level: High
Speed Limit: 15 KM/Hr
Coordinates: 11.03267, 77.08951

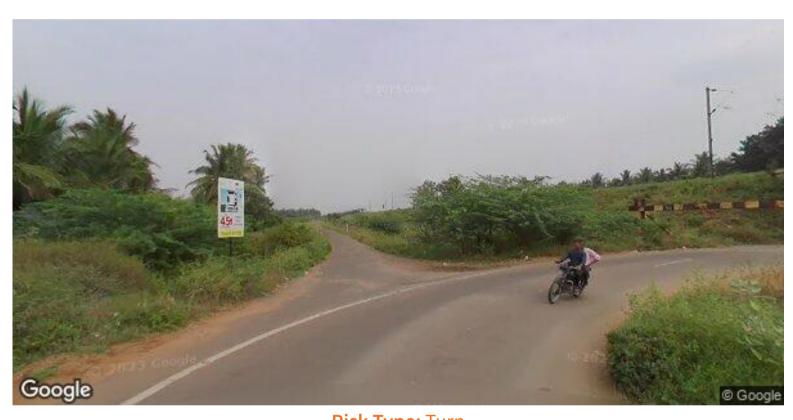
Risk Type: Turn
Risk Level: High
Speed Limit: 15 KM/Hr
Coordinates: 11.03560, 77.09403

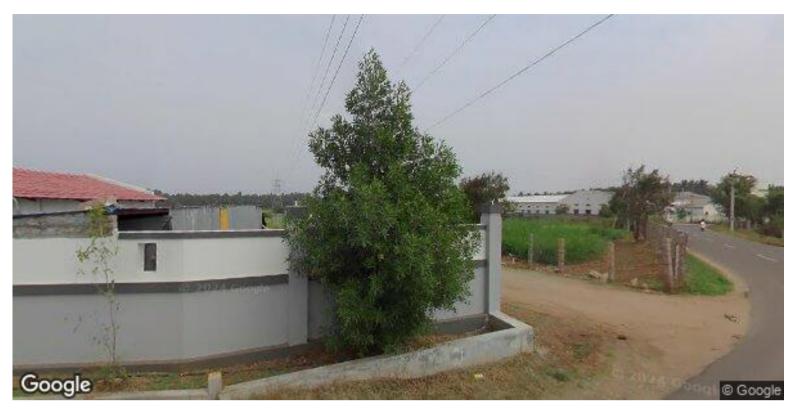
Coordinates: 11.03106, 77.09486

Risk Type: Turn
Risk Level: High
Speed Limit: 15 KM/Hr

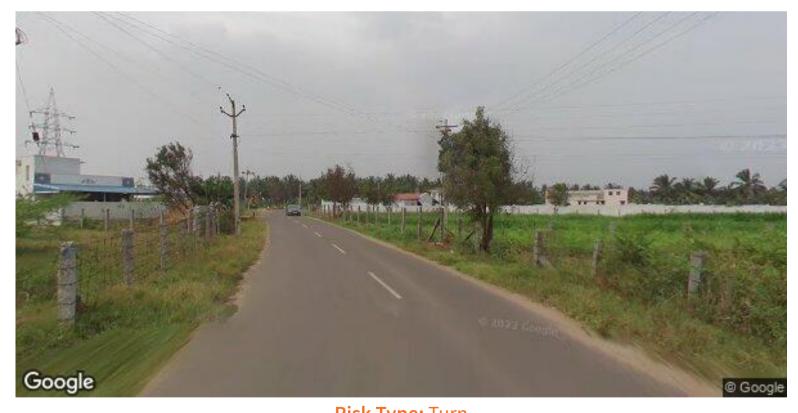
Coordinates: 11.03057, 77.09537

Risk Type: Turn
Risk Level: Medium
Speed Limit: 30 KM/Hr

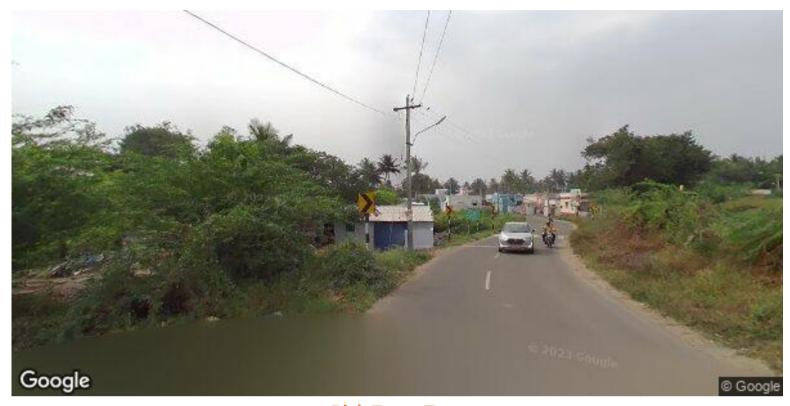
Risk Type: Turn
Risk Level: High
Speed Limit: 15 KM/Hr
Coordinates: 11.02727, 77.09847

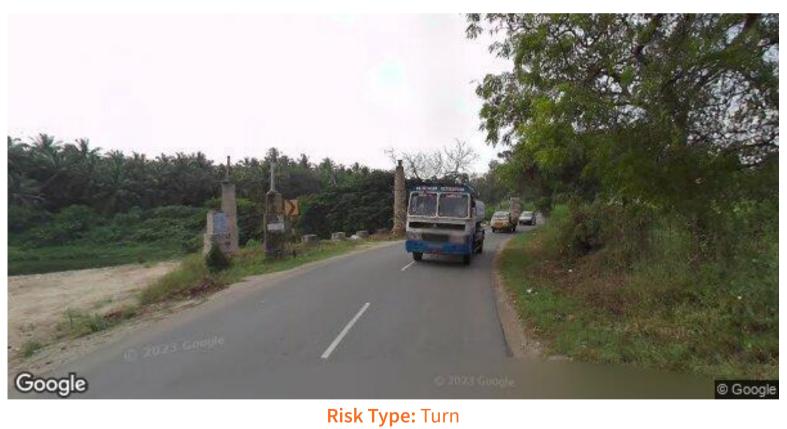
Risk Level: Medium
Speed Limit: 30 KM/Hr
Coordinates: 11.03323, 77.11422

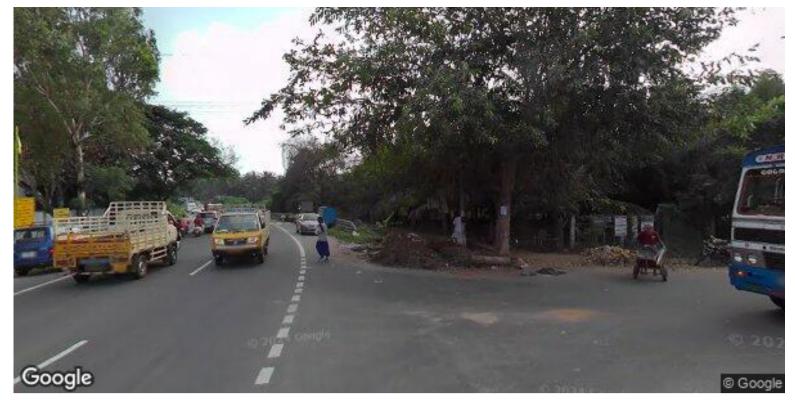
Risk Type: Turn
Risk Level: High
Speed Limit: 15 KM/Hr
Coordinates: 11.03352, 77.11509

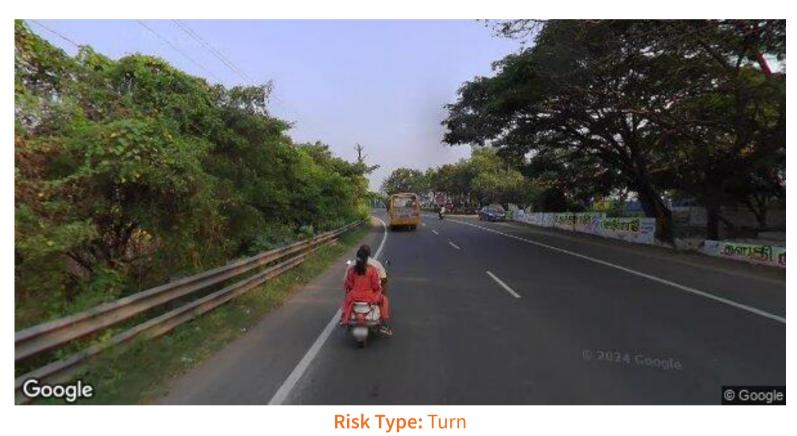
Risk Level: Medium
Speed Limit: 30 KM/Hr
Coordinates: 11.03154, 77.11673

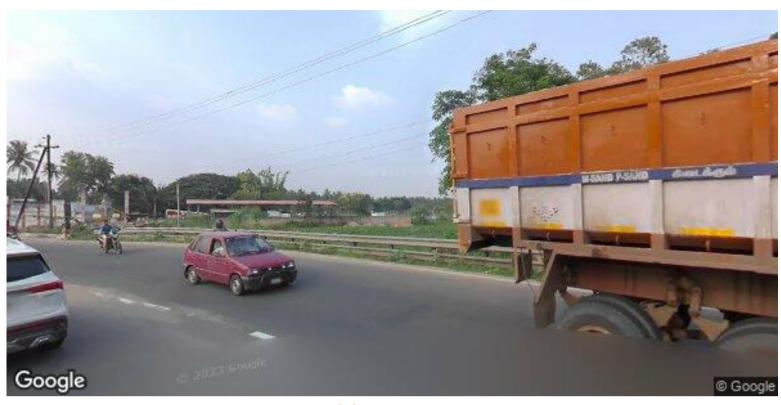
Coordinates: 11.02970, 77.12192

Risk Type: Turn
Risk Level: Medium
Speed Limit: 30 KM/Hr

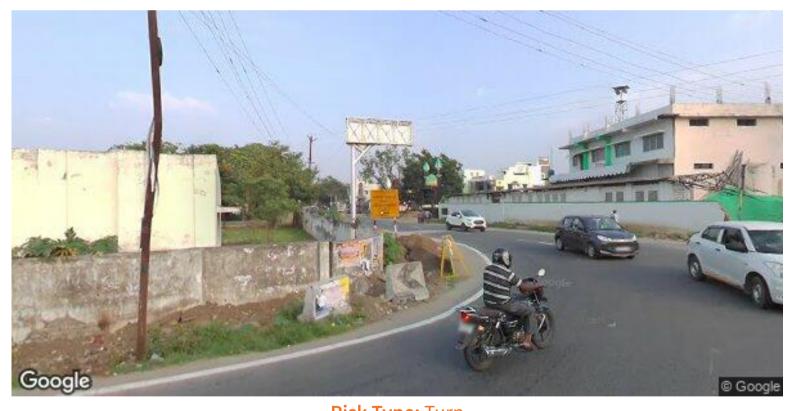
Coordinates: 11.02928, 77.12212

Risk Type: Turn
Risk Level: High
Speed Limit: 15 KM/Hr

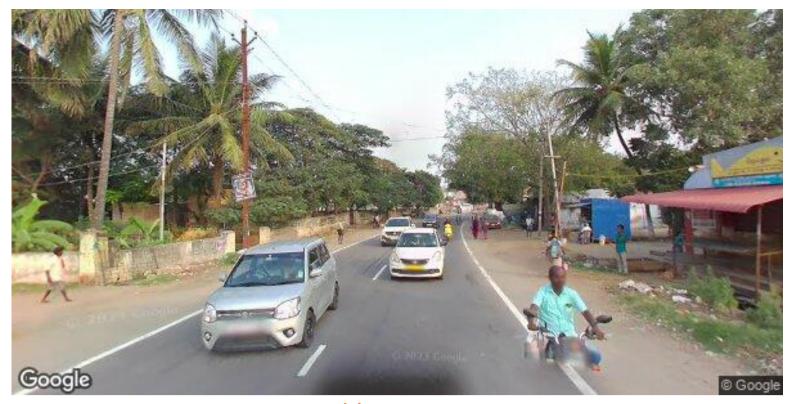
Risk Type: Turn
Risk Level: Medium
Speed Limit: 30 KM/Hr
Coordinates: 11.02950, 77.12393

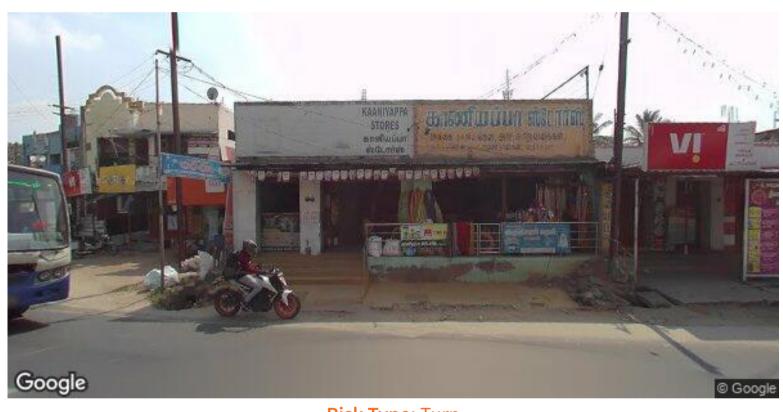
Risk Type: Turn
Risk Level: Medium
Speed Limit: 30 KM/Hr
Coordinates: 10.99572, 77.28148

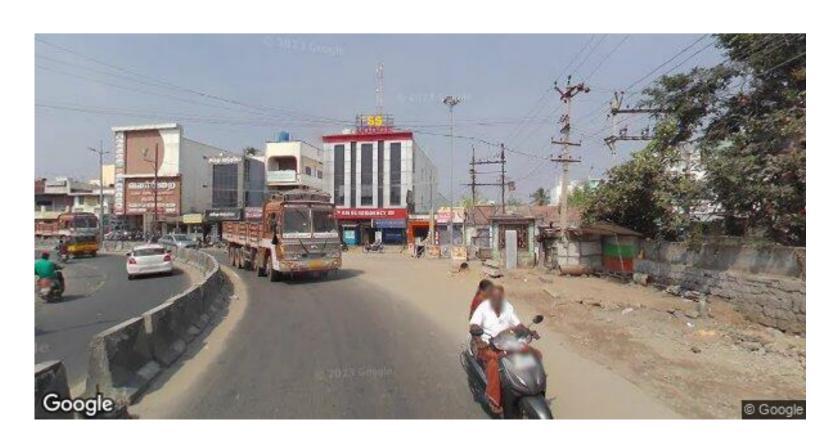
Coordinates: 10.99541, 77.28179

Risk Type: Turn
Risk Level: High
Speed Limit: 15 KM/Hr

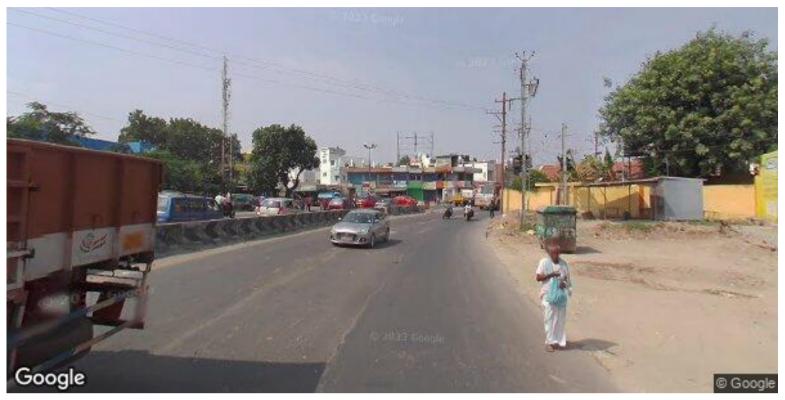
Coordinates: 10.99424, 77.28192

Risk Type: Turn
Risk Level: High
Speed Limit: 15 KM/Hr

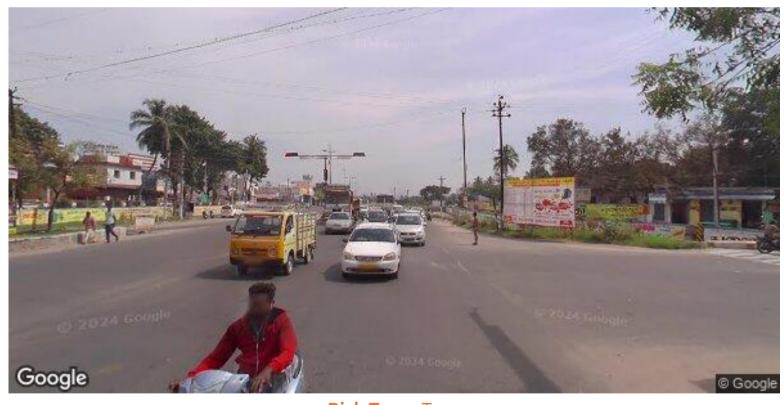
Coordinates: 10.99391, 77.28559

Risk Type: Turn
Risk Level: High
Speed Limit: 15 KM/Hr

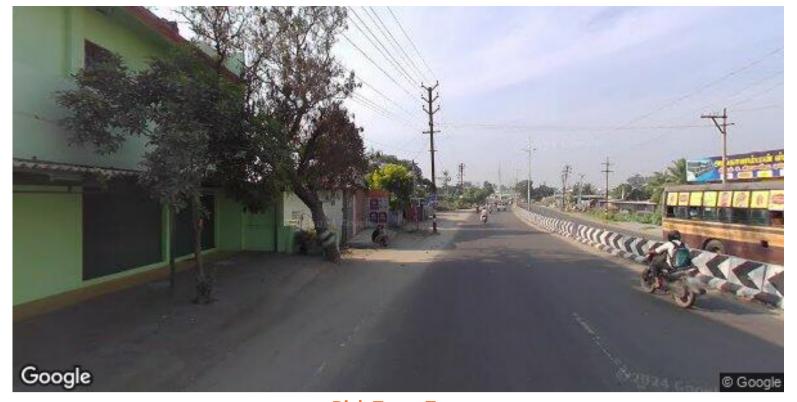
Risk Type: Turn
Risk Level: Medium
Speed Limit: 30 KM/Hr
Coordinates: 10.98906, 77.28494

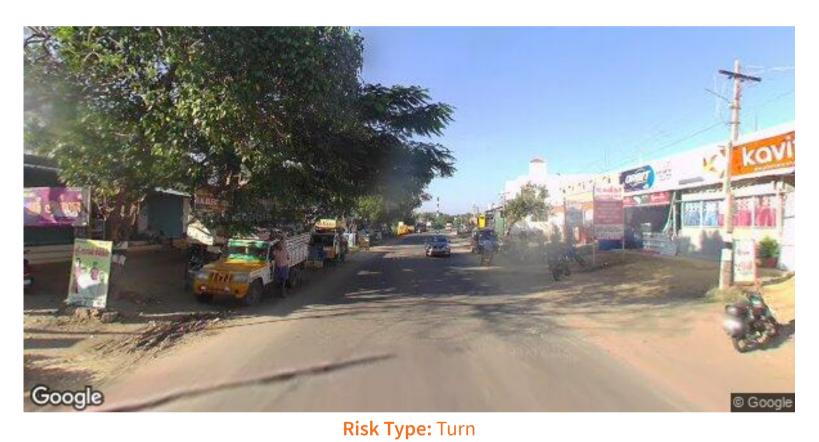
Risk Level: Medium
Speed Limit: 30 KM/Hr
Coordinates: 10.91573, 77.26608

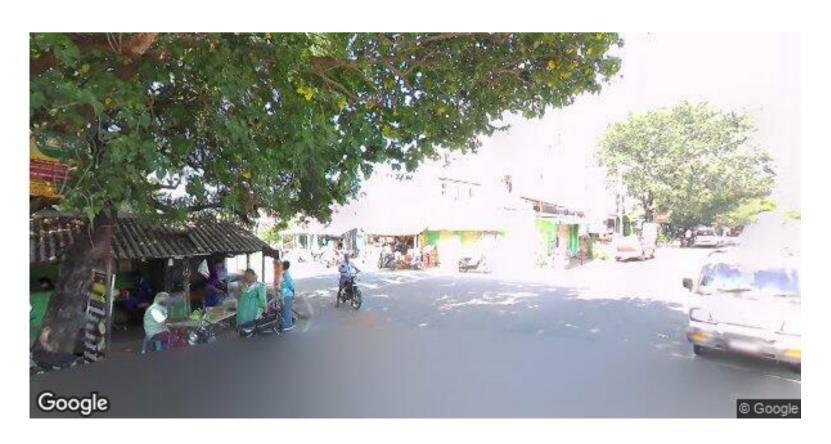
Coordinates: 10.65978, 77.27183

Risk Type: Turn
Risk Level: High
Speed Limit: 15 KM/Hr

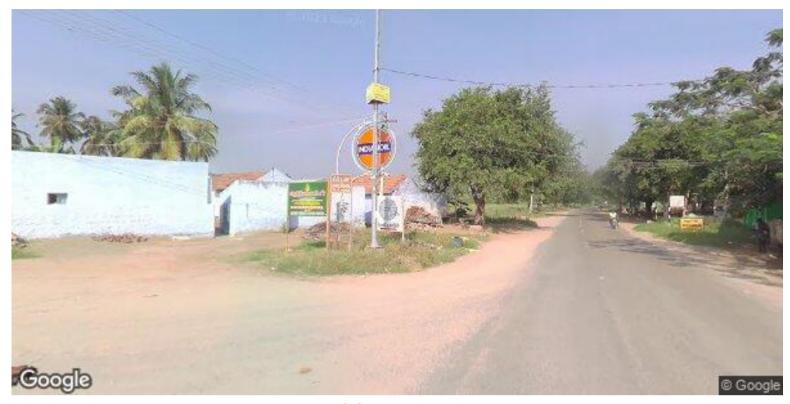
Coordinates: 10.62623, 77.33109

Risk Type: Turn
Risk Level: Medium
Speed Limit: 30 KM/Hr

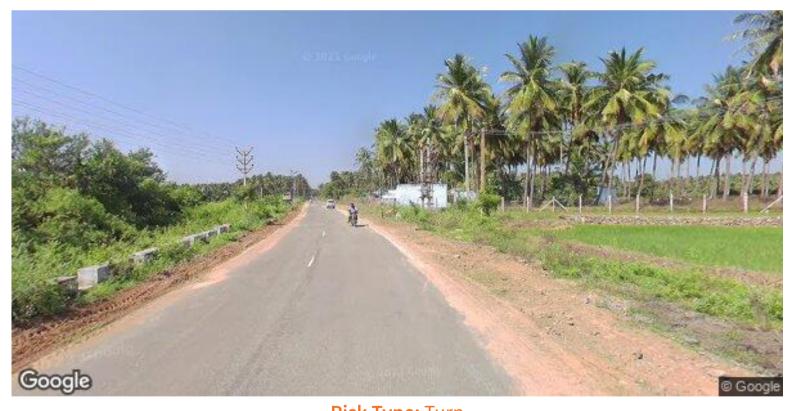
Coordinates: 10.59335, 77.34672

Risk Type: Turn
Risk Level: Medium
Speed Limit: 30 KM/Hr

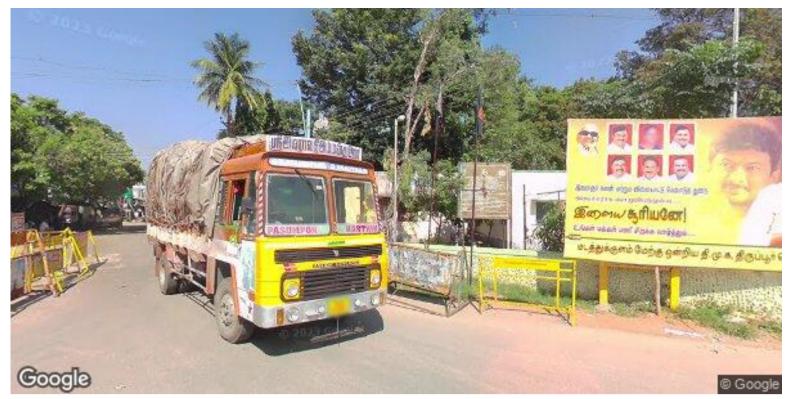
Coordinates: 10.55909, 77.36238

Risk Type: Turn
Risk Level: High
Speed Limit: 15 KM/Hr

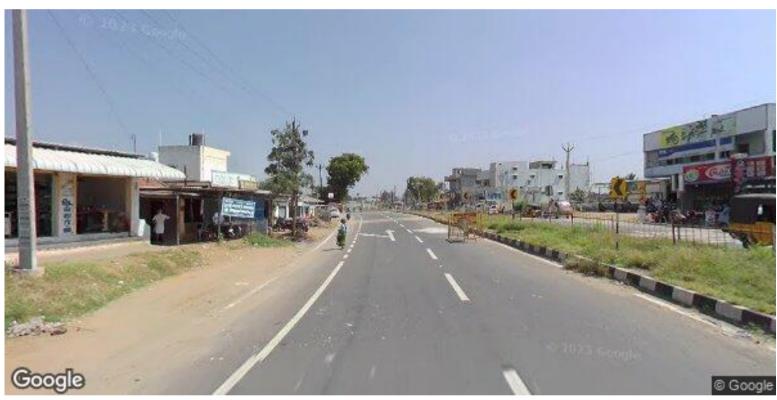
Risk Type: Turn
Risk Level: Medium
Speed Limit: 30 KM/Hr
Coordinates: 10.54580, 77.39011

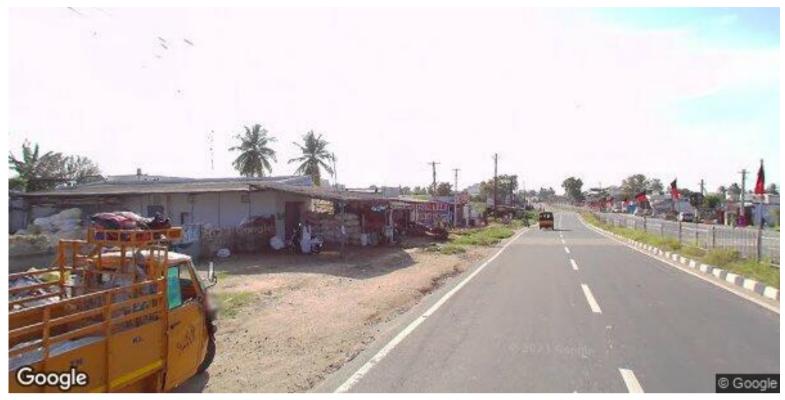
Coordinates: 10.54564, 77.39281

Risk Type: Blind Spot Risk Level: Blind Spot Speed Limit: 10 KM/Hr

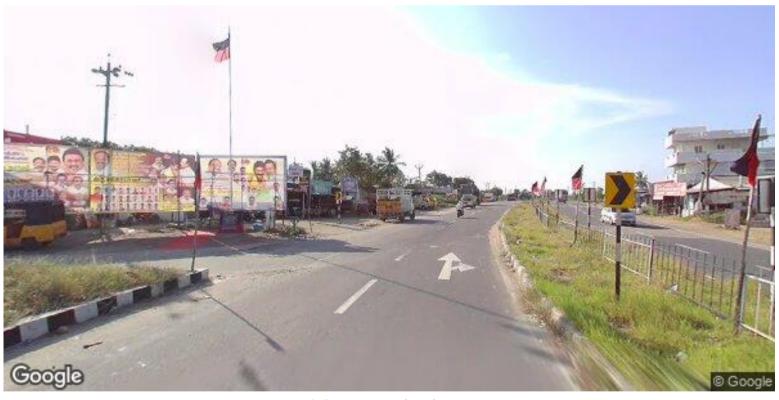
Coordinates: 10.54569, 77.39004

Risk Type: Blind Spot
Risk Level: Blind Spot
Speed Limit: 10 KM/Hr
