JOURNEY RISK MANAGEMENT (JRM) STUDY

Salem Terminal TO K A K MAHALAKSHMI ENTERPRISES

Route Safety Analysis: CVQF+23W, Sangagiri to G822+HGF, Dasappagounden Pudur, Tamil Nadu

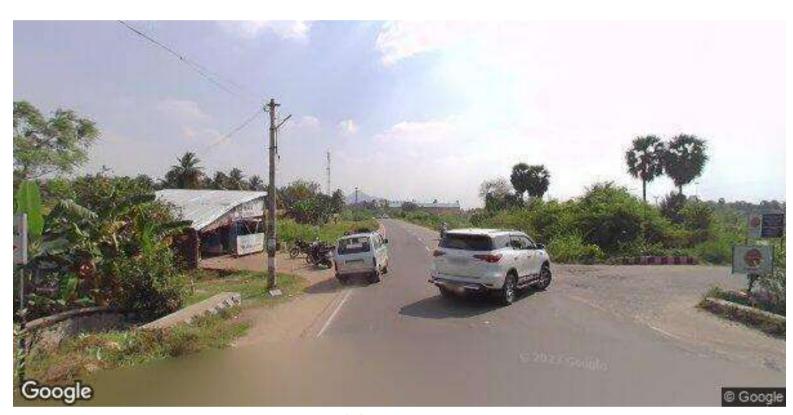
Risk Type: Turn
Risk Level: High
Speed Limit: 15 KM/Hr
Coordinates: 11.44029, 77.87544

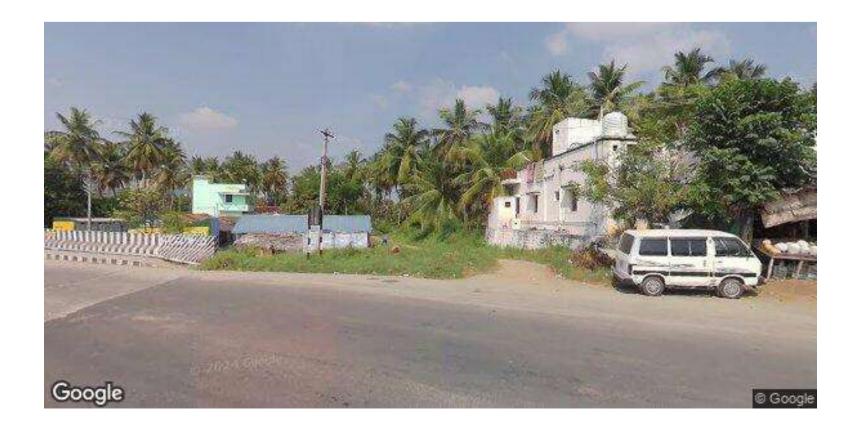
Coordinates: 11.44898, 77.87410

Risk Type: Turn
Risk Level: High
Speed Limit: 15 KM/Hr

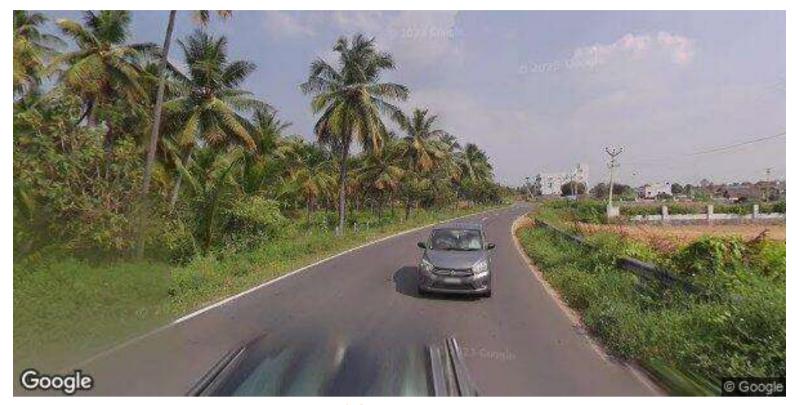
Risk Type: Turn
Risk Level: Medium
Speed Limit: 30 KM/Hr
Coordinates: 11.45357, 77.85789

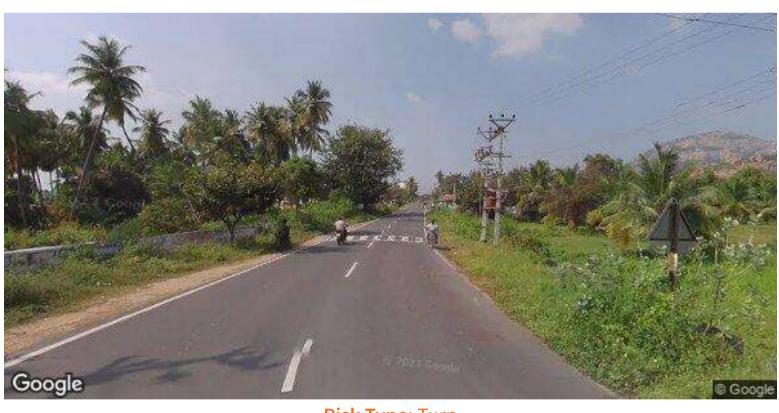
Coordinates: 11.45352, 77.85698

Risk Type: Turn
Risk Level: High
Speed Limit: 15 KM/Hr

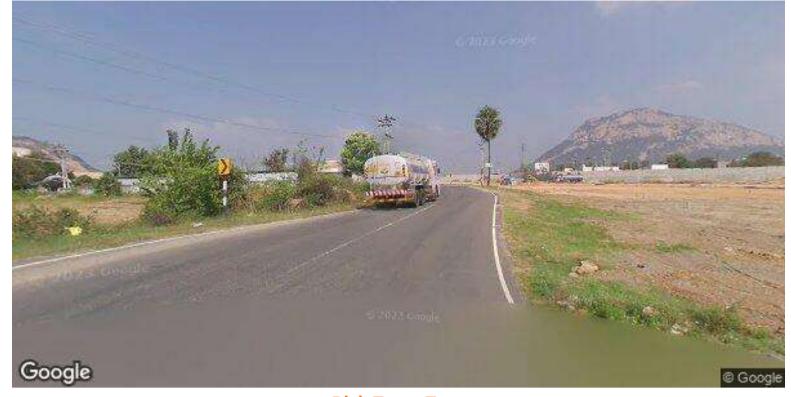
Risk Type: Turn
Risk Level: Medium
Speed Limit: 30 KM/Hr
Coordinates: 11.45847, 77.85140

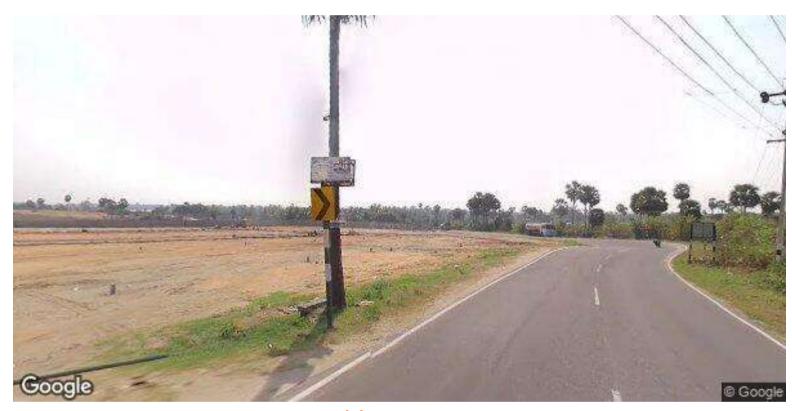
Risk Type: Turn
Risk Level: Medium
Speed Limit: 30 KM/Hr
Coordinates: 11.45898, 77.85135

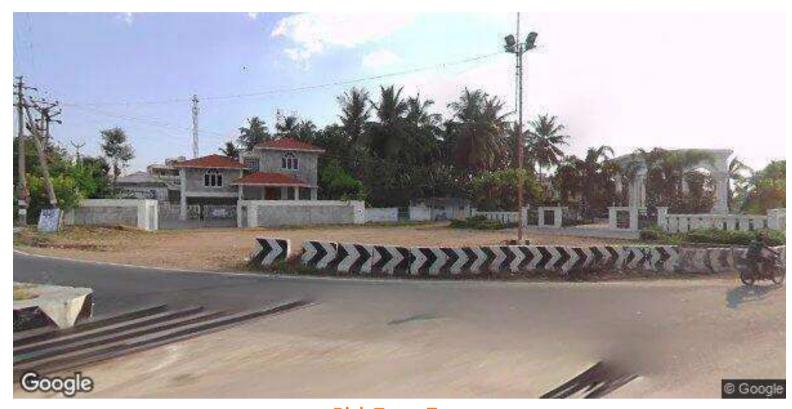
Coordinates: 11.46314, 77.84928

Risk Type: Turn
Risk Level: Medium
Speed Limit: 30 KM/Hr

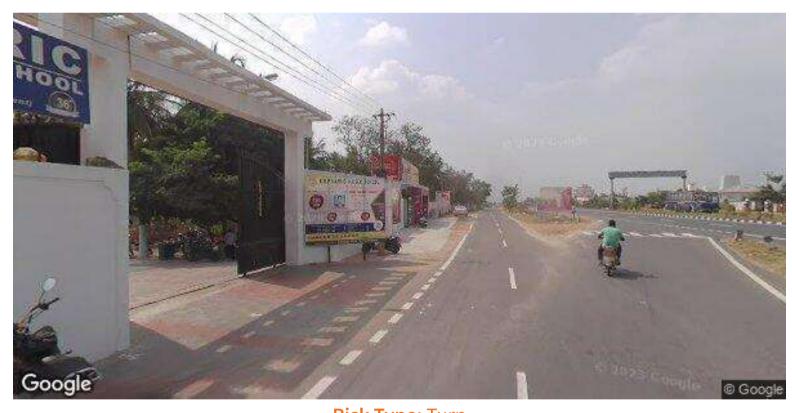
Coordinates: 11.45509, 77.81383

Risk Type: Turn
Risk Level: Medium
Speed Limit: 30 KM/Hr

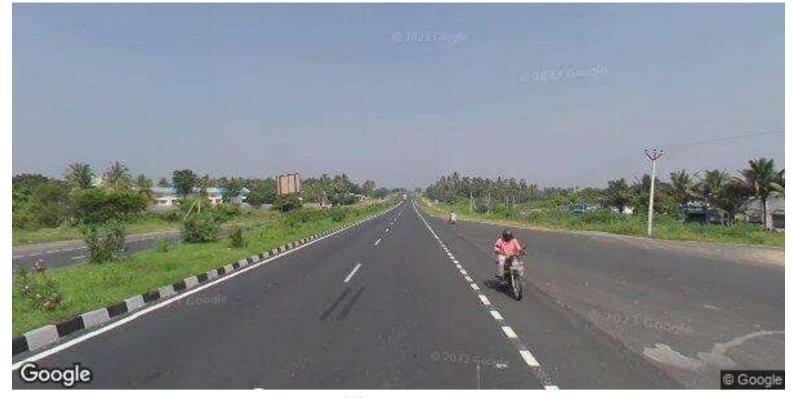
Risk Type: Turn
Risk Level: High
Speed Limit: 15 KM/Hr
Coordinates: 11.40046, 77.65371

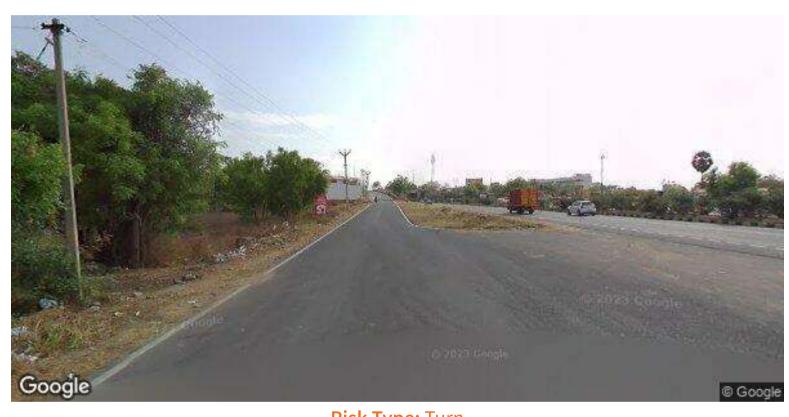
Risk Type: Turn
Risk Level: High
Speed Limit: 15 KM/Hr
Coordinates: 11.40035, 77.65383

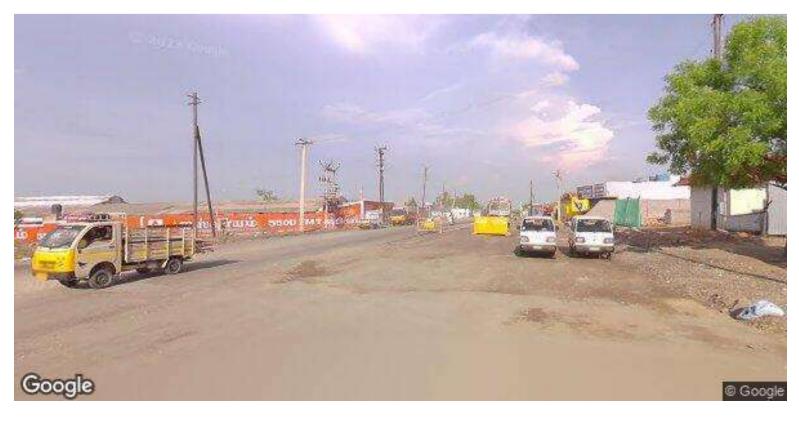
Coordinates: 11.39829, 77.65233

Risk Type: Turn
Risk Level: High
Speed Limit: 15 KM/Hr

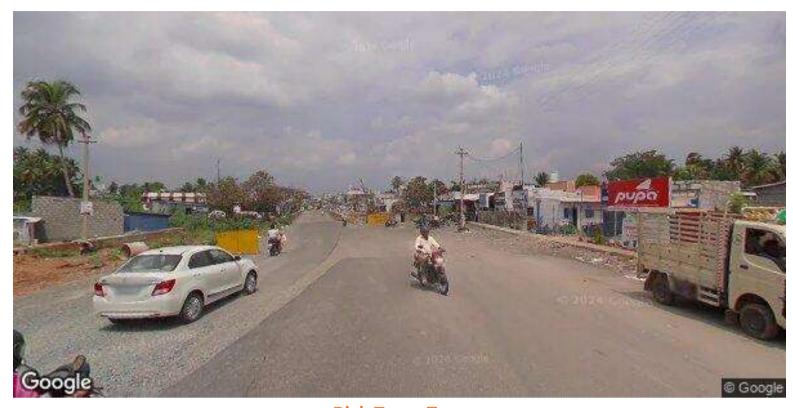
Risk Type: Turn
Risk Level: Medium
Speed Limit: 30 KM/Hr
Coordinates: 11.42079, 77.56127

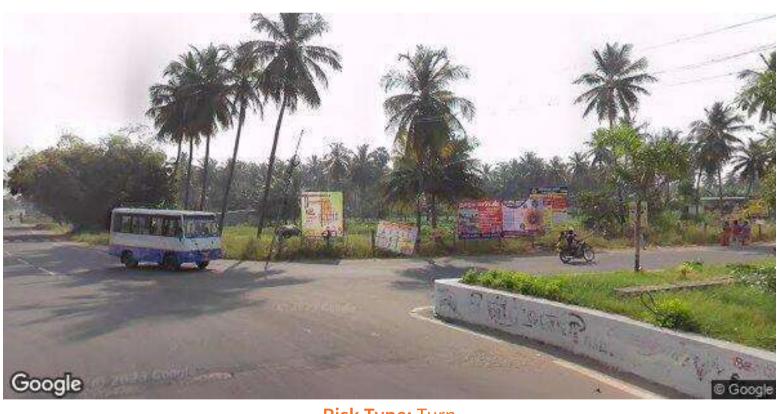
Coordinates: 11.45745, 77.36598

Risk Type: Turn
Risk Level: High
Speed Limit: 15 KM/Hr

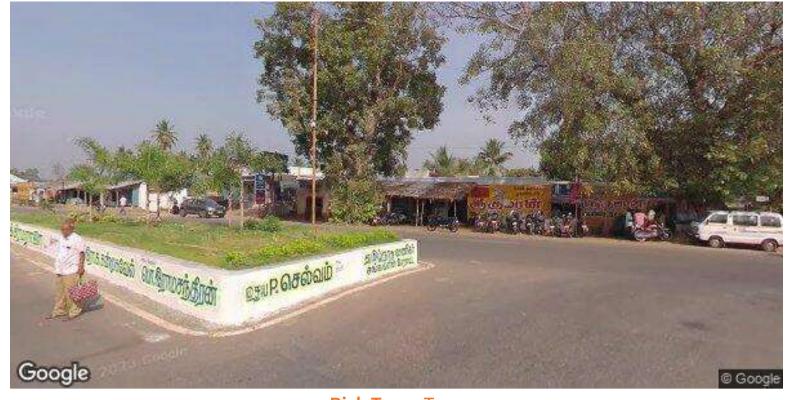
Risk Type: Turn
Risk Level: Medium
Speed Limit: 30 KM/Hr
Coordinates: 11.45747, 77.36596

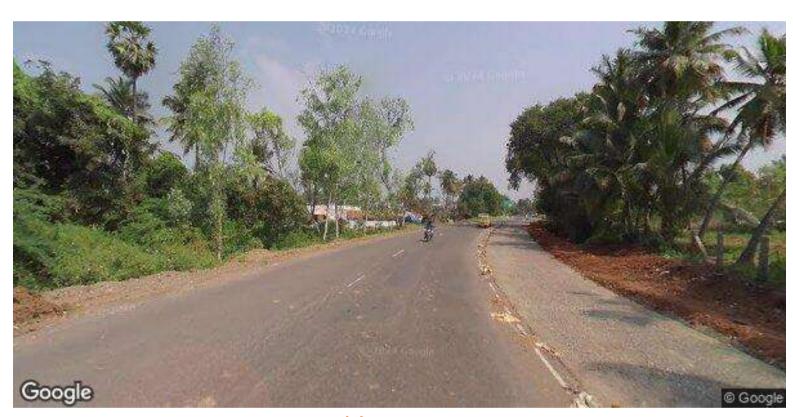
Risk Type: Turn
Risk Level: Medium
Speed Limit: 30 KM/Hr
Coordinates: 11.45763, 77.36309

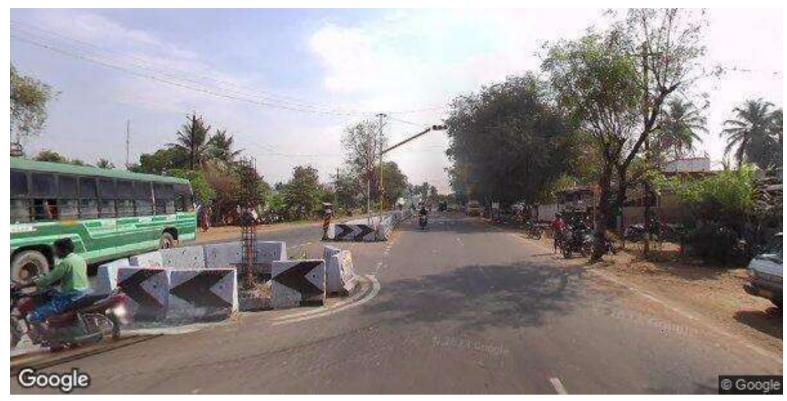
Coordinates: 11.45959, 77.30751

Risk Type: Turn
Risk Level: High
Speed Limit: 15 KM/Hr

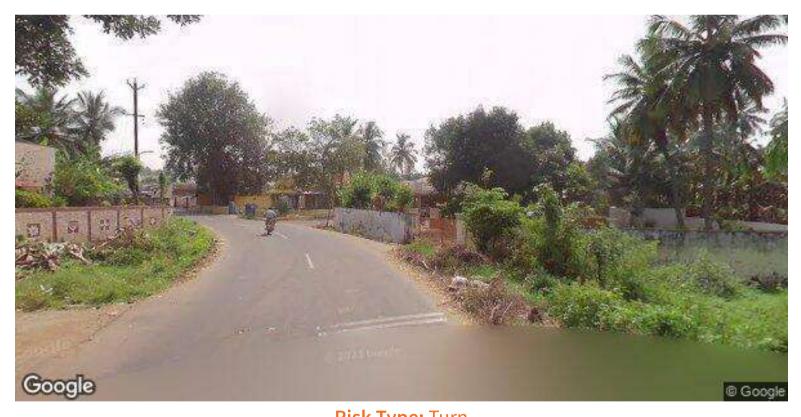
Coordinates: 11.46612, 77.30076

Risk Type: Turn
Risk Level: Medium
Speed Limit: 30 KM/Hr

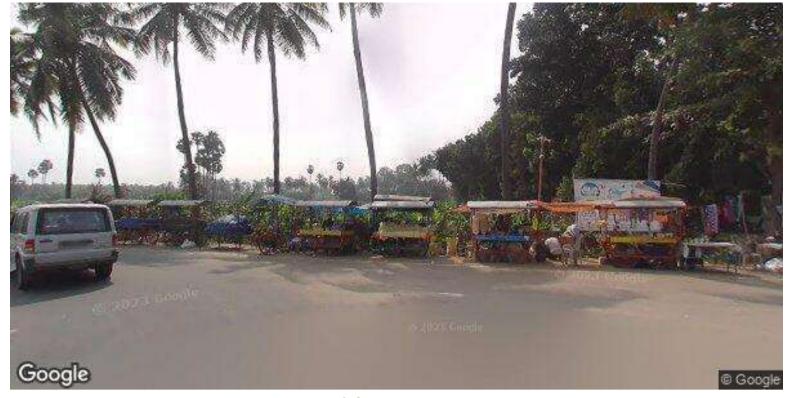
Risk Type: Turn
Risk Level: High
Speed Limit: 15 KM/Hr
Coordinates: 11.47154, 77.29802

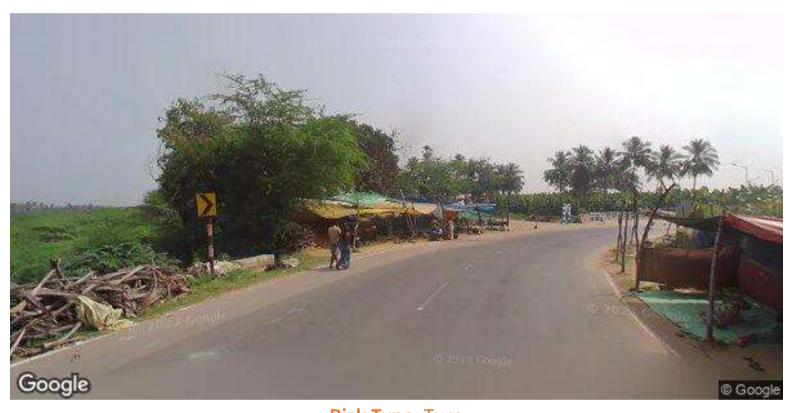
Risk Type: Turn
Risk Level: Medium
Speed Limit: 30 KM/Hr
Coordinates: 11.47329, 77.29852

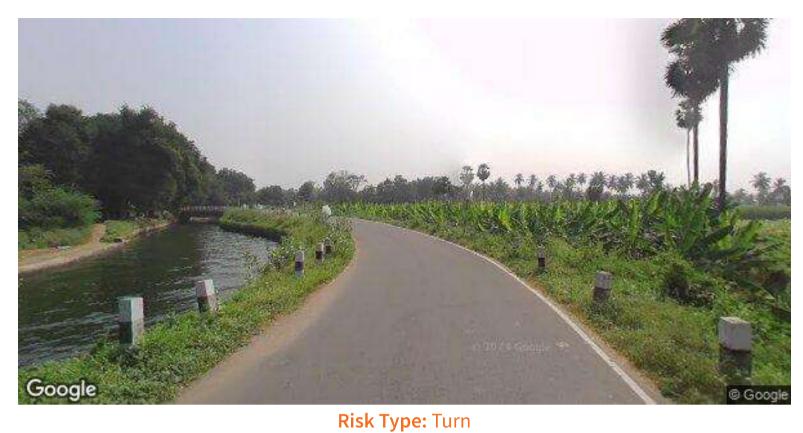
Risk Type. Turn
Risk Level: Medium
Speed Limit: 30 KM/Hr
Coordinates: 11.47522, 77.29448

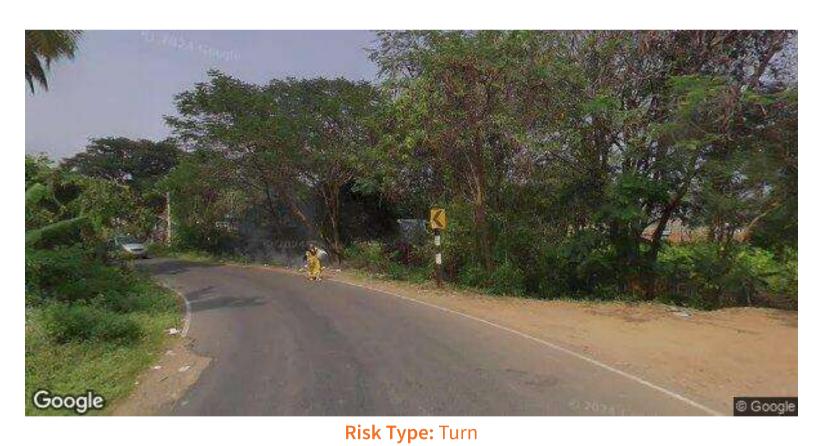
Risk Level: High
Speed Limit: 15 KM/Hr
Coordinates: 11.47598, 77.29452

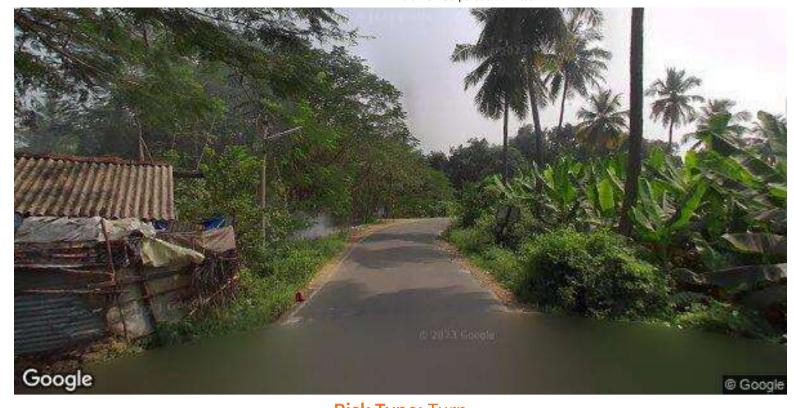
Risk Type: Turn
Risk Level: Medium
Speed Limit: 30 KM/Hr
Coordinates: 11.47625, 77.29425

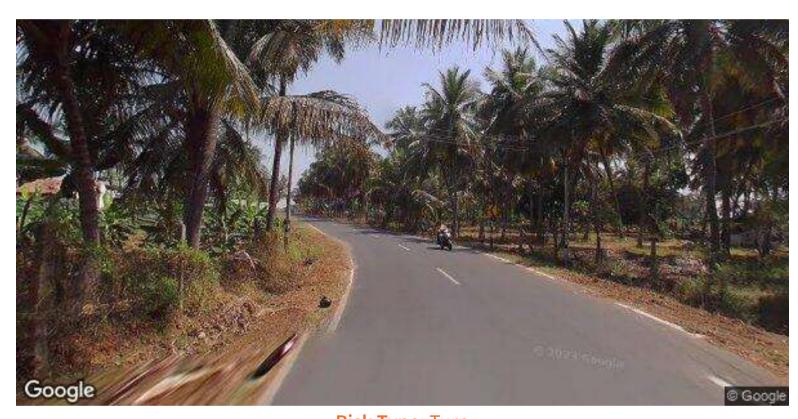
Risk Type: Turn
Risk Level: Medium
Speed Limit: 30 KM/Hr
Coordinates: 11.47740, 77.28980

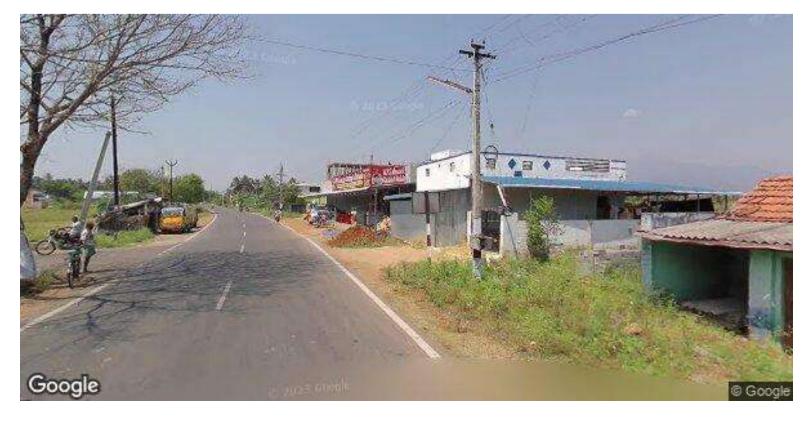
Coordinates: 11.48499, 77.28237

Risk Type: Blind Spot Risk Level: Blind Spot Speed Limit: 10 KM/Hr

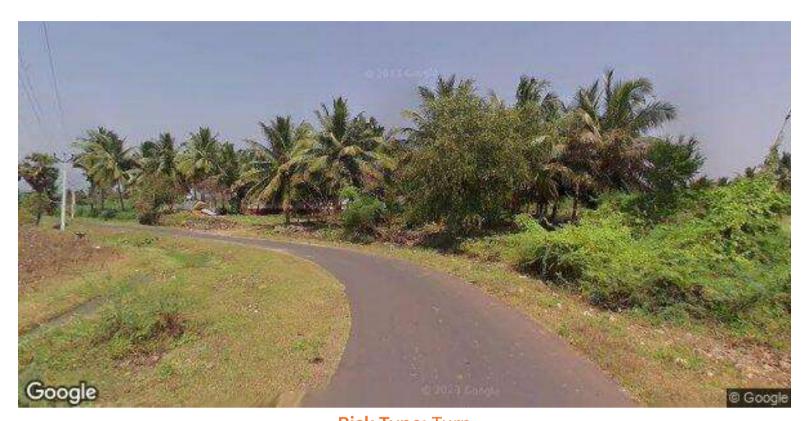
Risk Type: Turn
Risk Level: Medium
Speed Limit: 30 KM/Hr
Coordinates: 11.48601, 77.28317

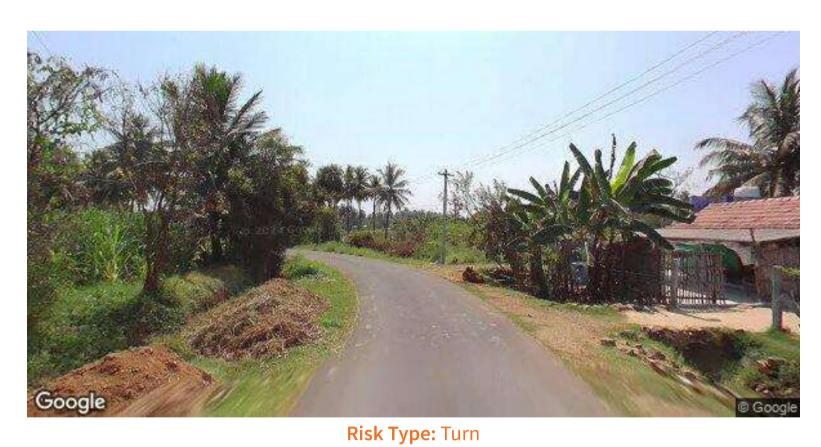
Risk Level: High
Speed Limit: 15 KM/Hr
Coordinates: 11.48720, 77.28243

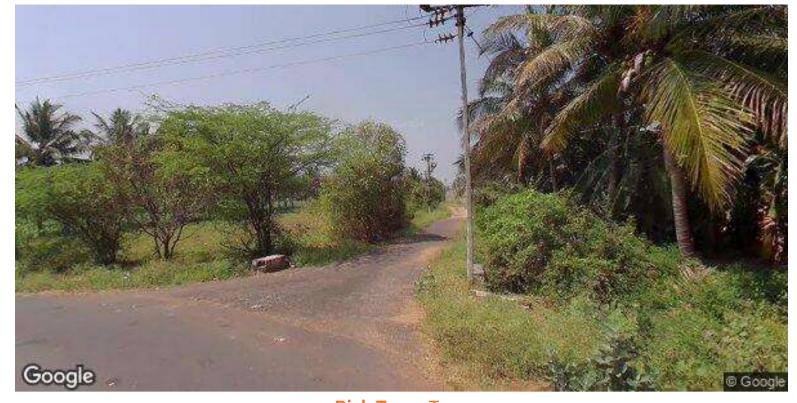
Risk Type: Turn
Risk Level: High
Speed Limit: 15 KM/Hr
Coordinates: 11.49173, 77.28363

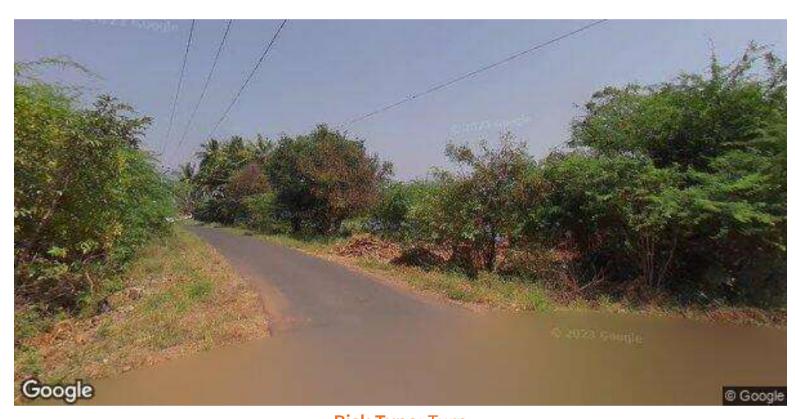
Risk Type: Turn
Risk Level: High
Speed Limit: 15 KM/Hr
Coordinates: 11.49122, 77.28577

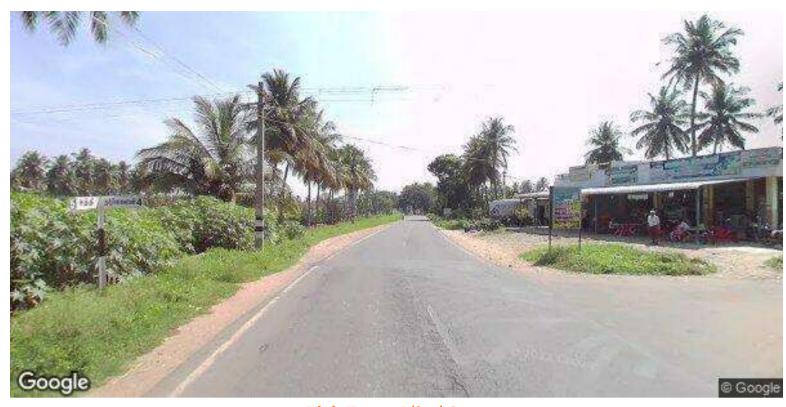
Risk Type: Blind Spot
Risk Level: Blind Spot
Speed Limit: 10 KM/Hr
Coordinates: 11.49885, 77.28762

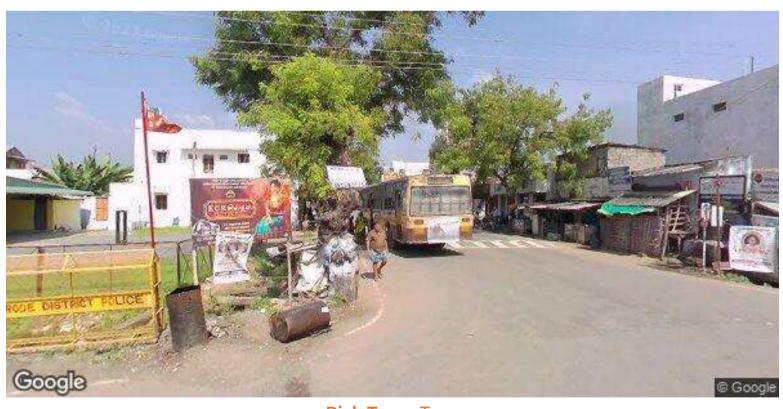
Coordinates: 11.49668, 77.30171

Risk Type: Turn
Risk Level: High
Speed Limit: 15 KM/Hr
