JOURNEY RISK MANAGEMENT (JRM) STUDY

IOCL Coimbatore Terminal to R R Aagency

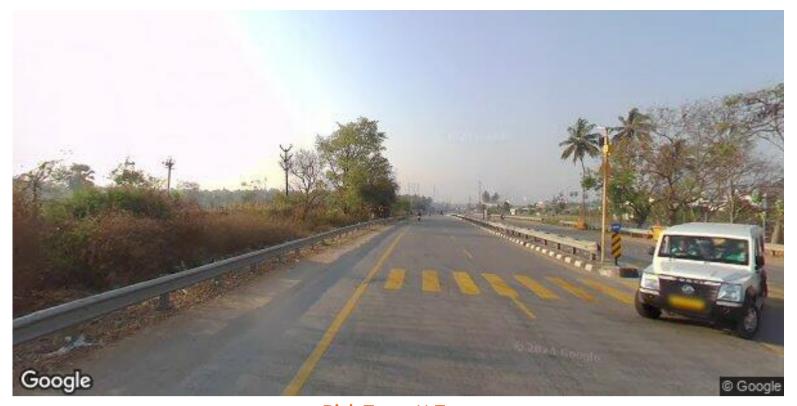
Coordinates: 10.7493636, 77.02019659999999

Risk Type: U-Turn
Risk Level: High
Speed Limit: 10 KM/Hr

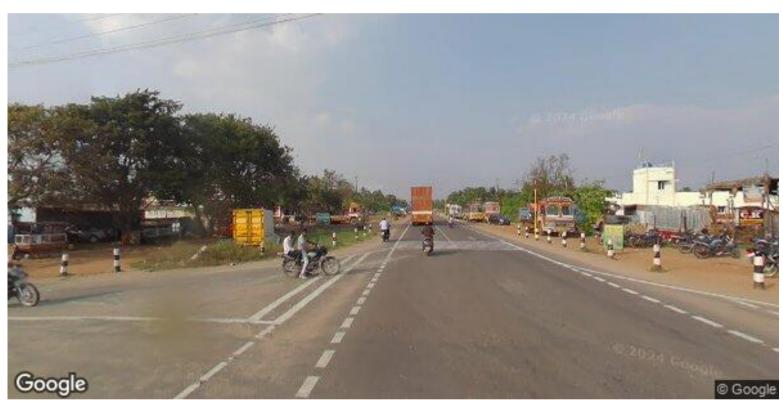
Coordinates: 11.03211, 77.07640

Risk Type: Blind Spot
Risk Level: Blind Spot
Speed Limit: 10 KM/Hr

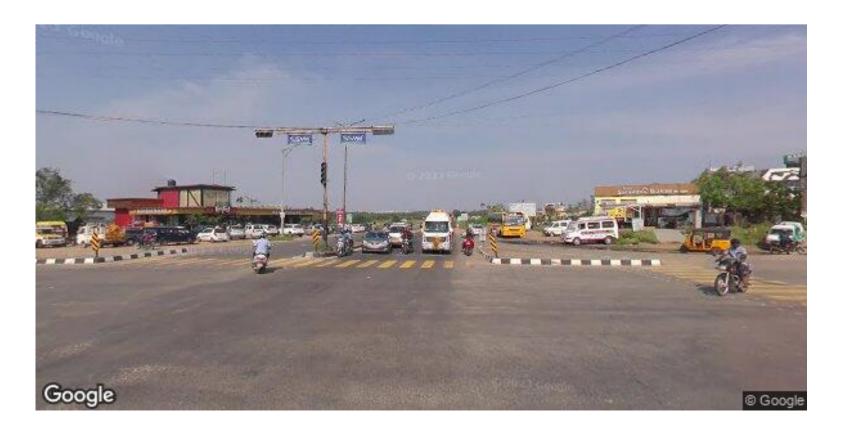
Coordinates: 10.91785, 76.98617

Risk Type: Blind Spot Risk Level: Blind Spot Speed Limit: 10 KM/Hr

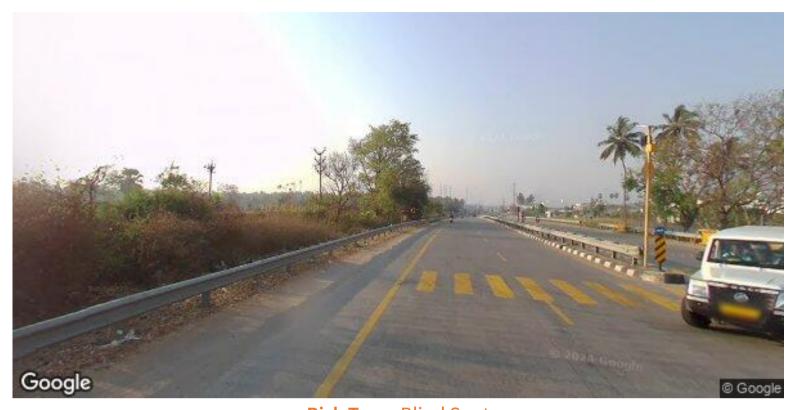
Coordinates: 10.74936, 77.02020

Risk Type: Blind Spot Risk Level: Blind Spot Speed Limit: 10 KM/Hr

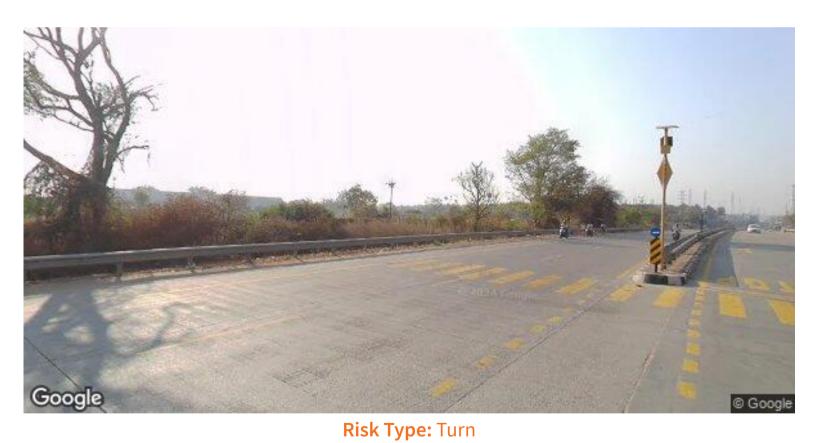
Coordinates: 10.74936, 77.02009

Risk Type: Turn
Risk Level: High
Speed Limit: 15 KM/Hr

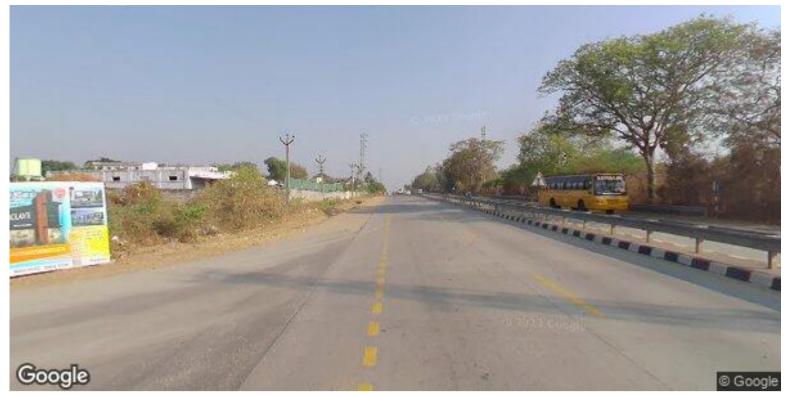
Coordinates: 10.75093, 77.02003

Risk Type: Blind Spot Risk Level: Blind Spot Speed Limit: 10 KM/Hr

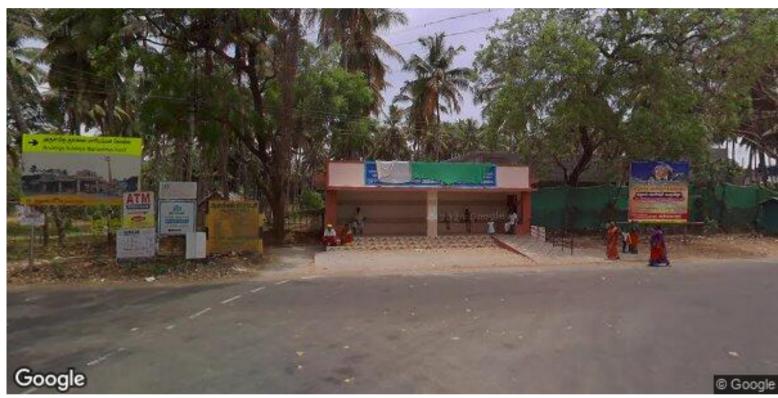
Coordinates: 10.75015, 76.99326

Risk Type: Turn
Risk Level: High
Speed Limit: 15 KM/Hr

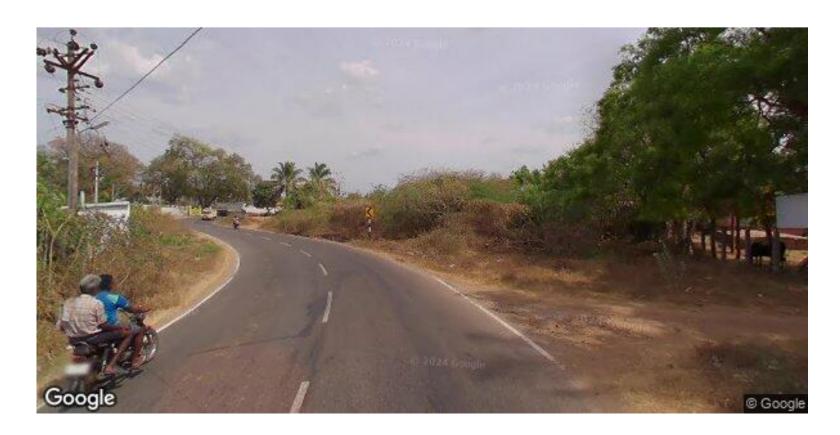
Coordinates: 10.74180, 76.98687

Risk Type: Turn
Risk Level: Medium
Speed Limit: 30 KM/Hr

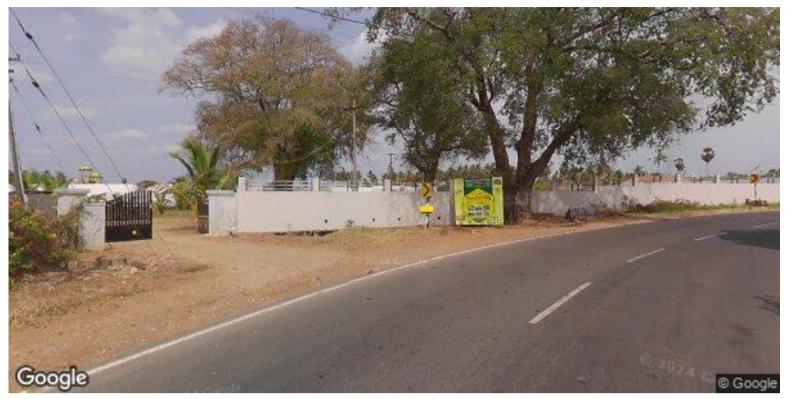
Risk Type: Turn
Risk Level: Medium
Speed Limit: 30 KM/Hr
Coordinates: 10.74142, 76.98751

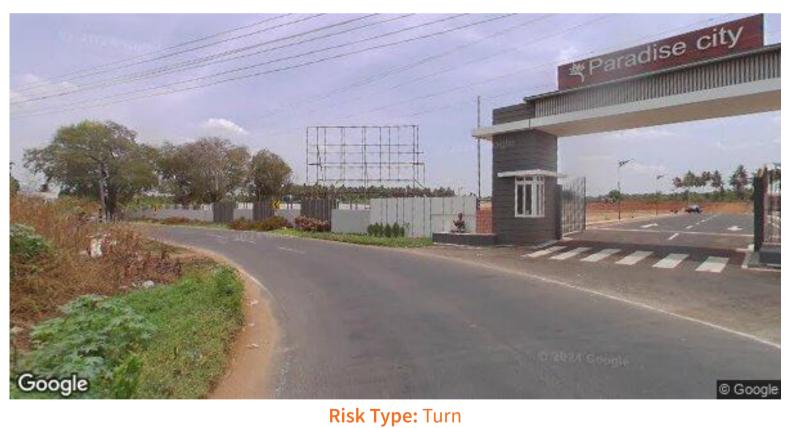
Risk Level: Medium
Speed Limit: 30 KM/Hr
Coordinates: 10.74060, 76.98758

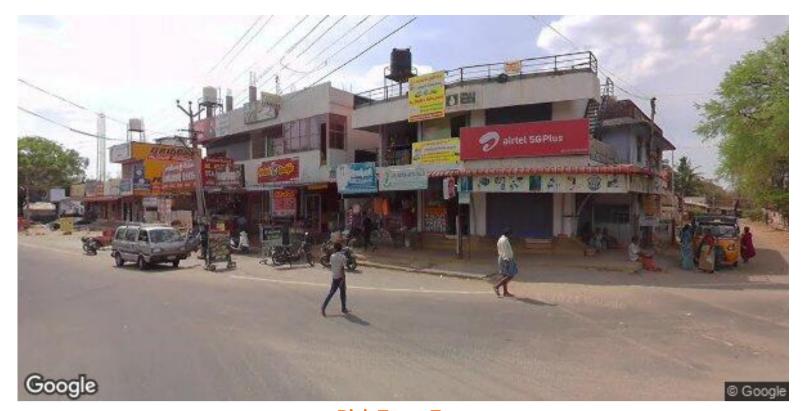
Risk Type: Turn
Risk Level: Medium
Speed Limit: 30 KM/Hr
Coordinates: 10.73737, 76.98461
