JOURNEY RISK MANAGEMENT (JRM) STUDY

IOCL Coimbatore Terminal to Tamilnadu Magnesite Ltd

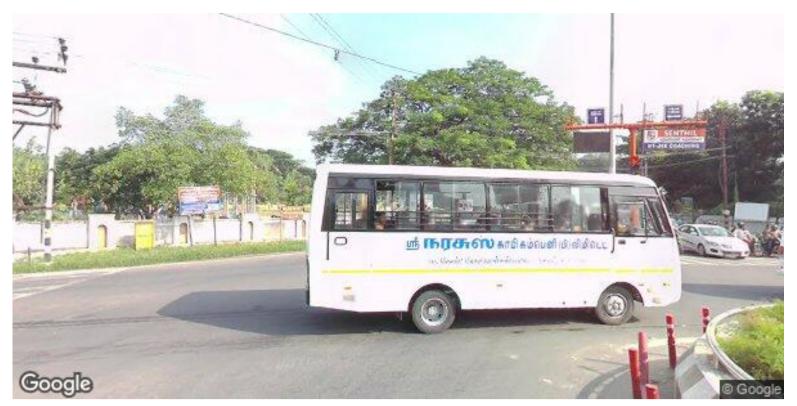
Coordinates: 11.67557, 78.15976

Risk Type: Roundabout
Risk Level: High
Speed Limit: 15 KM/Hr

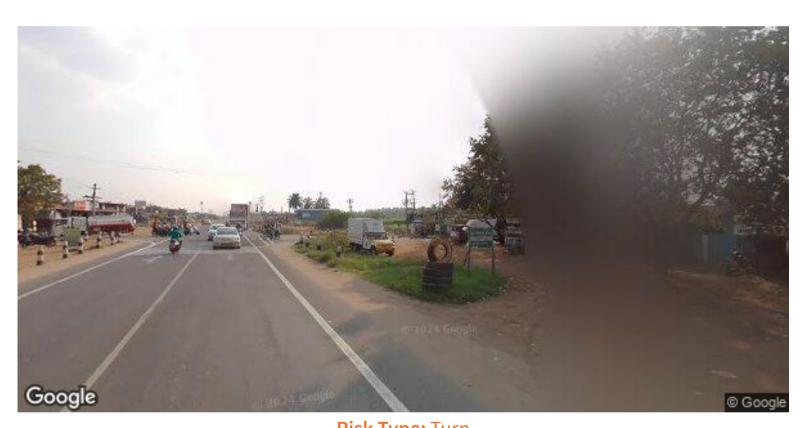
Risk Type: Turn
Risk Level: High
Speed Limit: 15 KM/Hr
Coordinates: 11.03255, 77.07645

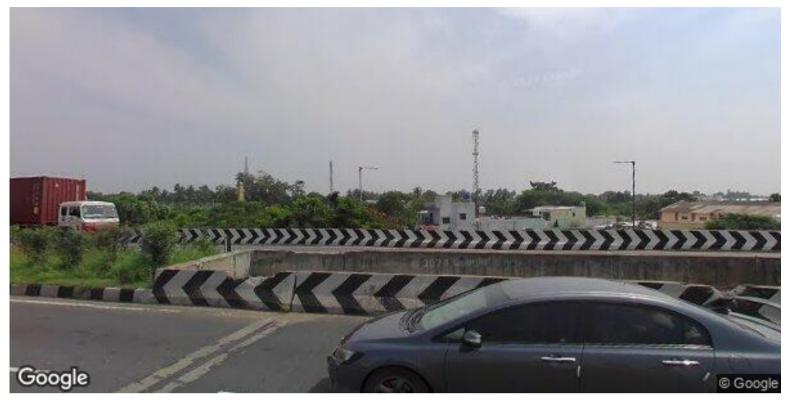
Risk Type: Turn
Risk Level: Medium
Speed Limit: 30 KM/Hr
Coordinates: 11.15332, 77.21111

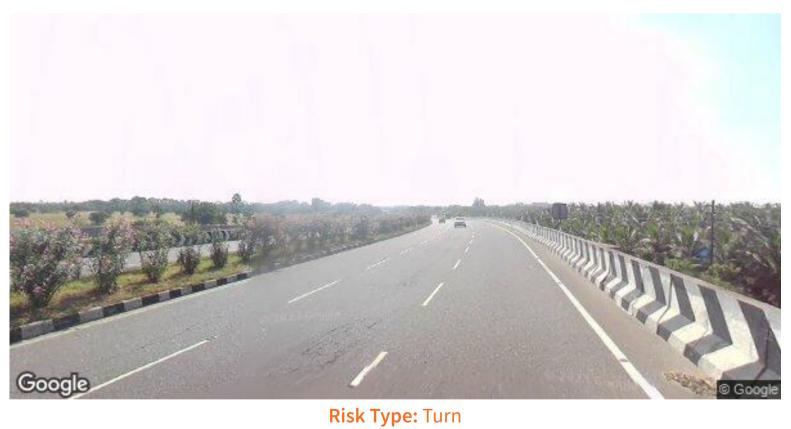
Risk Type. Turn
Risk Level: Medium
Speed Limit: 30 KM/Hr
Coordinates: 11.17621, 77.24067

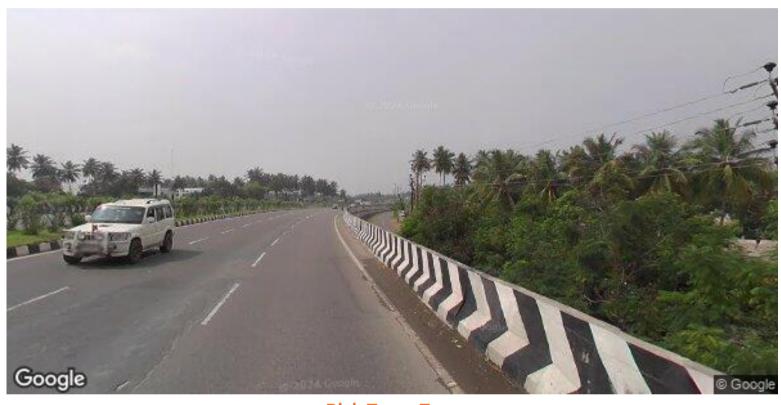
Risk Type: Turn
Risk Level: Medium
Speed Limit: 30 KM/Hr
Coordinates: 11.20521, 77.34049

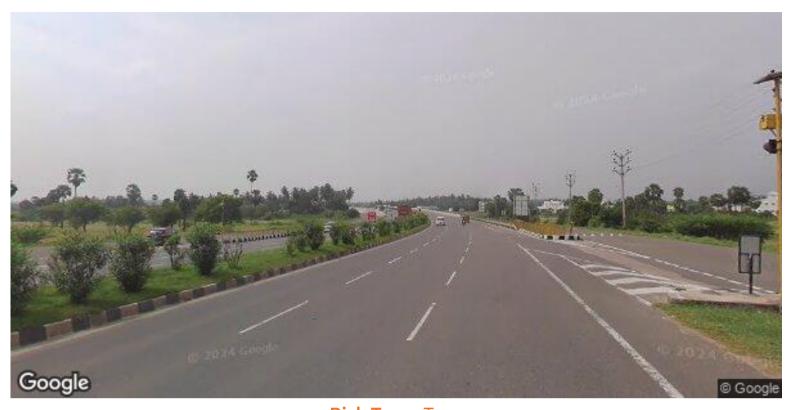
Risk Type: Turn
Risk Level: Medium
Speed Limit: 30 KM/Hr
Coordinates: 11.21586, 77.34724

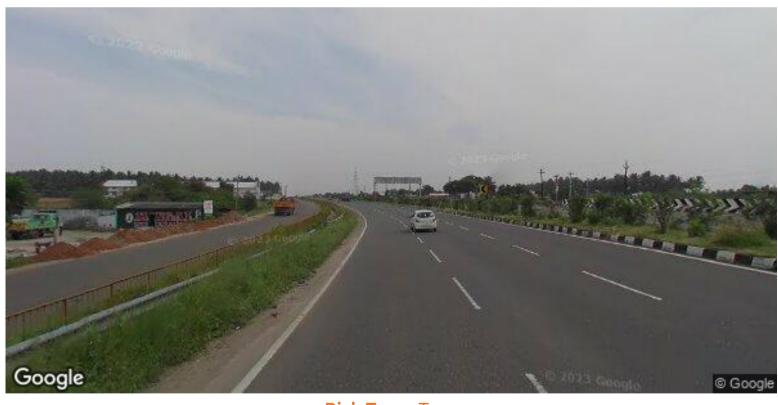
Risk Type: Turn
Risk Level: Medium
Speed Limit: 30 KM/Hr
Coordinates: 11.20738, 77.37188

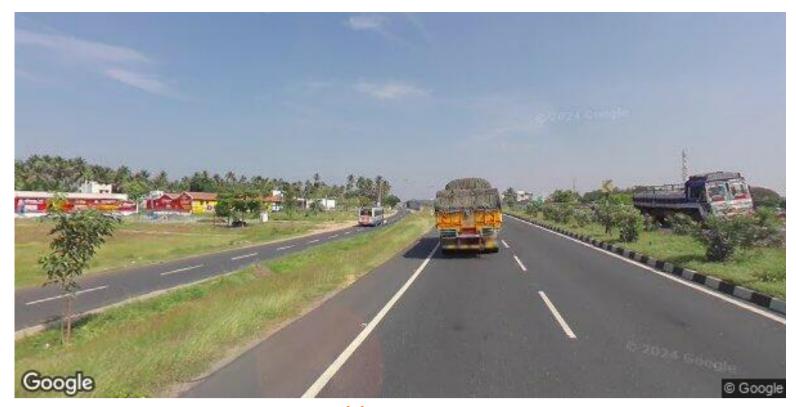
Risk Type: Turn
Risk Level: Medium
Speed Limit: 30 KM/Hr
Coordinates: 11.19889, 77.41911

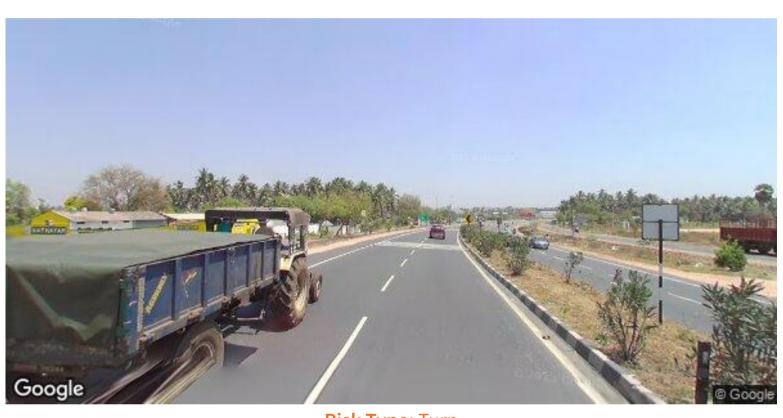
Risk Type: Turn
Risk Level: Medium
Speed Limit: 30 KM/Hr
Coordinates: 11.24024, 77.49505

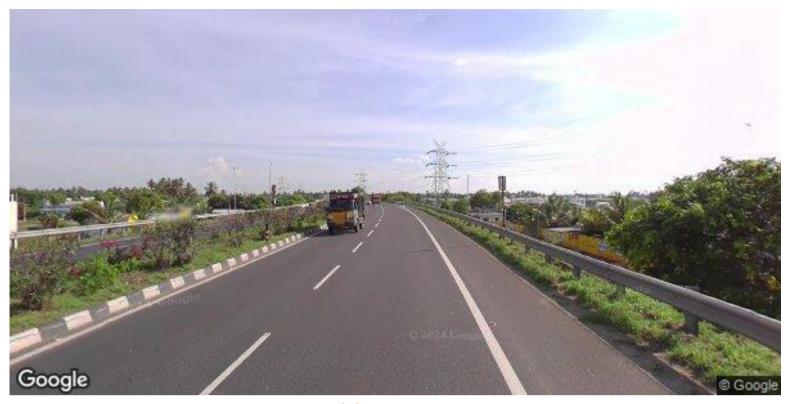
Risk Type: Turn
Risk Level: Medium
Speed Limit: 30 KM/Hr
Coordinates: 11.34049, 77.63123

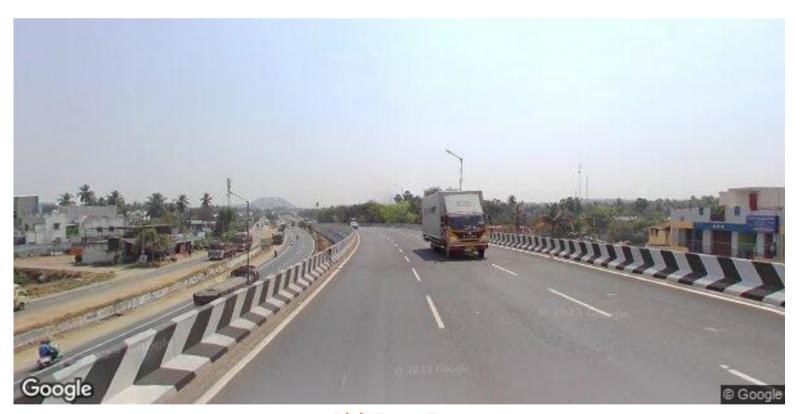
Risk Type: Turn
Risk Level: Medium
Speed Limit: 30 KM/Hr
Coordinates: 11.42890, 77.67519

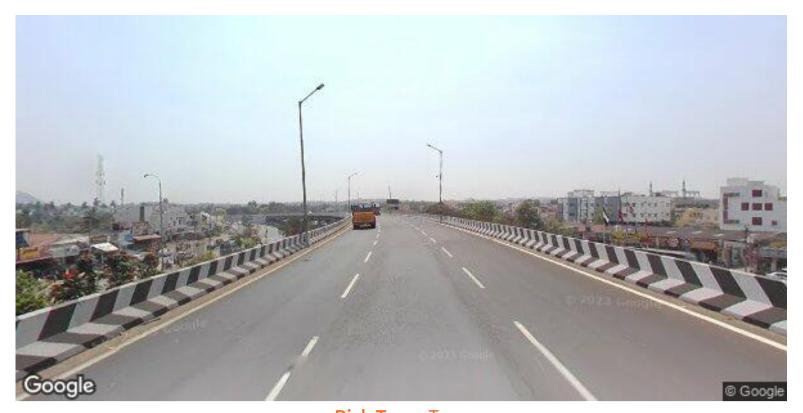
Risk Type: Turn
Risk Level: Medium
Speed Limit: 30 KM/Hr
Coordinates: 11.43091, 77.67598

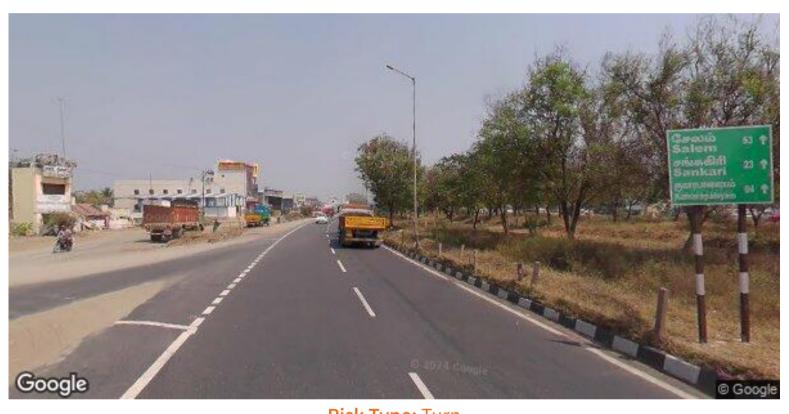
Risk Type: Turn
Risk Level: Medium
Speed Limit: 30 KM/Hr
Coordinates: 11.43243, 77.67851

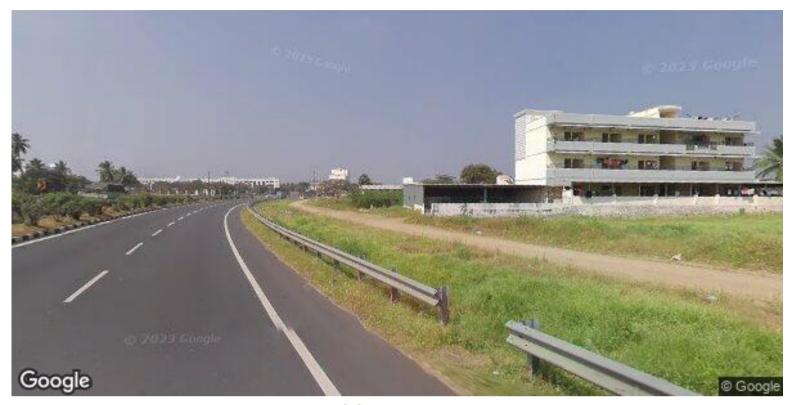
Coordinates: 11.44973, 77.77550

Risk Type: Turn
Risk Level: Medium
Speed Limit: 30 KM/Hr

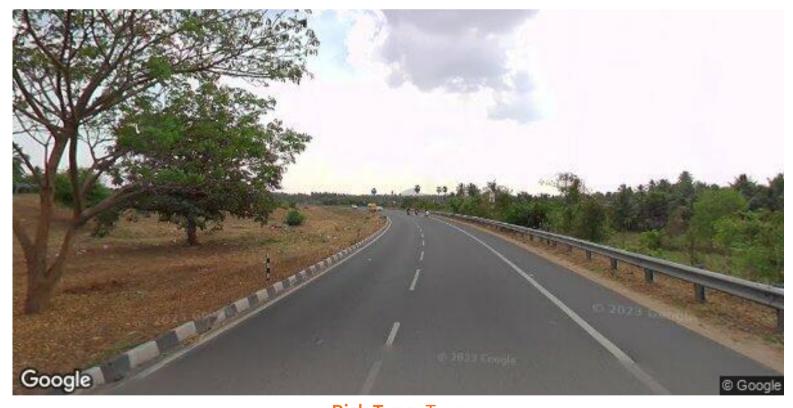
Coordinates: 11.53590, 77.95827

Risk Type: Turn
Risk Level: Medium
Speed Limit: 30 KM/Hr

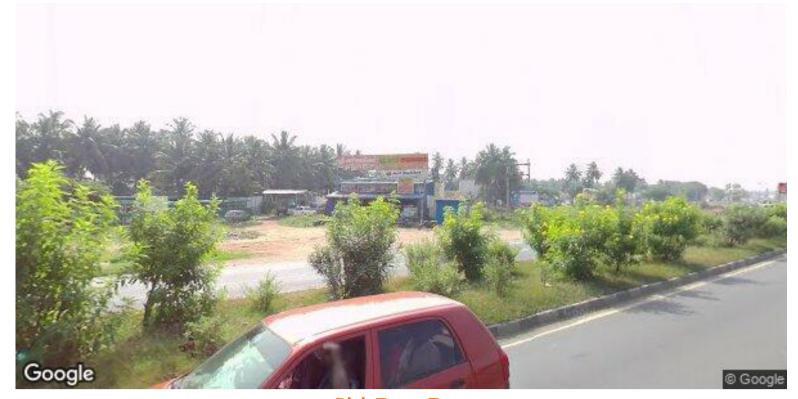
Risk Type: Turn
Risk Level: Medium
Speed Limit: 30 KM/Hr
Coordinates: 11.62382, 78.10875

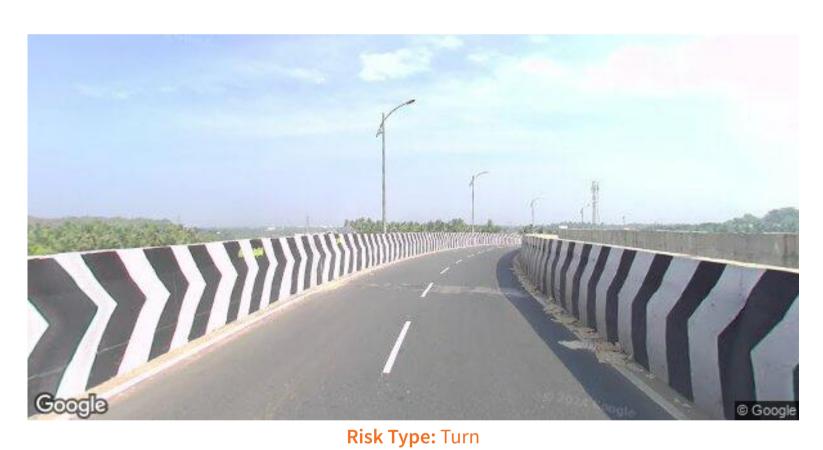
Risk Level: High
Speed Limit: 15 KM/Hr
Coordinates: 11.64144, 78.11791

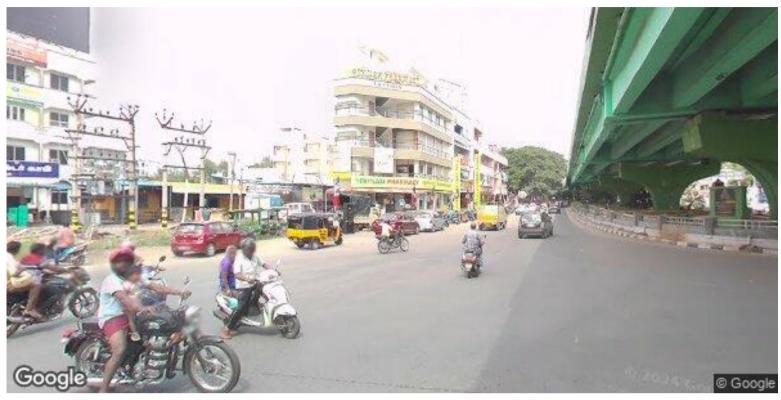
Coordinates: 11.67582, 78.12786

Risk Type: Turn
Risk Level: High
Speed Limit: 15 KM/Hr

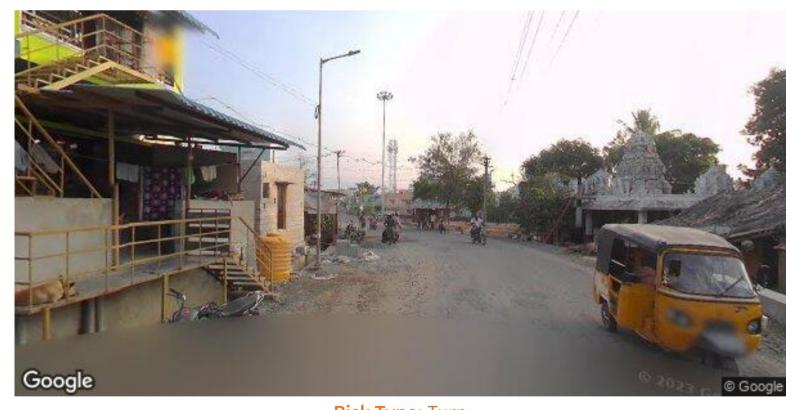
Coordinates: 11.70717, 78.16253

Risk Type: Turn
Risk Level: Medium
Speed Limit: 30 KM/Hr
