JOURNEY RISK MANAGEMENT (JRM) STUDY

Salem Terminal to BAAGA FUELS

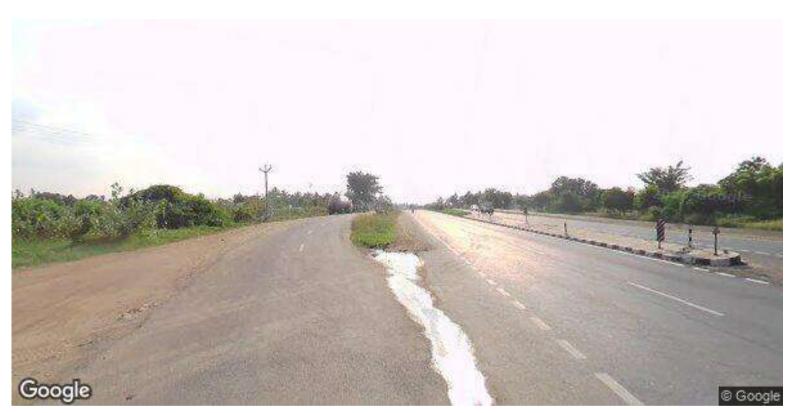
Coordinates: 11.3141552, 77.6131059

Risk Type: U-Turn Risk Level: High

Speed Limit: 10 KM/Hr

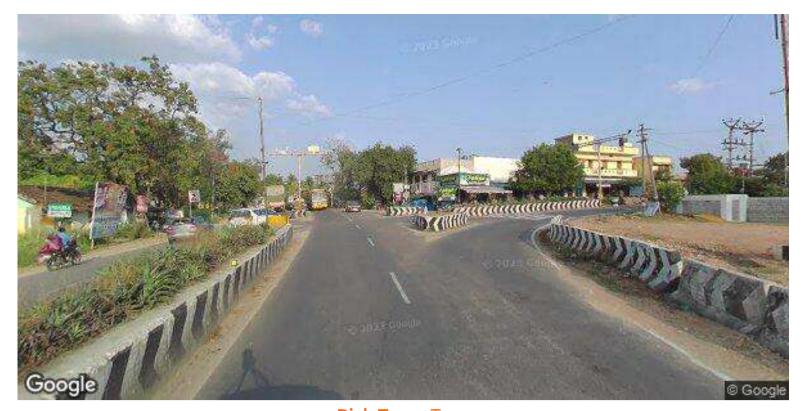
Risk Type: Turn
Risk Level: Medium
Speed Limit: 30 KM/Hr
Coordinates: 11.46318, 77.84913

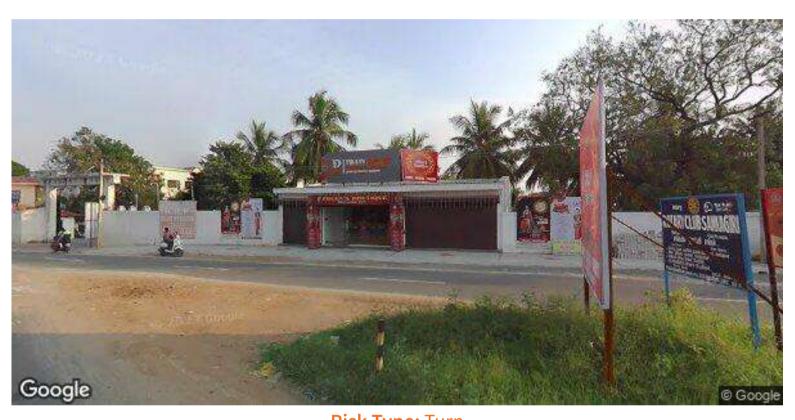
Risk Type: Turn
Risk Level: High
Speed Limit: 15 KM/Hr
Coordinates: 11.45516, 77.81346

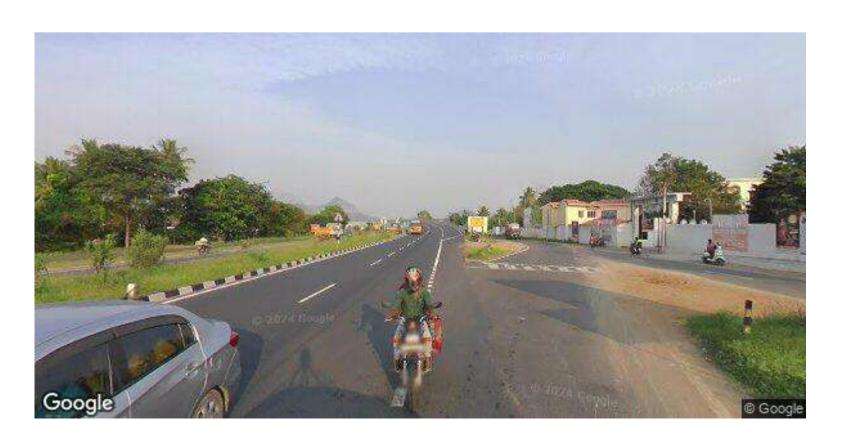
Coordinates: 11.45521, 77.81343

Risk Type: Turn
Risk Level: High
Speed Limit: 15 KM/Hr

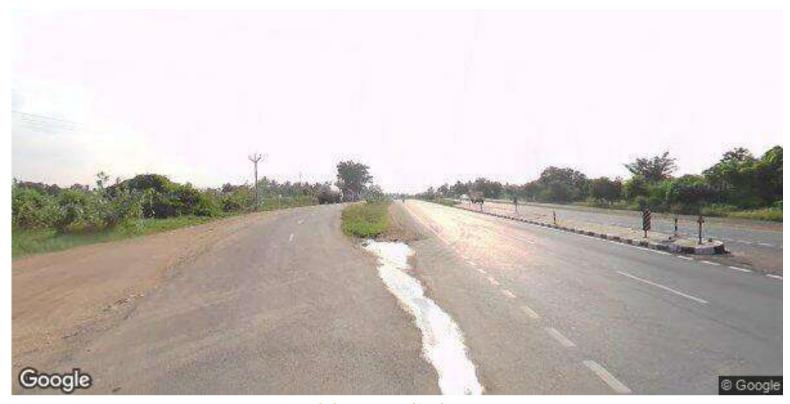
Risk Type: Blind Spot
Risk Level: Blind Spot
Speed Limit: 10 KM/Hr
Coordinates: 11.31416, 77.61311

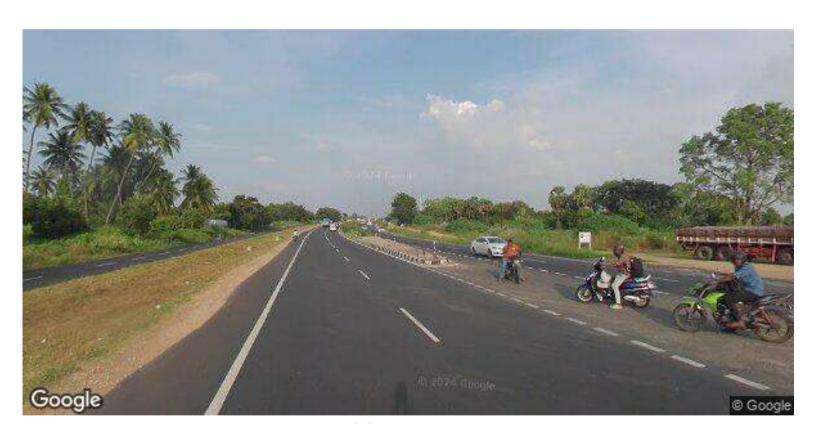
Risk Type: Turn
Risk Level: High
Speed Limit: 15 KM/Hr
Coordinates: 11.31425, 77.61303

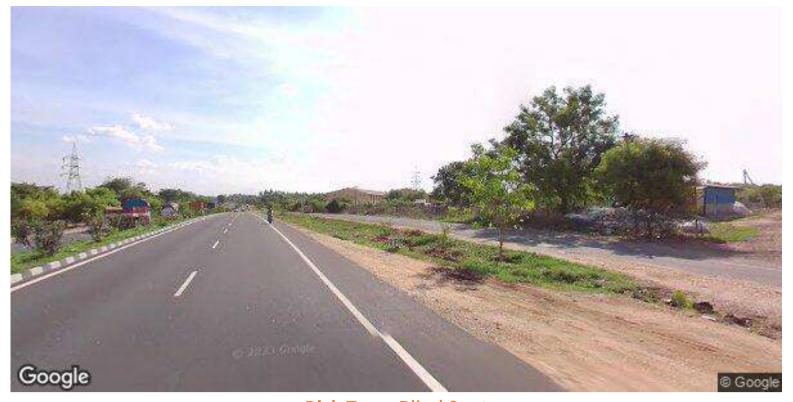
Risk Type: Blind Spot
Risk Level: Blind Spot
Speed Limit: 10 KM/Hr
Coordinates: 11.31812, 77.61873

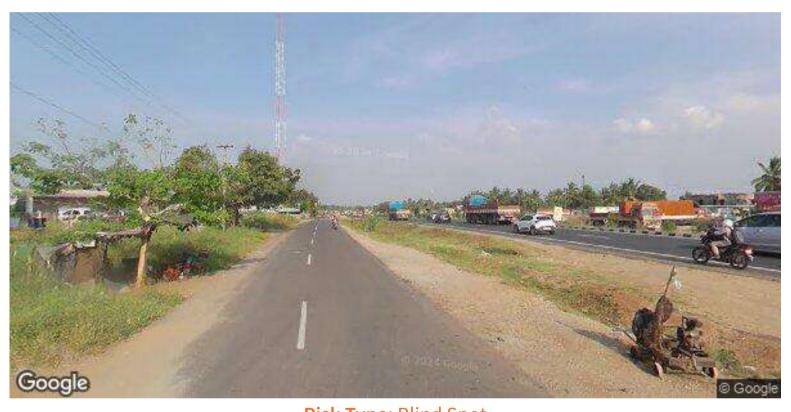
Risk Type: Blind Spot
Risk Level: Blind Spot
Speed Limit: 10 KM/Hr
Coordinates: 11.31824, 77.61861

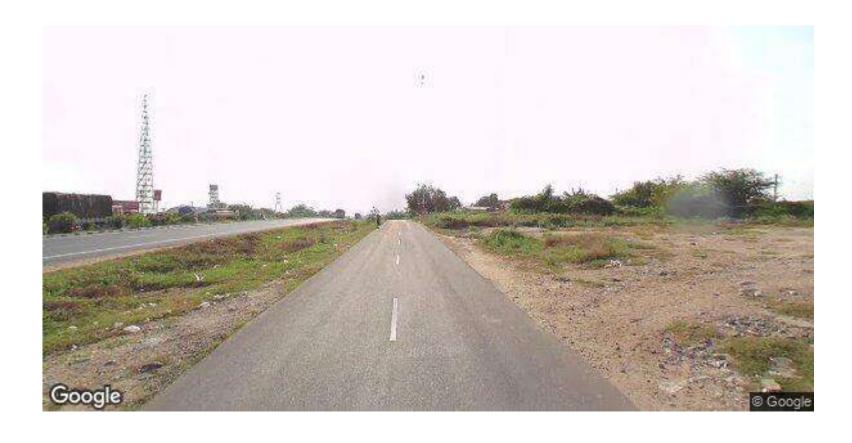
Coordinates: 11.31869, 77.61950

Risk Type: Blind Spot Risk Level: Blind Spot Speed Limit: 10 KM/Hr

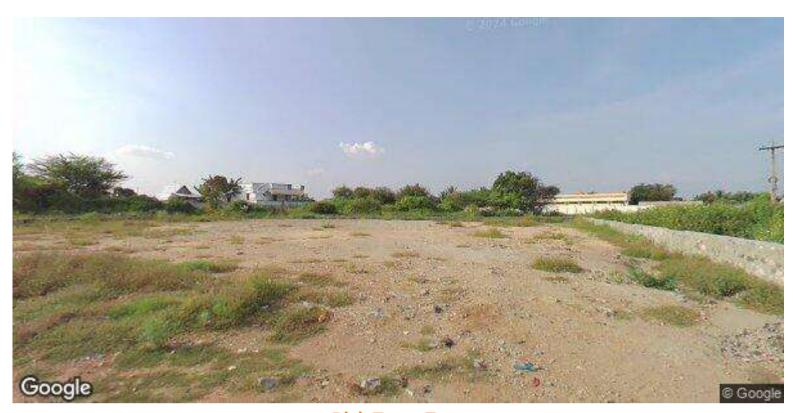
Coordinates: 11.31889, 77.61931

Risk Type: Turn
Risk Level: High
Speed Limit: 15 KM/Hr
