JOURNEY RISK MANAGEMENT (JRM) STUDY

Salem Terminal to BAKYA LAKSHMI FUELS

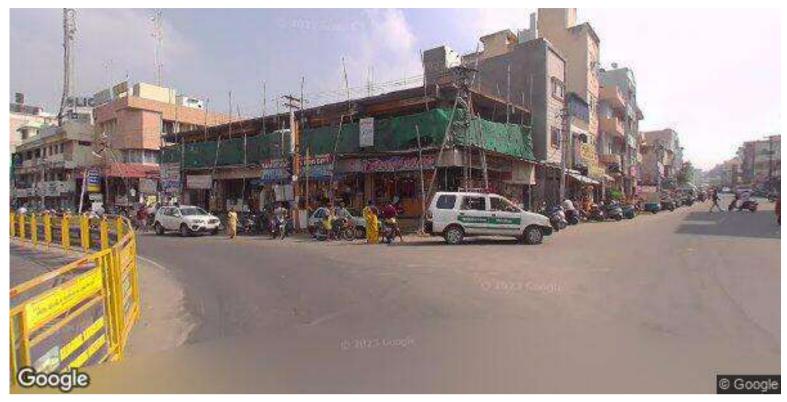
Coordinates: 11.37868, 77.89498

Risk Type: Turn
Risk Level: High
Speed Limit: 15 KM/Hr

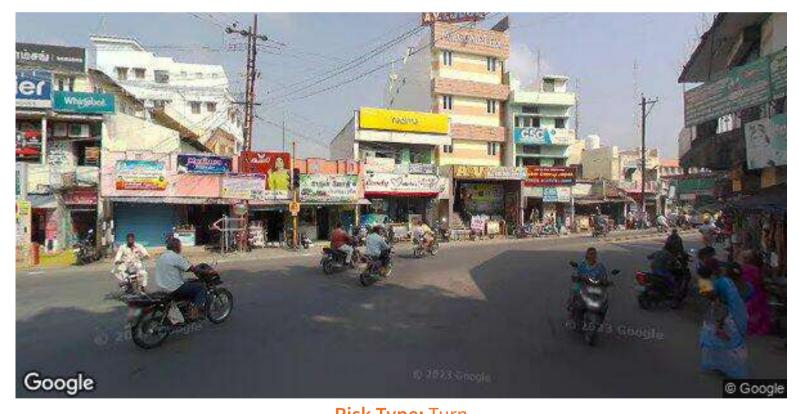
Coordinates: 11.37842, 77.89452

Risk Type: Turn
Risk Level: Medium
Speed Limit: 30 KM/Hr

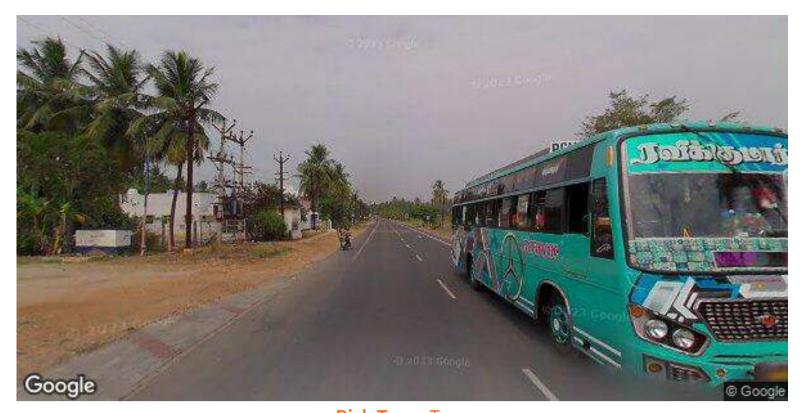
Risk Type: Turn
Risk Level: Medium
Speed Limit: 30 KM/Hr
Coordinates: 11.30869, 77.92911

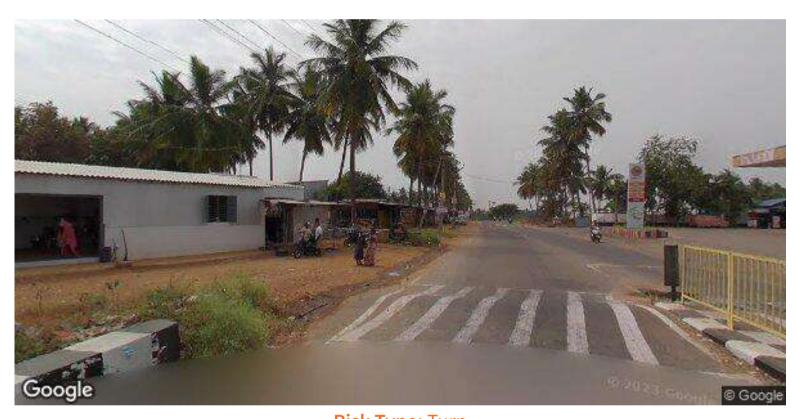
Risk Type: Turn
Risk Level: Medium
Speed Limit: 30 KM/Hr
Coordinates: 11.30849, 77.92910

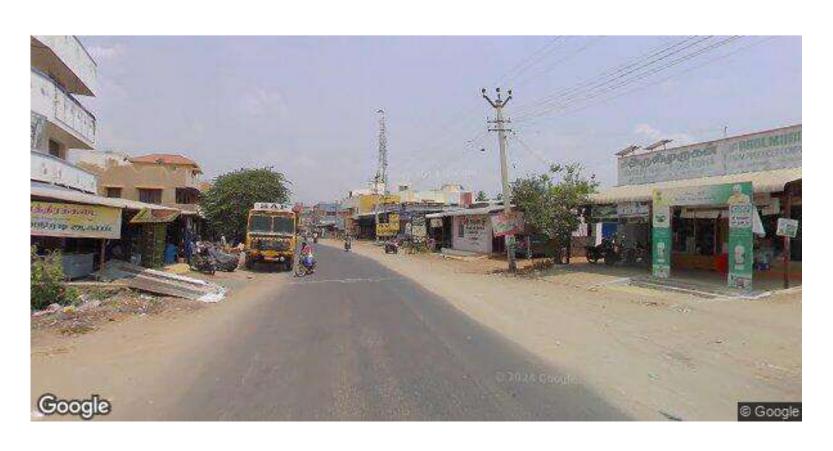
Coordinates: 11.24172, 77.87357

Risk Type: Turn
Risk Level: Medium
Speed Limit: 30 KM/Hr

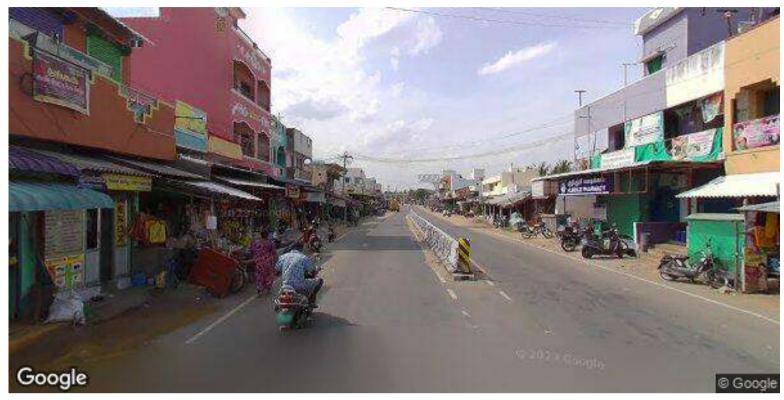
Coordinates: 11.24000, 77.87363

Risk Type: Turn
Risk Level: High
Speed Limit: 15 KM/Hr

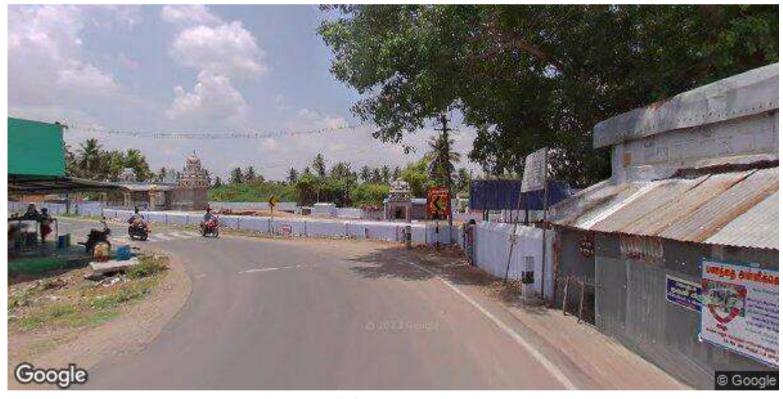
Coordinates: 11.24053, 77.86902

Risk Type: Turn
Risk Level: Medium
Speed Limit: 30 KM/Hr

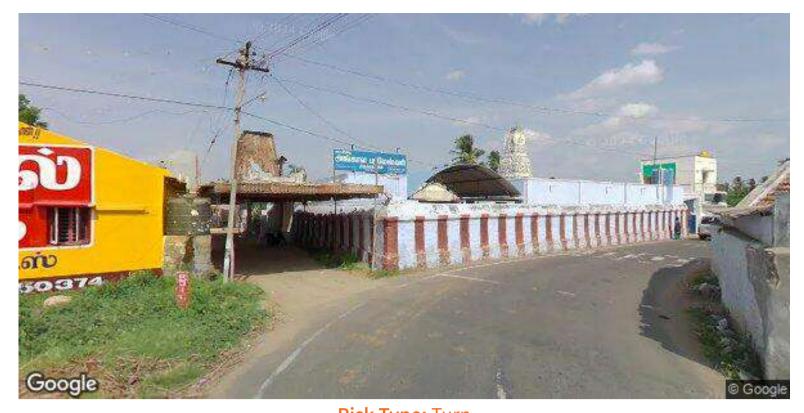
Risk Type: Turn
Risk Level: Medium
Speed Limit: 30 KM/Hr
Coordinates: 11.24115, 77.86891

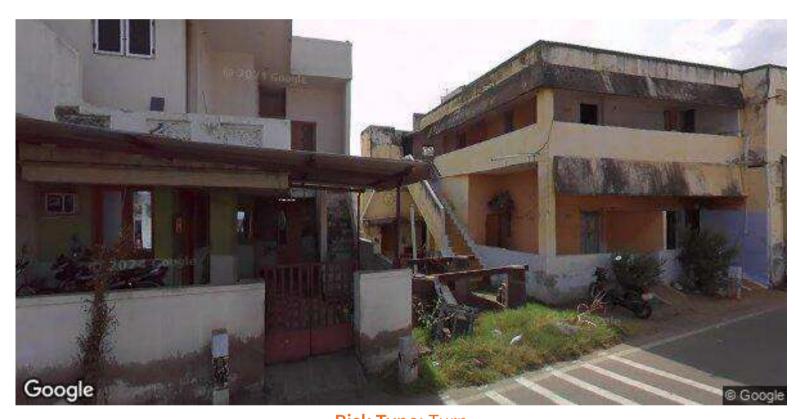
Risk Type: Turn
Risk Level: Medium
Speed Limit: 30 KM/Hr
Coordinates: 11.24122, 77.86883

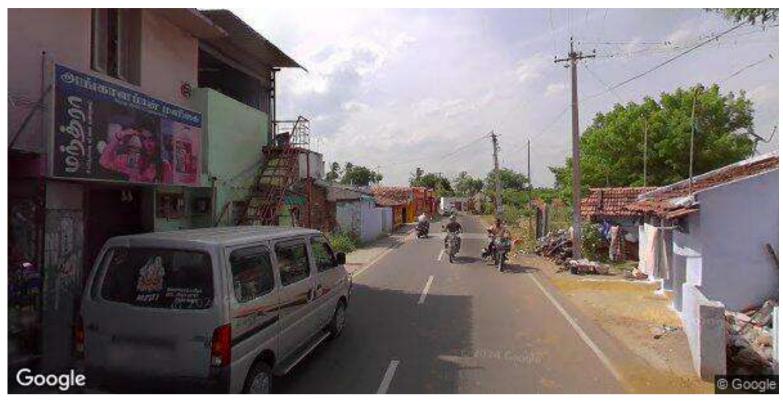
Coordinates: 11.24170, 77.86842

Risk Type: Turn
Risk Level: High
Speed Limit: 15 KM/Hr

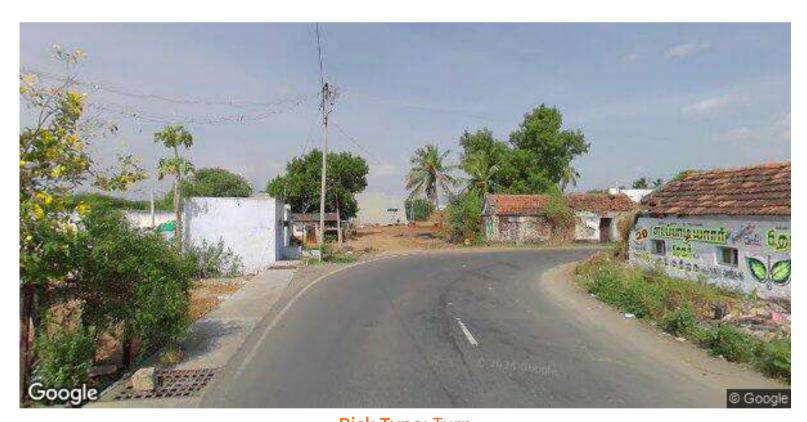
Risk Type: Turn
Risk Level: High
Speed Limit: 15 KM/Hr
Coordinates: 11.24248, 77.86829

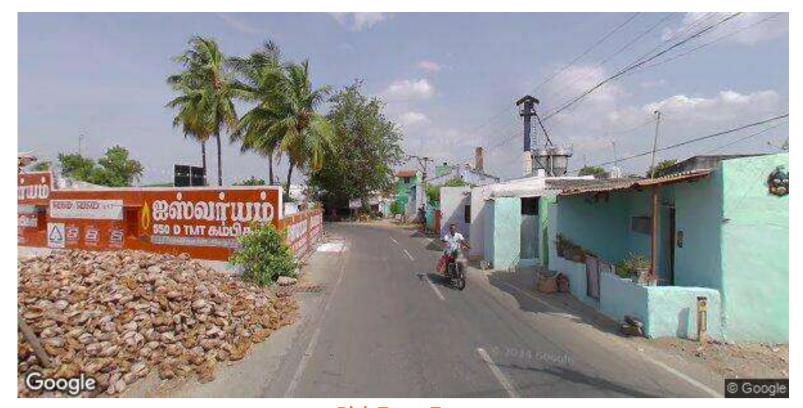
Risk Type: Turn
Risk Level: High
Speed Limit: 15 KM/Hr
Coordinates: 11.24257, 77.86776

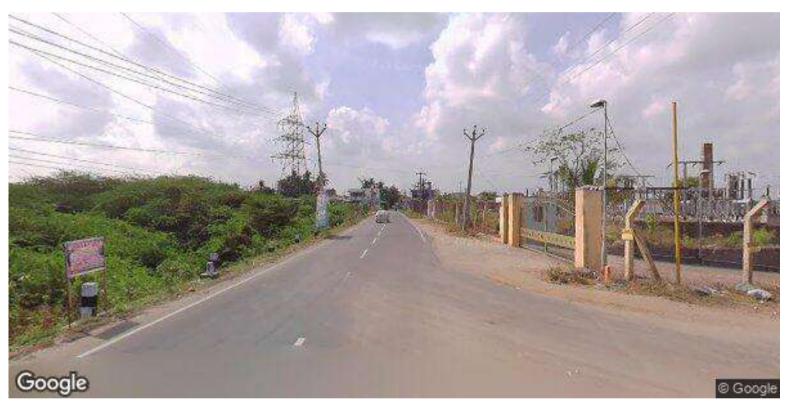
Risk Type: Blind Spot
Risk Level: Blind Spot
Speed Limit: 10 KM/Hr
Coordinates: 11.24384, 77.86689

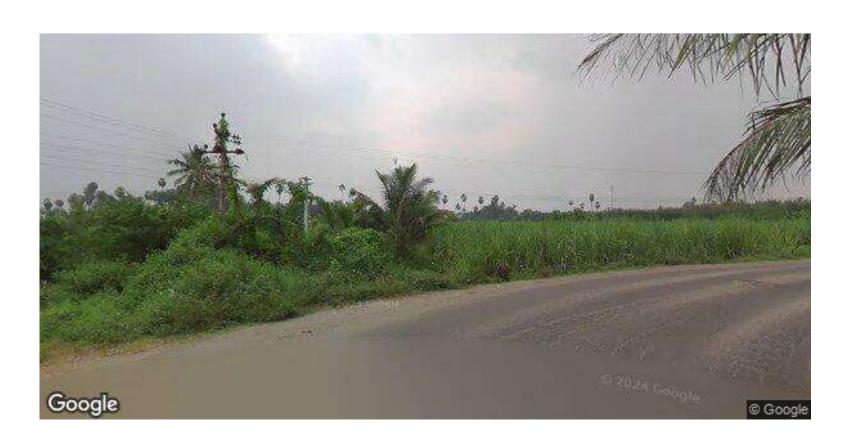
Coordinates: 11.24101, 77.86034

Risk Type: Turn
Risk Level: Medium
Speed Limit: 30 KM/Hr

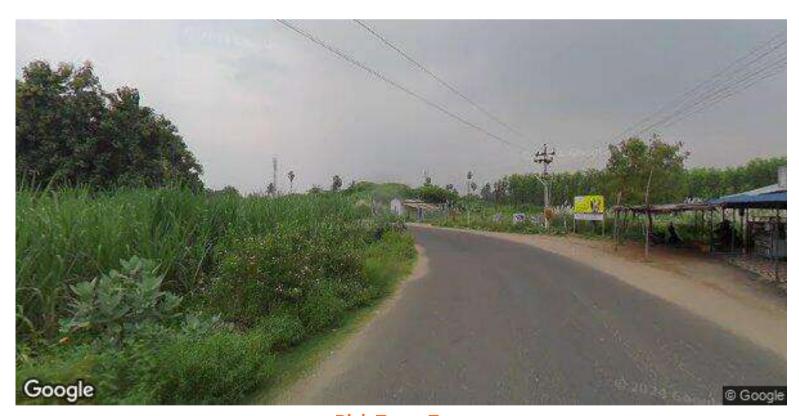
Risk Type: Turn
Risk Level: Medium
Speed Limit: 30 KM/Hr
Coordinates: 11.24200, 77.85882

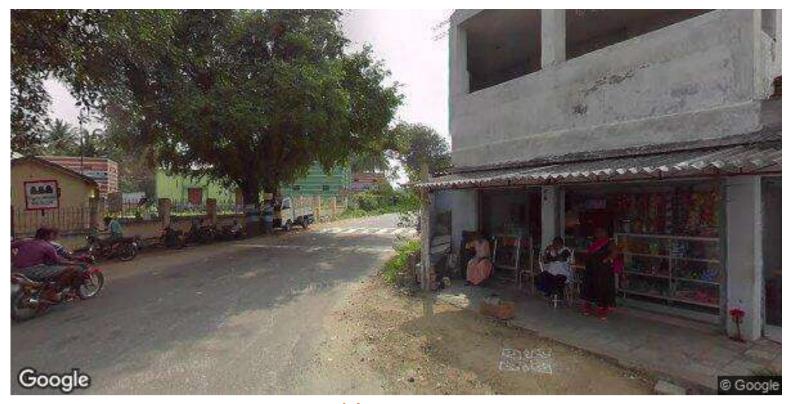
Risk Type: Turn
Risk Level: Medium
Speed Limit: 30 KM/Hr
Coordinates: 11.13664, 77.76524

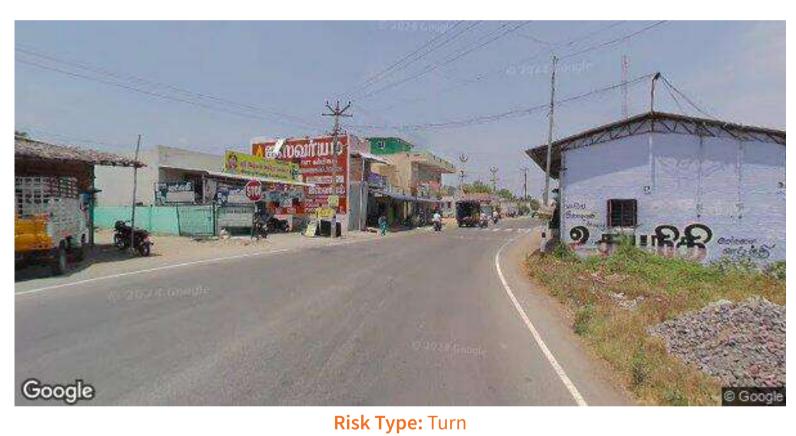
Coordinates: 11.04718, 77.73742

Risk Type: Turn

Risk Level: Medium

Speed Limit: 30 KM/Hr

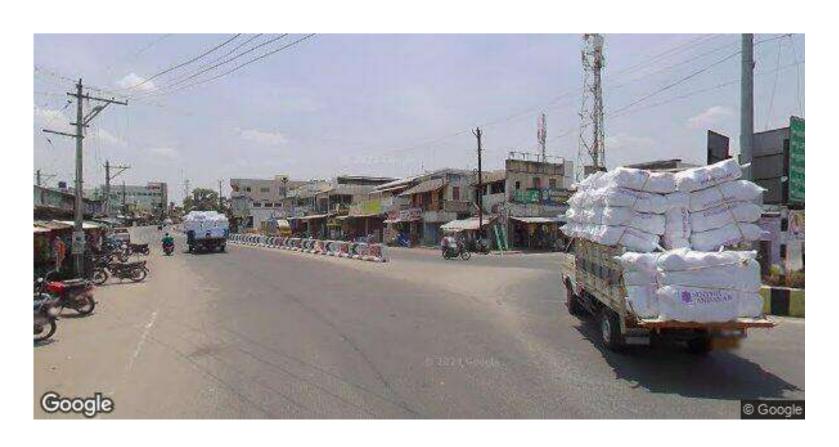
Coordinates: 11.04515, 77.73621

Risk Type: Turn
Risk Level: High
Speed Limit: 15 KM/Hr

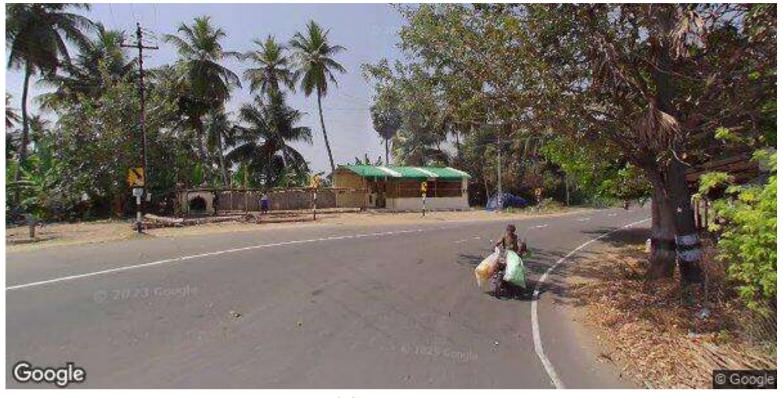
Risk Type: Turn
Risk Level: High
Speed Limit: 15 KM/Hr
Coordinates: 10.99026, 77.72511

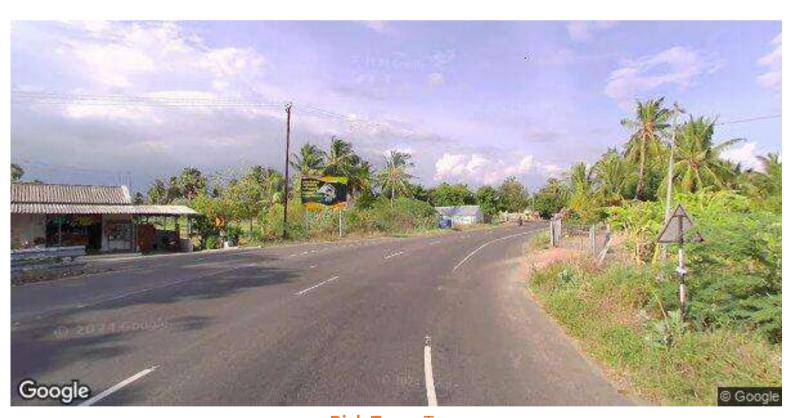
Risk Type: Turn
Risk Level: High
Speed Limit: 15 KM/Hr
Coordinates: 10.98974, 77.72388

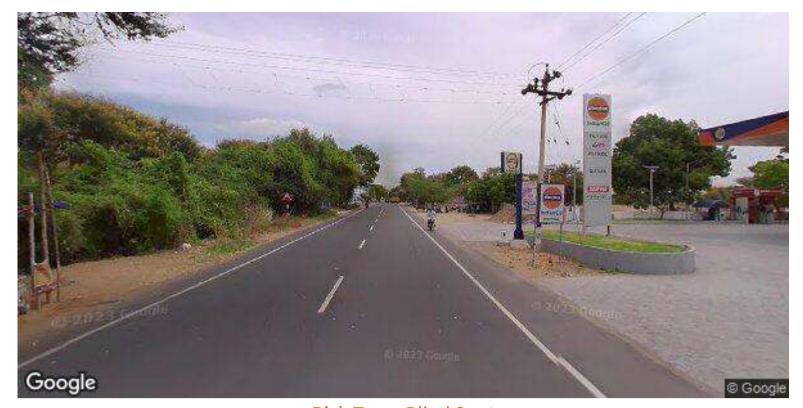
Coordinates: 10.96959, 77.71867

Risk Type: Blind Spot
Risk Level: Blind Spot
Speed Limit: 10 KM/Hr
