JOURNEY RISK MANAGEMENT (JRM) STUDY

IOCL Coimbatore Terminal to Selvanayagi and Co

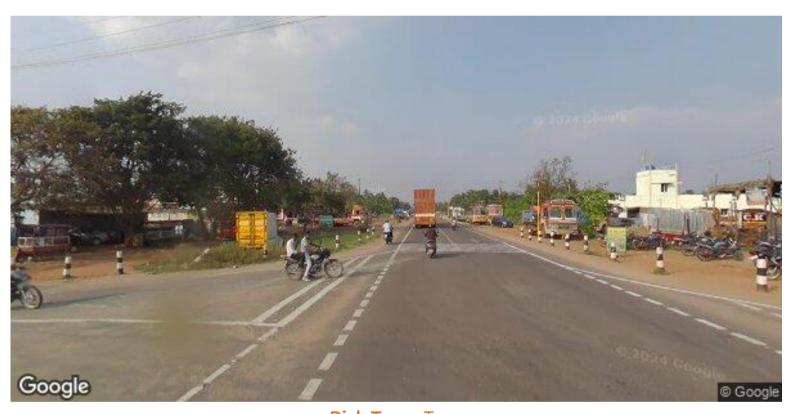
Risk Type: Turn
Risk Level: High

Speed Limit: 15 KM/Hr Coordinates: 11.03211, 77.07640

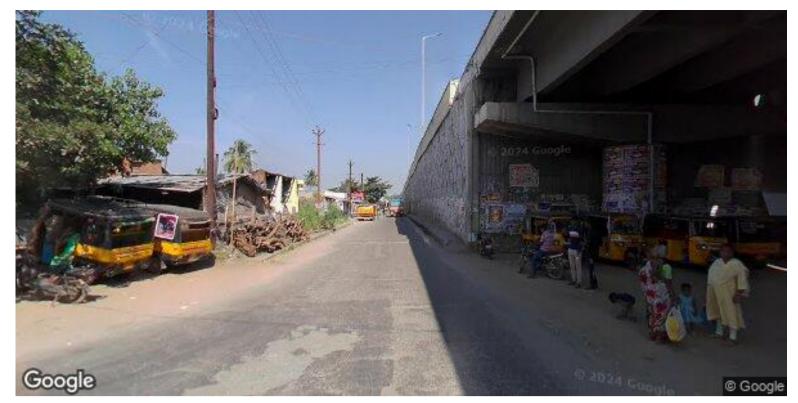
Risk Type: Blind Spot Risk Level: Blind Spot Speed Limit: 10 KM/Hr

Coordinates: 11.10783, 77.17709

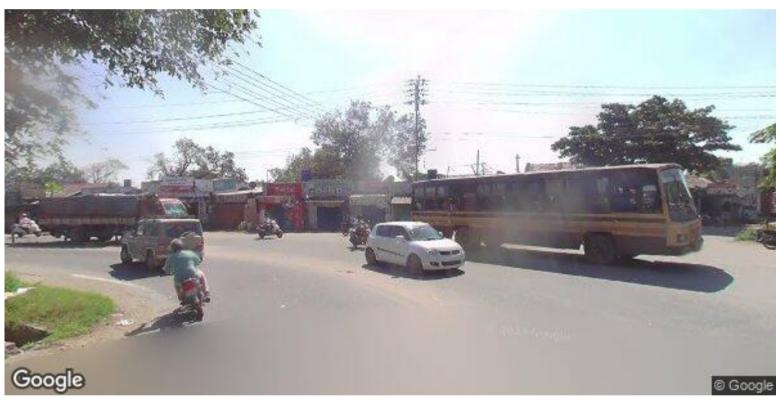
Risk Type: Turn
Risk Level: High
Speed Limit: 15 KM/Hr

Coordinates: 11.08748, 77.18469

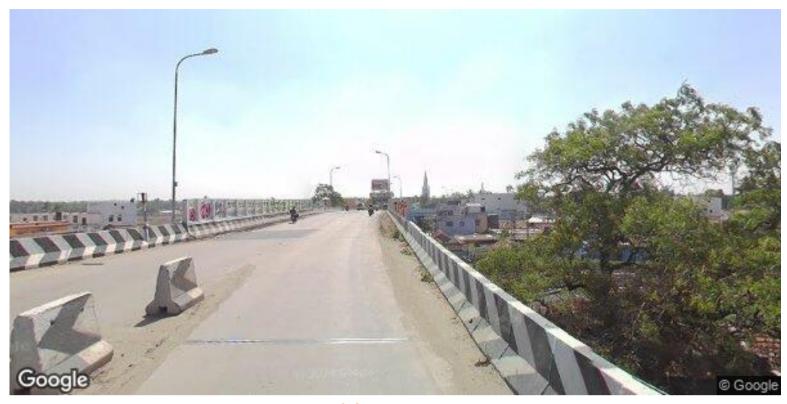
Risk Type: Turn
Risk Level: Medium
Speed Limit: 30 KM/Hr
Coordinates: 11.08826, 77.18786

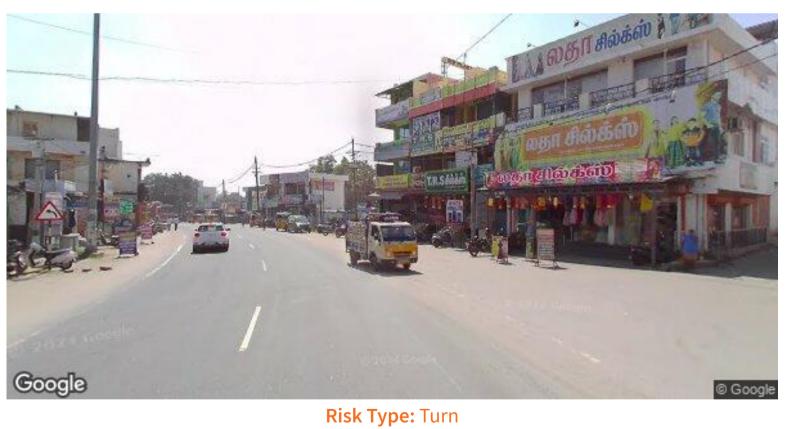
Risk Type. Turn
Risk Level: Medium
Speed Limit: 30 KM/Hr
Coordinates: 11.08537, 77.18776

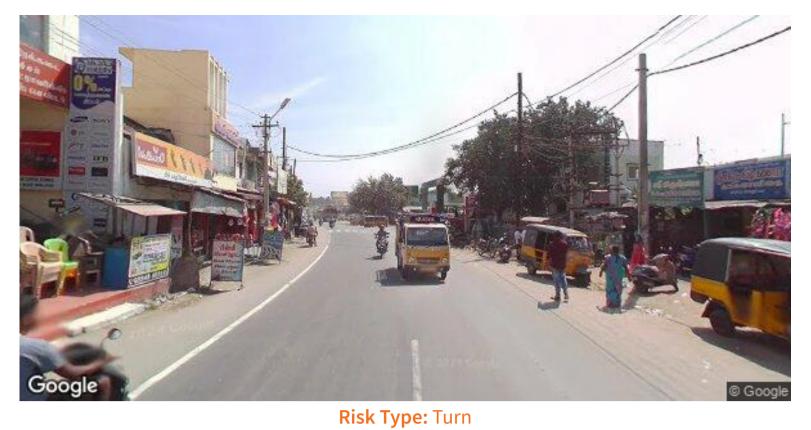
Risk Type: Turn

Risk Level: Medium

Speed Limit: 30 KM/Hr

Coordinates: 11.08474, 77.18785

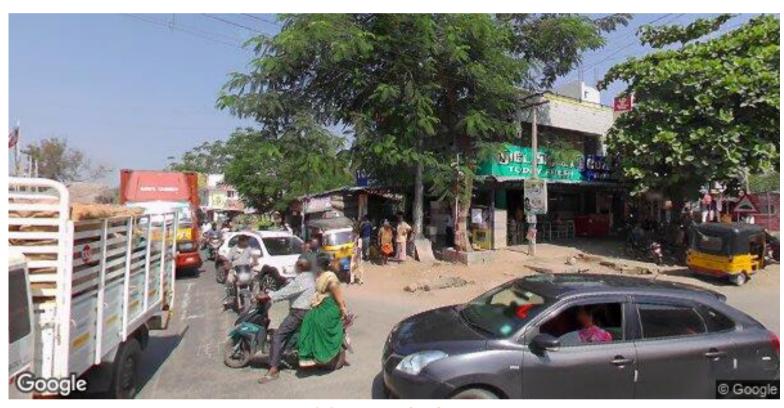
Risk Type: Blind Spot
Risk Level: Blind Spot
Speed Limit: 10 KM/Hr
Coordinates: 11.07394, 77.19267

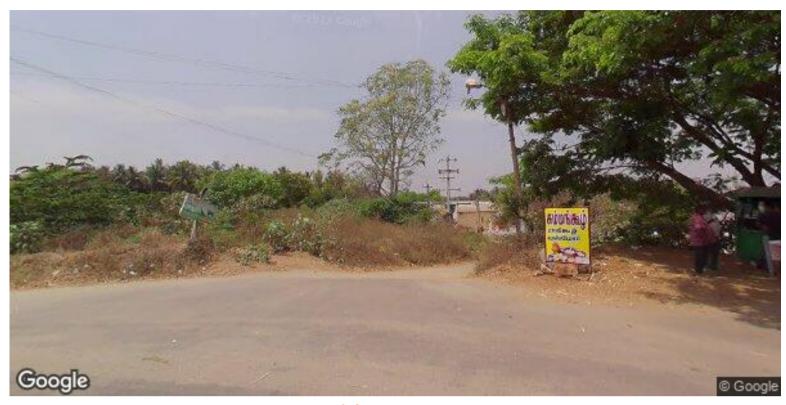
Risk Type: Turn
Risk Level: High
Speed Limit: 15 KM/Hr
Coordinates: 11.07563, 77.19752

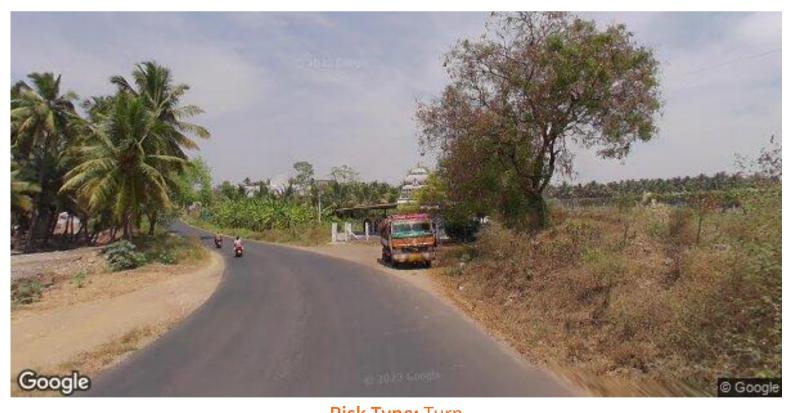
Risk Type: Turn
Risk Level: Medium
Speed Limit: 30 KM/Hr
Coordinates: 11.07721, 77.20414

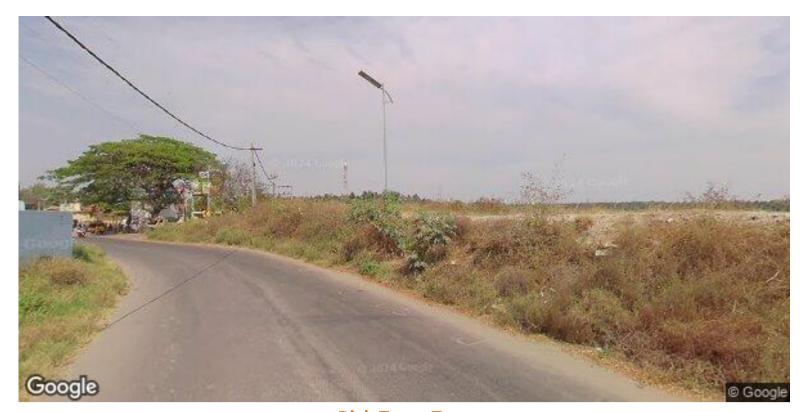
Risk Type: Turn
Risk Level: Medium
Speed Limit: 30 KM/Hr
Coordinates: 11.08421, 77.21319

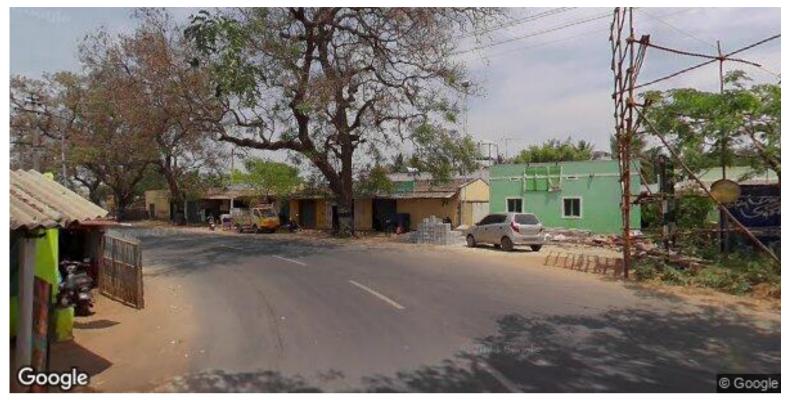
Risk Type: Turn
Risk Level: High
Speed Limit: 15 KM/Hr

Coordinates: 11.09062, 77.22674

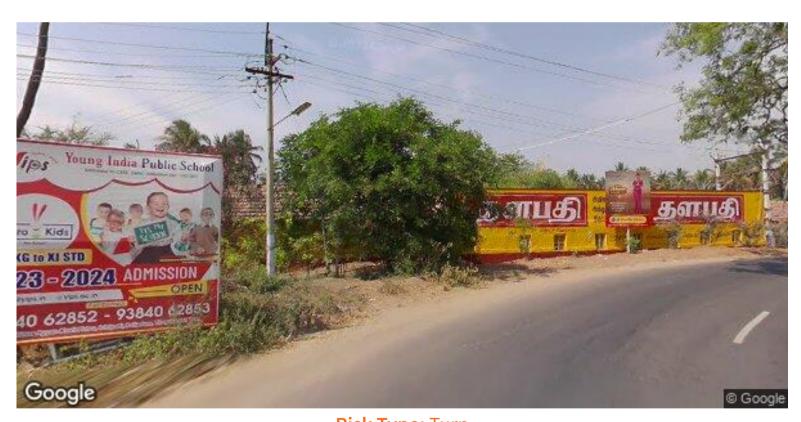
Risk Type: Turn
Risk Level: High
Speed Limit: 15 KM/Hr
Coordinates: 11.09247, 77.22714

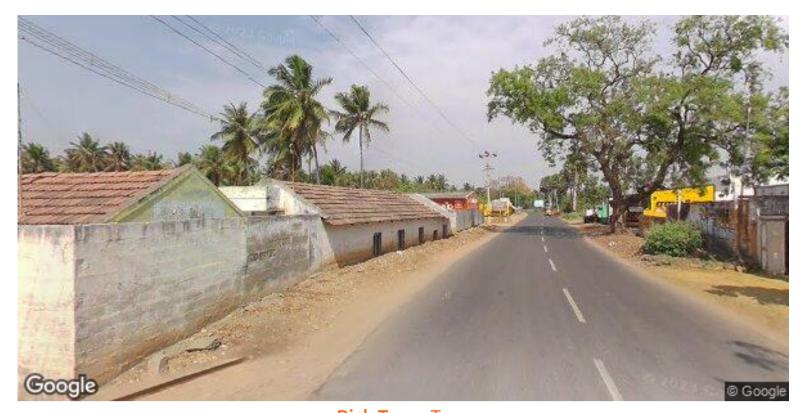
Risk Type: Turn
Risk Level: Medium
Speed Limit: 30 KM/Hr
Coordinates: 11.09265, 77.22747

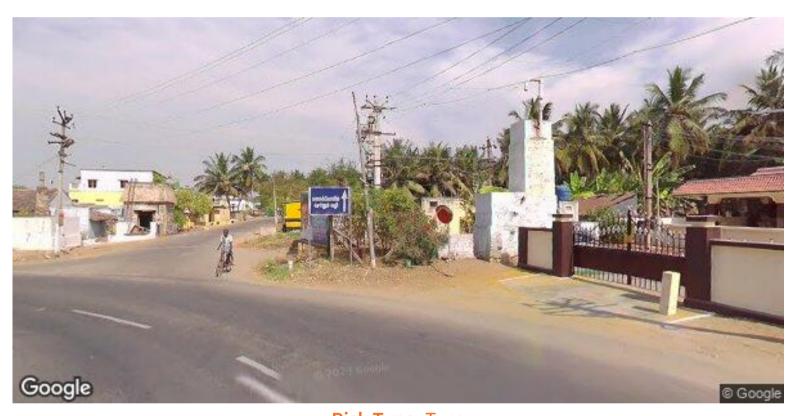
Risk Type: Turn
Risk Level: High
Speed Limit: 15 KM/Hr
Coordinates: 11.09346, 77.23358

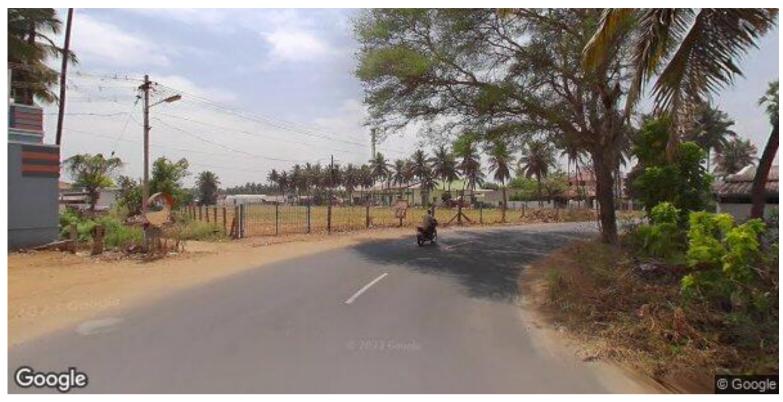
Risk Type: Turn
Risk Level: High
Speed Limit: 15 KM/Hr

Coordinates: 11.09576, 77.23663

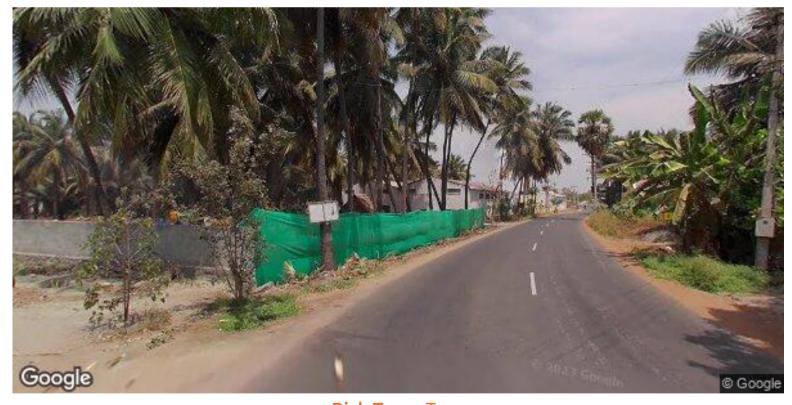
Risk Type: Turn
Risk Level: High
Speed Limit: 15 KM/Hr

Coordinates: 11.09617, 77.23686

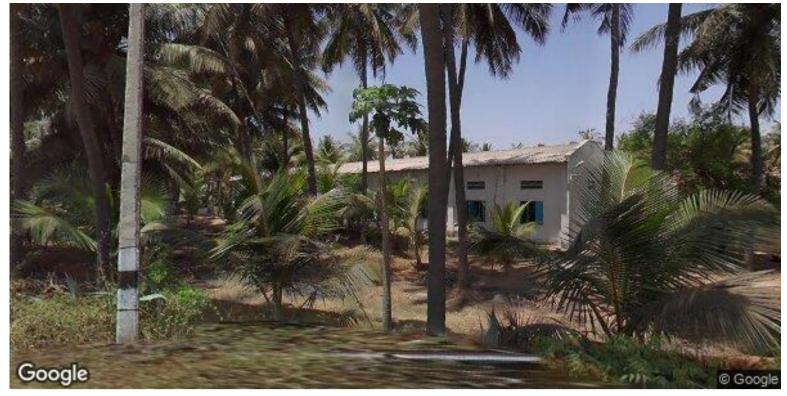
Risk Type: Turn
Risk Level: High
Speed Limit: 15 KM/Hr
Coordinates: 11.09689, 77.24288

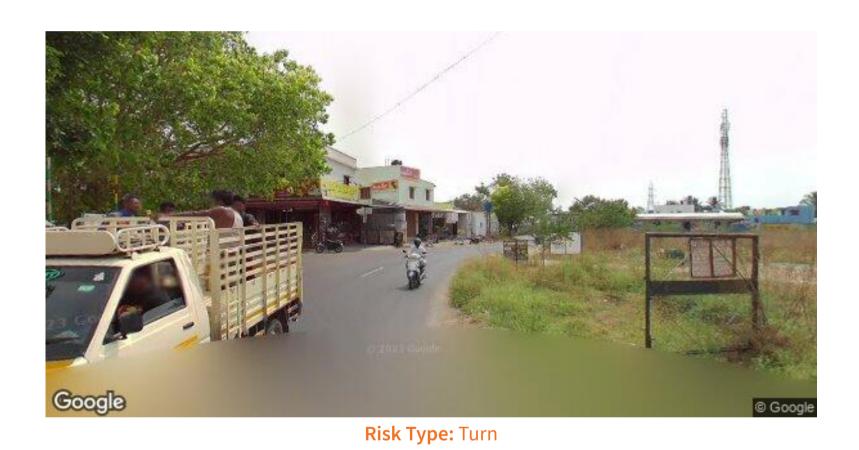
Risk Level: Medium
Speed Limit: 30 KM/Hr
Coordinates: 11.10138, 77.24891

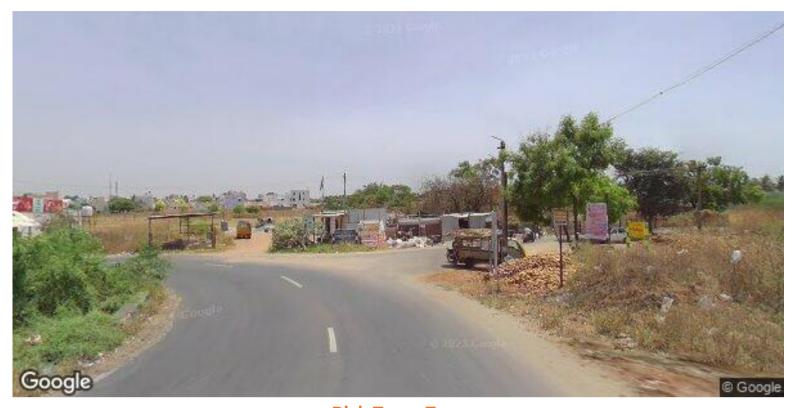
Risk Type: Turn
Risk Level: Medium
Speed Limit: 30 KM/Hr
Coordinates: 11.10087, 77.26426

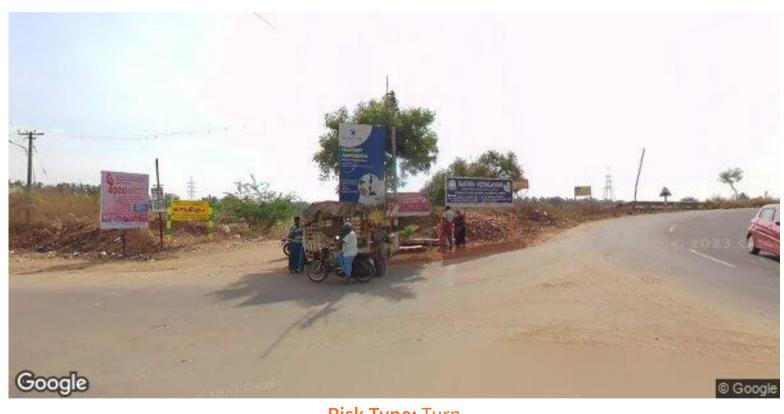
Risk Type: Turn
Risk Level: Medium
Speed Limit: 30 KM/Hr
Coordinates: 11.10086, 77.26444

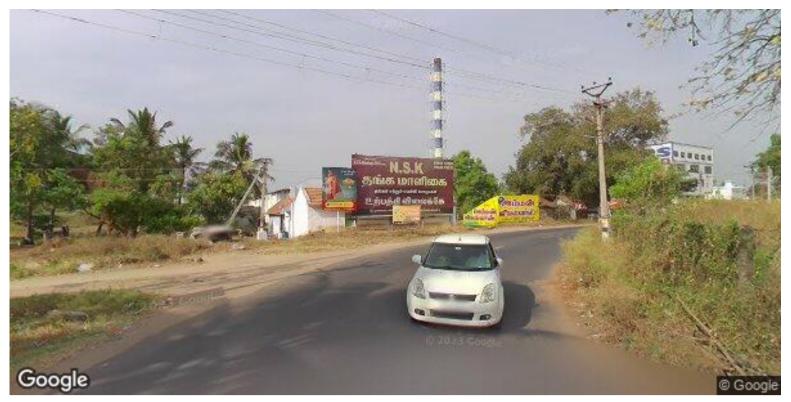
Risk Type: Turn
Risk Level: High
Speed Limit: 15 KM/Hr

Coordinates: 11.10181, 77.26509

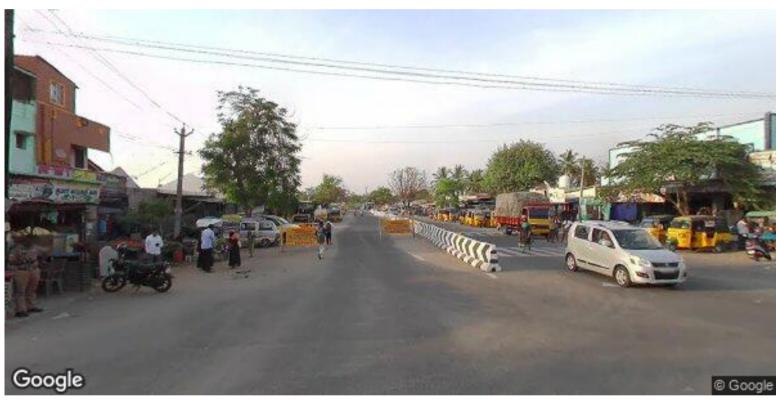
Risk Type: Turn
Risk Level: High
Speed Limit: 15 KM/Hr

Coordinates: 11.10246, 77.27138

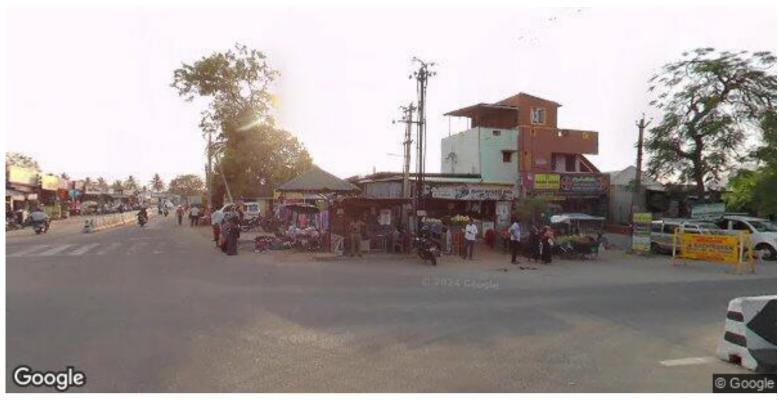
Risk Type: Turn
Risk Level: Medium
Speed Limit: 30 KM/Hr
Coordinates: 11.10250, 77.27143

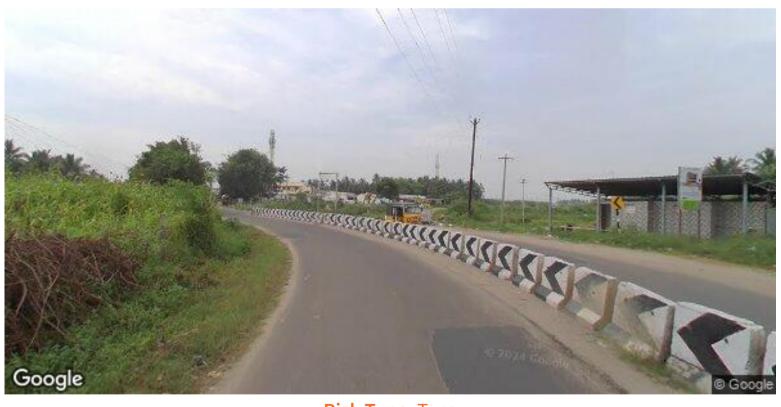
Risk Type: Turn
Risk Level: High
Speed Limit: 15 KM/Hr
Coordinates: 11.10238, 77.29955

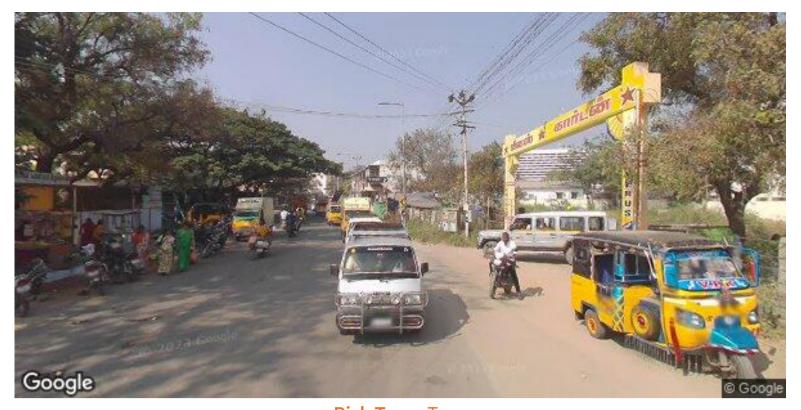
Risk Type: Turn
Risk Level: Medium
Speed Limit: 30 KM/Hr
Coordinates: 11.09901, 77.31958

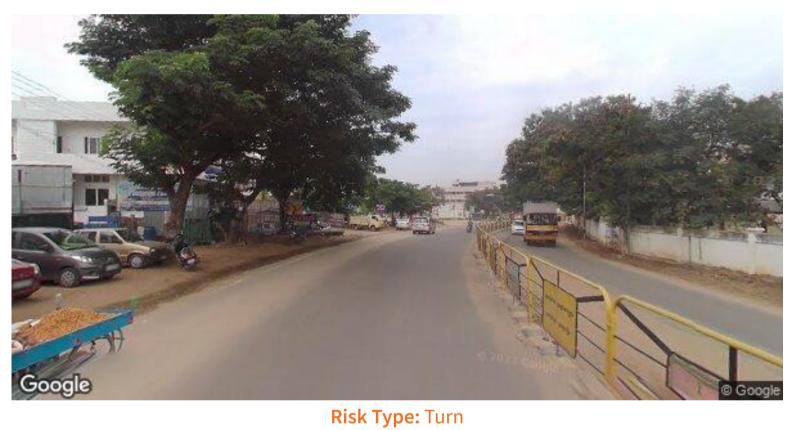
Risk Type: Turn
Risk Level: Medium
Speed Limit: 30 KM/Hr
Coordinates: 11.09748, 77.32180

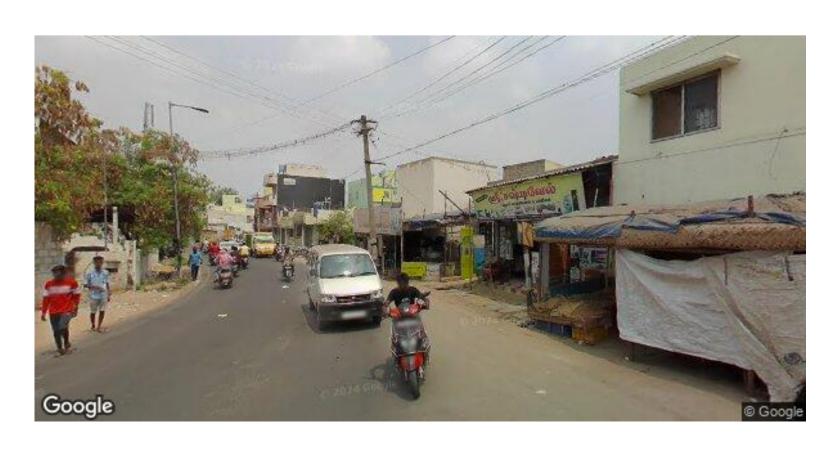
Risk Type: Turn
Risk Level: High
Speed Limit: 15 KM/Hr

Coordinates: 11.09657, 77.33977

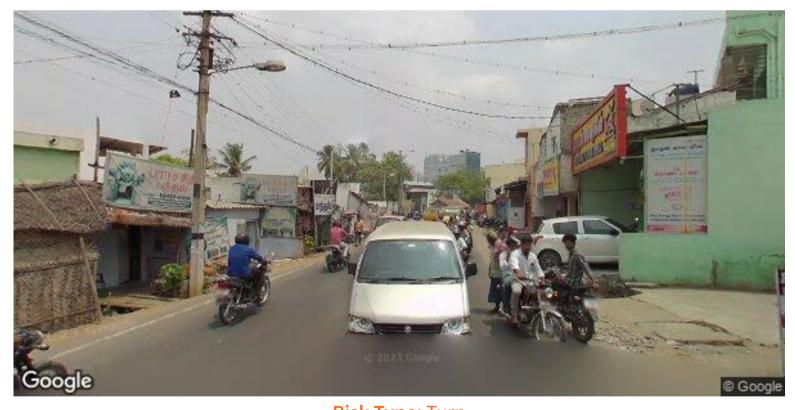
Risk Type: Turn
Risk Level: Medium
Speed Limit: 30 KM/Hr
Coordinates: 11.09794, 77.33979

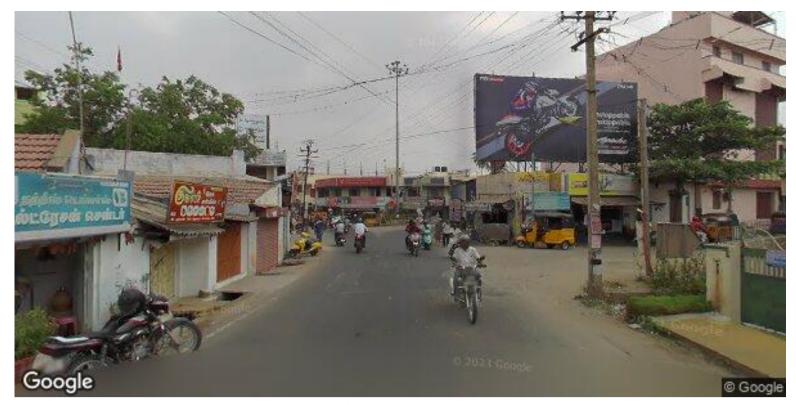
Risk Type: Turn
Risk Level: Medium
Speed Limit: 30 KM/Hr
Coordinates: 11.09875, 77.34131

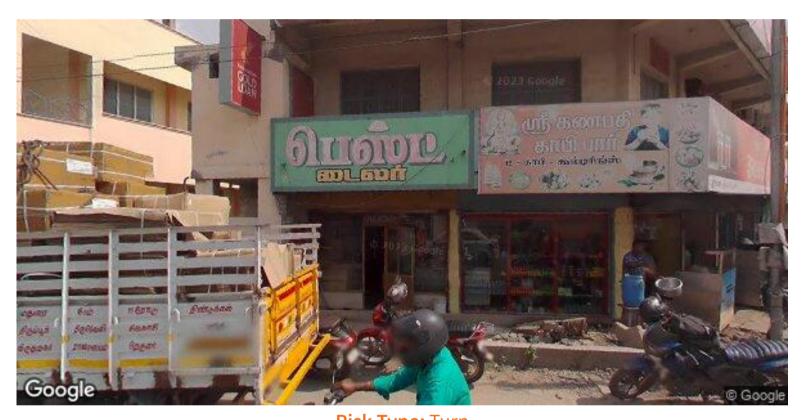
Risk Type: Turn
Risk Level: Medium
Speed Limit: 30 KM/Hr
Coordinates: 11.09924, 77.34144

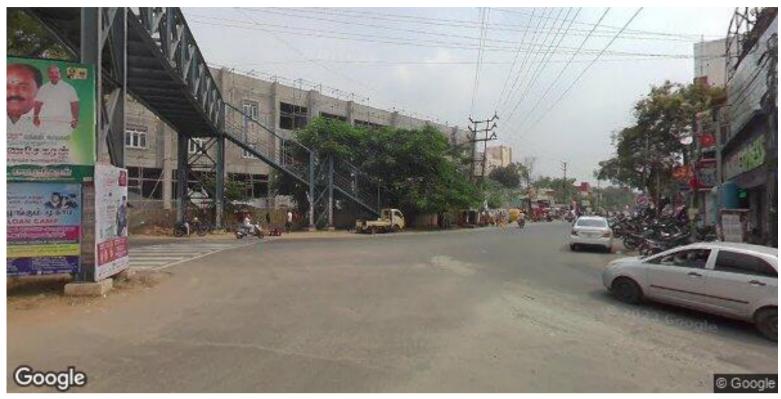
Risk Type: Turn
Risk Level: High
Speed Limit: 15 KM/Hr

Coordinates: 11.10680, 77.34121

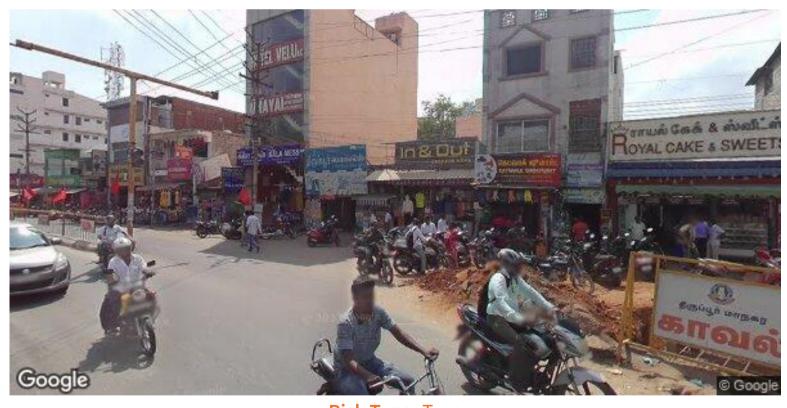
Risk Type: Turn
Risk Level: High
Speed Limit: 15 KM/Hr
Coordinates: 11.10754, 77.34012

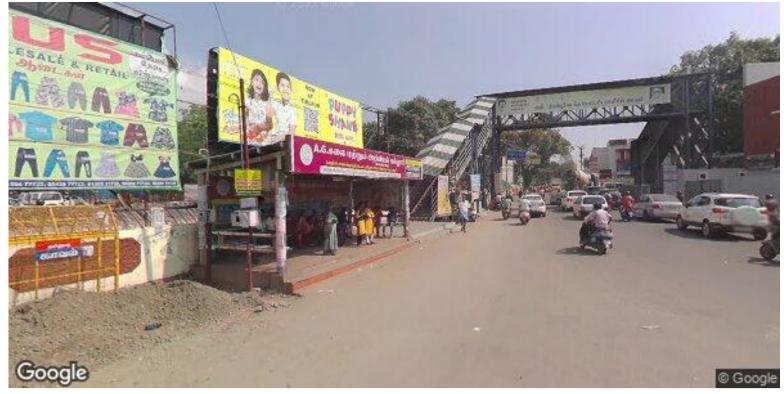
Risk Type: Turn
Risk Level: High
Speed Limit: 15 KM/Hr
Coordinates: 11.10781, 77.34014

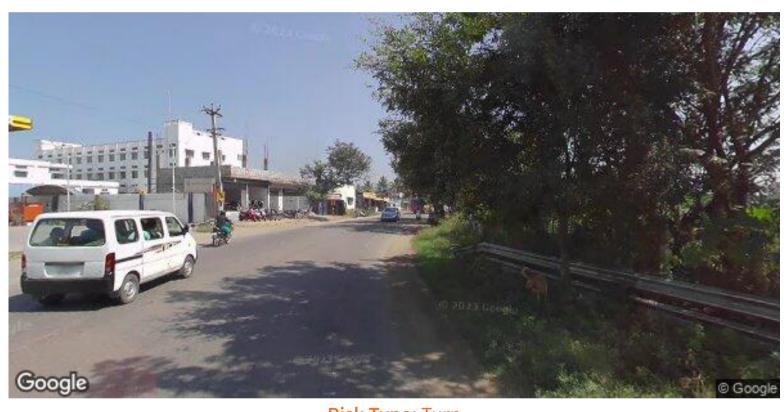
Risk Type: Turn
Risk Level: Medium
Speed Limit: 30 KM/Hr
Coordinates: 11.12261, 77.38320

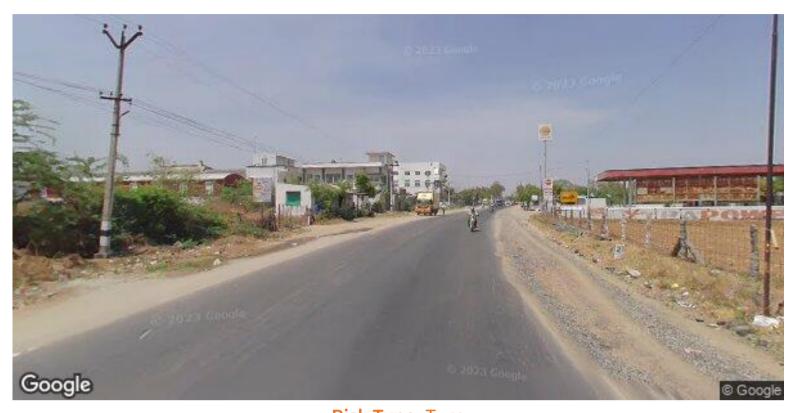
Risk Type: Turn
Risk Level: Medium
Speed Limit: 30 KM/Hr

Coordinates: 11.12986, 77.40294
