JOURNEY RISK MANAGEMENT (JRM) STUDY

IOCL Coimbatore Terminal to Sri Krishna Fuels

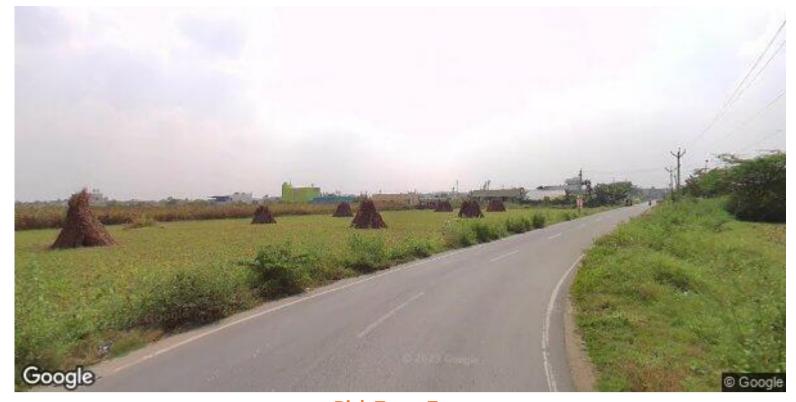
Coordinates: 11.12357, 77.04303

Risk Type: Turn
Risk Level: Medium
Speed Limit: 30 KM/Hr

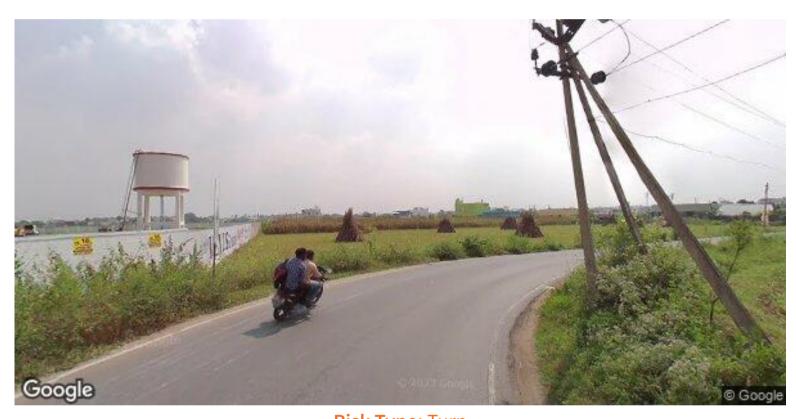
Risk Type: Turn
Risk Level: Medium
Speed Limit: 30 KM/Hr
Coordinates: 11.12366, 77.04297

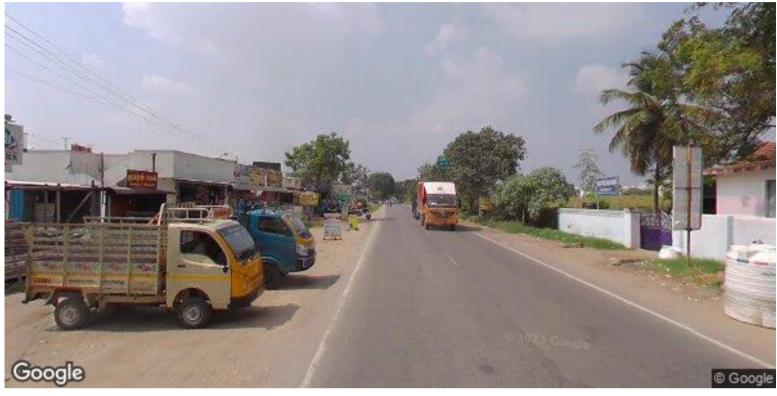
Coordinates: 11.13291, 77.04230

Risk Type: Turn
Risk Level: High
Speed Limit: 15 KM/Hr

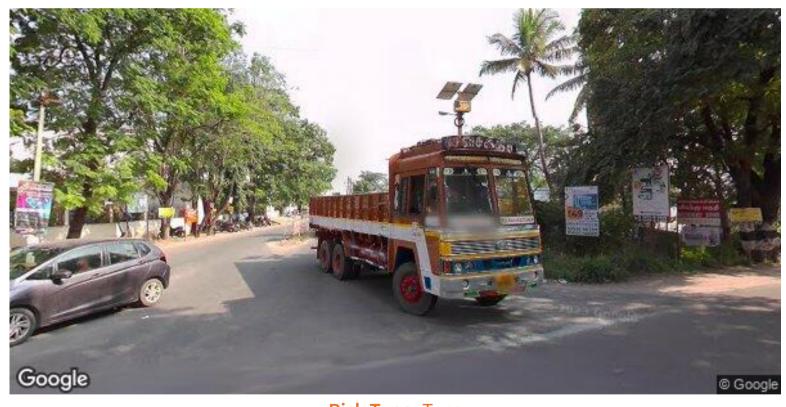
Coordinates: 11.13350, 77.03352

Risk Type: Turn
Risk Level: High
Speed Limit: 15 KM/Hr

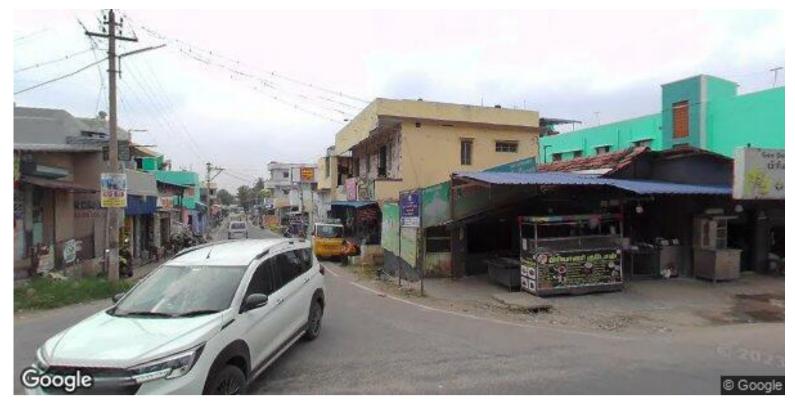
Coordinates: 11.13744, 77.03599

Risk Type: Blind Spot Risk Level: Blind Spot Speed Limit: 10 KM/Hr

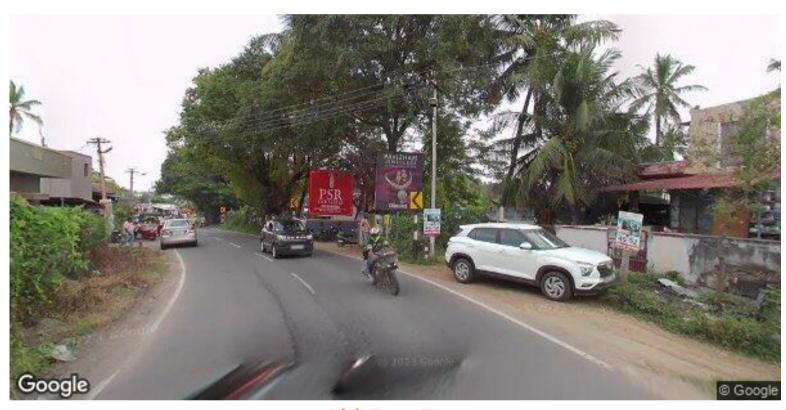
Risk Type: Turn
Risk Level: Medium
Speed Limit: 30 KM/Hr
Coordinates: 11.13663, 77.03025

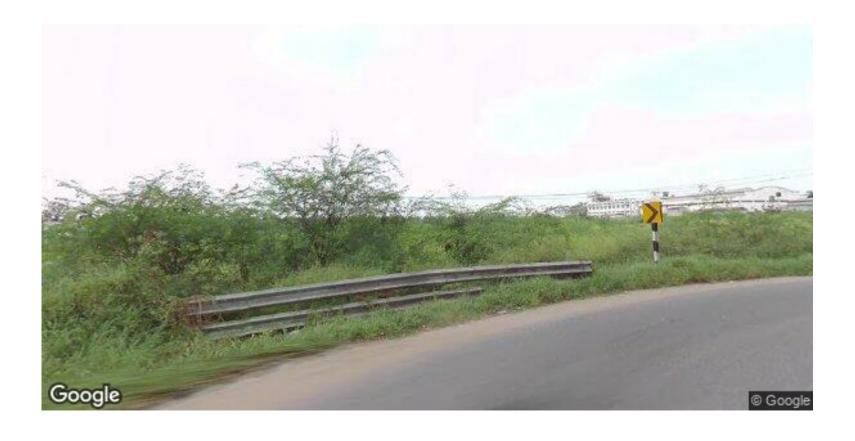
Coordinates: 11.13663, 77.03012

Risk Type: Turn
Risk Level: High
Speed Limit: 15 KM/Hr

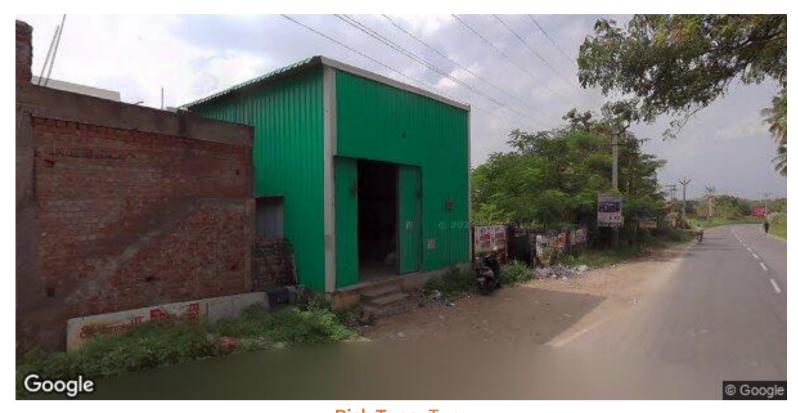
Risk Type: Turn
Risk Level: High
Speed Limit: 15 KM/Hr
Coordinates: 11.13963, 77.02926

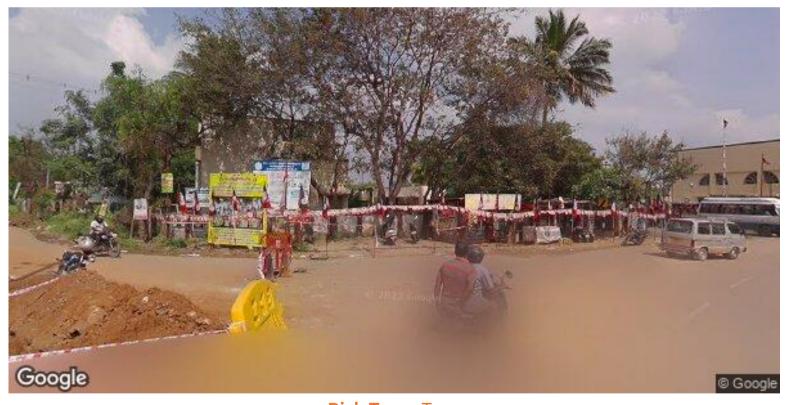
Risk Type: Turn
Risk Level: High
Speed Limit: 15 KM/Hr
Coordinates: 11.14337, 77.02076

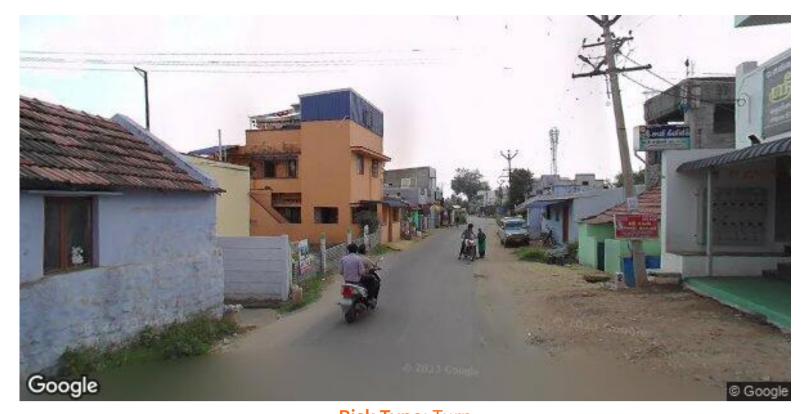
Risk Type: Turn
Risk Level: Medium
Speed Limit: 30 KM/Hr
Coordinates: 11.14511, 77.02005

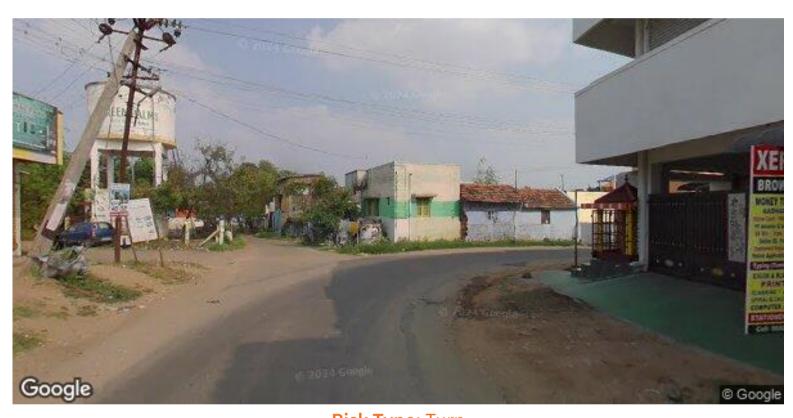
Risk Type: Turn
Risk Level: Medium
Speed Limit: 30 KM/Hr
Coordinates: 11.14519, 77.01994

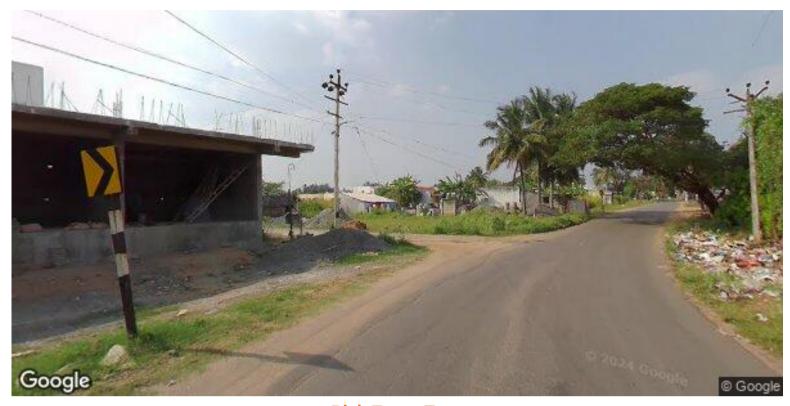
Coordinates: 11.14506, 77.01808

Risk Type: Turn
Risk Level: Medium
Speed Limit: 30 KM/Hr

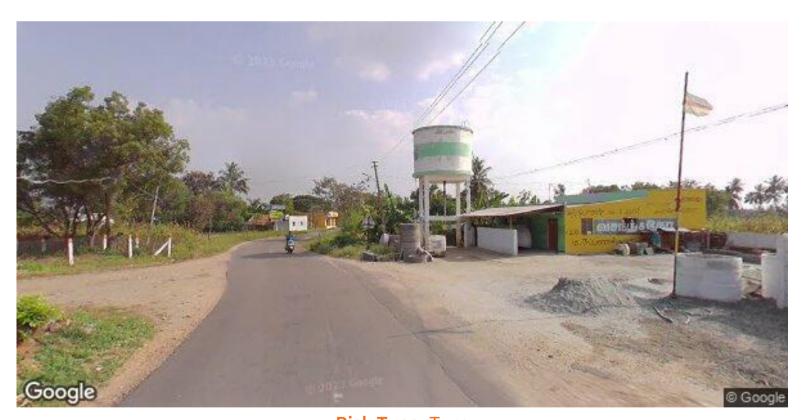
Coordinates: 11.15582, 77.00906

Risk Type: Turn
Risk Level: Medium
Speed Limit: 30 KM/Hr

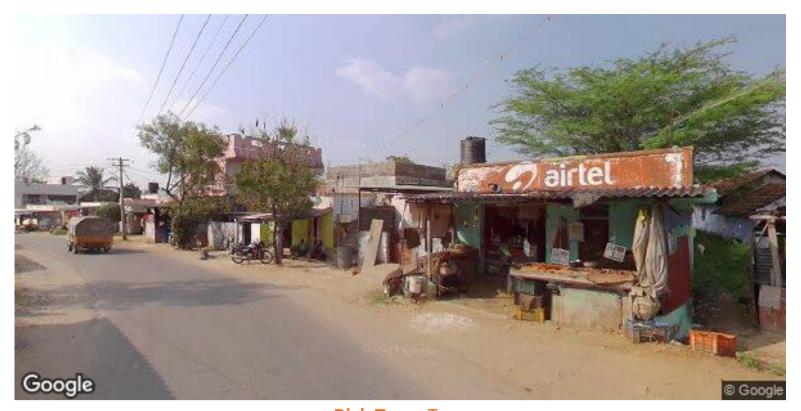
Risk Type: Turn
Risk Level: Medium
Speed Limit: 30 KM/Hr
Coordinates: 11.15986, 77.00680

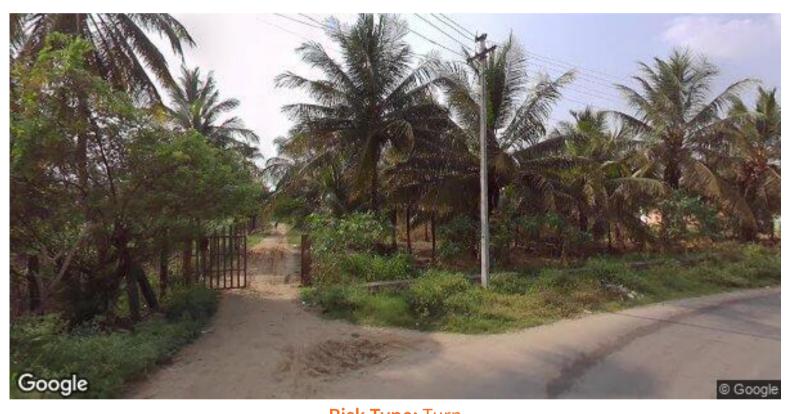
Risk Type: Turn
Risk Level: High
Speed Limit: 15 KM/Hr
Coordinates: 11.15965, 77.00356

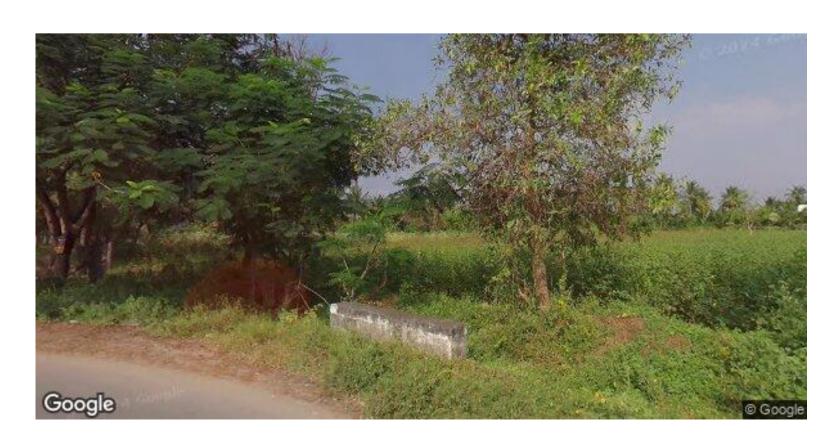
Coordinates: 11.16067, 77.00341

Risk Type: Turn
Risk Level: High
Speed Limit: 15 KM/Hr

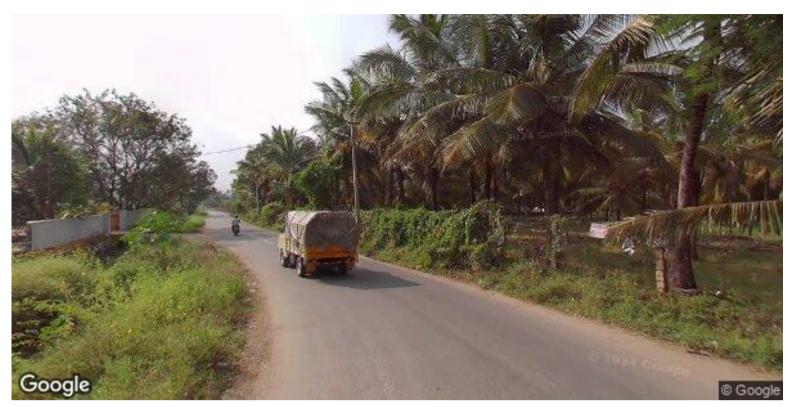
Coordinates: 11.16073, 77.00332

Risk Type: Turn
Risk Level: Medium
Speed Limit: 30 KM/Hr

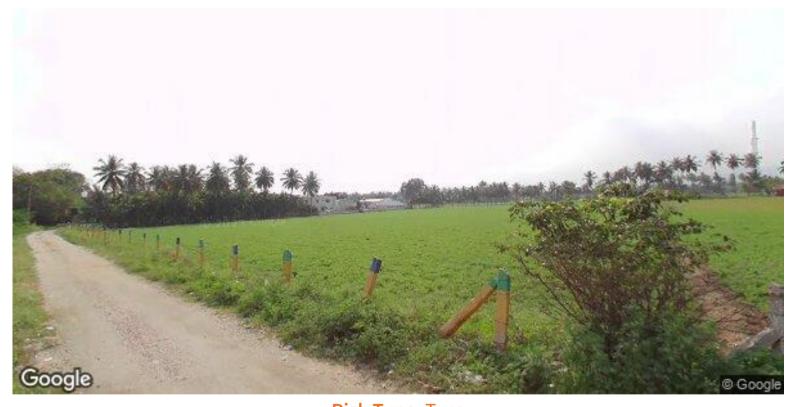
Risk Type: Turn
Risk Level: Medium
Speed Limit: 30 KM/Hr
Coordinates: 11.16037, 77.00099

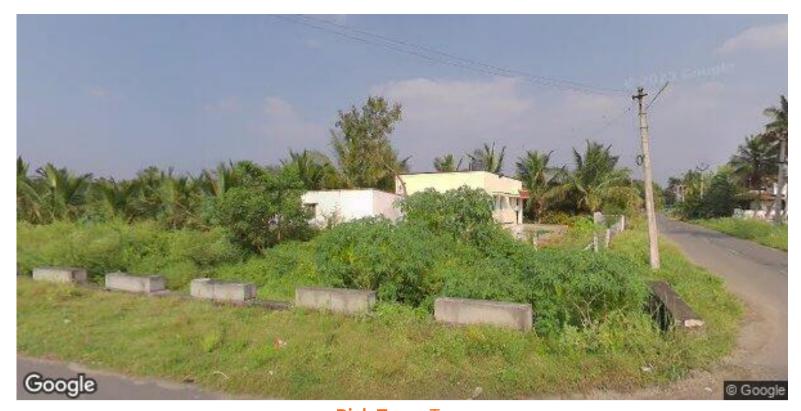
Risk Type: Turn
Risk Level: Medium
Speed Limit: 30 KM/Hr
Coordinates: 11.16040, 77.00094

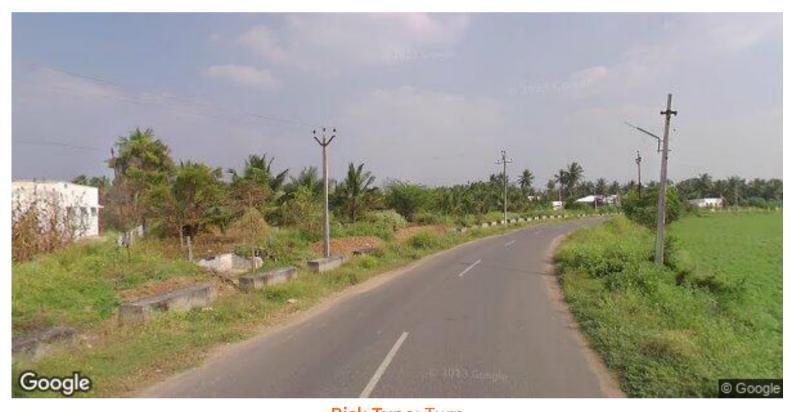
Risk Type: Turn
Risk Level: Medium
Speed Limit: 30 KM/Hr
Coordinates: 11.16121, 77.00043

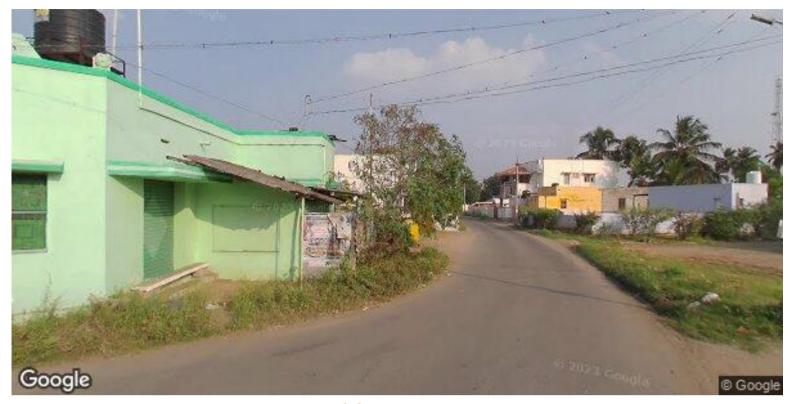
Coordinates: 11.16220, 76.99654

Risk Type: Turn
Risk Level: High
Speed Limit: 15 KM/Hr

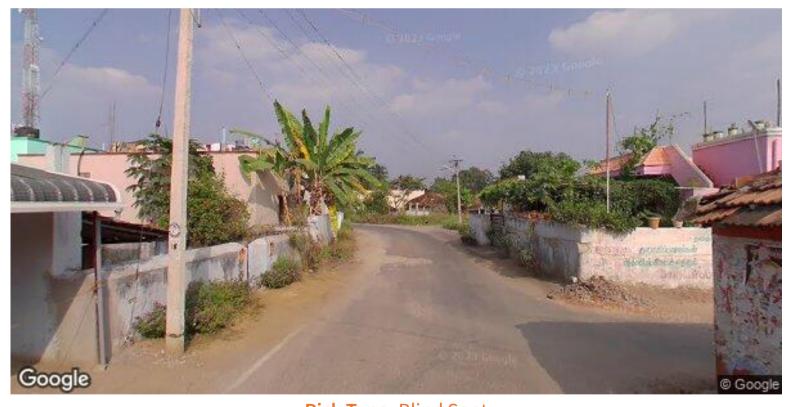
Coordinates: 11.16262, 76.99646

Risk Type: Blind Spot Risk Level: Blind Spot Speed Limit: 10 KM/Hr

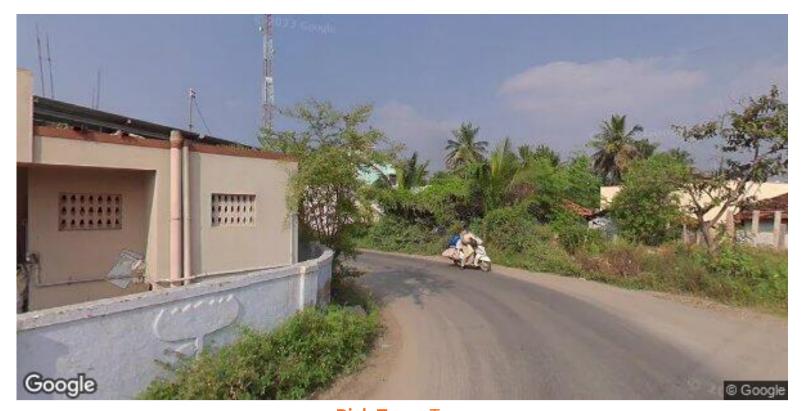
Risk Type: Turn
Risk Level: Medium
Speed Limit: 30 KM/Hr
Coordinates: 11.16271, 76.99667

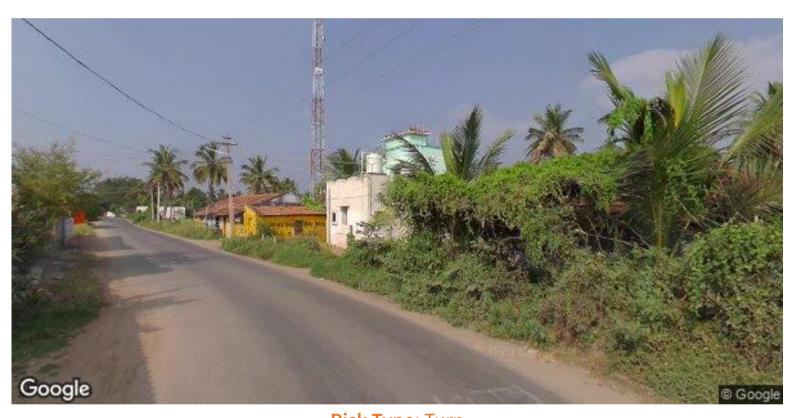
Risk Type: Turn
Risk Level: Medium
Speed Limit: 30 KM/Hr
Coordinates: 11.16279, 76.99670

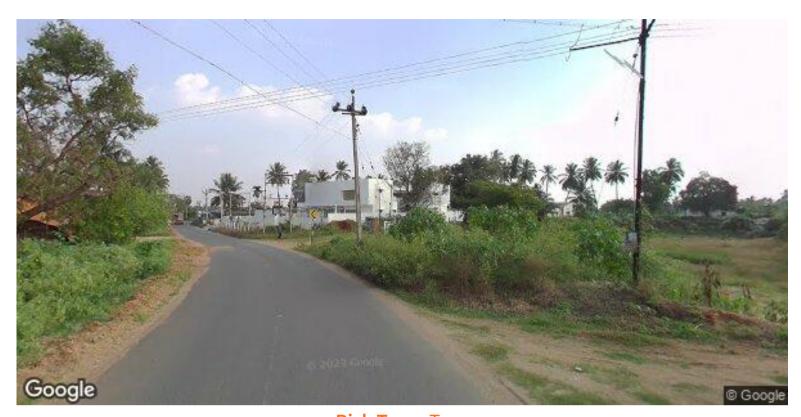
Risk Type: Turn
Risk Level: Medium
Speed Limit: 30 KM/Hr
Coordinates: 11.17290, 76.99216

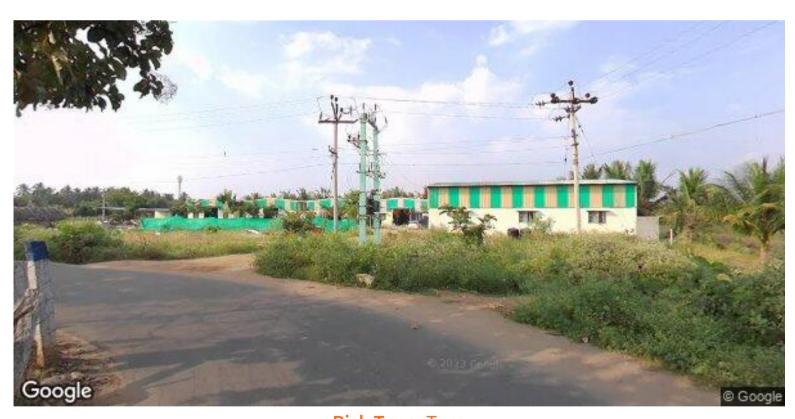
Risk Type: Turn
Risk Level: Medium
Speed Limit: 30 KM/Hr
Coordinates: 11.17379, 76.99181

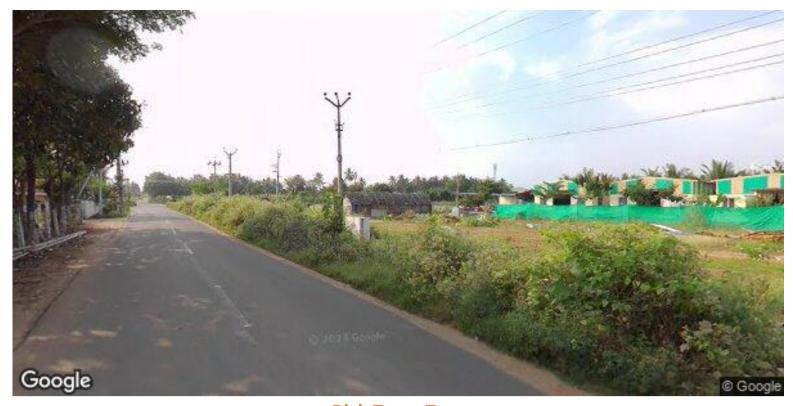
Risk Type: Turn
Risk Level: Medium
Speed Limit: 30 KM/Hr
Coordinates: 11.17392, 76.99166

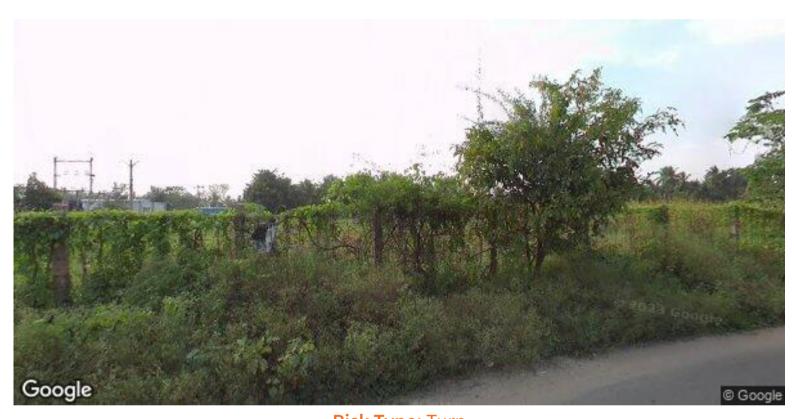
Risk Type: Turn
Risk Level: High
Speed Limit: 15 KM/Hr
Coordinates: 11.17390, 76.99070

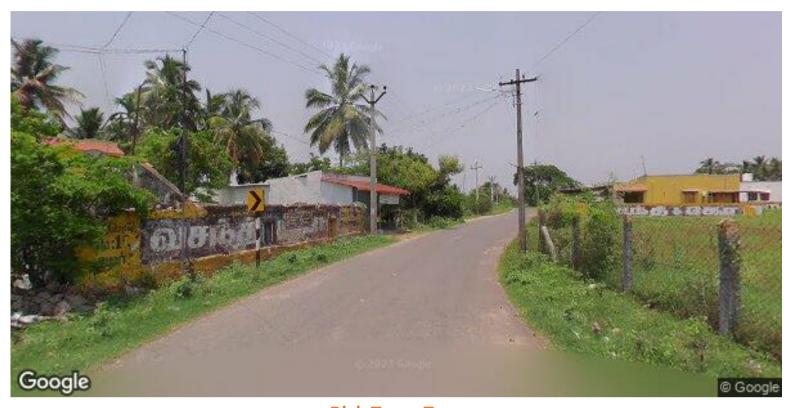
Risk Type: Turn
Risk Level: Medium
Speed Limit: 30 KM/Hr
Coordinates: 11.17698, 76.99007

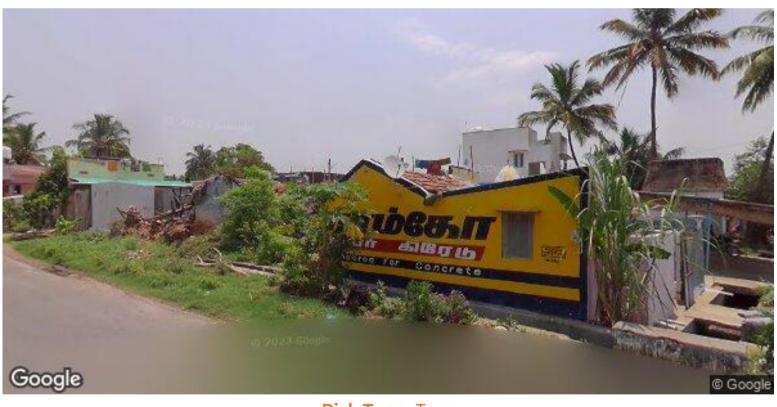
Risk Type: Turn
Risk Level: High
Speed Limit: 15 KM/Hr
Coordinates: 11.17708, 76.98998

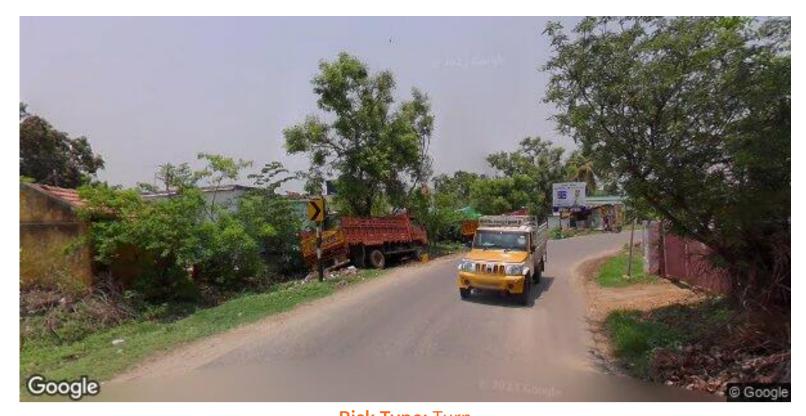
Risk Type: Turn
Risk Level: Medium
Speed Limit: 30 KM/Hr
Coordinates: 11.17754, 76.98799

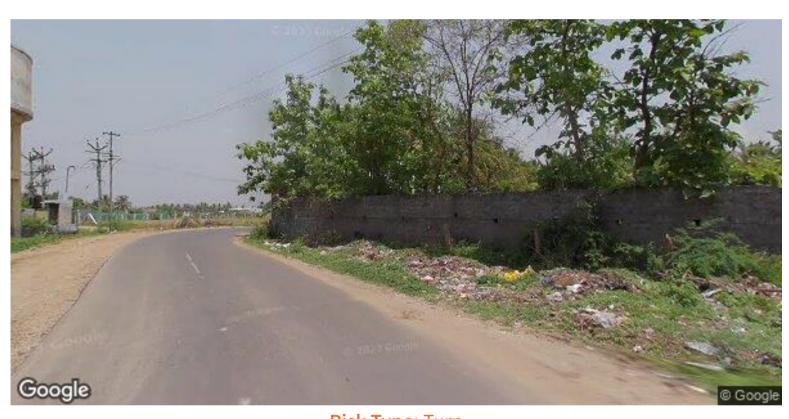
Risk Type: Turn
Risk Level: Medium
Speed Limit: 30 KM/Hr
Coordinates: 11.17695, 76.98636

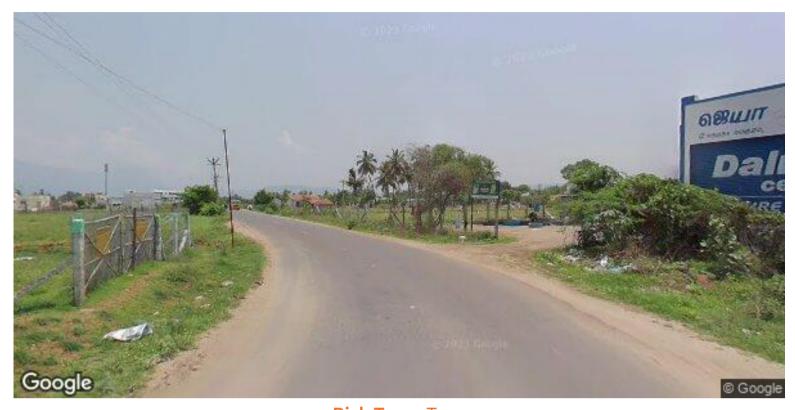
Risk Type: Turn
Risk Level: Medium
Speed Limit: 30 KM/Hr
Coordinates: 11.17640, 76.98486

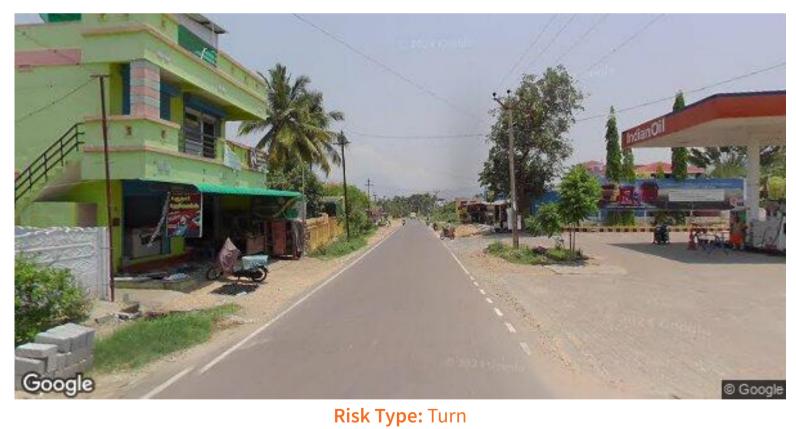
Risk Type. Turn
Risk Level: High
Speed Limit: 15 KM/Hr
Coordinates: 11.17505, 76.97821
