JOURNEY RISK MANAGEMENT (JRM) STUDY

Salem Terminal TO S P S MARKETING

Route Photos of Risky Spots

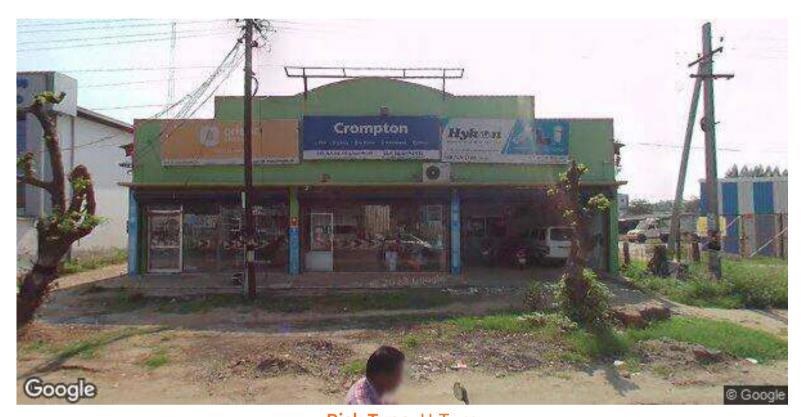
Coordinates: 11.0999904, 77.3822943

Risk Type: U-Turn
Risk Level: High
Speed Limit: 10 KM/Hr

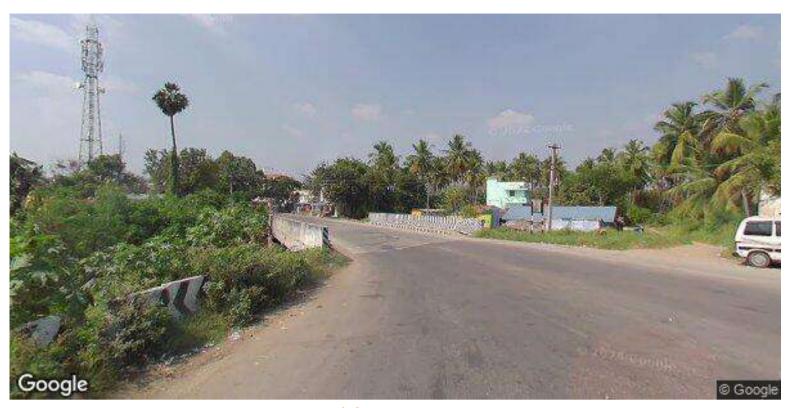
Risk Type: Turn
Risk Level: High
Speed Limit: 15 KM/Hr
Coordinates: 11.44893, 77.87413

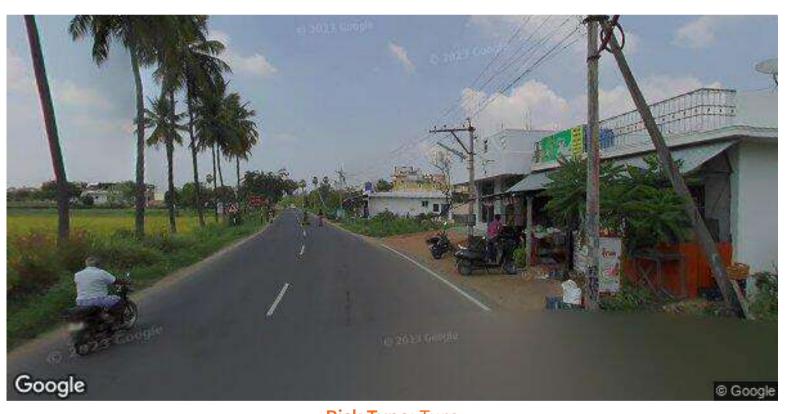
Risk Type: Turn
Risk Level: Medium
Speed Limit: 30 KM/Hr
Coordinates: 11.45127, 77.86734

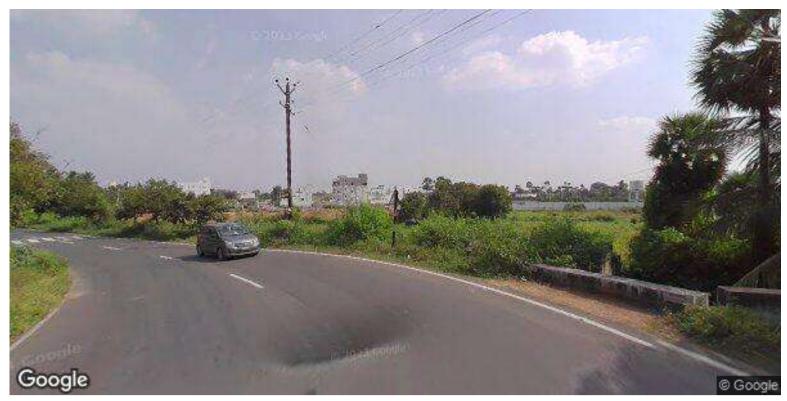
Risk Type: Turn
Risk Level: High
Speed Limit: 15 KM/Hr
Coordinates: 11.45350, 77.85700

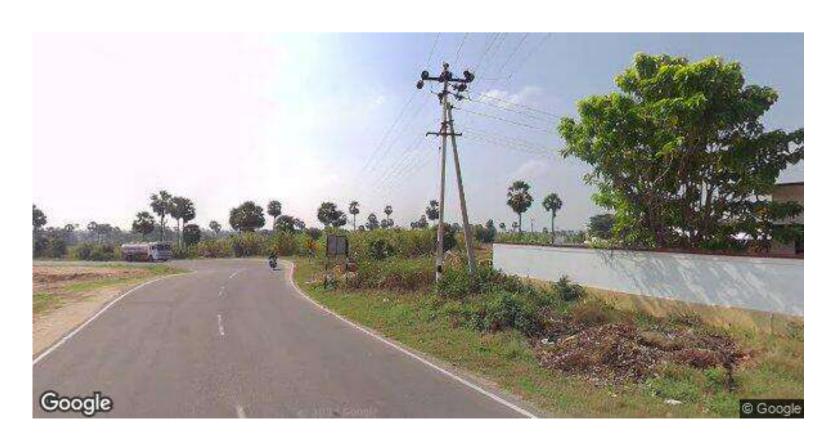
Coordinates: 11.45889, 77.85136

Risk Type: Turn
Risk Level: Medium
Speed Limit: 30 KM/Hr

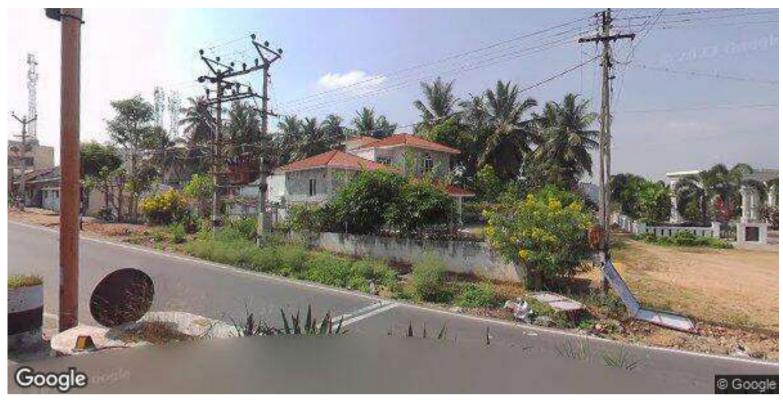
Coordinates: 11.46303, 77.84945

Risk Type: Turn
Risk Level: High
Speed Limit: 15 KM/Hr

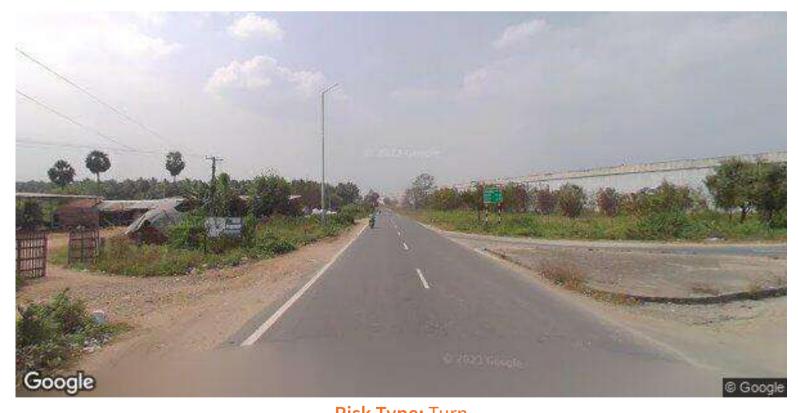
Coordinates: 11.45542, 77.81725

Risk Type: Turn
Risk Level: High
Speed Limit: 15 KM/Hr

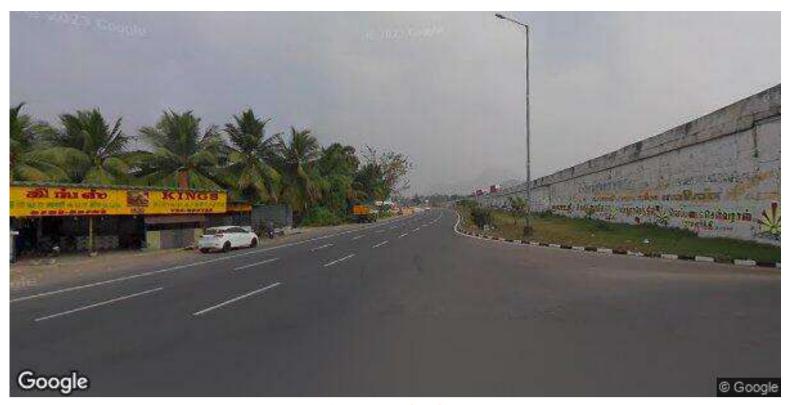
Risk Type: Blind Spot Risk Level: Blind Spot Speed Limit: 10 KM/Hr **Coordinates:** 11.45634, 77.81673

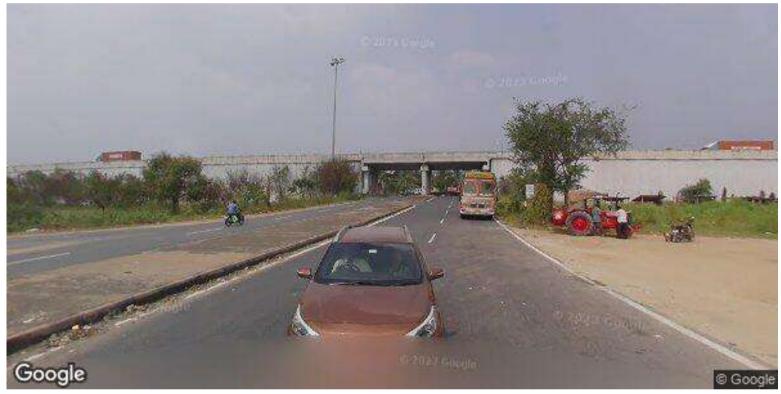
Risk Type: Turn Risk Level: High Speed Limit: 15 KM/Hr **Coordinates:** 11.45556, 77.81729

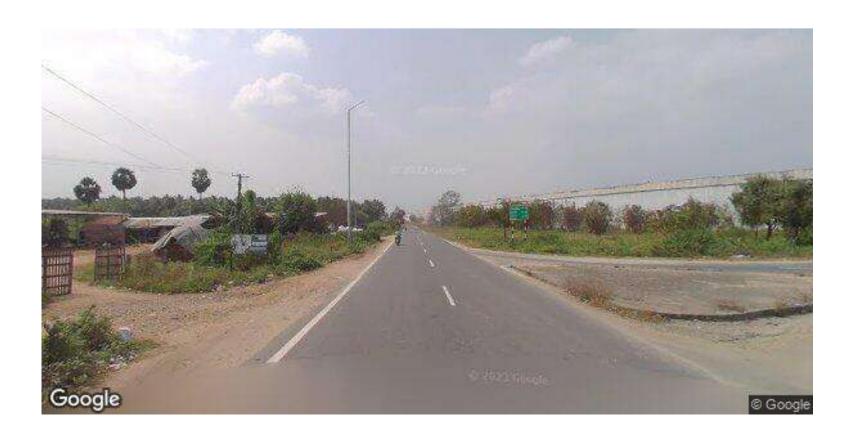
Coordinates: 11.45542, 77.81725

Risk Type: Turn
Risk Level: High
Speed Limit: 15 KM/Hr

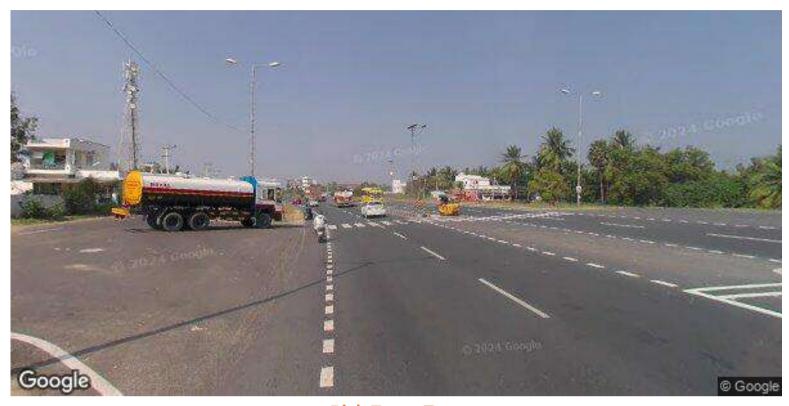
Coordinates: 11.45081, 77.77034

Risk Type: Turn
Risk Level: Medium
Speed Limit: 30 KM/Hr

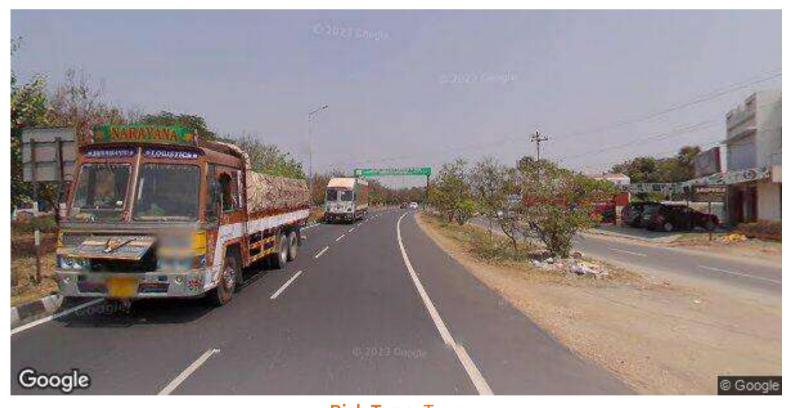
Coordinates: 11.43192, 77.67803

Risk Type: Turn
Risk Level: Medium
Speed Limit: 30 KM/Hr

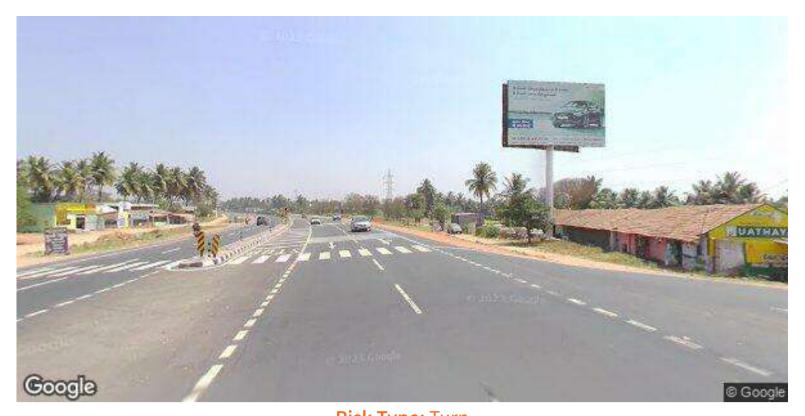
Risk Type: Turn
Risk Level: Medium
Speed Limit: 30 KM/Hr
Coordinates: 11.23716, 77.50666

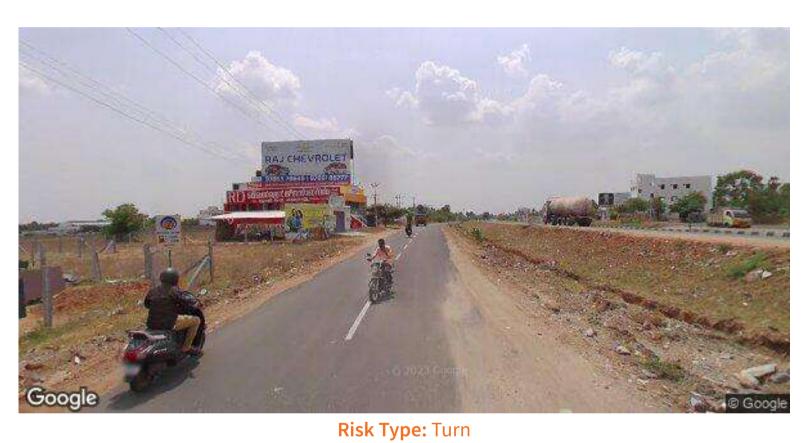
Coordinates: 11.23697, 77.50655

Risk Type: Turn

Risk Level: High

Speed Limit: 15 KM/Hr

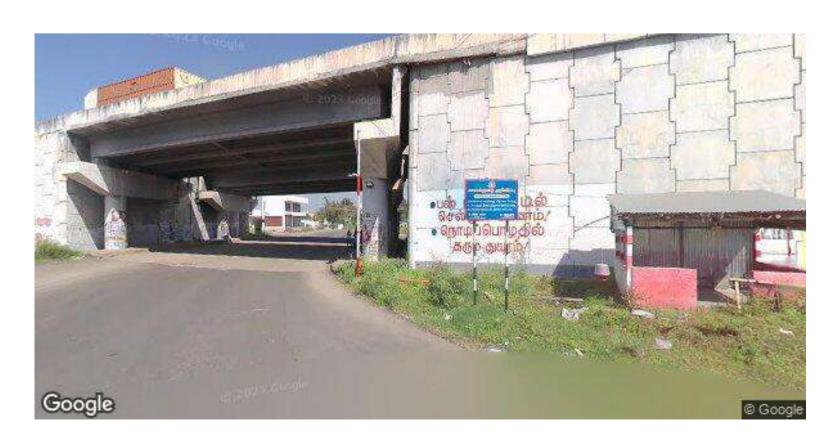
Coordinates: 11.23687, 77.50213

Risk Type: Blind Spot Risk Level: Blind Spot Speed Limit: 10 KM/Hr

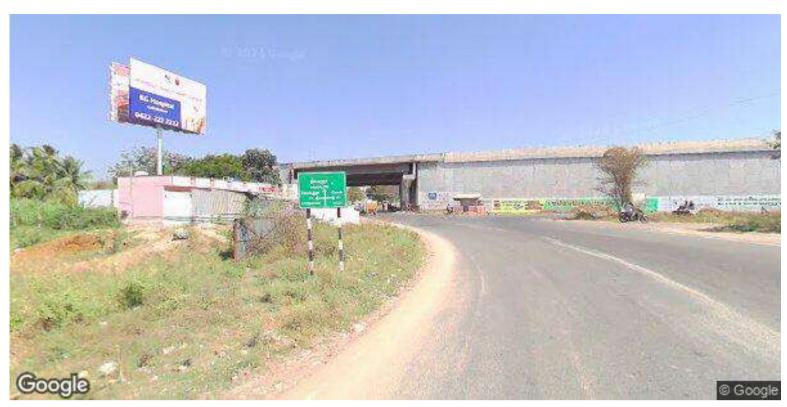
Coordinates: 11.23645, 77.50218

Risk Type: Turn
Risk Level: Medium
Speed Limit: 30 KM/Hr

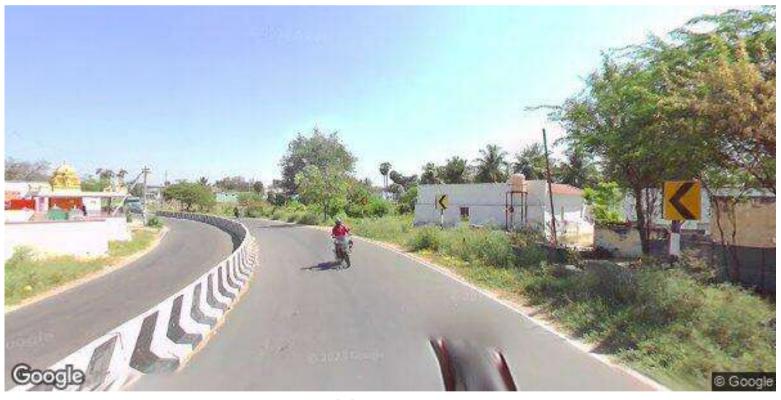
Coordinates: 11.23386, 77.50098

Risk Type: Turn
Risk Level: High
Speed Limit: 15 KM/Hr

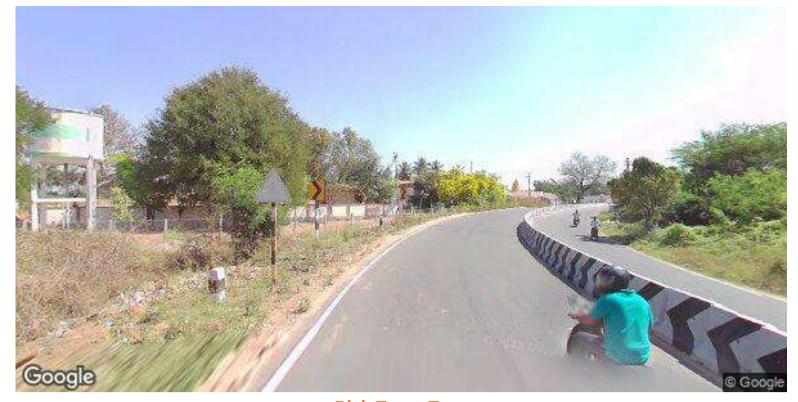
Risk Type: Turn
Risk Level: Medium
Speed Limit: 30 KM/Hr
Coordinates: 11.23319, 77.49954

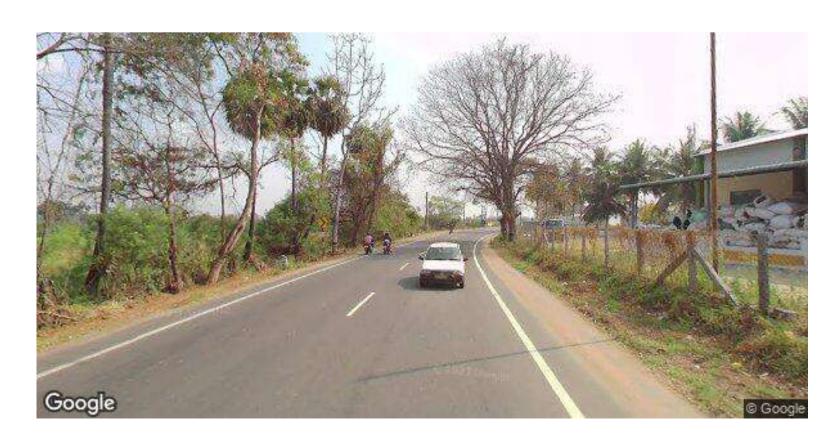
Coordinates: 11.18389, 77.46306

Risk Type: Turn
Risk Level: Medium
Speed Limit: 30 KM/Hr

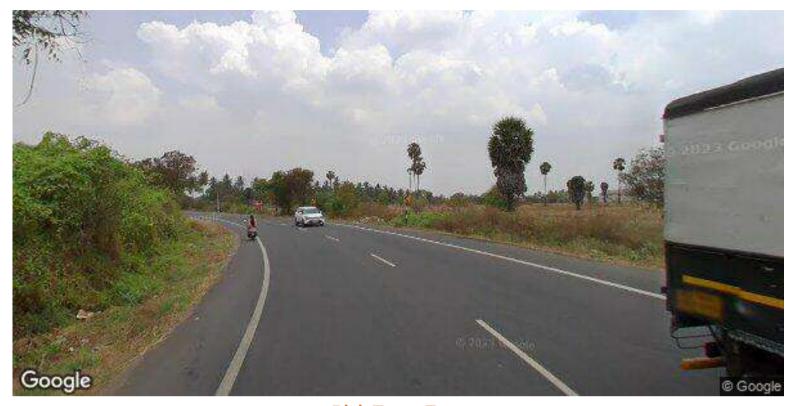
Risk Type: Turn
Risk Level: Medium
Speed Limit: 30 KM/Hr
Coordinates: 11.17834, 77.46162

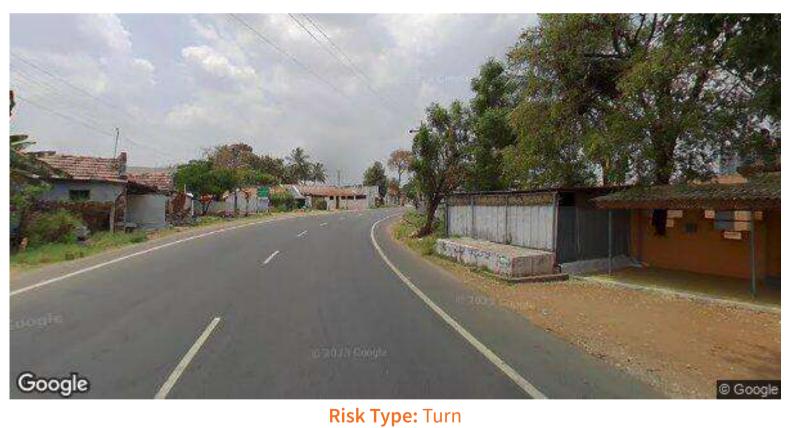
Risk Level: Medium
Speed Limit: 30 KM/Hr
Coordinates: 11.17518, 77.45976

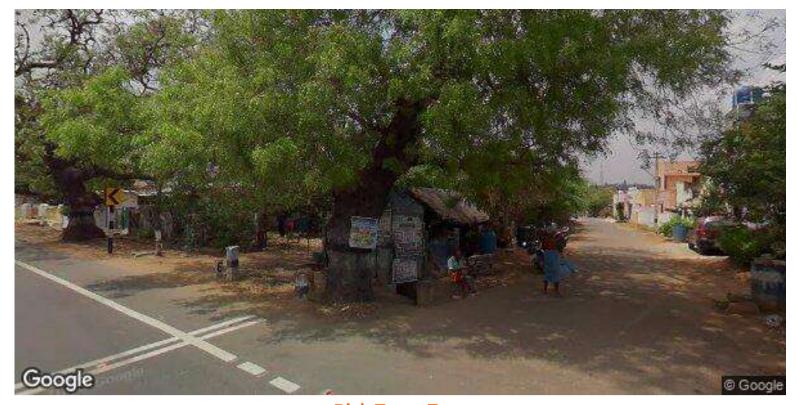
Risk Type: Turn
Risk Level: Medium
Speed Limit: 30 KM/Hr
Coordinates: 11.17366, 77.45728

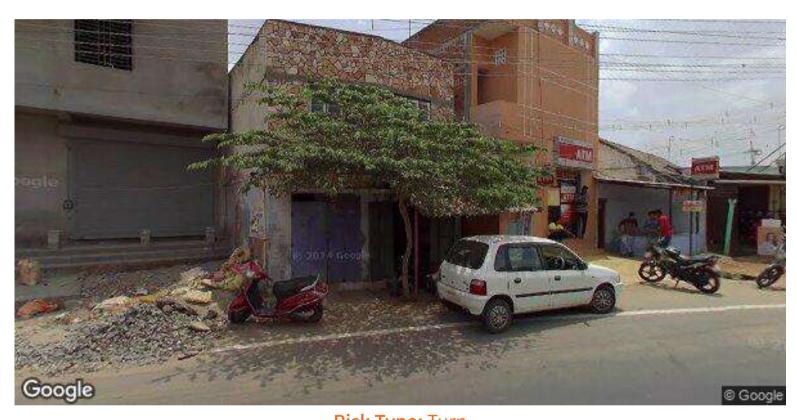
Risk Type: Turn
Risk Level: Medium
Speed Limit: 30 KM/Hr
Coordinates: 11.17144, 77.45602

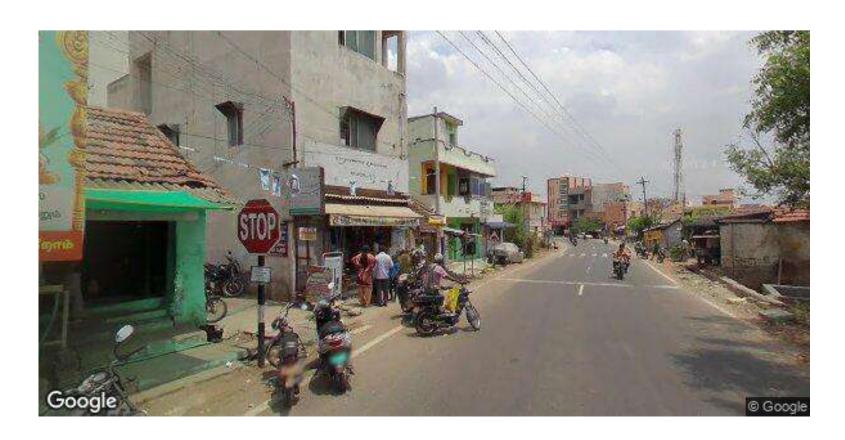
Coordinates: 11.17103, 77.45527

Risk Type: Turn
Risk Level: High
Speed Limit: 15 KM/Hr

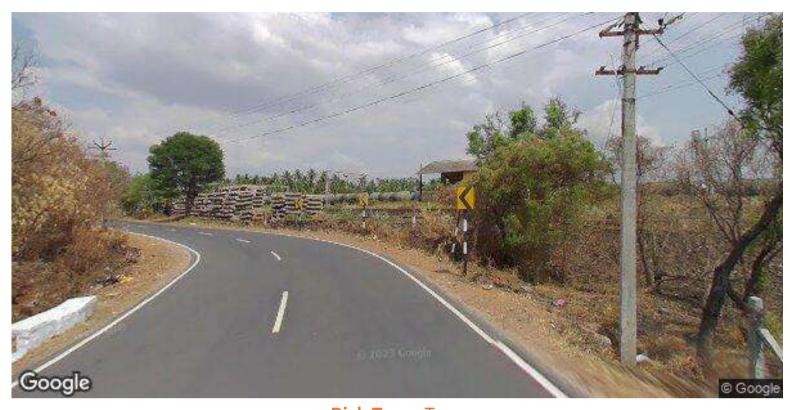
Risk Type: Turn
Risk Level: High
Speed Limit: 15 KM/Hr
Coordinates: 11.15693, 77.44742

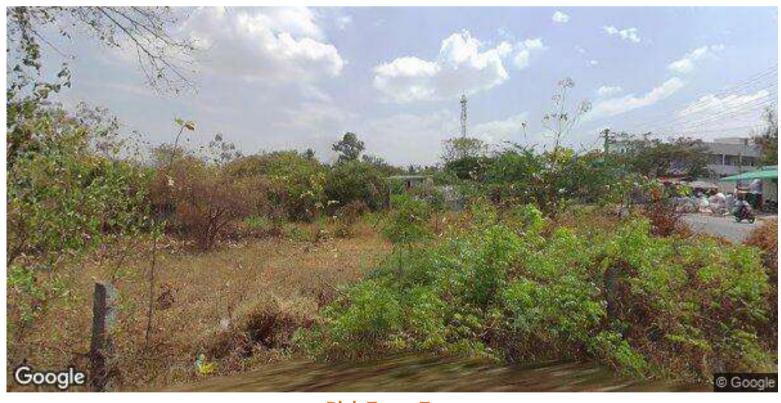
Risk Type: Turn
Risk Level: High
Speed Limit: 15 KM/Hr
Coordinates: 11.15727, 77.44546

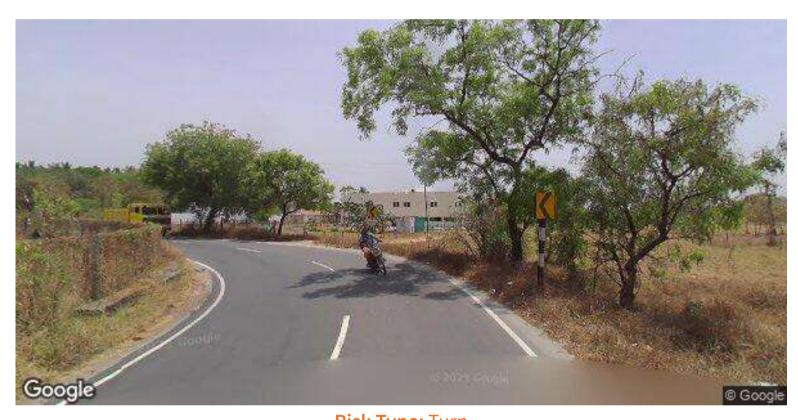
Risk Type: Turn
Risk Level: Medium
Speed Limit: 30 KM/Hr
Coordinates: 11.15595, 77.43624

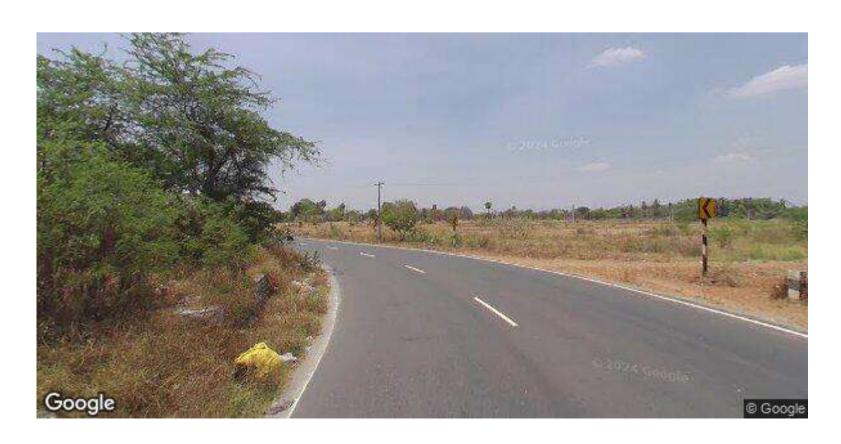
Coordinates: 11.15646, 77.43598

Risk Type: Turn
Risk Level: High
Speed Limit: 15 KM/Hr

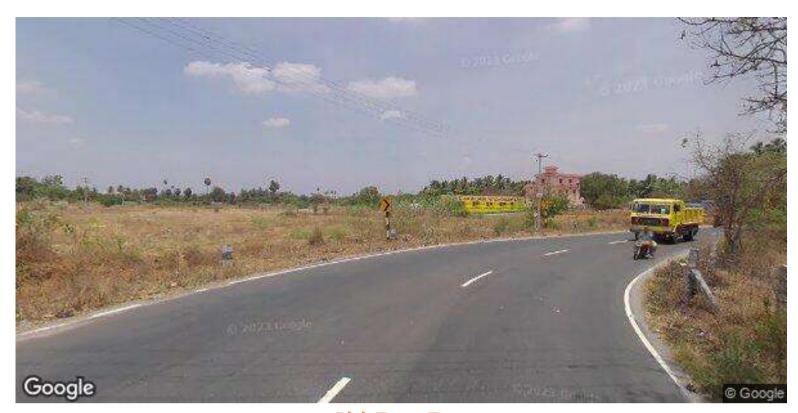
Risk Type: Turn
Risk Level: Medium
Speed Limit: 30 KM/Hr
Coordinates: 11.15642, 77.43541

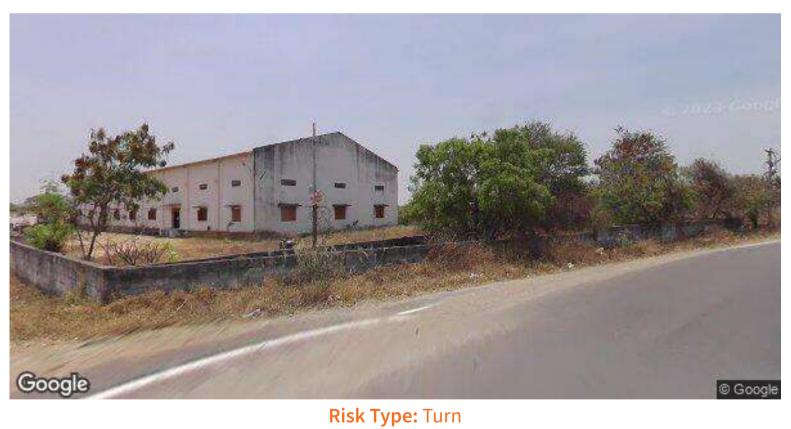
Risk Level: High
Speed Limit: 15 KM/Hr
Coordinates: 11.15606, 77.43505

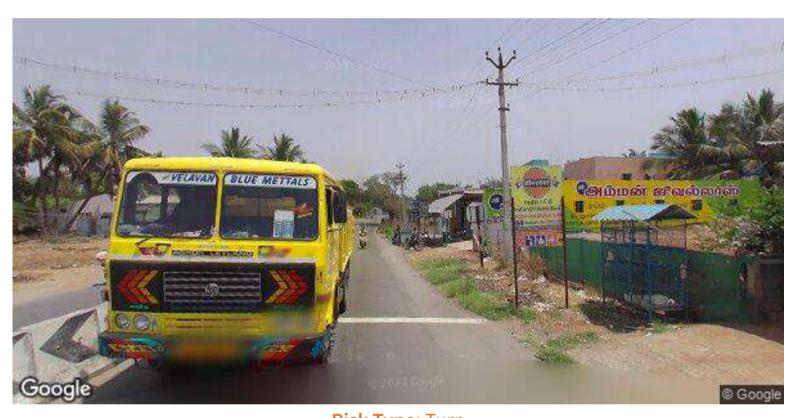
Risk Type: Turn
Risk Level: Medium
Speed Limit: 30 KM/Hr
Coordinates: 11.15839, 77.42789

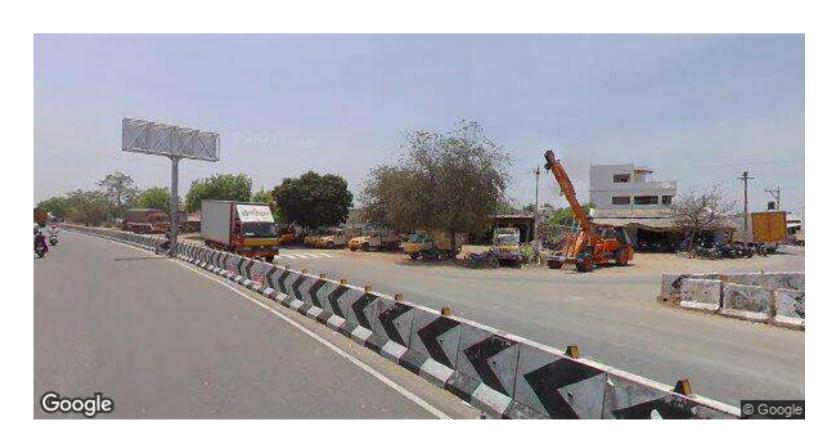
Coordinates: 11.15833, 77.42740

Risk Type: Turn
Risk Level: High
Speed Limit: 15 KM/Hr

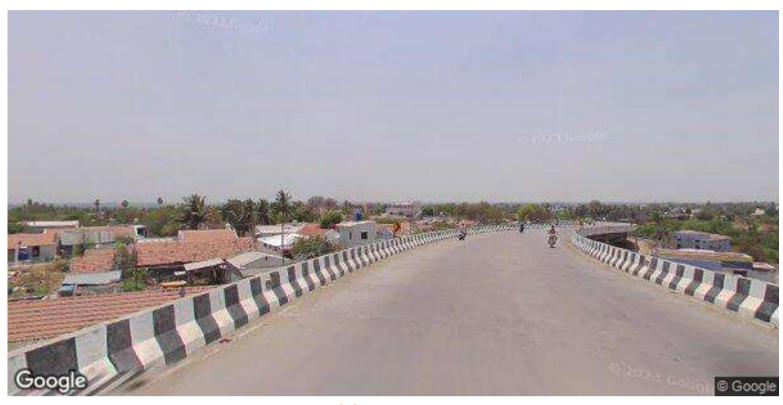
Risk Type: Turn
Risk Level: Medium
Speed Limit: 30 KM/Hr
Coordinates: 11.15226, 77.42425

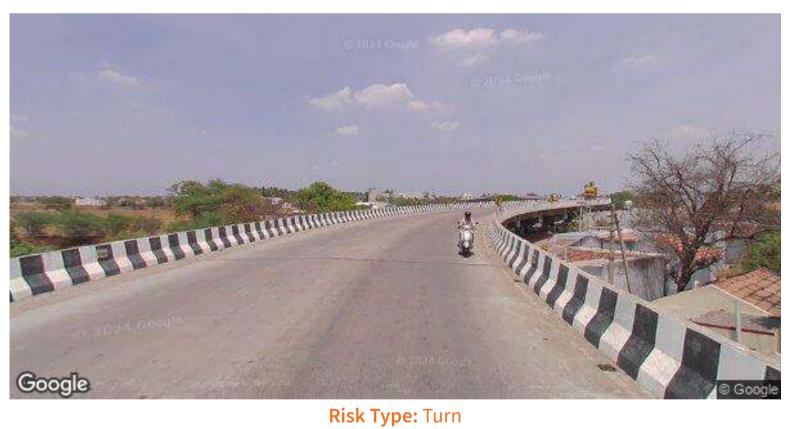
Risk Type. Turn
Risk Level: Medium
Speed Limit: 30 KM/Hr
Coordinates: 11.15141, 77.42304

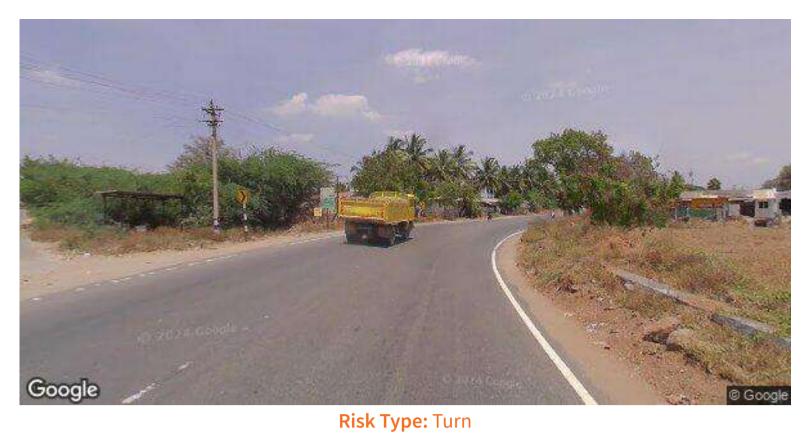
Risk Type: Turn
Risk Level: Medium
Speed Limit: 30 KM/Hr
Coordinates: 11.14904, 77.42031

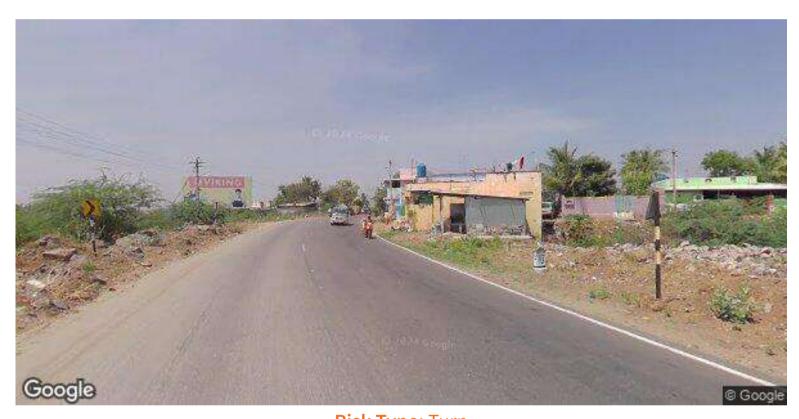
Risk Type: Turn
Risk Level: Medium
Speed Limit: 30 KM/Hr
Coordinates: 11.13860, 77.41623

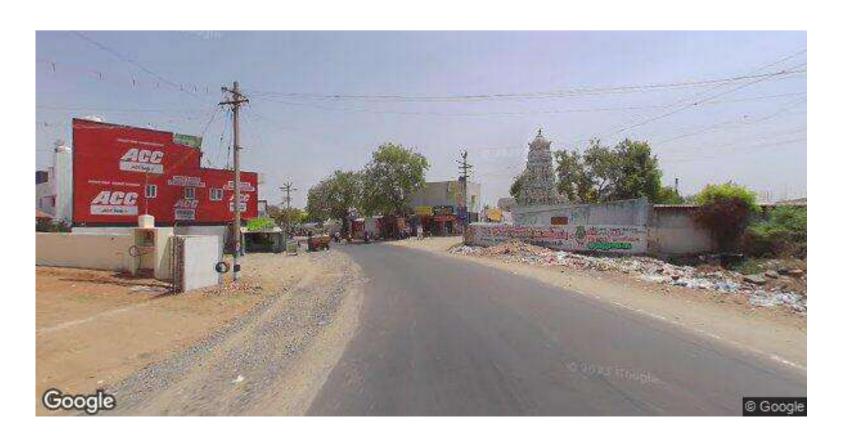
Coordinates: 11.12993, 77.40310

Risk Type: Turn
Risk Level: Medium
Speed Limit: 30 KM/Hr

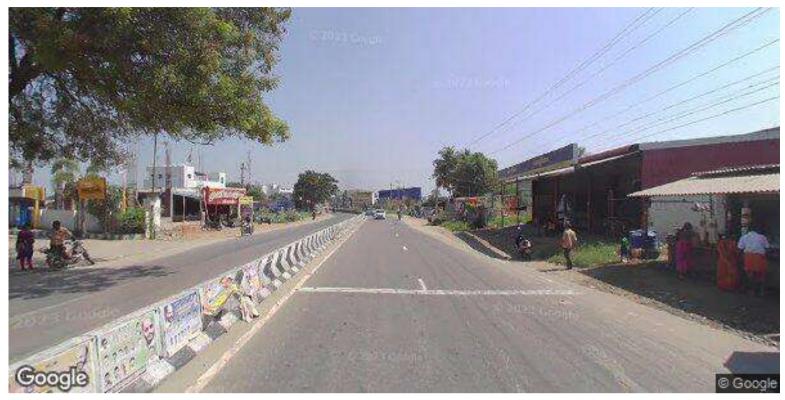
Coordinates: 11.12780, 77.39364

Risk Type: Turn
Risk Level: High
Speed Limit: 15 KM/Hr

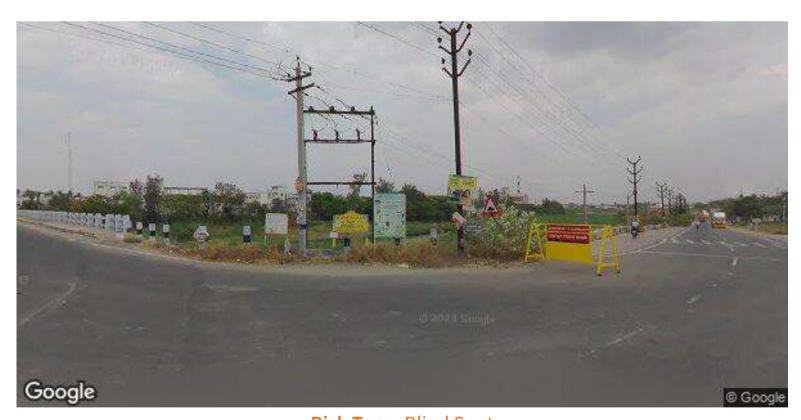
Coordinates: 11.11848, 77.39475

Risk Type: Blind Spot
Risk Level: Blind Spot
Speed Limit: 10 KM/Hr

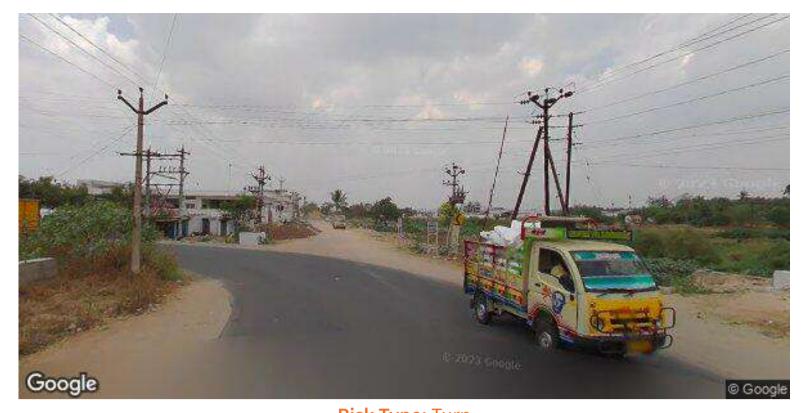
Risk Type: Turn
Risk Level: Medium
Speed Limit: 30 KM/Hr
Coordinates: 11.11841, 77.39405

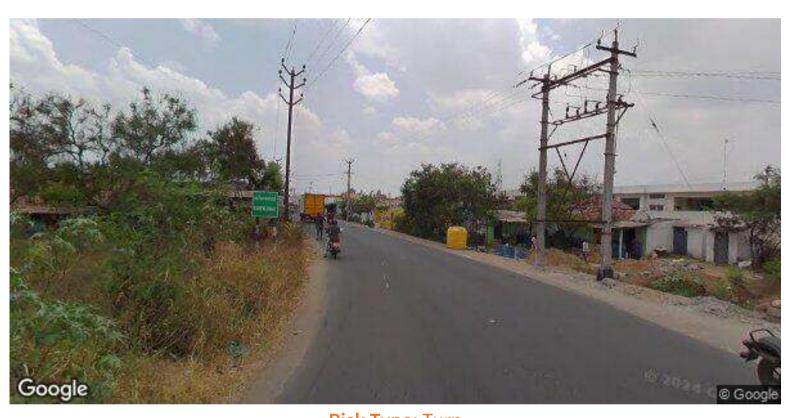
Risk Type: Turn
Risk Level: Medium
Speed Limit: 30 KM/Hr
Coordinates: 11.11826, 77.39386

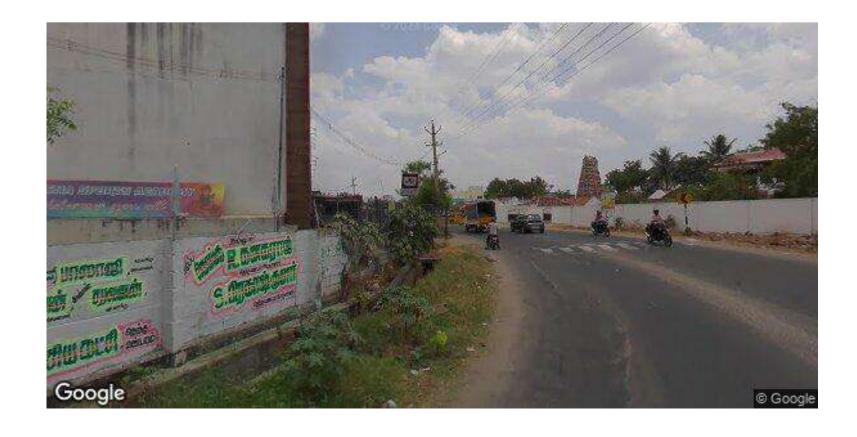
Coordinates: 11.10290, 77.39189

Risk Type: Turn
Risk Level: High
Speed Limit: 15 KM/Hr

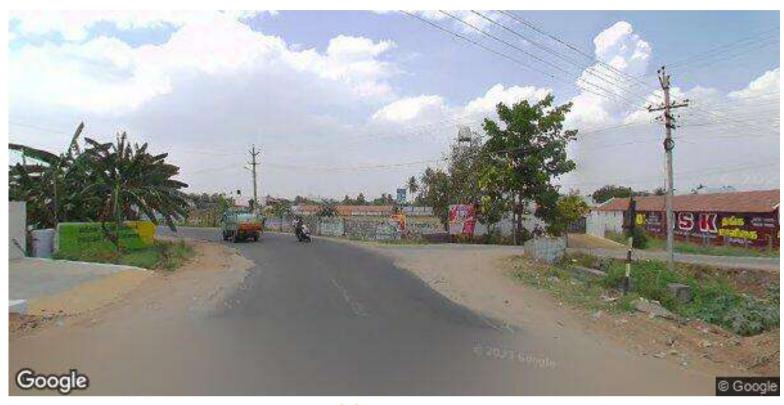
Coordinates: 11.10233, 77.39295

Risk Type: Turn
Risk Level: Medium
Speed Limit: 30 KM/Hr

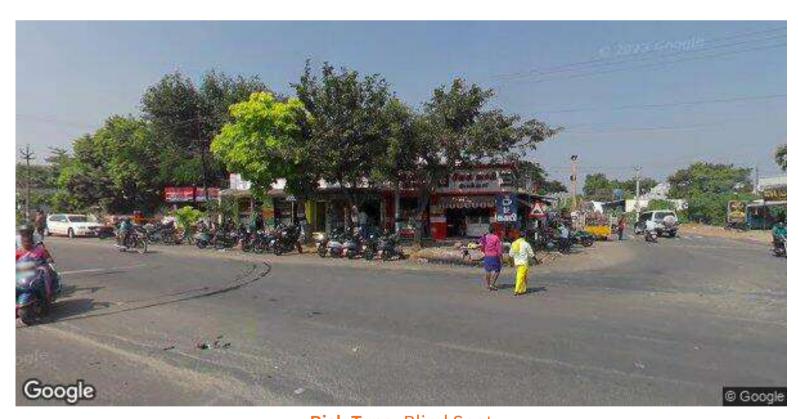
Coordinates: 11.09878, 77.39311

Risk Type: Blind Spot
Risk Level: Blind Spot
Speed Limit: 10 KM/Hr

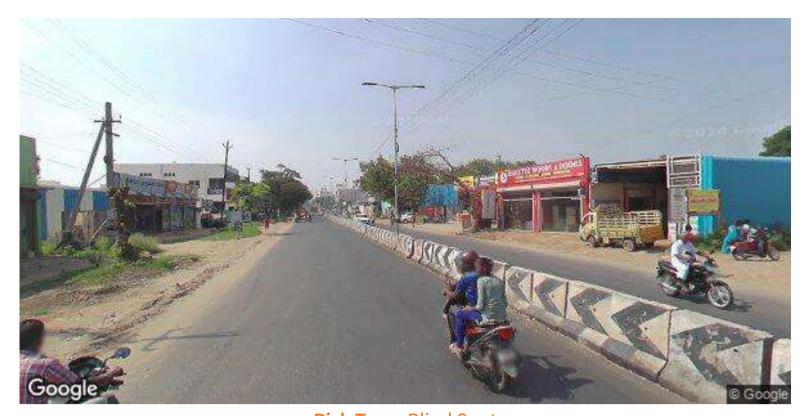
Coordinates: 11.09997, 77.38242

Risk Type: Blind Spot Risk Level: Blind Spot Speed Limit: 10 KM/Hr
