JOURNEY RISK MANAGEMENT (JRM) STUDY

Salem Terminal to A.GEE.FUELS

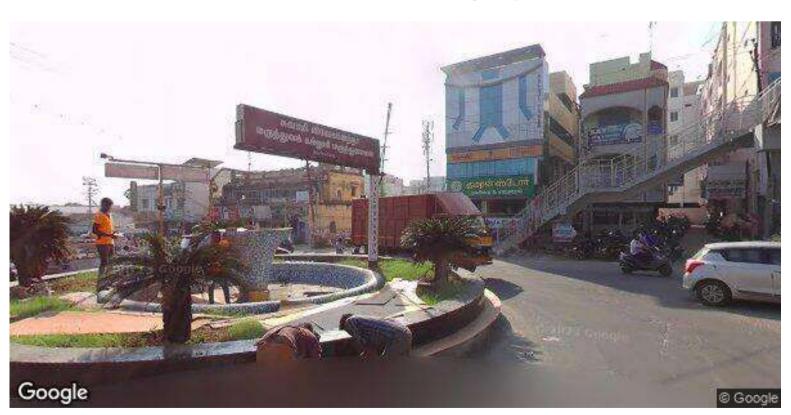
Coordinates: 11.38395, 77.89480

Risk Type: Roundabout
Risk Level: High
Speed Limit: 15 KM/Hr

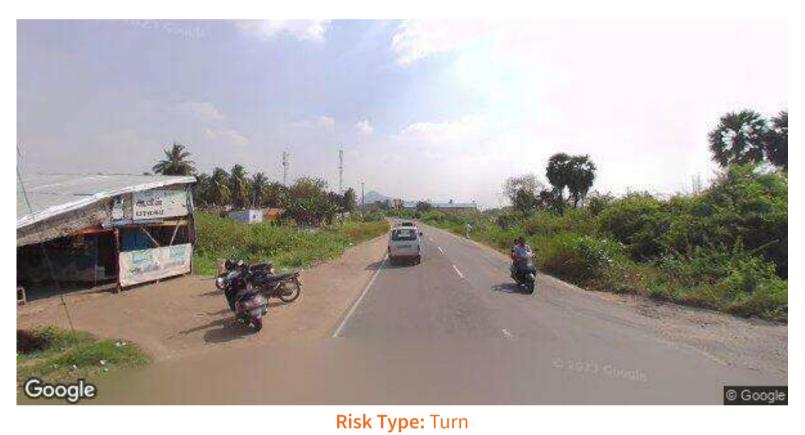
Risk Level: High
Speed Limit: 15 KM/Hr
Coordinates: 11.44022, 77.87546

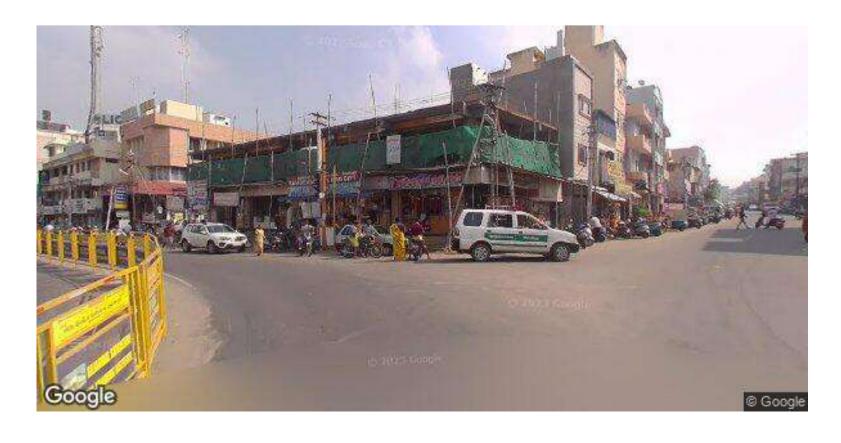
Coordinates: 11.37868, 77.89498

Risk Type: Turn
Risk Level: High
Speed Limit: 15 KM/Hr

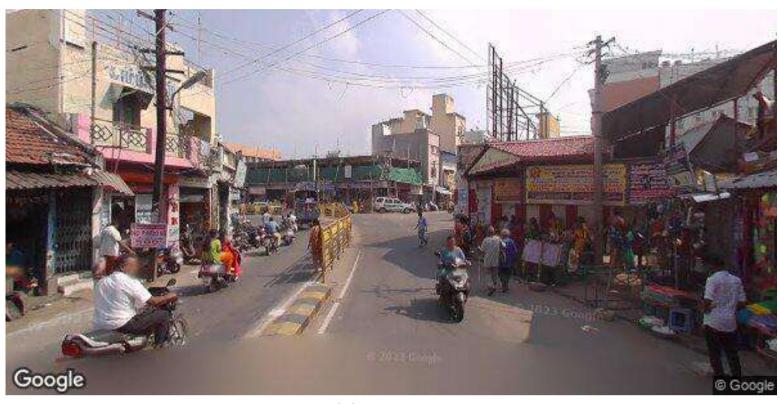
Coordinates: 11.37857, 77.89473

Risk Type: Turn
Risk Level: Medium
Speed Limit: 30 KM/Hr

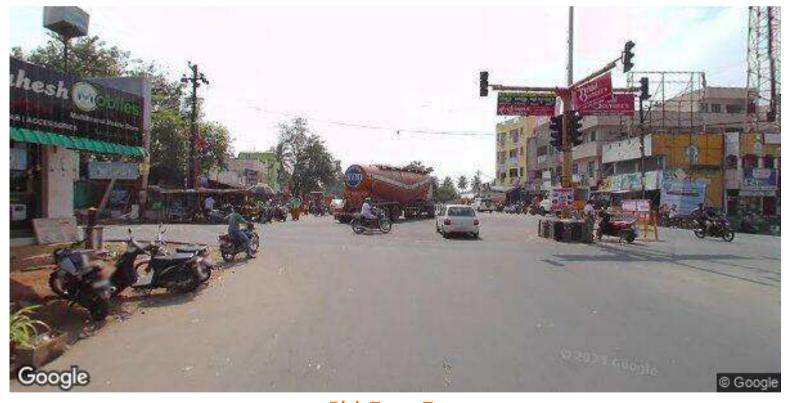
Coordinates: 11.36616, 77.88885

Risk Type: Turn
Risk Level: High
Speed Limit: 15 KM/Hr

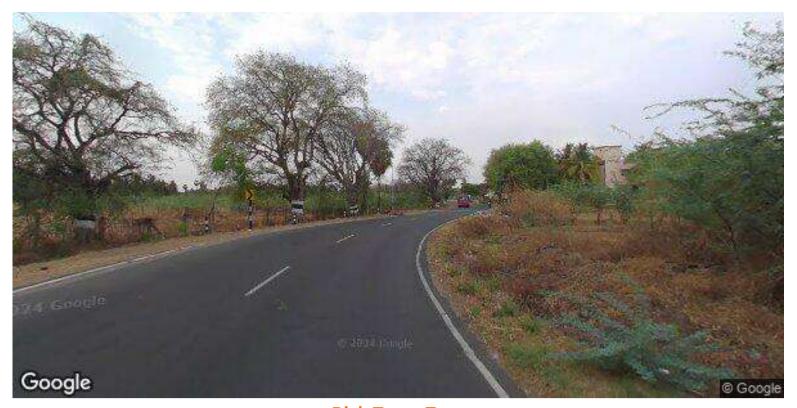
Risk Type: Turn
Risk Level: Medium
Speed Limit: 30 KM/Hr
Coordinates: 11.34067, 77.86347

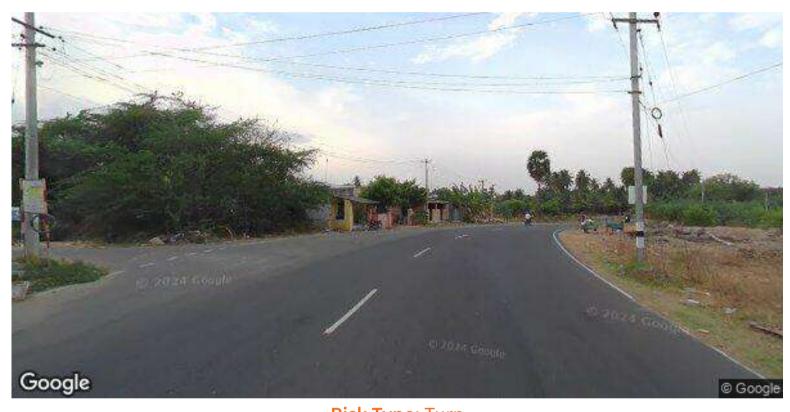
Risk Type: Turn
Risk Level: Medium
Speed Limit: 30 KM/Hr
Coordinates: 11.33854, 77.86216

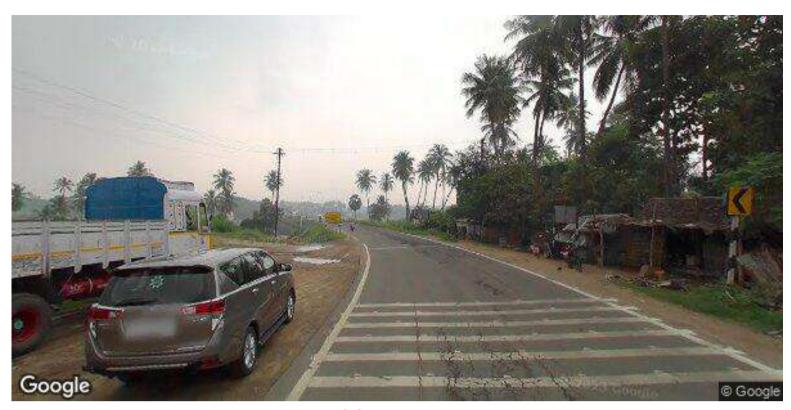
Risk Type: Turn
Risk Level: Medium
Speed Limit: 30 KM/Hr
Coordinates: 11.30952, 77.77587

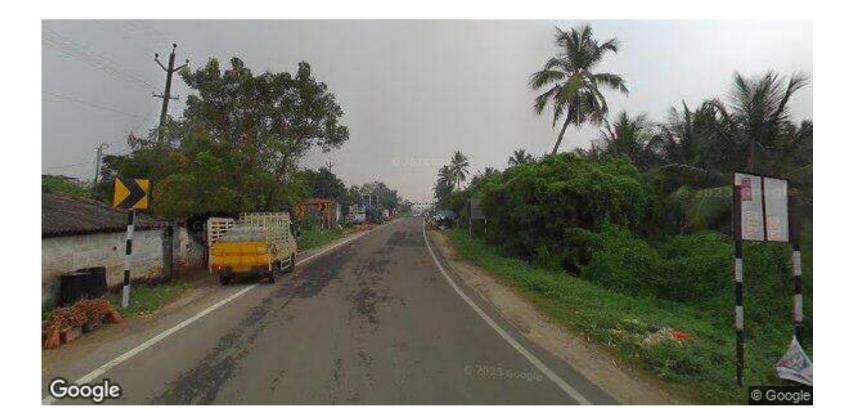
Risk Type: Turn
Risk Level: Medium
Speed Limit: 30 KM/Hr
Coordinates: 11.30973, 77.76712

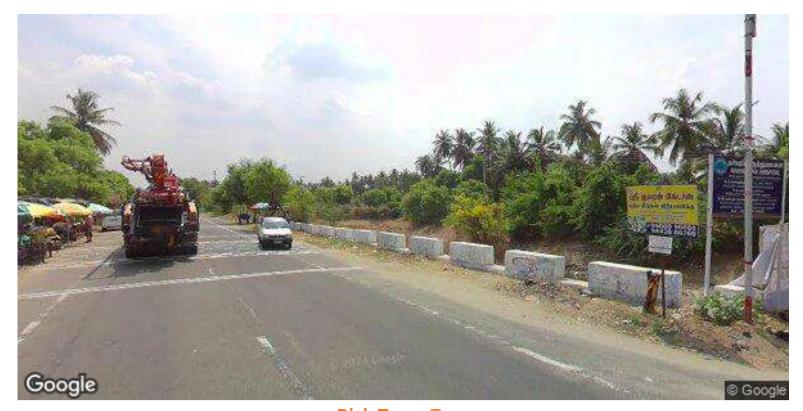
Risk Type: Turn
Risk Level: High
Speed Limit: 15 KM/Hr
Coordinates: 11.29490, 77.74685

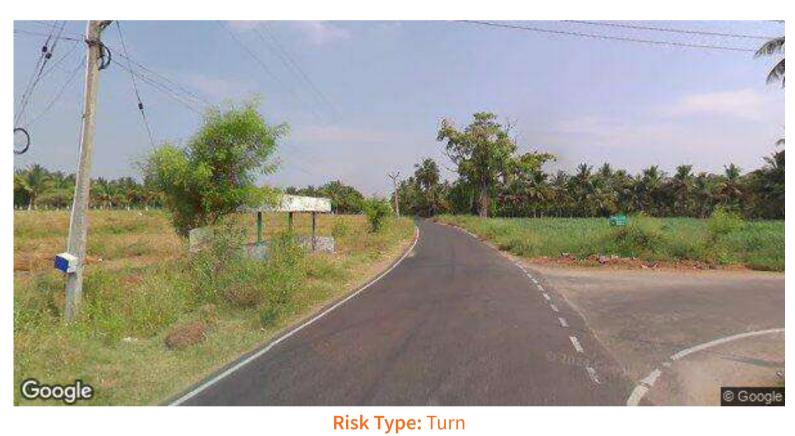
Risk Type: Turn
Risk Level: High
Speed Limit: 15 KM/Hr
Coordinates: 11.29141, 77.74662

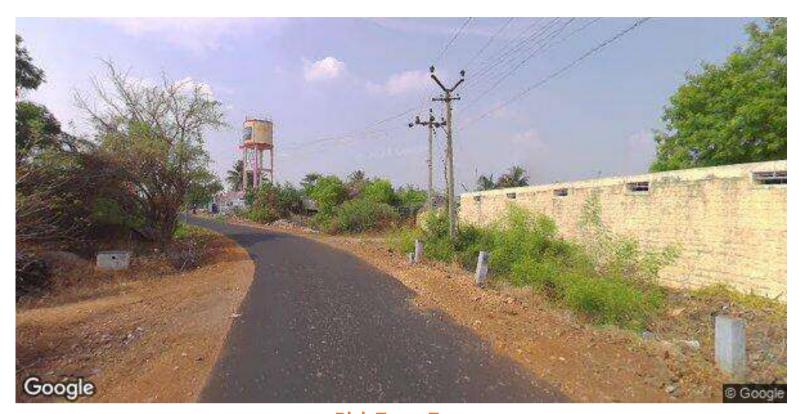
Risk Type: Turn
Risk Level: Medium
Speed Limit: 30 KM/Hr
Coordinates: 11.28573, 77.74281

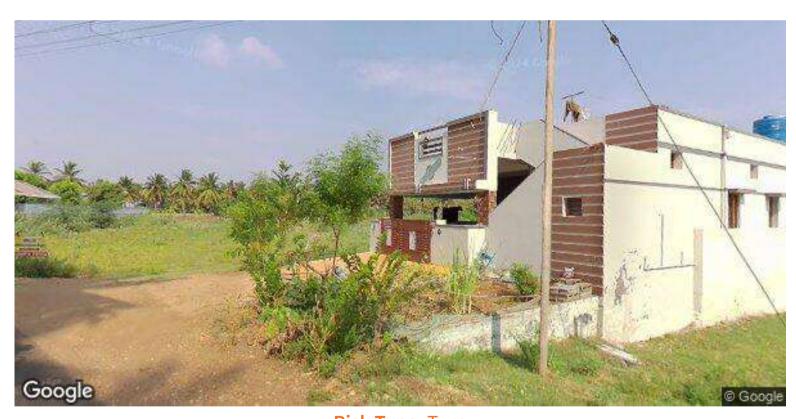
Risk Type: Turn
Risk Level: High
Speed Limit: 15 KM/Hr
Coordinates: 11.27319, 77.72981

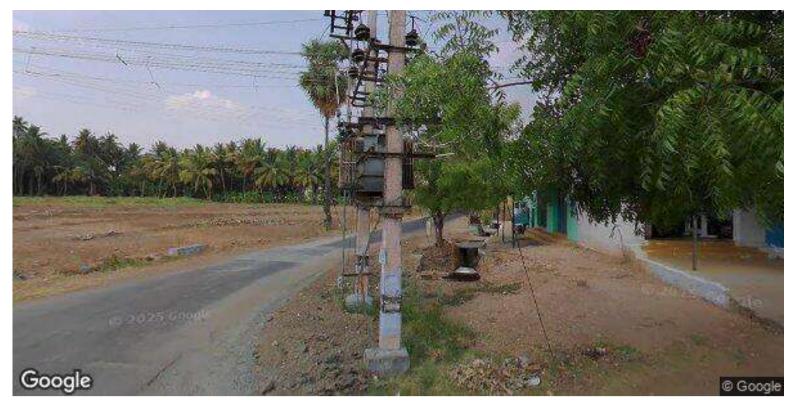
Coordinates: 11.27330, 77.72715

Risk Type: Blind Spot Risk Level: Blind Spot Speed Limit: 10 KM/Hr

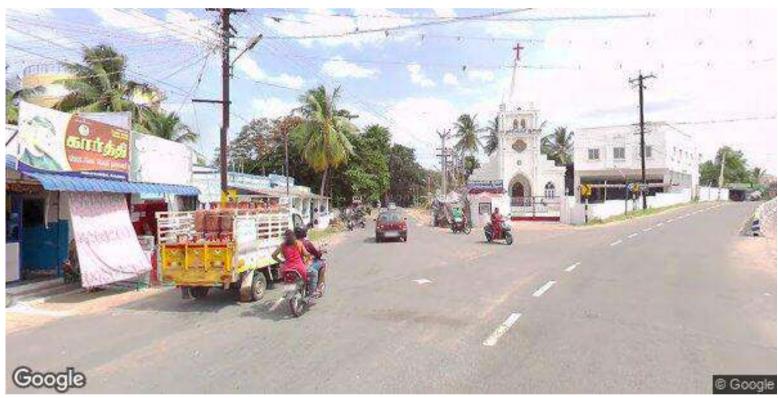
Risk Type: Turn
Risk Level: Medium
Speed Limit: 30 KM/Hr
Coordinates: 11.23054, 77.71796

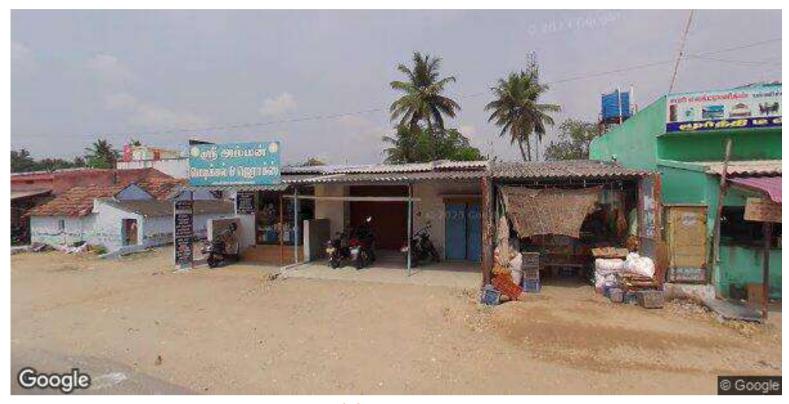
Risk Type: Turn
Risk Level: Medium
Speed Limit: 30 KM/Hr
Coordinates: 11.20776, 77.70916

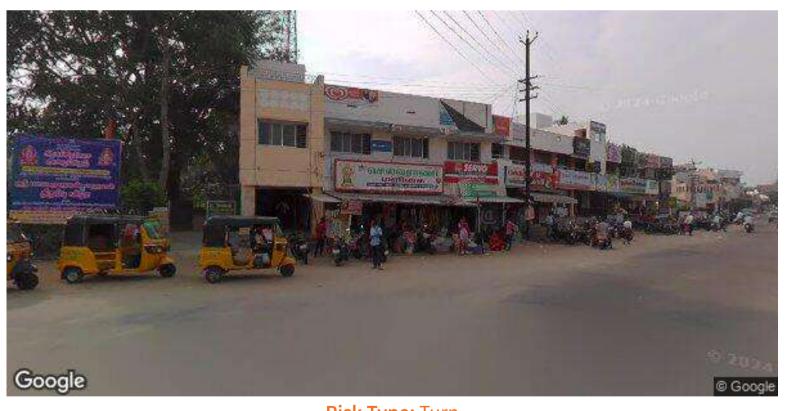
Risk Type: Turn
Risk Level: High
Speed Limit: 15 KM/Hr
Coordinates: 11.15942, 77.70068

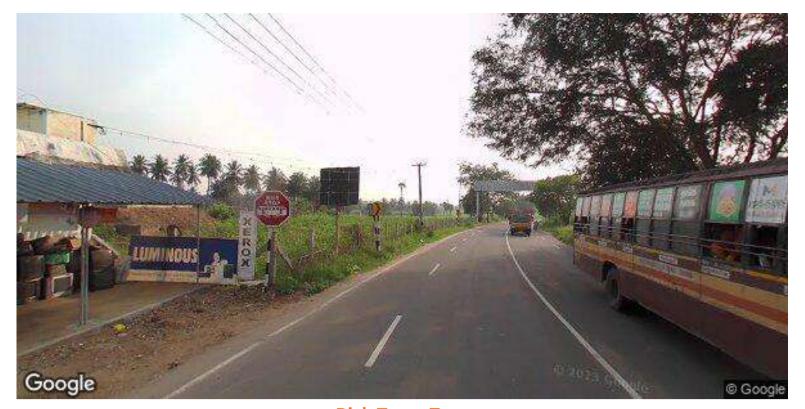
Risk Type: Turn
Risk Level: Medium
Speed Limit: 30 KM/Hr
Coordinates: 11.12102, 77.67919

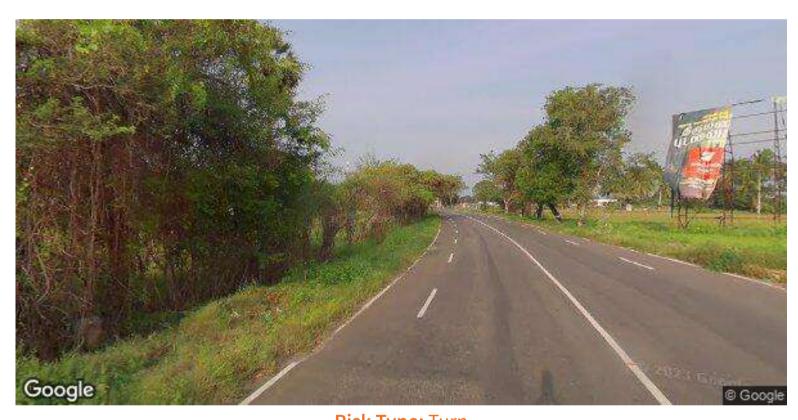
Risk Type: Turn
Risk Level: Medium
Speed Limit: 30 KM/Hr
Coordinates: 11.11932, 77.67786

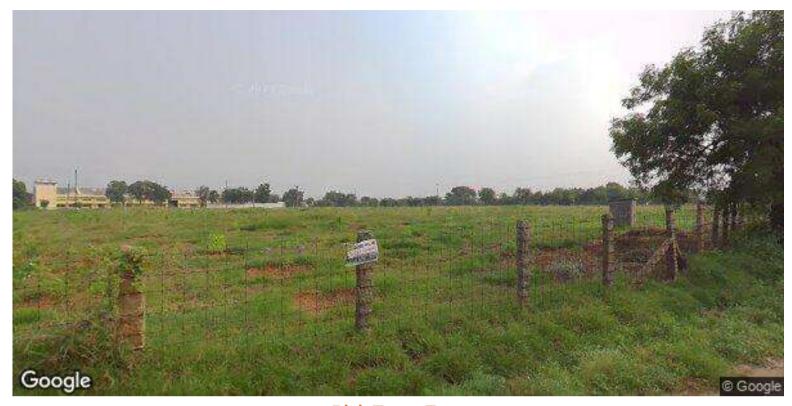
Risk Type: Turn
Risk Level: Medium
Speed Limit: 30 KM/Hr
Coordinates: 11.09491, 77.66603

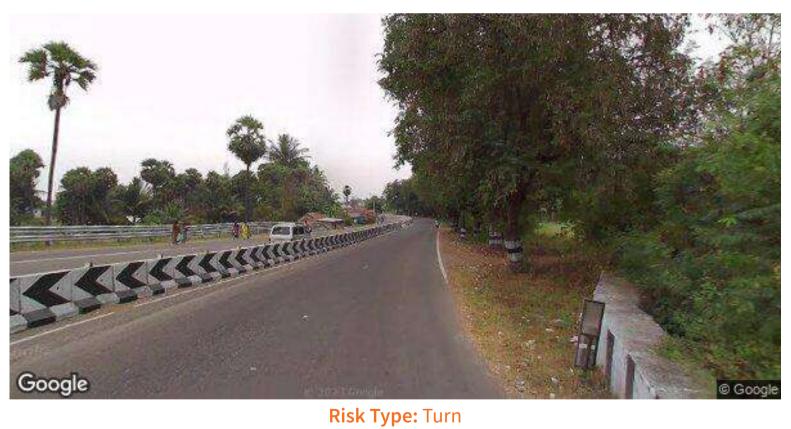
Risk Level: Medium
Speed Limit: 30 KM/Hr
Coordinates: 11.08296, 77.65857

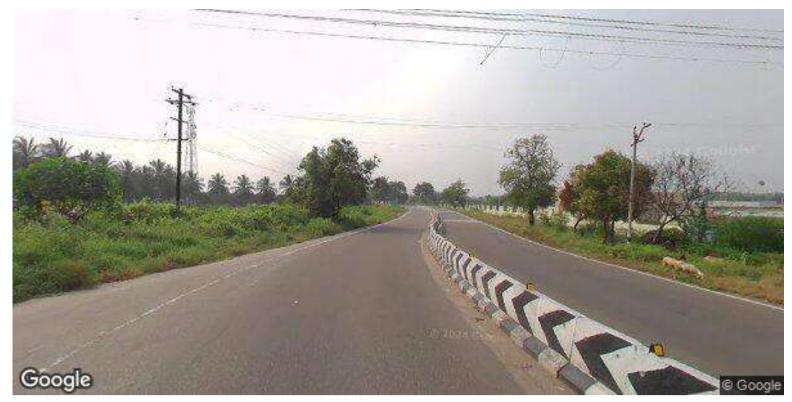
Risk Type: Turn
Risk Level: Medium
Speed Limit: 30 KM/Hr
Coordinates: 11.06183, 77.63924

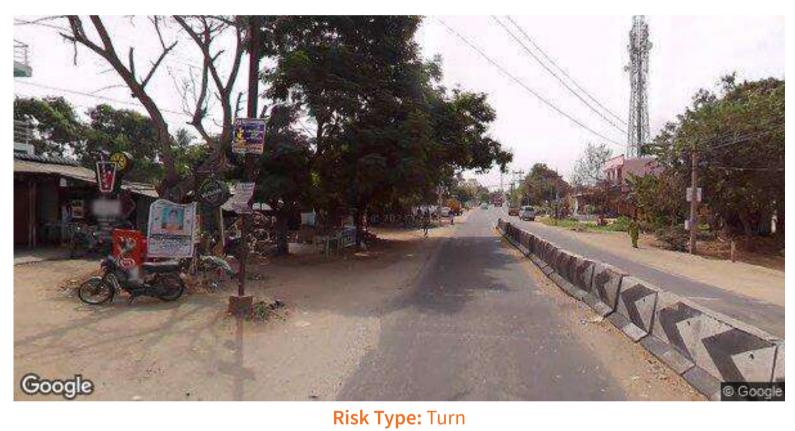
Risk Level: High
Speed Limit: 15 KM/Hr
Coordinates: 11.00826, 77.56962

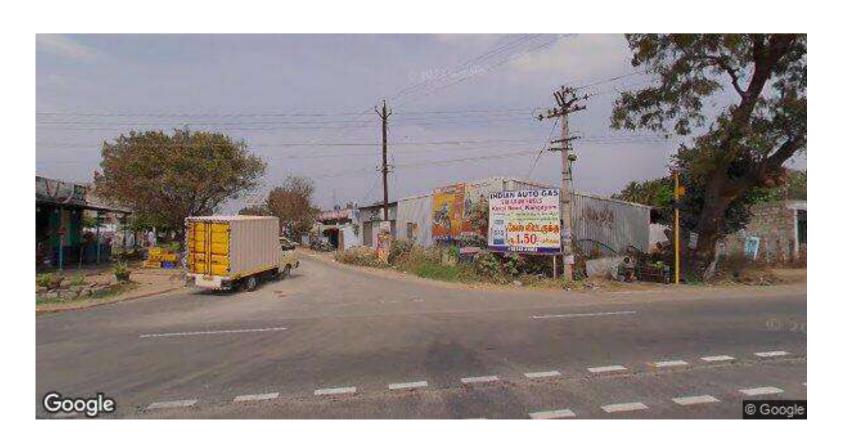
Coordinates: 11.00058, 77.56882

Risk Type: Blind Spot
Risk Level: Blind Spot
Speed Limit: 10 KM/Hr

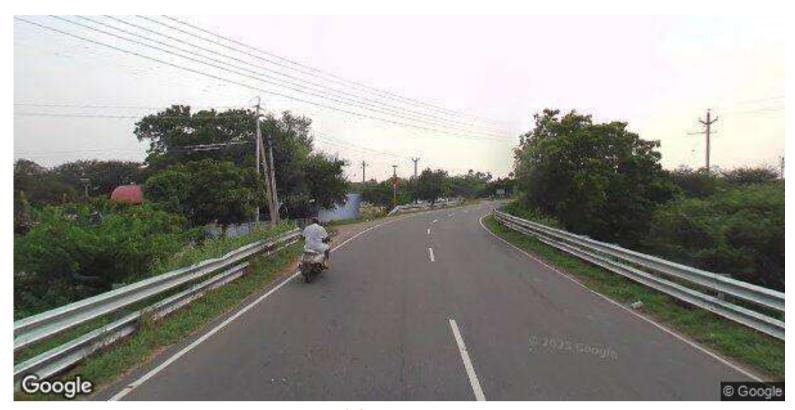
Coordinates: 10.94722, 77.54709

Risk Type: Turn
Risk Level: Medium
Speed Limit: 30 KM/Hr

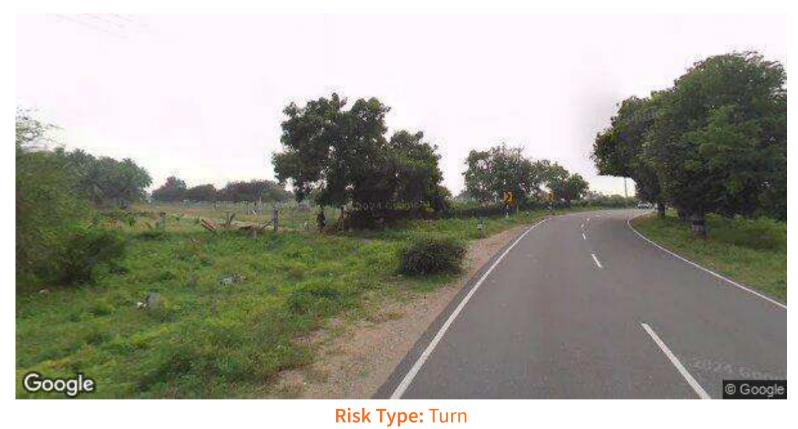
Coordinates: 10.93895, 77.53976

Risk Type: Turn
Risk Level: Medium
Speed Limit: 30 KM/Hr

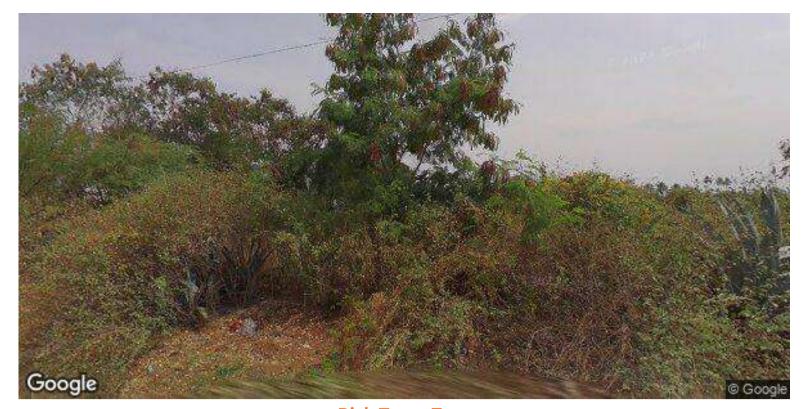
Risk Type: Turn
Risk Level: Medium
Speed Limit: 30 KM/Hr
Coordinates: 10.93054, 77.53265

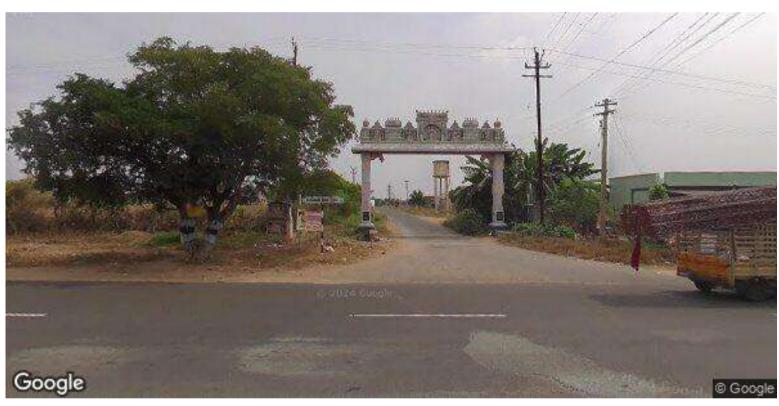
Coordinates: 10.89940, 77.52804

Risk Type: Turn
Risk Level: High
Speed Limit: 15 KM/Hr
