WELCOME TO JOURNEY RISK MANAGEMENT (JRM) STUDY USING ARTIFICIAL INTELLIGENCE (AI) FOR IOCL TRICHY TERMINAL

IOCL TIRCHY TERMINAL (10.7753, 78.8368) TO THIRUVERUMBUR VATTARA MANBODY LORRY, (10.841959, 78.958237), TOTAL DISTANCE -13 KM

* Route Safety Analysis Report

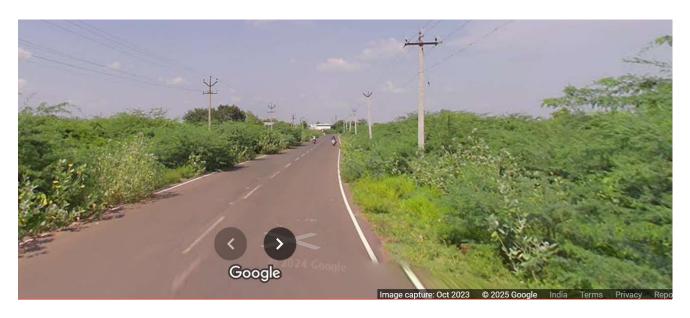
IMAGE:-SHARP TURN RISK LEVEL:-MEDIUM COORDI.

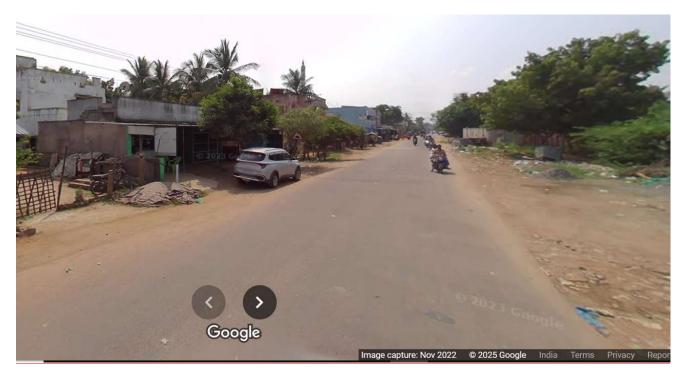
IMAGE:- SHARP TURN RISK LEVEL:- MEDIUM COORDI.

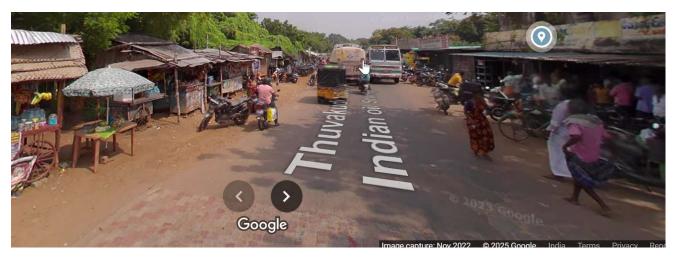
IMAGE:-SHARP TURN RISK LEVEL:-MEDIUM COORDI.

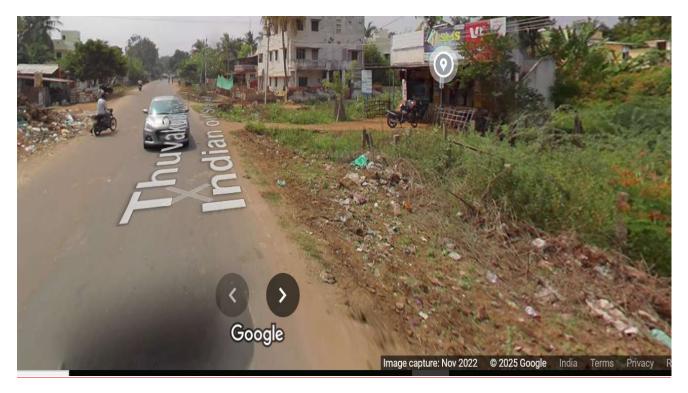
IMAGE:- SHARP TURN RISK LEVEL:- MEDIUM COORDI.

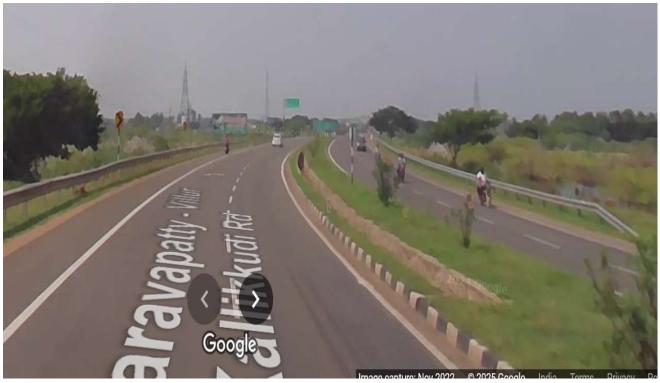
IMAGE:- SHARP TURN, RISK LEVEL:- MEDIUM, COORDI.

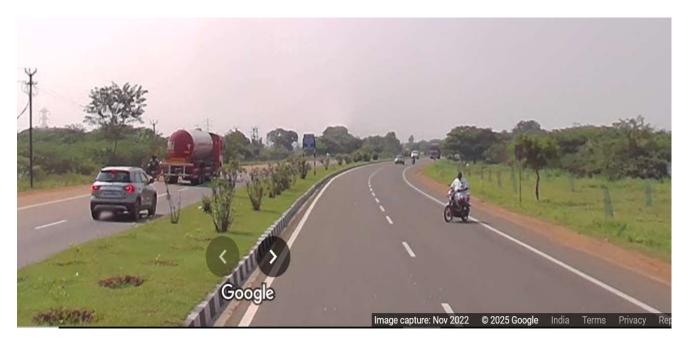
IMAGE:- SHARP TURN RISK LEVEL:- MEDIUM COORDI.

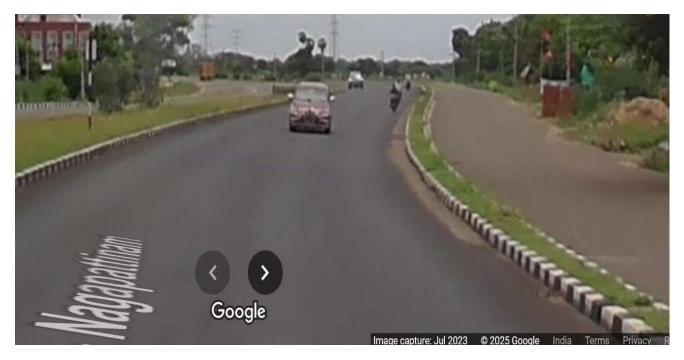
IMAGE:- SHARP TURN RISK LEVEL:- MEDIUM COORDI.

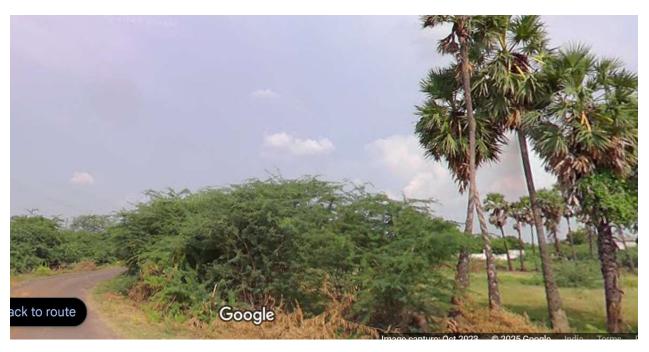
IMAGE:- SHARP TURN RISK LEVEL:- MEDIUM COORDI.

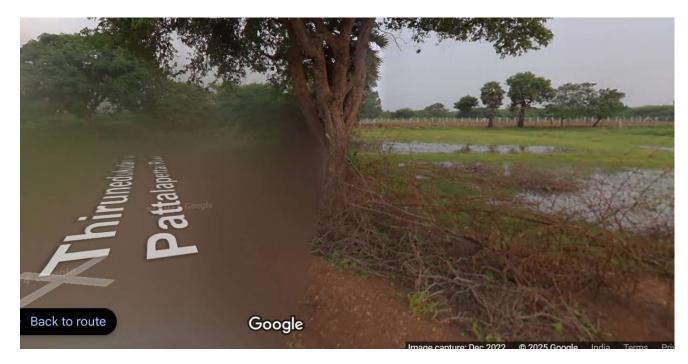
IMAGE:- SHARP TURN RISK LEVEL:- MEDIUM COORDI.

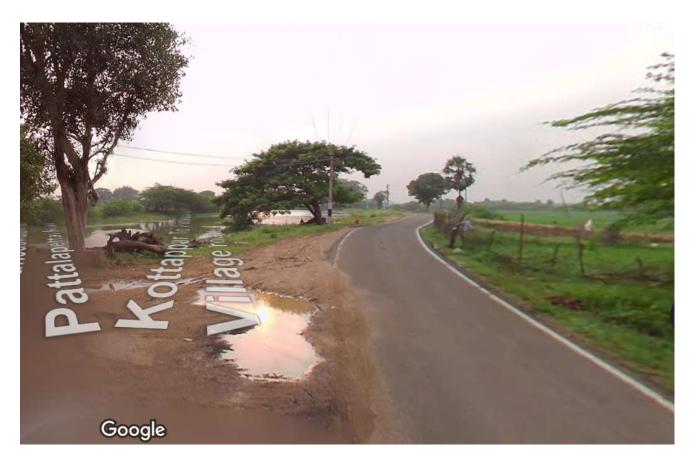
IMAGE:-SHARP TURN RISK LEVEL:-MEDIUM COORDI.

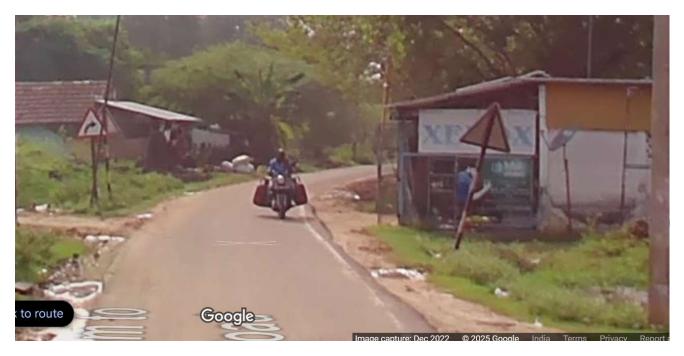
IMAGE:-SHARP TURN RISK LEVEL:-MEDIUM COORDI

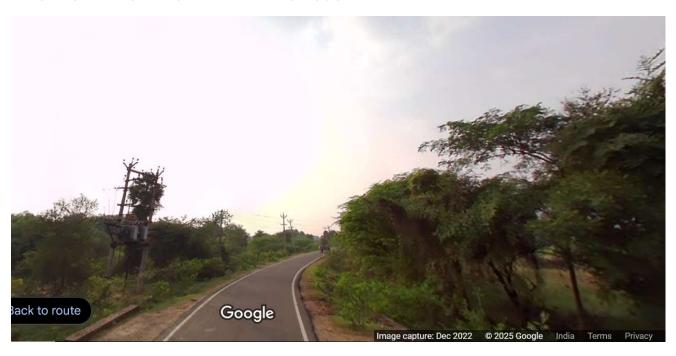
IMAGE:-SHARP TURN RISK LEVEL:-MEDIUM COORDI

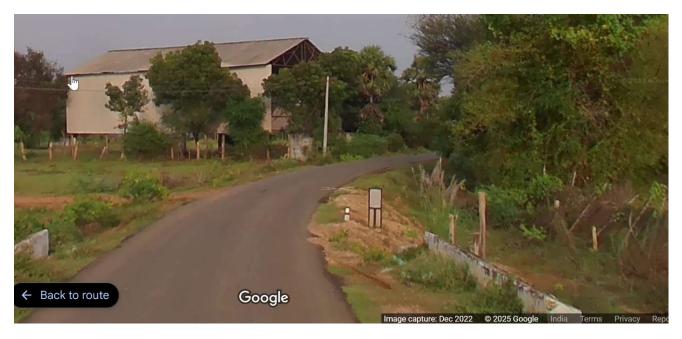
IMAGE:-SHARP TURN RISK LEVEL:-MEDIUM COORDI

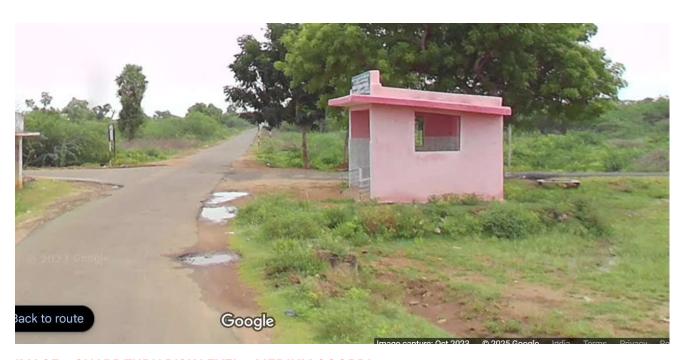
IMAGE:-SHARP TURN RISK LEVEL:-MEDIUM COORDI

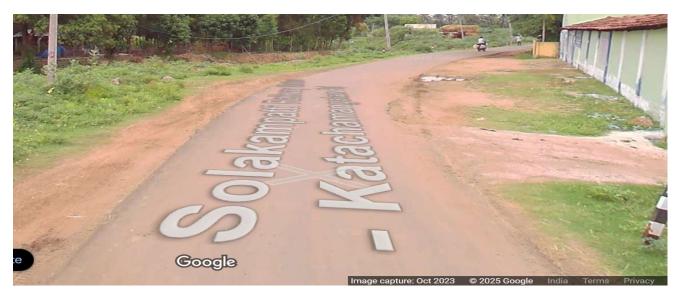
IMAGE:-SHARP TURN RISK LEVEL:-MEDIUM COORDI
