JOURNEY RISK MANAGEMENT (JRM) STUDY

IOCL Coimbatore Terminal to Ravichandra

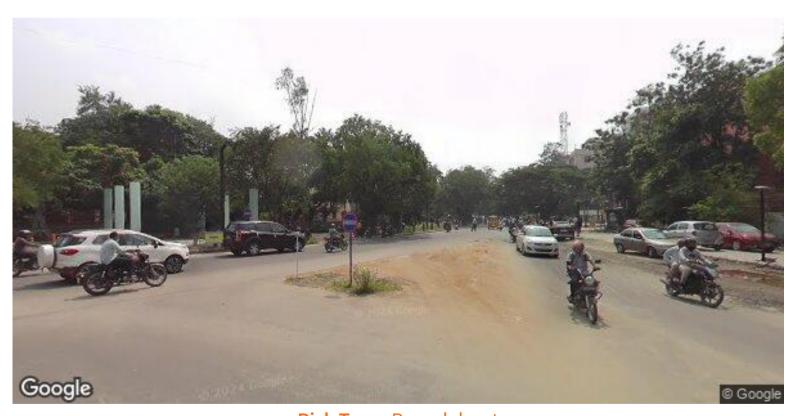
Coordinates: 11.00090, 76.97343

Risk Type: Roundabout
Risk Level: High
Speed Limit: 15 KM/Hr

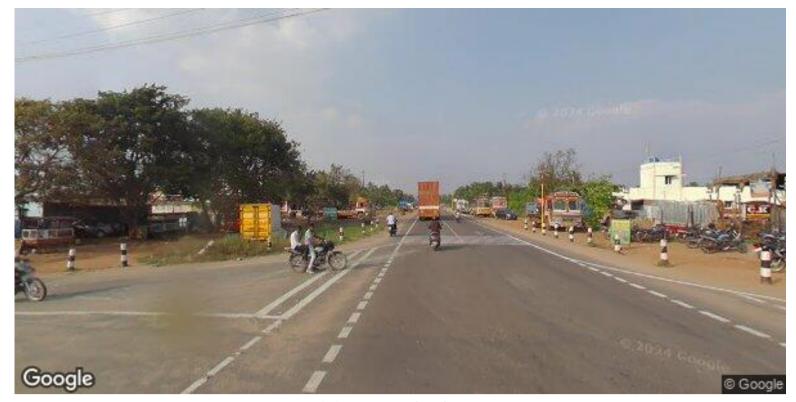
Coordinates: 11.03211, 77.07640

Risk Type: Blind Spot Risk Level: Blind Spot Speed Limit: 10 KM/Hr

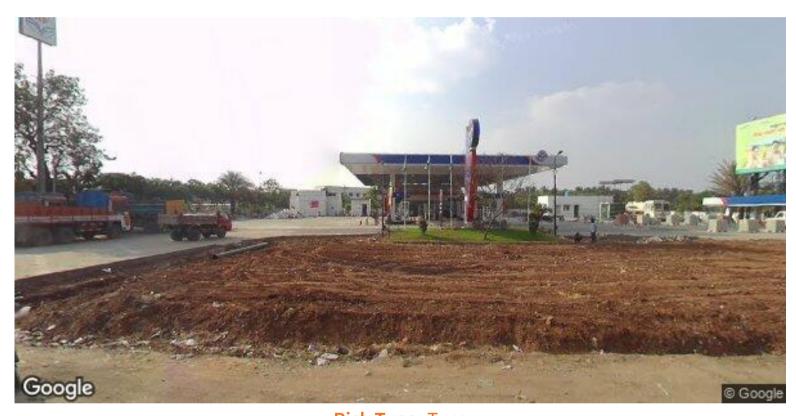
Risk Type: Turn
Risk Level: Medium
Speed Limit: 30 KM/Hr
Coordinates: 11.00873, 77.07114

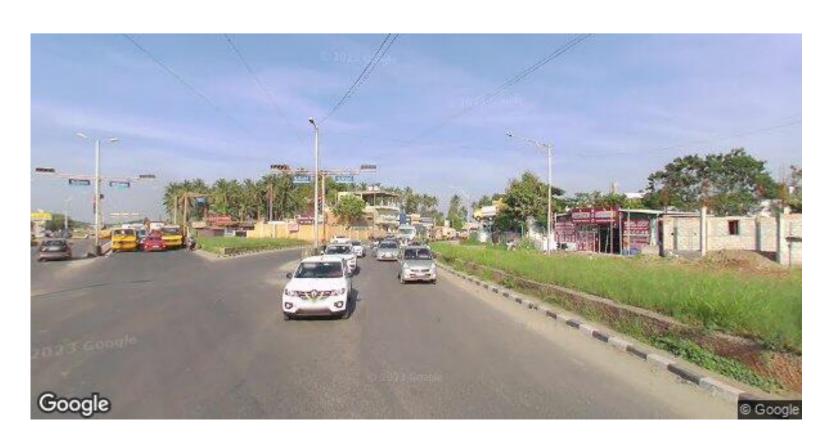
Coordinates: 11.00737, 77.07049

Risk Type: Turn
Risk Level: Medium
Speed Limit: 30 KM/Hr

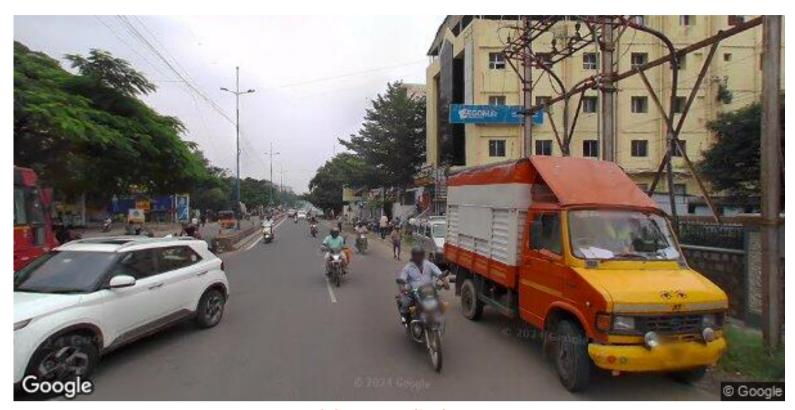
Risk Type: Blind Spot
Risk Level: Blind Spot
Speed Limit: 10 KM/Hr
Coordinates: 10.99519, 76.97443

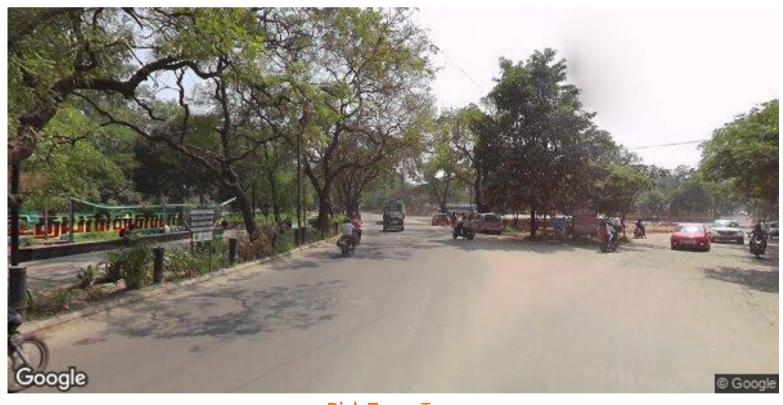
Risk Type: Turn
Risk Level: Medium
Speed Limit: 30 KM/Hr
Coordinates: 10.99927, 76.97399

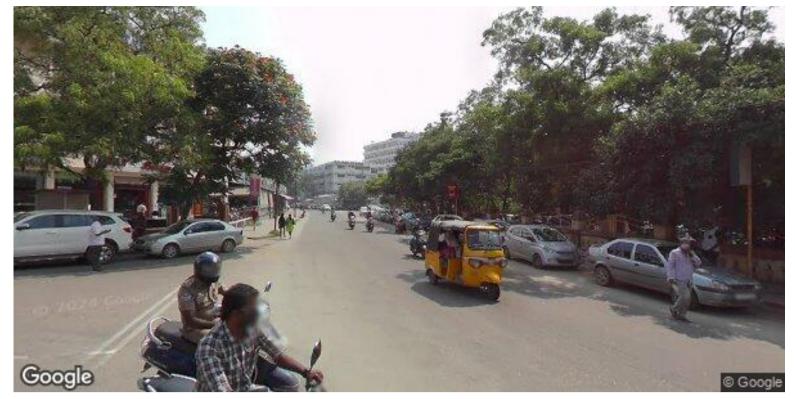
Risk Type: Turn
Risk Level: High
Speed Limit: 15 KM/Hr
Coordinates: 11.00081, 76.97015

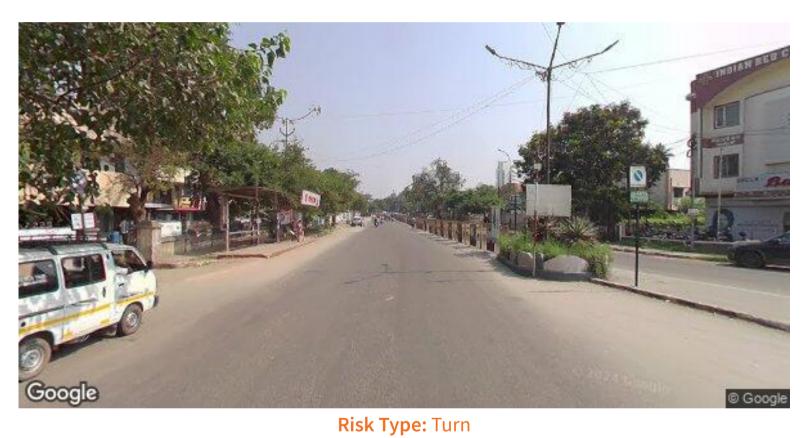
Risk Level: High
Speed Limit: 15 KM/Hr
Coordinates: 11.00112, 76.97010

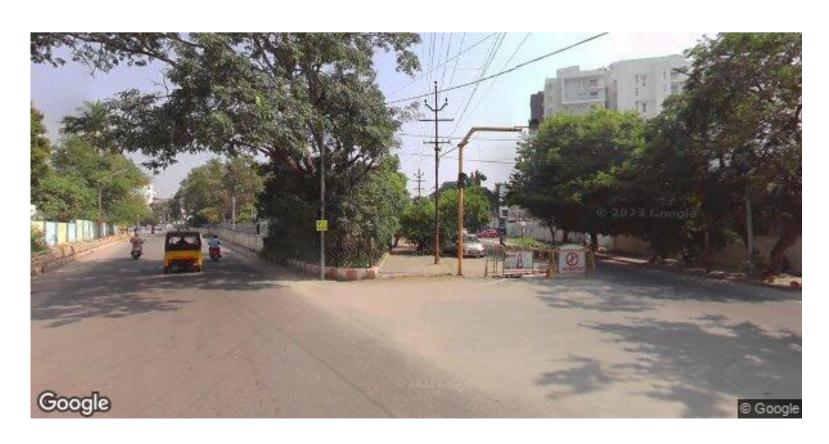
Coordinates: 11.00277, 76.97221

Risk Type: Turn
Risk Level: Medium
Speed Limit: 30 KM/Hr

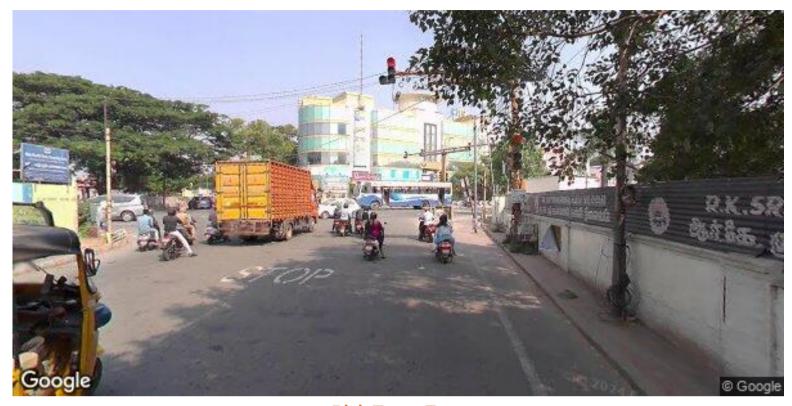
Risk Type: Turn
Risk Level: Medium
Speed Limit: 30 KM/Hr
Coordinates: 11.00358, 76.97255

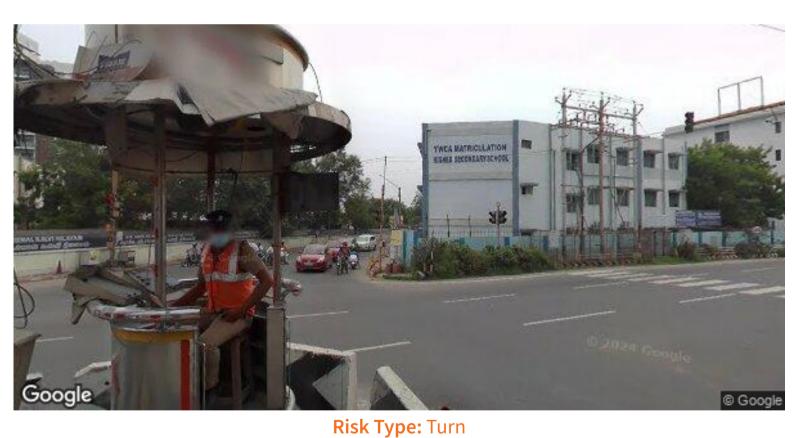
Coordinates: 11.00391, 76.97244

Risk Type: Turn

Risk Level: High

Speed Limit: 15 KM/Hr
