# JOURNEY RISK MANAGEMENT (JRM) STUDY

### **IOCL Coimbatore Terminal to S S Agencies**

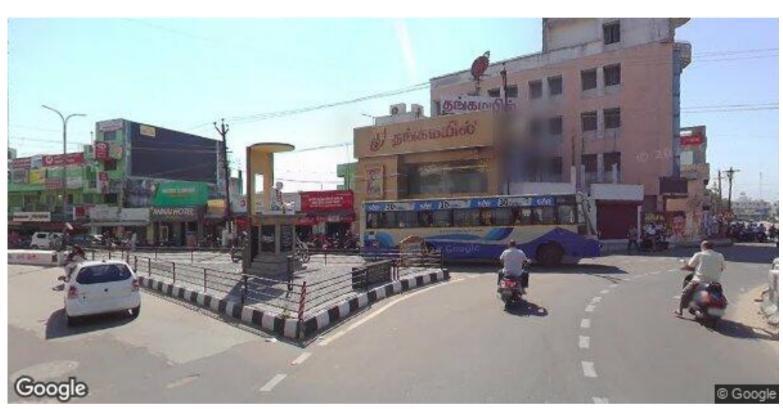
**Coordinates:** 10.66197, 77.00818

Risk Type: Roundabout
Risk Level: High
Speed Limit: 15 KM/Hr

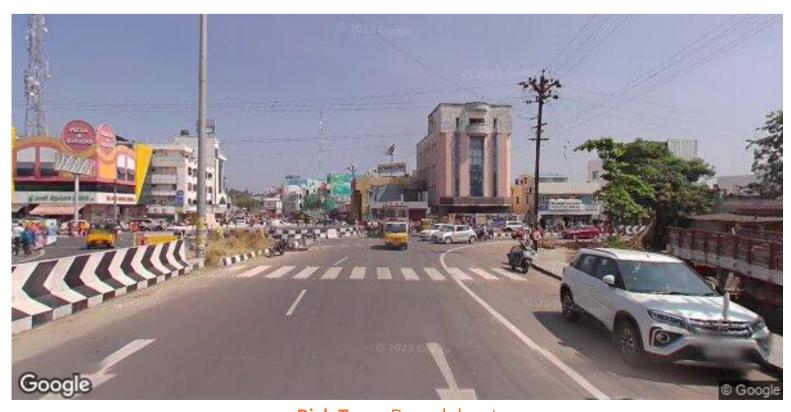
Risk Type: Roundabout
Risk Level: High

Speed Limit: 15 KM/Hr
Coordinates: 10.66176, 77.00771

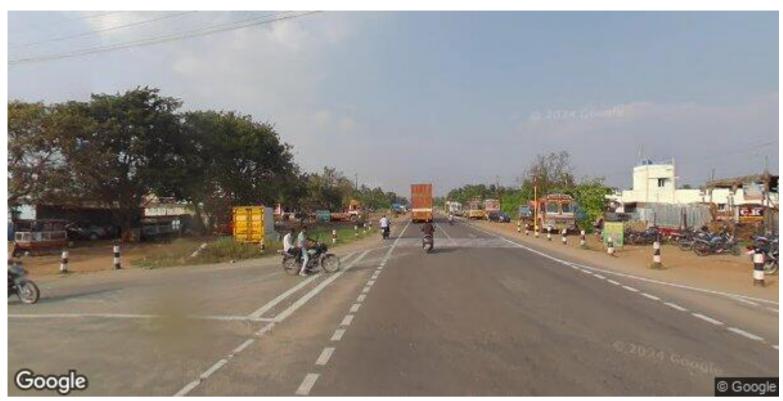
**Coordinates:** 11.03211, 77.07640

Risk Type: Blind Spot
Risk Level: Blind Spot
Speed Limit: 10 KM/Hr

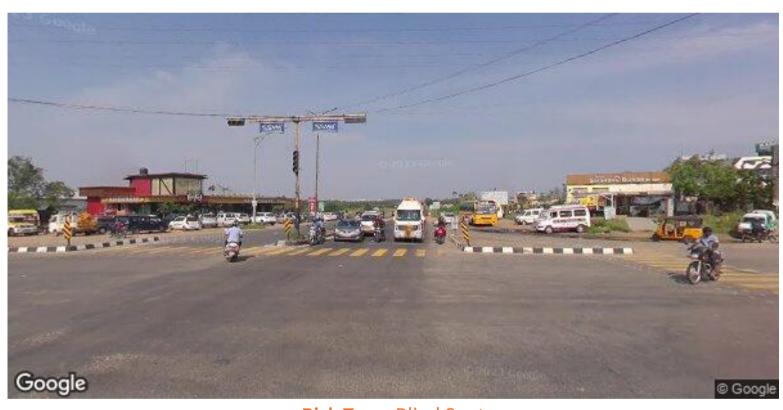
Risk Type: Blind Spot
Risk Level: Blind Spot
Speed Limit: 10 KM/Hr
Coordinates: 10.91785, 76.98617

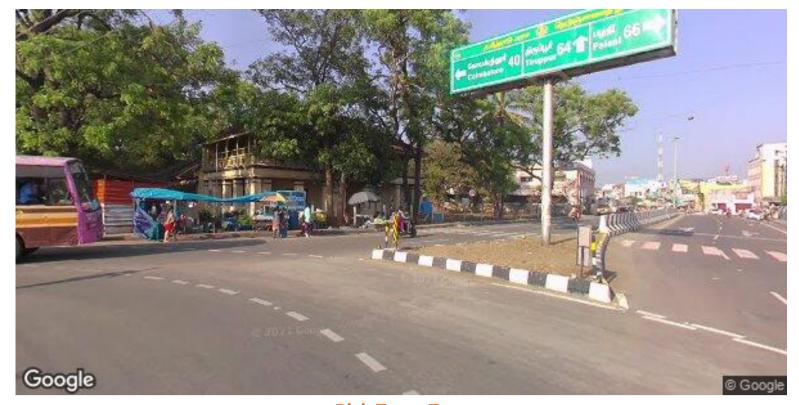
Risk Type: Turn
Risk Level: Medium
Speed Limit: 30 KM/Hr
Coordinates: 10.66172, 77.00697

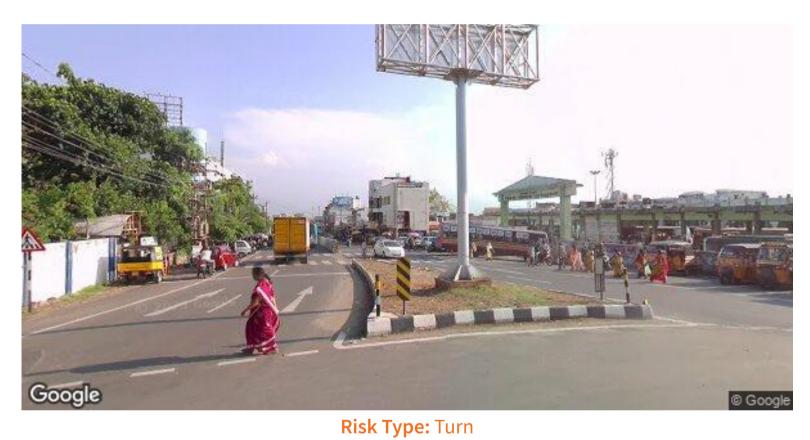
Risk Level: High
Speed Limit: 15 KM/Hr
Coordinates: 10.66167, 77.00688

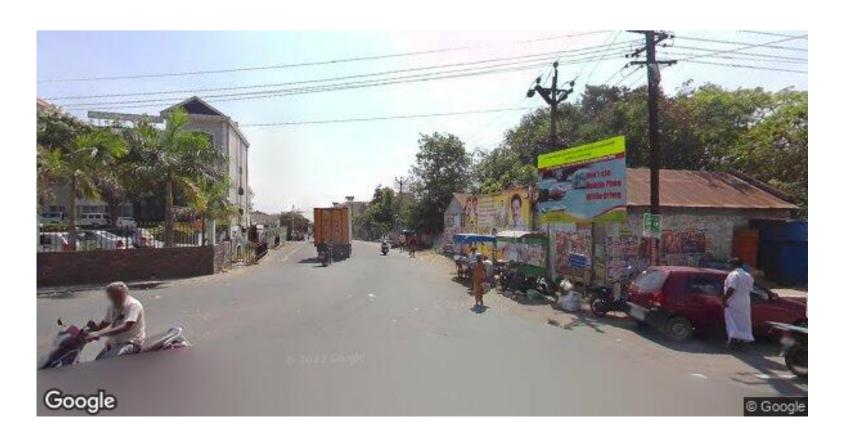
**Coordinates:** 10.66318, 77.00202

Risk Type: Blind Spot Risk Level: Blind Spot Speed Limit: 10 KM/Hr

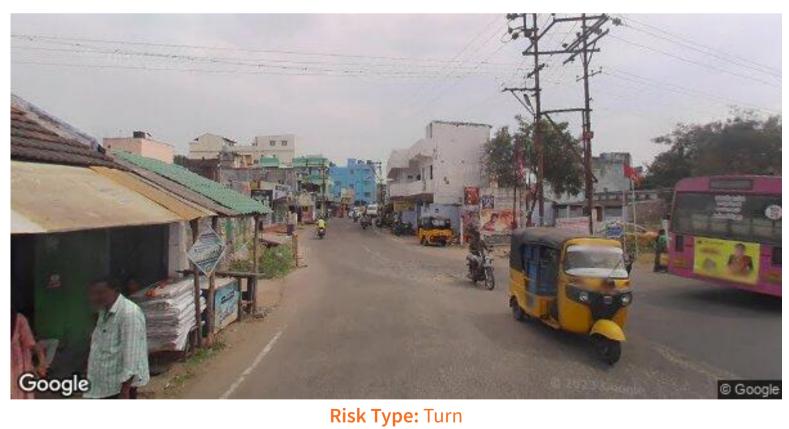
Risk Type. Turn
Risk Level: High
Speed Limit: 15 KM/Hr
Coordinates: 10.66026, 77.00309

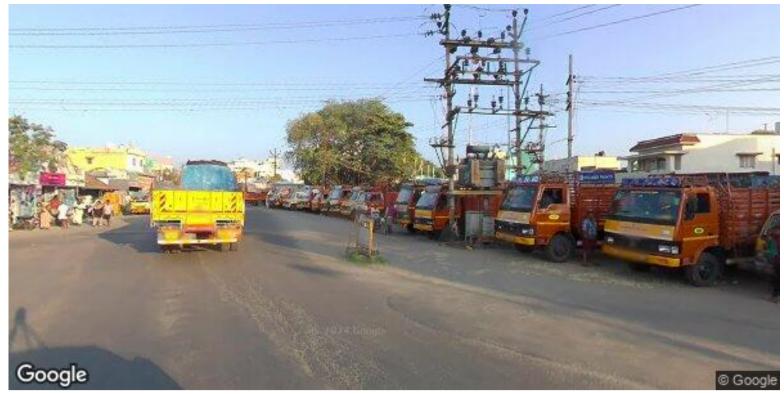
Risk Type: Turn
Risk Level: High
Speed Limit: 15 KM/Hr
Coordinates: 10.65535, 77.00337

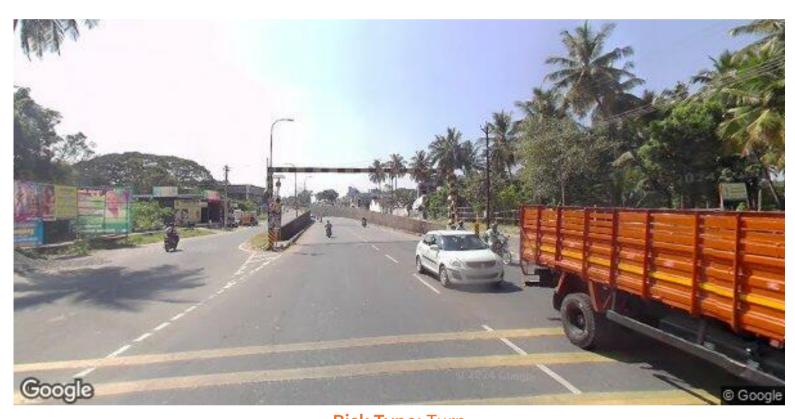
Risk Type: Turn
Risk Level: Medium
Speed Limit: 30 KM/Hr
Coordinates: 10.65103, 76.98757

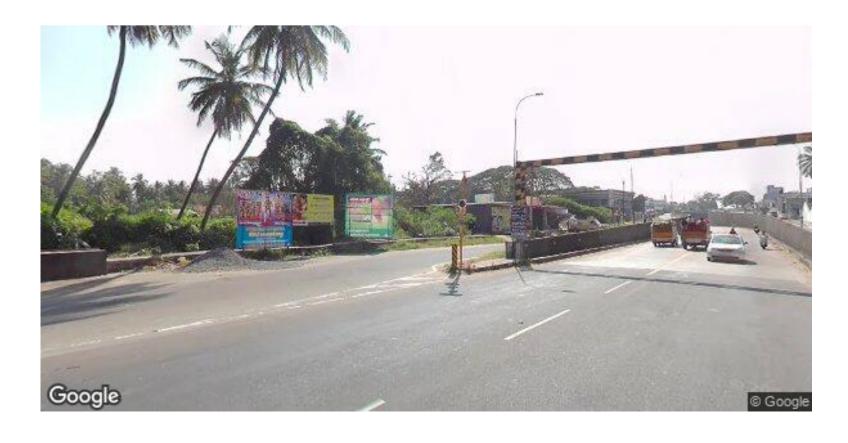
**Coordinates:** 10.65105, 76.98749

Risk Type: Turn
Risk Level: Medium
Speed Limit: 30 KM/Hr
