JOURNEY RISK MANAGEMENT (JRM) STUDY

Salem Terminal to VAIRAVEL AGENCIES

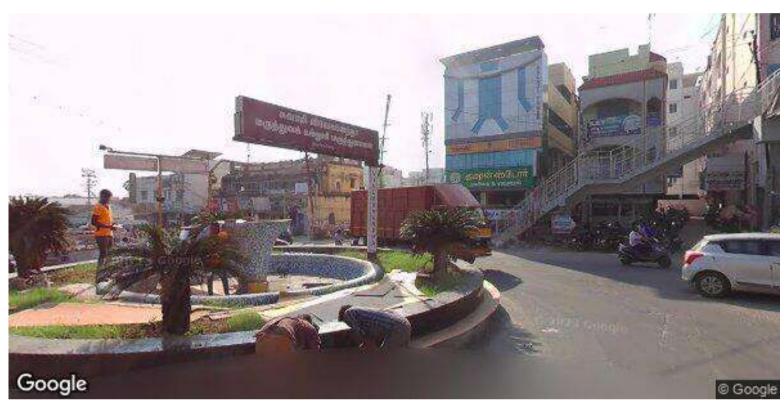
Coordinates: 11.38395, 77.89480

Risk Type: Roundabout
Risk Level: High
Speed Limit: 15 KM/Hr

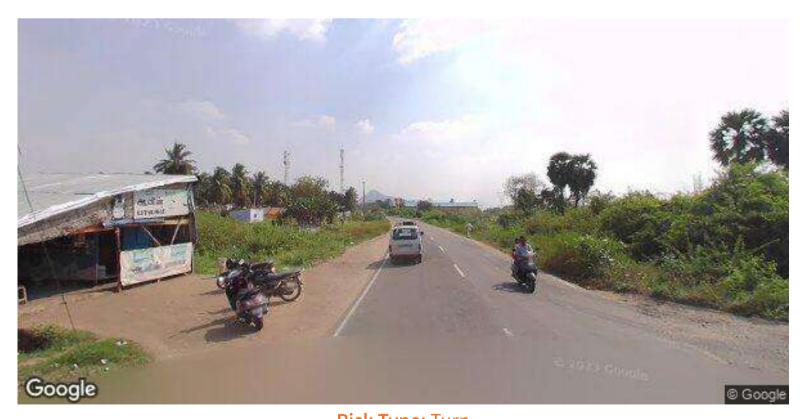
Risk Type: Turn
Risk Level: High
Speed Limit: 15 KM/Hr
Coordinates: 11.44022, 77.87546

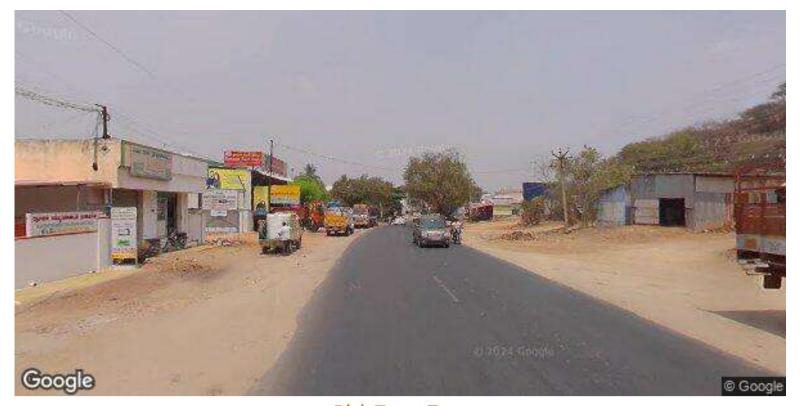
Risk Type: Turn
Risk Level: Medium
Speed Limit: 30 KM/Hr
Coordinates: 11.39983, 77.88377

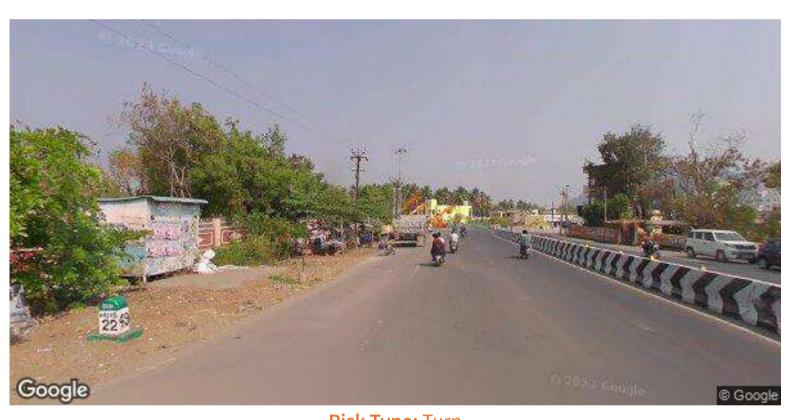
Risk Type: Turn
Risk Level: Medium
Speed Limit: 30 KM/Hr
Coordinates: 11.39706, 77.88825

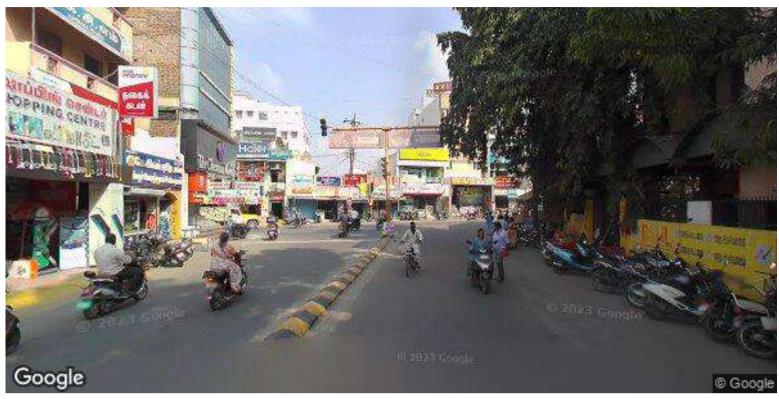
Coordinates: 11.37823, 77.89448

Risk Type: Turn
Risk Level: Medium
Speed Limit: 30 KM/Hr

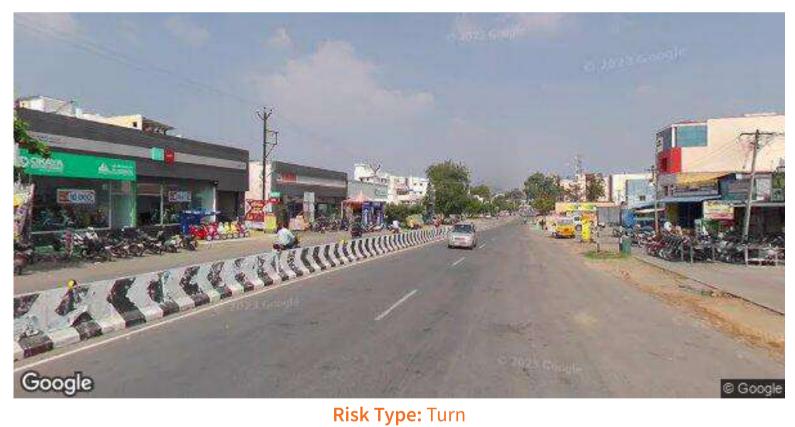
Coordinates: 11.36638, 77.88885

Risk Type: Turn
Risk Level: Medium
Speed Limit: 30 KM/Hr

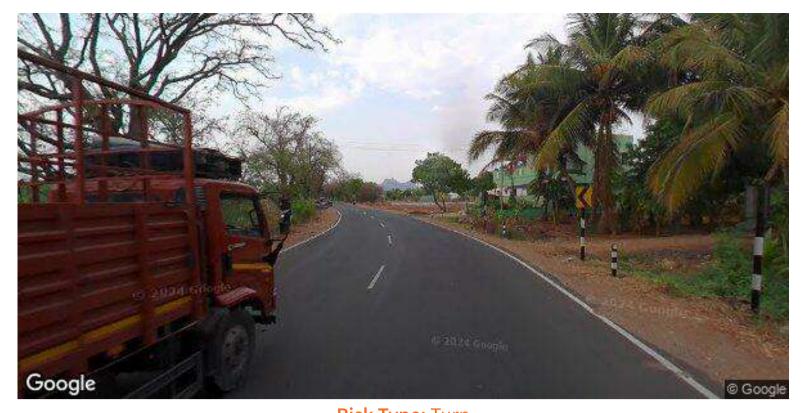
Risk Type: Turn
Risk Level: Medium
Speed Limit: 30 KM/Hr
Coordinates: 11.34105, 77.86426

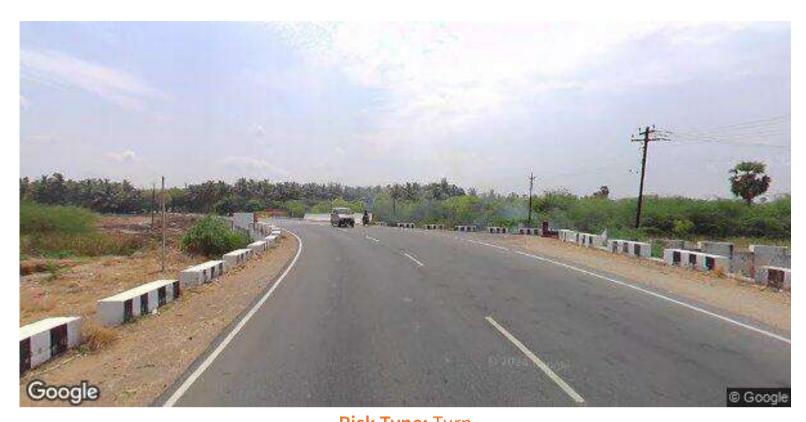
Risk Type: Turn
Risk Level: Medium
Speed Limit: 30 KM/Hr
Coordinates: 11.31746, 77.84231

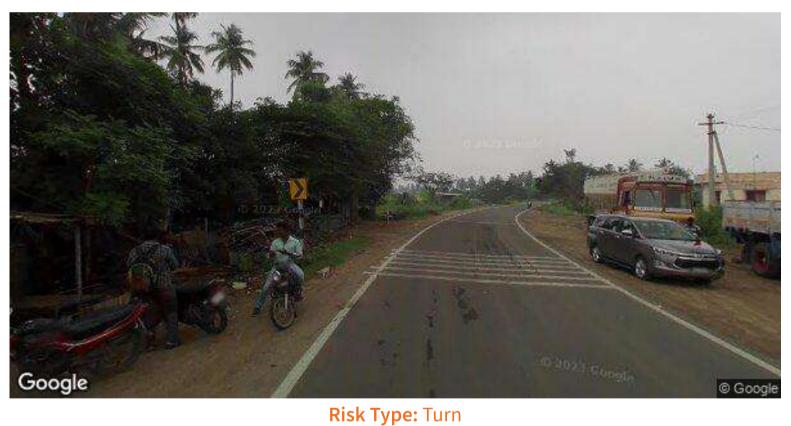
Risk Type: Turn
Risk Level: Medium
Speed Limit: 30 KM/Hr
Coordinates: 11.30951, 77.77598

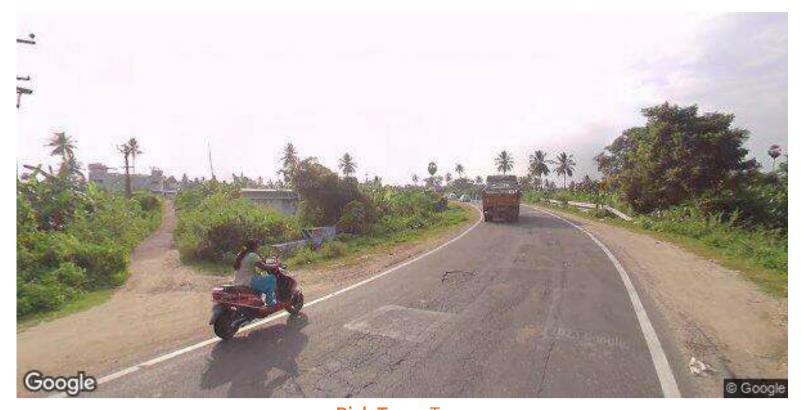
Risk Type: Turn
Risk Level: Medium
Speed Limit: 30 KM/Hr
Coordinates: 11.31109, 77.77183

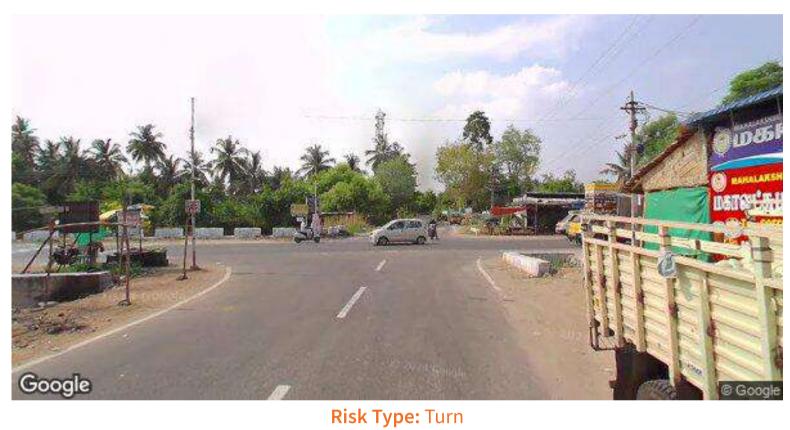
Risk Type: Turn
Risk Level: High
Speed Limit: 15 KM/Hr
Coordinates: 11.29473, 77.74685

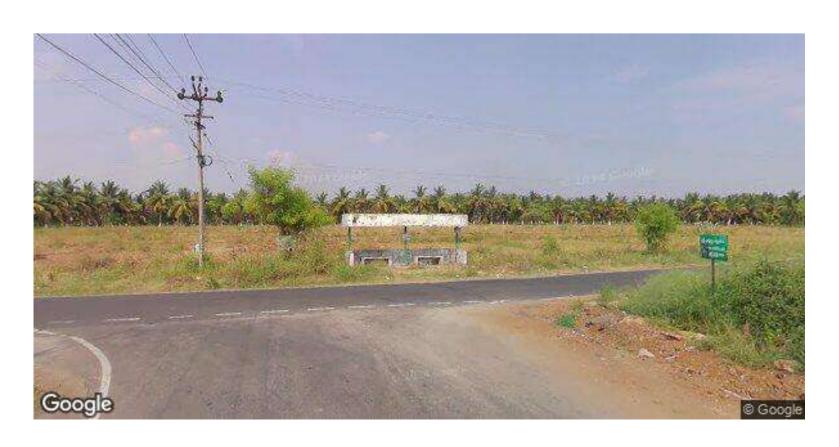
Coordinates: 11.29128, 77.74656

Risk Type: Turn
Risk Level: High
Speed Limit: 15 KM/Hr

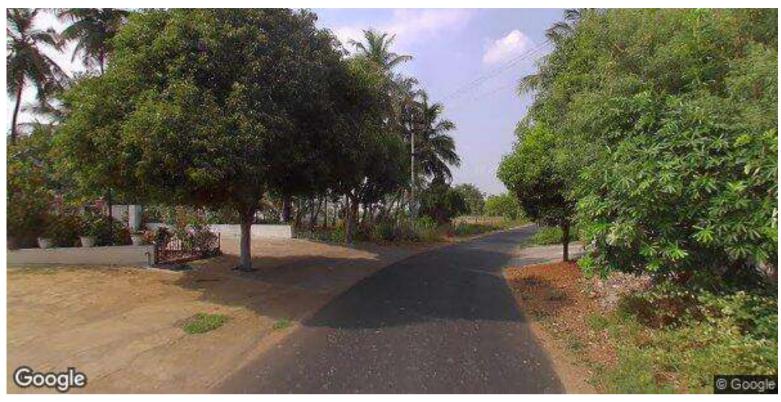
Risk Type: Turn
Risk Level: Medium
Speed Limit: 30 KM/Hr
Coordinates: 11.28859, 77.74323

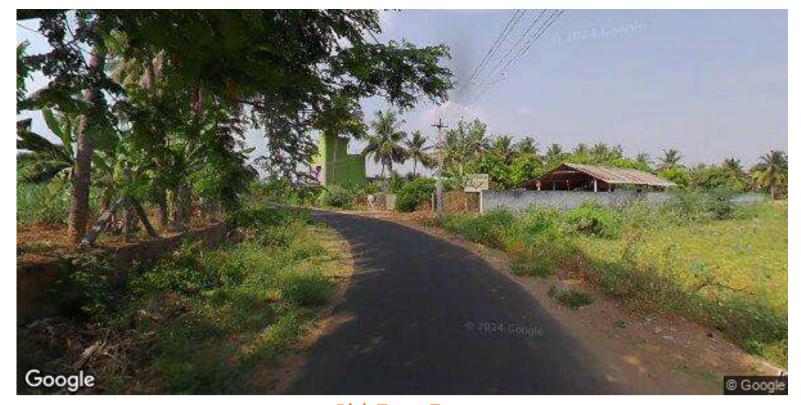
Risk Type: Turn
Risk Level: High
Speed Limit: 15 KM/Hr
Coordinates: 11.27326, 77.72991

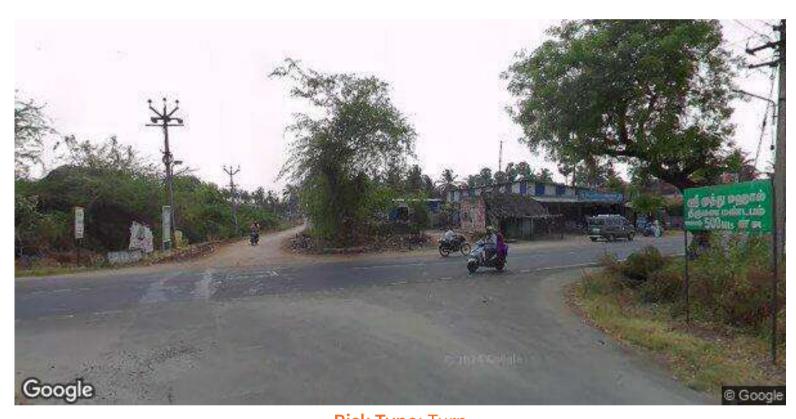
Risk Type: Turn
Risk Level: High
Speed Limit: 15 KM/Hr
Coordinates: 11.27330, 77.72720

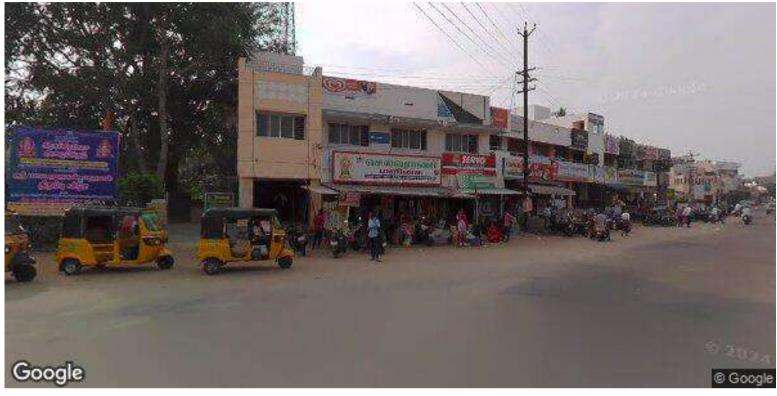
Coordinates: 11.15942, 77.70068

Risk Type: Turn
Risk Level: High
Speed Limit: 15 KM/Hr

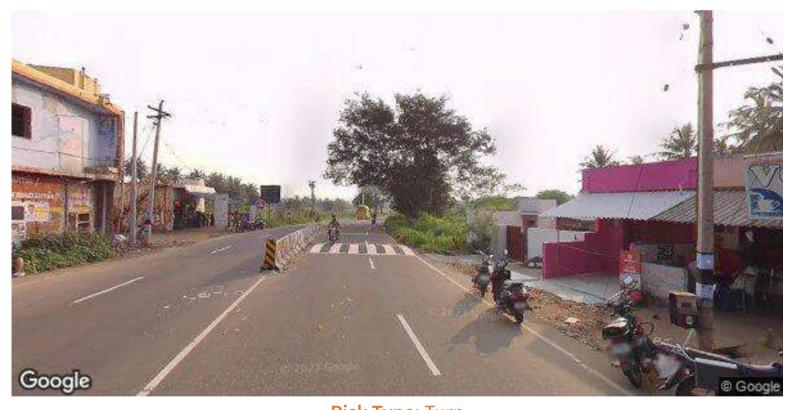
Risk Type: Turn
Risk Level: Medium
Speed Limit: 30 KM/Hr
Coordinates: 11.12126, 77.67929

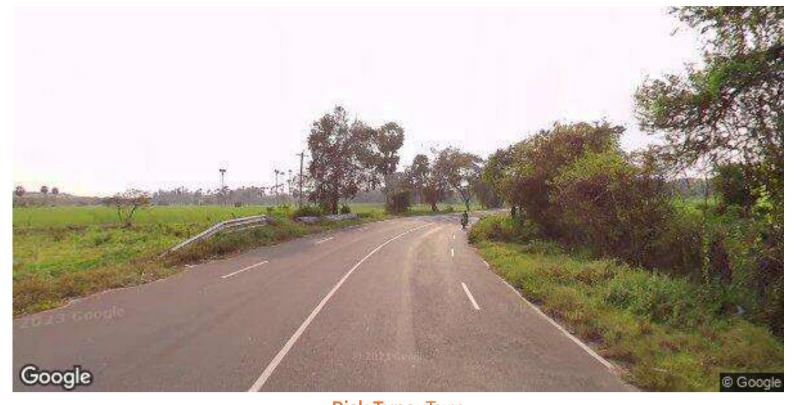
Risk Type: Turn
Risk Level: Medium
Speed Limit: 30 KM/Hr
Coordinates: 11.11935, 77.67790

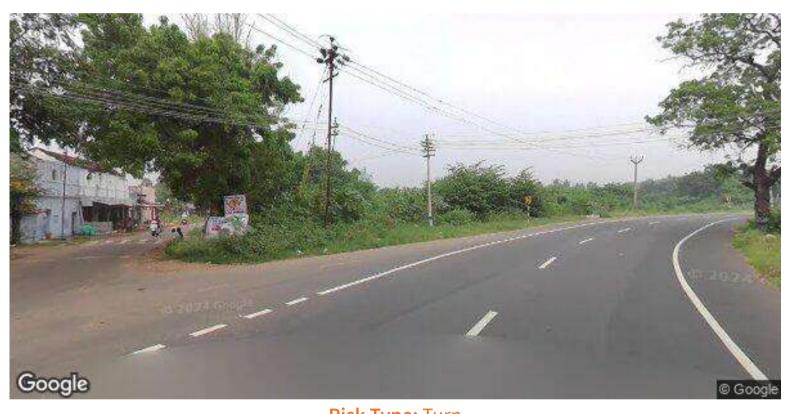
Risk Type: Turn
Risk Level: Medium
Speed Limit: 30 KM/Hr
Coordinates: 11.11716, 77.67178

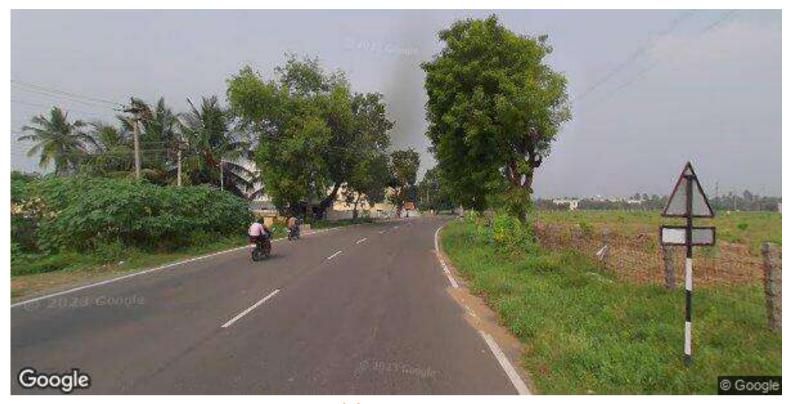
Coordinates: 11.09494, 77.66604

Risk Type: Turn
Risk Level: Medium
Speed Limit: 30 KM/Hr

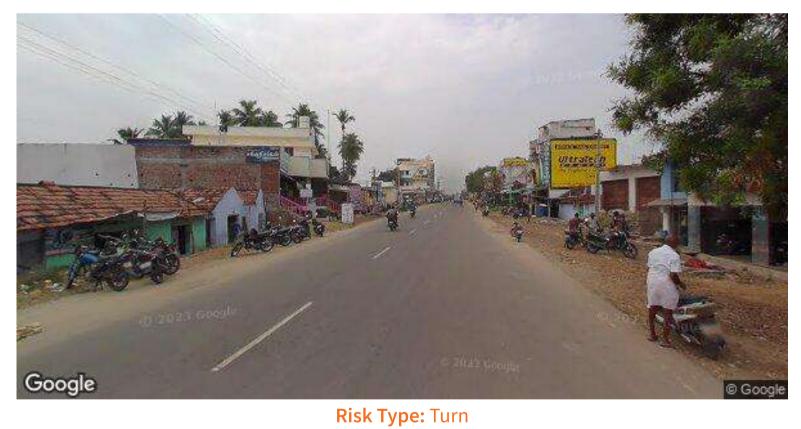
Risk Level: Medium
Speed Limit: 30 KM/Hr
Coordinates: 11.08701, 77.66412

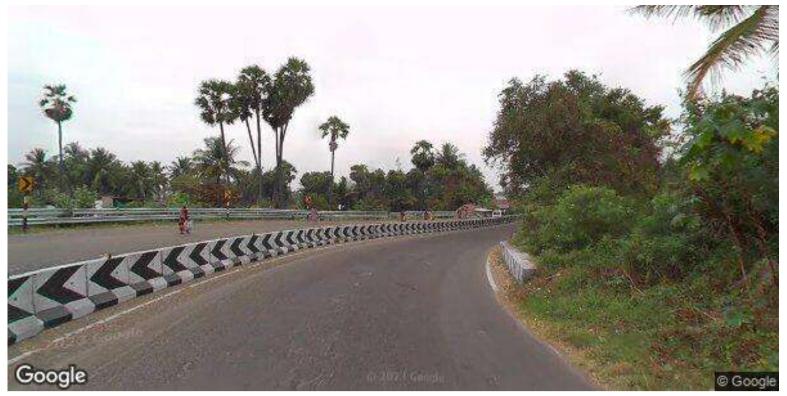
Coordinates: 11.08285, 77.65839

Risk Type: Turn
Risk Level: High
Speed Limit: 15 KM/Hr

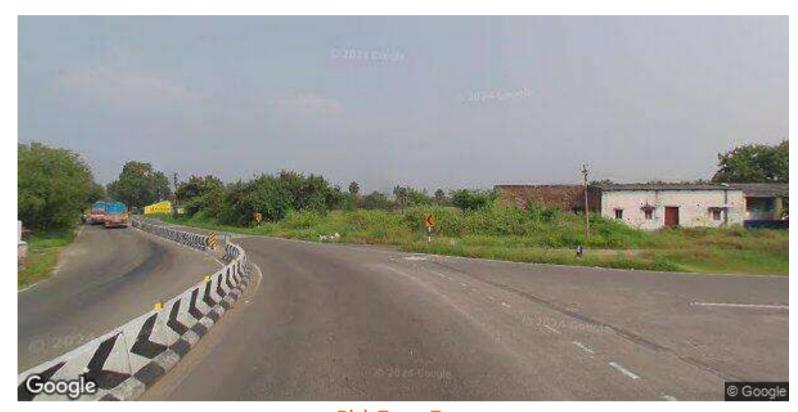
Risk Type: Turn
Risk Level: High
Speed Limit: 15 KM/Hr
Coordinates: 11.06183, 77.63929

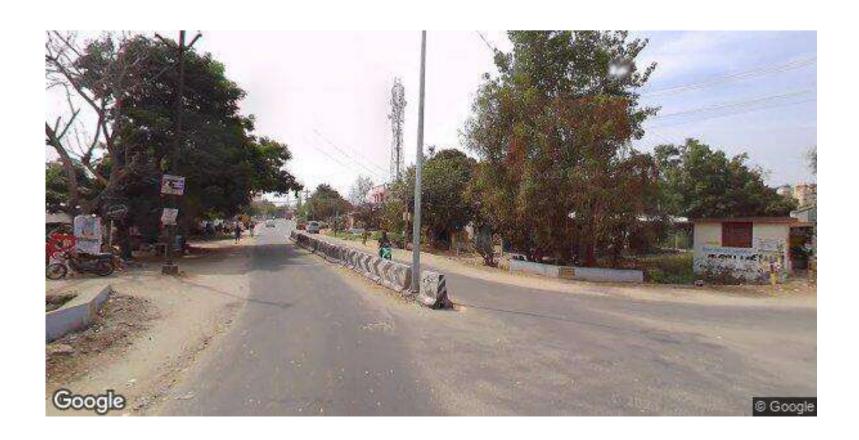
Coordinates: 11.00834, 77.56962

Risk Type: Turn
Risk Level: High
Speed Limit: 15 KM/Hr

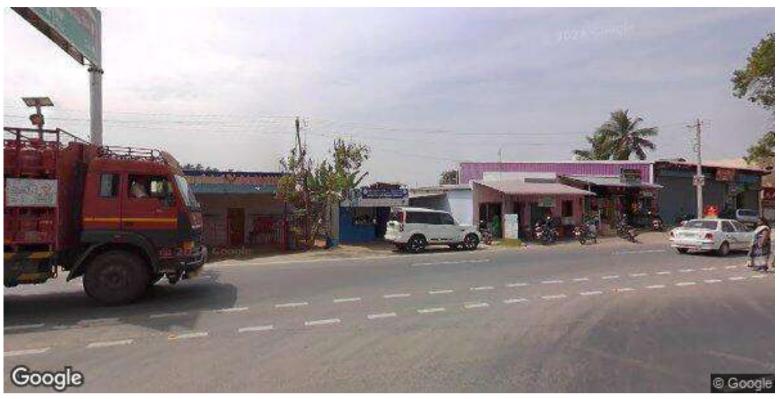
Coordinates: 11.00065, 77.56884

Risk Type: Blind Spot Risk Level: Blind Spot Speed Limit: 10 KM/Hr

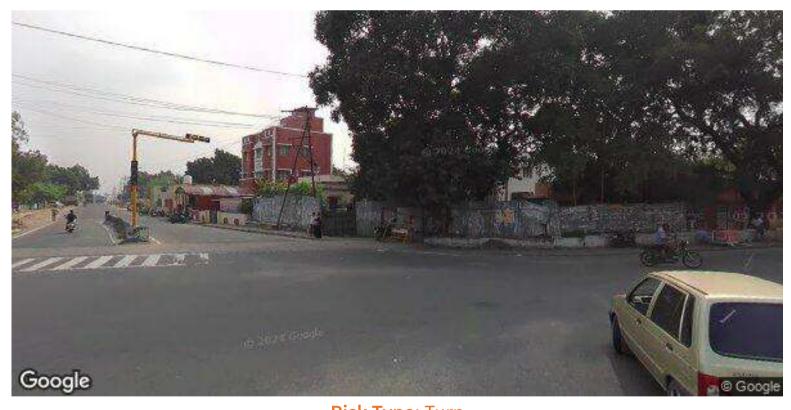
Risk Type: Turn
Risk Level: Medium
Speed Limit: 30 KM/Hr
Coordinates: 11.00170, 77.56267

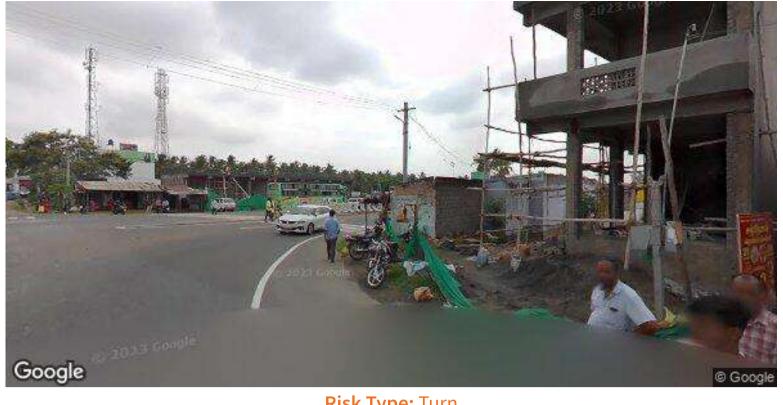
Risk Type: Turn
Risk Level: High
Speed Limit: 15 KM/Hr
Coordinates: 10.97021, 77.42717

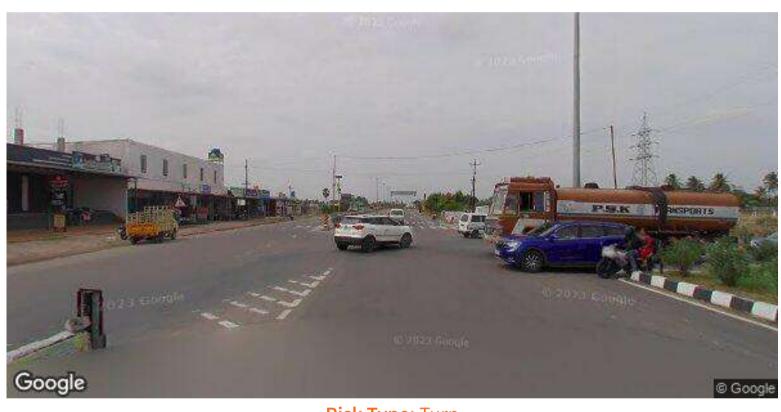
Risk Type: Turn
Risk Level: Medium
Speed Limit: 30 KM/Hr
Coordinates: 10.96816, 77.42718

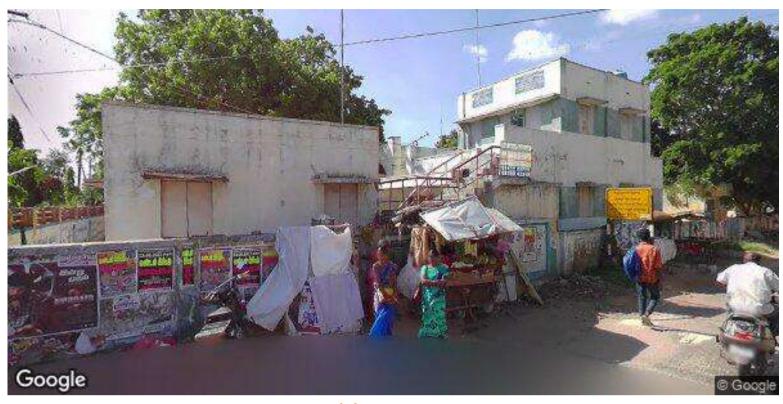
Coordinates: 10.97058, 77.36962

Risk Type: Turn
Risk Level: High
Speed Limit: 15 KM/Hr

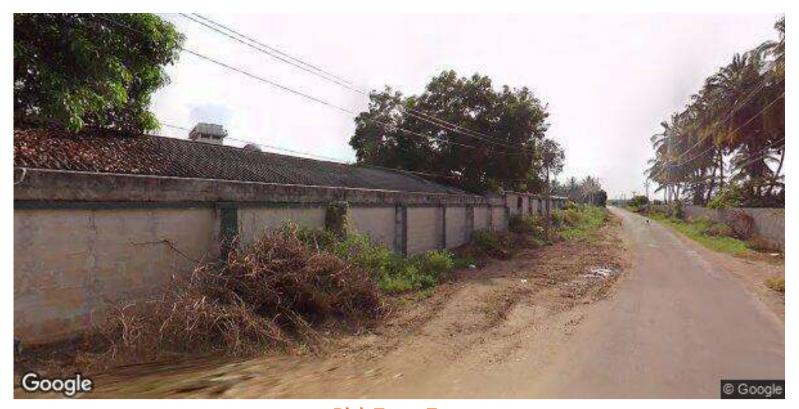
Risk Type: Turn
Risk Level: Medium
Speed Limit: 30 KM/Hr
Coordinates: 10.96448, 77.36586

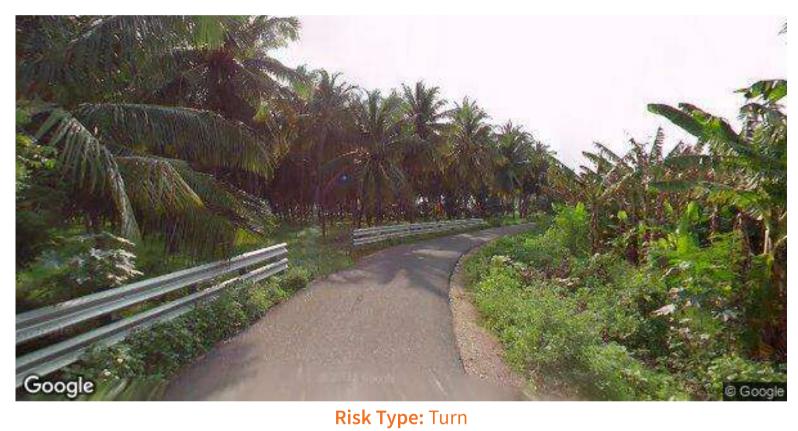
Risk Type: Turn
Risk Level: High
Speed Limit: 15 KM/Hr
Coordinates: 10.95865, 77.35820

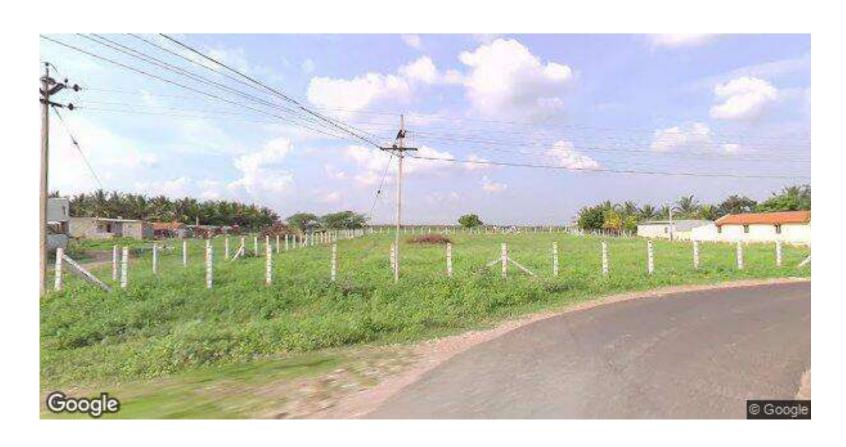
Coordinates: 10.95846, 77.35658

Risk Type: Turn
Risk Level: High
Speed Limit: 15 KM/Hr

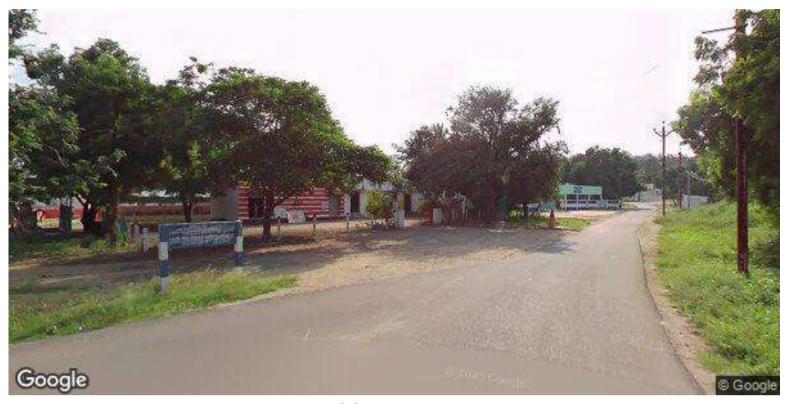
Risk Type: Turn
Risk Level: High
Speed Limit: 15 KM/Hr
Coordinates: 10.95366, 77.35642

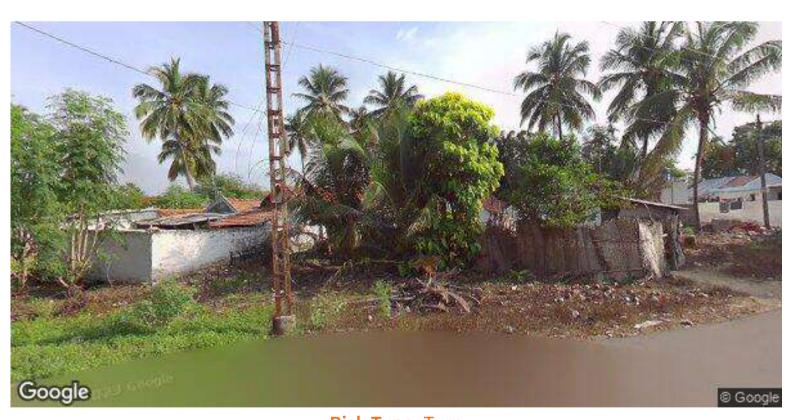
Risk Type: Turn
Risk Level: Medium
Speed Limit: 30 KM/Hr
Coordinates: 10.95322, 77.35534

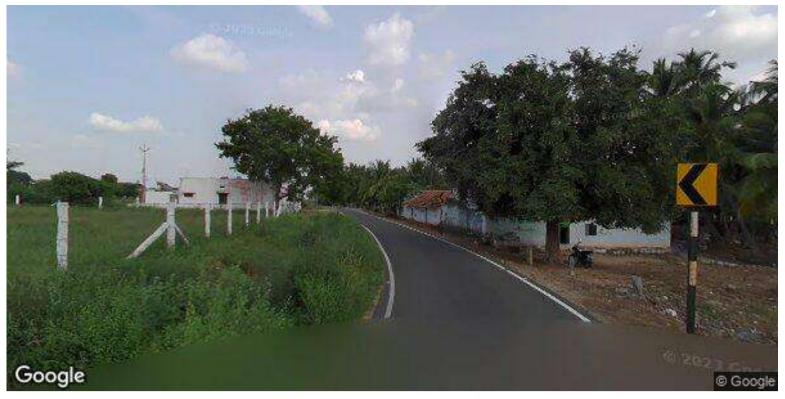
Risk Type: Turn
Risk Level: Medium
Speed Limit: 30 KM/Hr
Coordinates: 10.95414, 77.33798

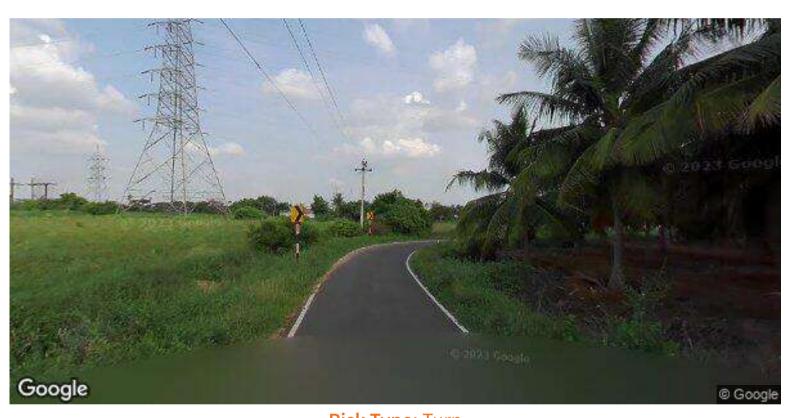
Risk Type: Turn
Risk Level: Medium
Speed Limit: 30 KM/Hr
Coordinates: 10.95504, 77.33685

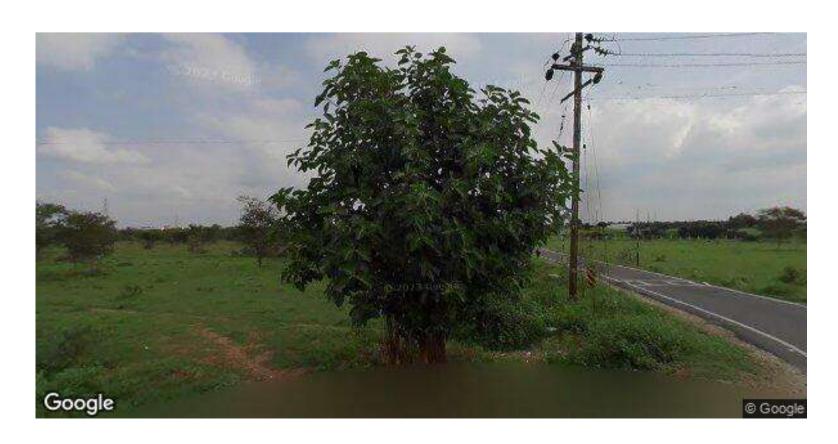
Coordinates: 10.95603, 77.32831

Risk Type: Blind Spot Risk Level: Blind Spot Speed Limit: 10 KM/Hr
