JOURNEY RISK MANAGEMENT (JRM) STUDY

Salem Terminal to SRI VETRIKUMARAN AUTO SERVICE

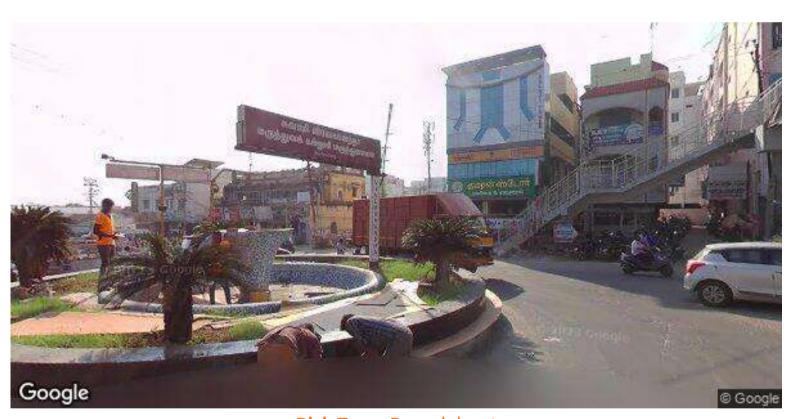
Coordinates: 11.38395, 77.89480

Risk Type: Roundabout
Risk Level: High
Speed Limit: 15 KM/Hr

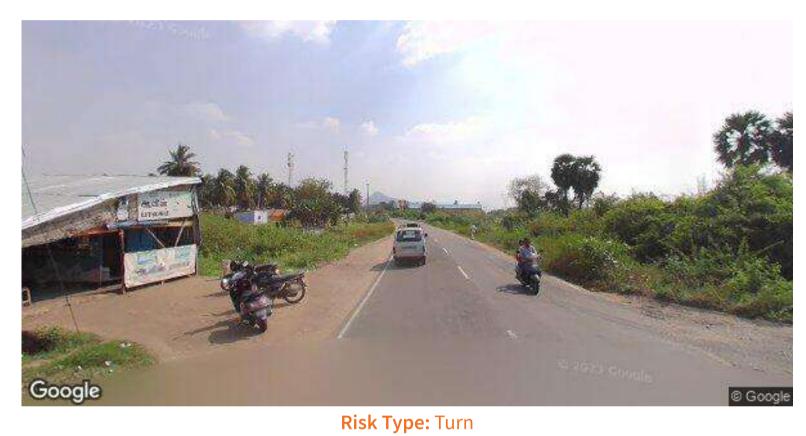
Risk Type: Turn
Risk Level: High
Speed Limit: 15 KM/Hr
Coordinates: 11.44022, 77.87546

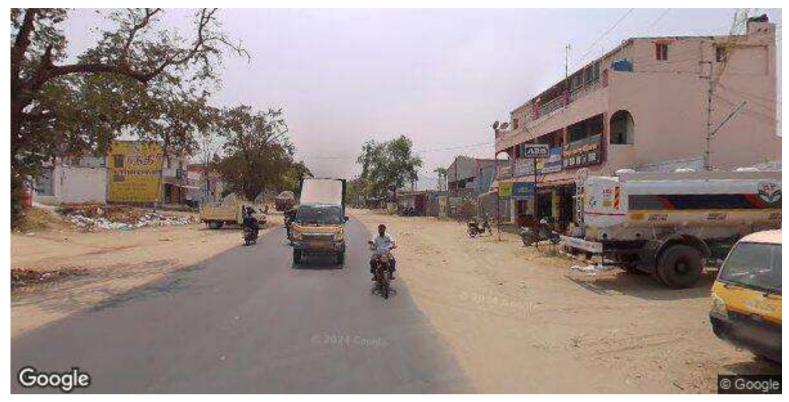
Coordinates: 11.39976, 77.88382

Risk Type: Turn
Risk Level: Medium
Speed Limit: 30 KM/Hr

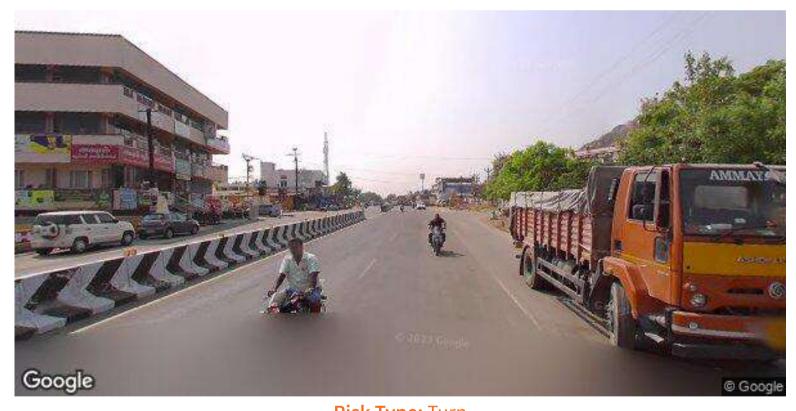
Risk Type: Turn
Risk Level: Medium
Speed Limit: 30 KM/Hr
Coordinates: 11.39690, 77.88852

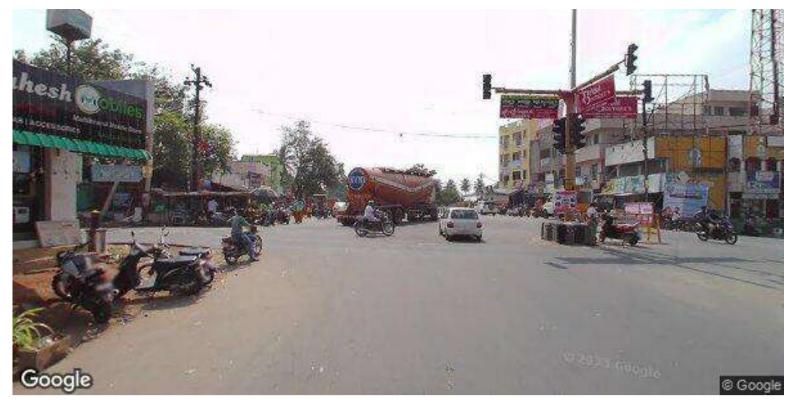
Risk Type: Turn
Risk Level: High
Speed Limit: 15 KM/Hr
Coordinates: 11.36616, 77.88885

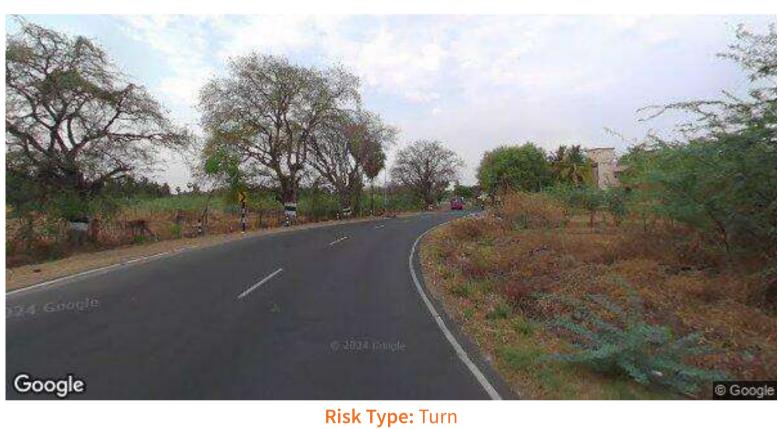
Risk Type: Turn
Risk Level: Medium
Speed Limit: 30 KM/Hr
Coordinates: 11.34067, 77.86347

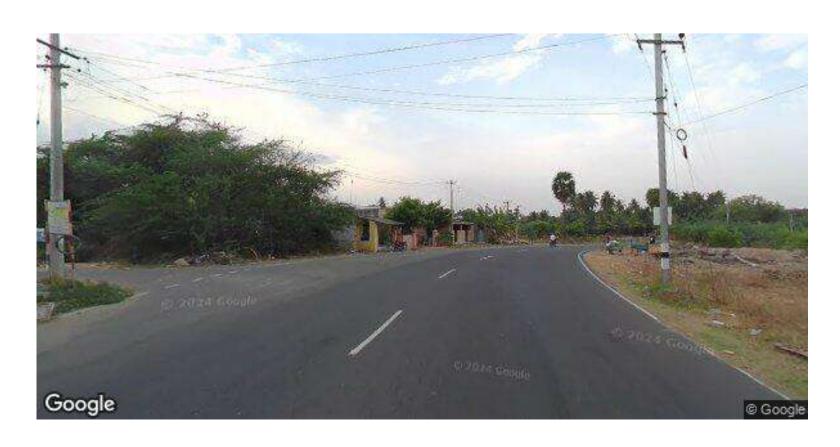
Coordinates: 11.33854, 77.86216

Risk Type: Turn
Risk Level: High
Speed Limit: 15 KM/Hr

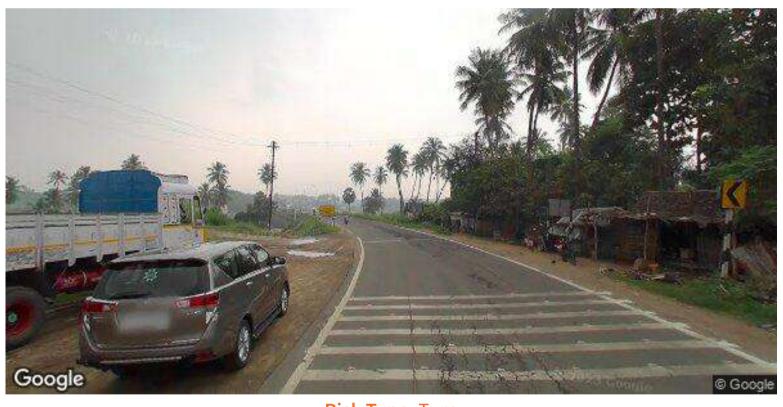
Risk Type: Turn
Risk Level: Medium
Speed Limit: 30 KM/Hr
Coordinates: 11.30952, 77.77587

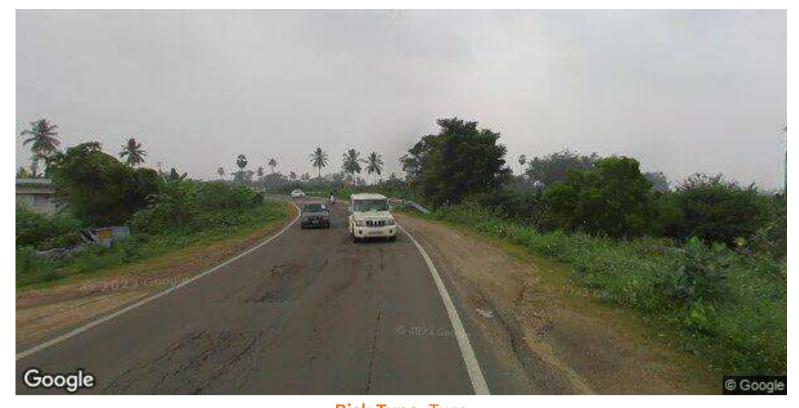
Risk Type: Turn
Risk Level: Medium
Speed Limit: 30 KM/Hr
Coordinates: 11.31111, 77.77178

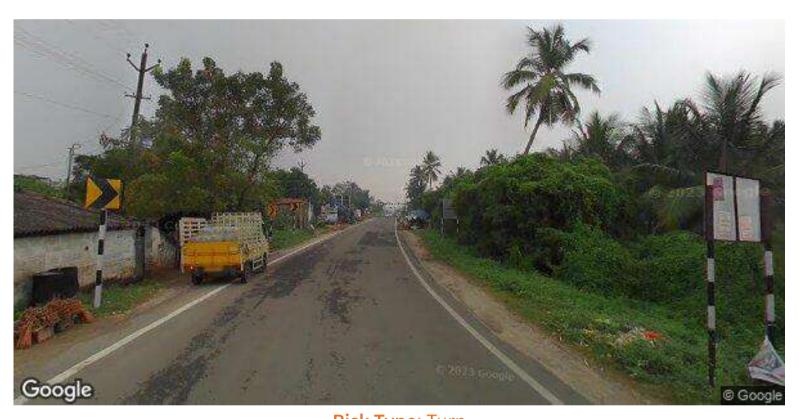
Risk Type: Turn
Risk Level: Medium
Speed Limit: 30 KM/Hr
Coordinates: 11.30973, 77.76712

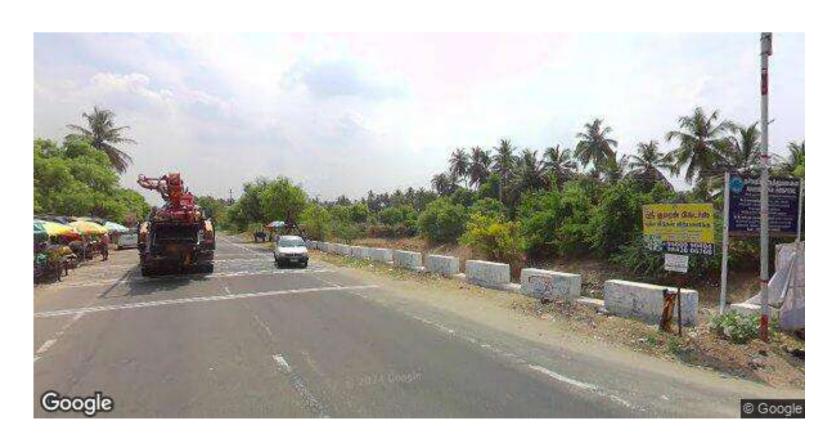
Coordinates: 11.29490, 77.74685

Risk Type: Turn
Risk Level: High
Speed Limit: 15 KM/Hr

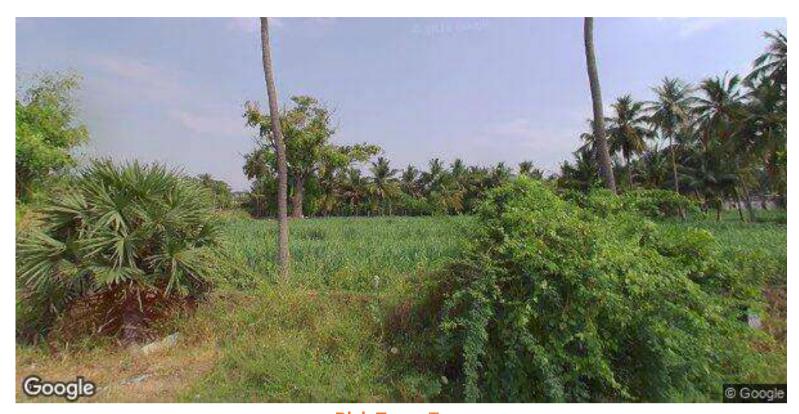
Risk Type: Turn
Risk Level: High
Speed Limit: 15 KM/Hr
Coordinates: 11.29125, 77.74646

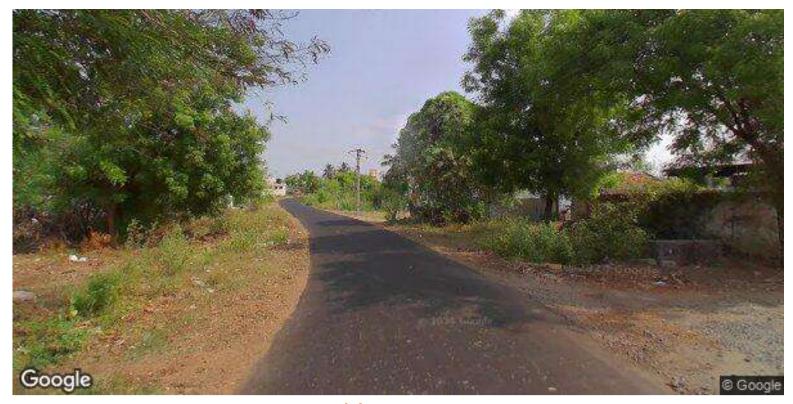
Risk Type: Turn
Risk Level: Medium
Speed Limit: 30 KM/Hr
Coordinates: 11.28844, 77.74319

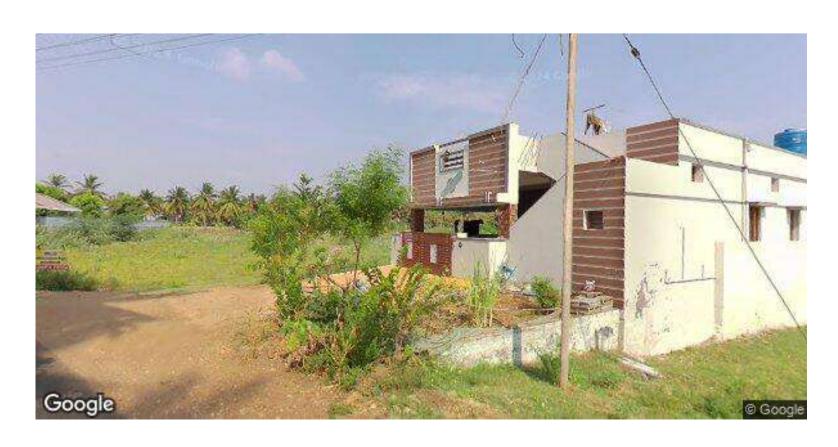
Coordinates: 11.27319, 77.72981

Risk Type: Turn
Risk Level: High
Speed Limit: 15 KM/Hr

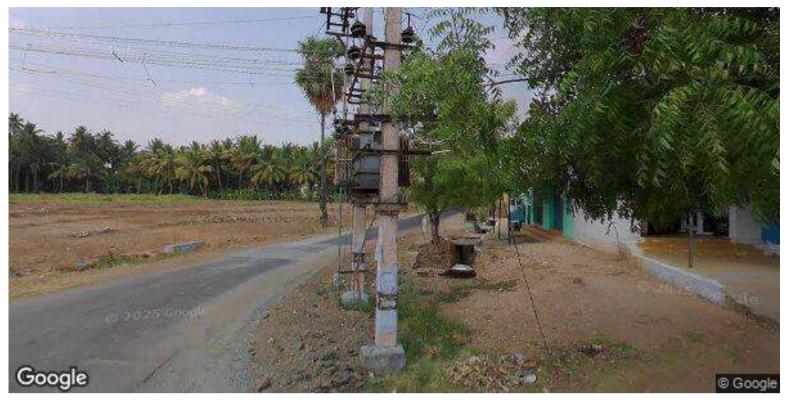
Coordinates: 11.27330, 77.72715

Risk Type: Blind Spot Risk Level: Blind Spot Speed Limit: 10 KM/Hr

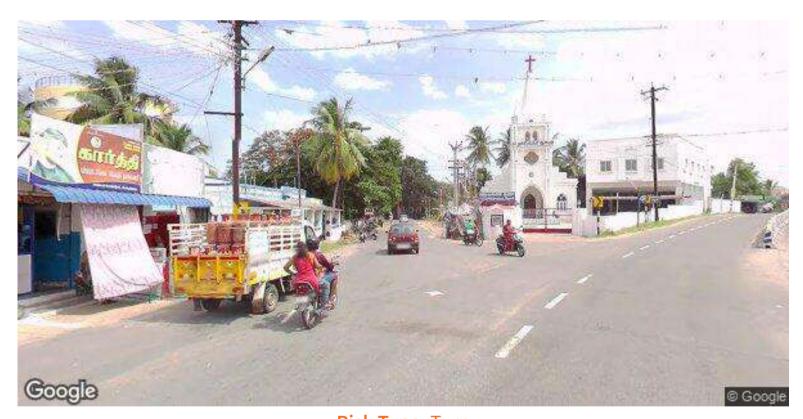
Risk Type: Turn
Risk Level: Medium
Speed Limit: 30 KM/Hr
Coordinates: 11.23054, 77.71796

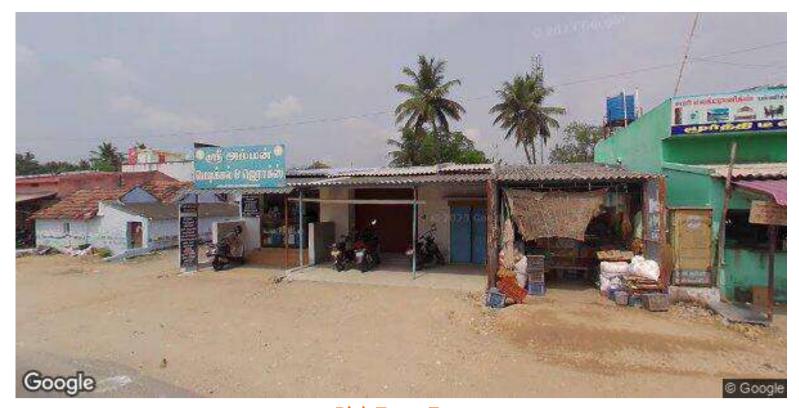
Risk Type: Turn
Risk Level: Medium
Speed Limit: 30 KM/Hr
Coordinates: 11.20776, 77.70916

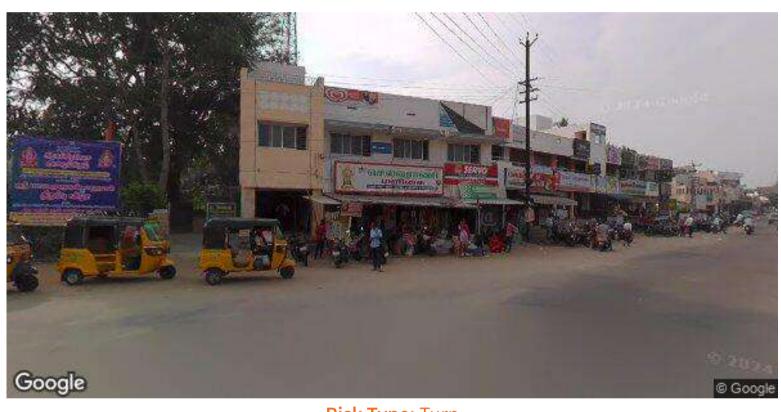
Risk Type: Turn
Risk Level: Medium
Speed Limit: 30 KM/Hr
Coordinates: 11.15942, 77.70068

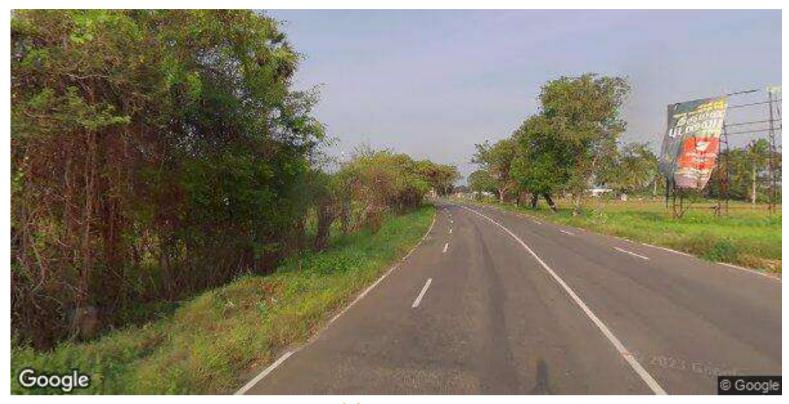
Risk Type: Turn
Risk Level: Medium
Speed Limit: 30 KM/Hr
Coordinates: 11.11932, 77.67786

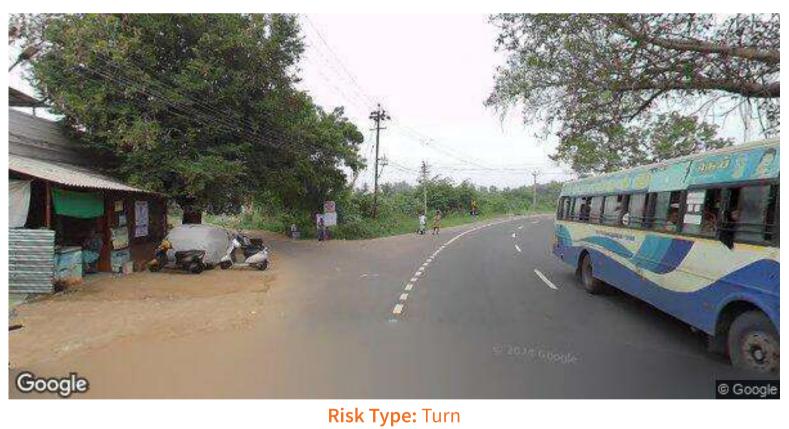
Risk Type. Turn
Risk Level: Medium
Speed Limit: 30 KM/Hr
Coordinates: 11.11710, 77.67175

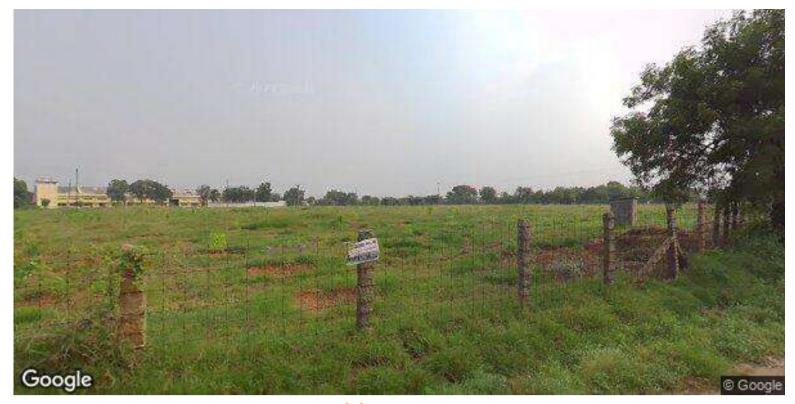
Risk Type: Turn
Risk Level: Medium
Speed Limit: 30 KM/Hr
Coordinates: 11.09491, 77.66603

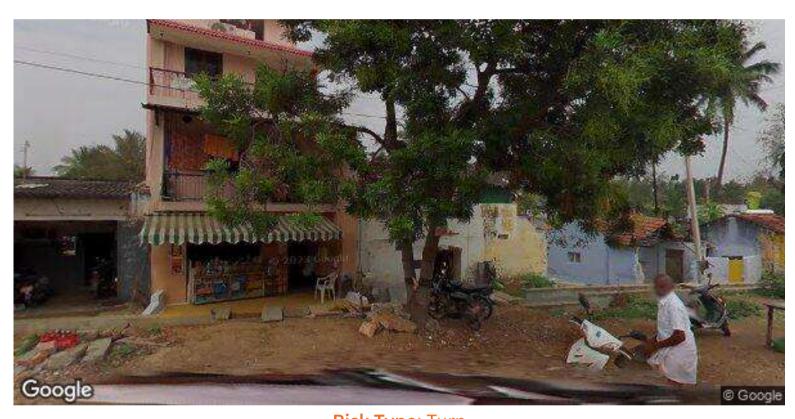
Risk Type: Turn
Risk Level: Medium
Speed Limit: 30 KM/Hr
Coordinates: 11.08696, 77.66407

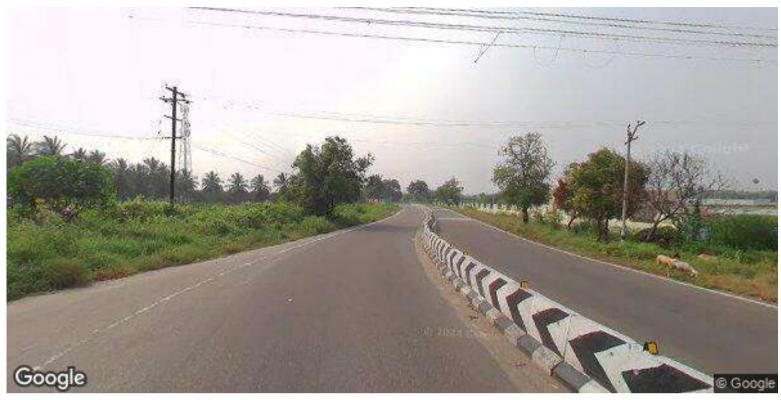
Coordinates: 11.06183, 77.63924

Risk Type: Turn
Risk Level: Medium
Speed Limit: 30 KM/Hr

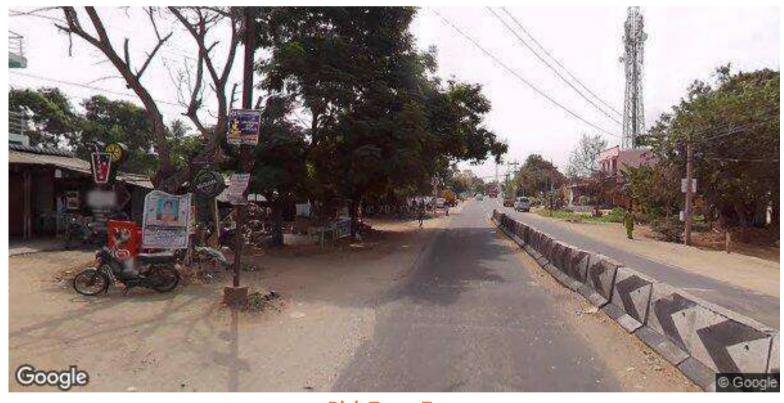
Coordinates: 11.00826, 77.56962

Risk Type: Turn
Risk Level: High
Speed Limit: 15 KM/Hr

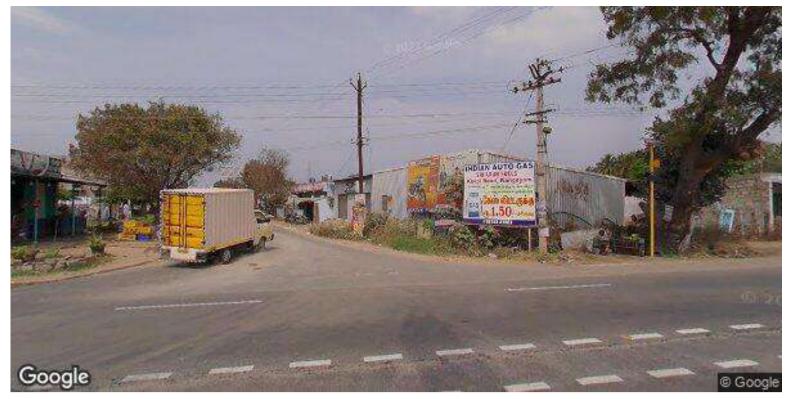
Coordinates: 11.00058, 77.56882

Risk Type: Blind Spot Risk Level: Blind Spot Speed Limit: 10 KM/Hr

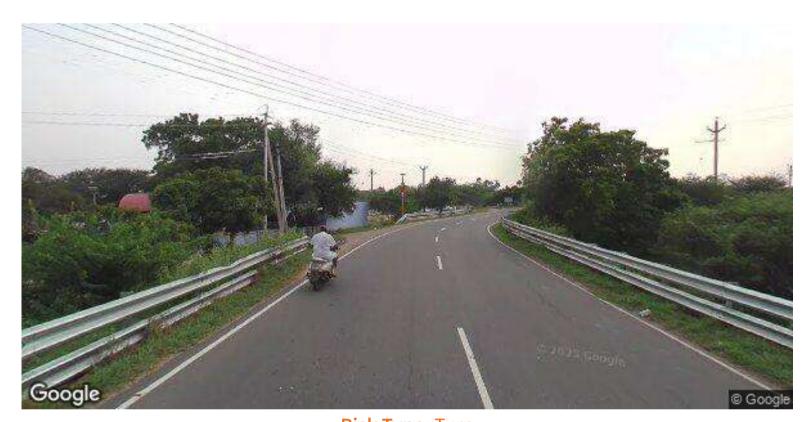
Risk Type: Turn
Risk Level: High
Speed Limit: 15 KM/Hr
Coordinates: 10.94722, 77.54709

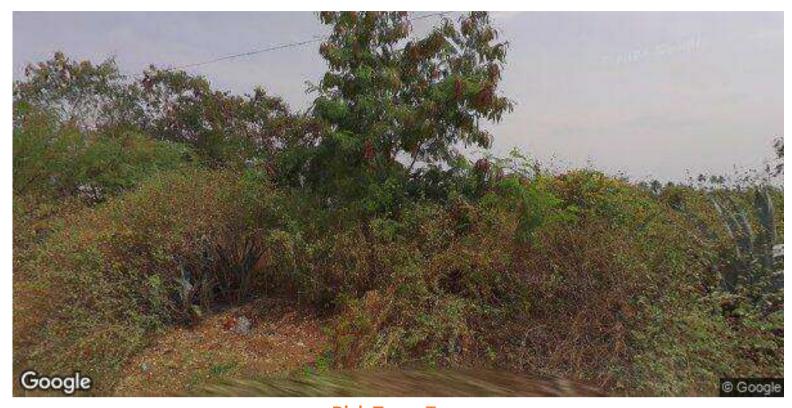
Risk Type: Turn
Risk Level: Medium
Speed Limit: 30 KM/Hr
Coordinates: 10.93054, 77.53265

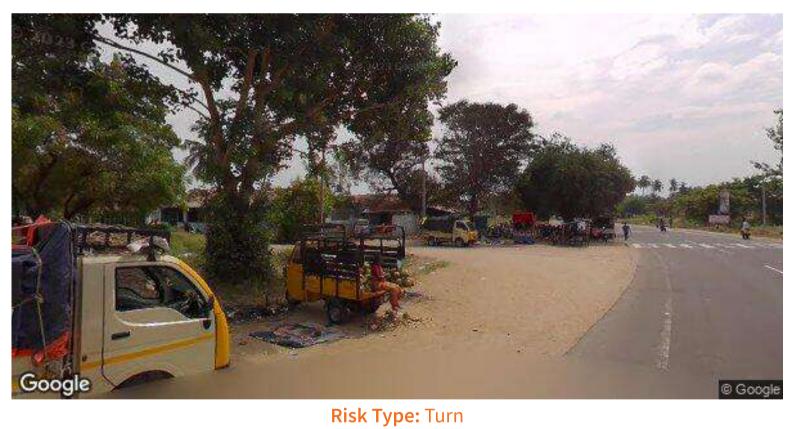
Risk Type. Turn
Risk Level: Medium
Speed Limit: 30 KM/Hr
Coordinates: 10.89213, 77.52646

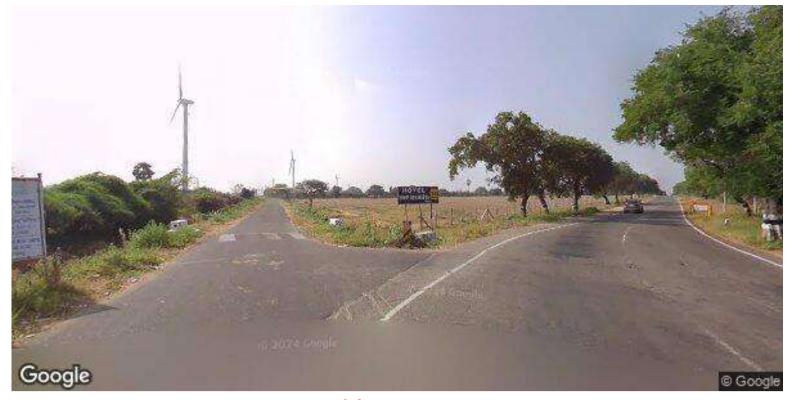
Coordinates: 10.83409, 77.52932

Risk Type: Turn
Risk Level: Medium
Speed Limit: 30 KM/Hr

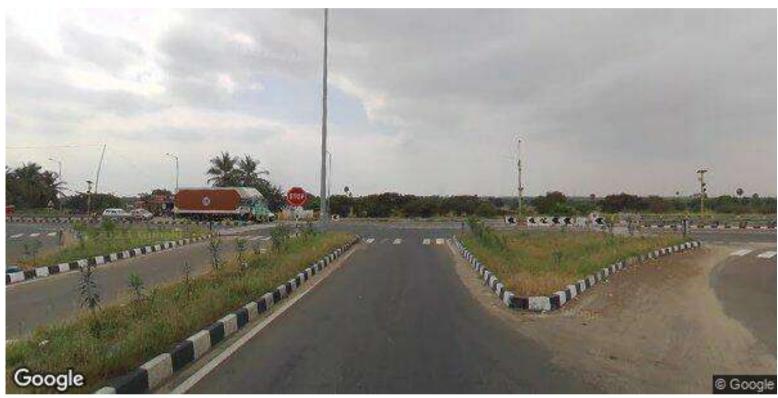
Coordinates: 10.77642, 77.50712

Risk Type: Turn
Risk Level: High
Speed Limit: 15 KM/Hr

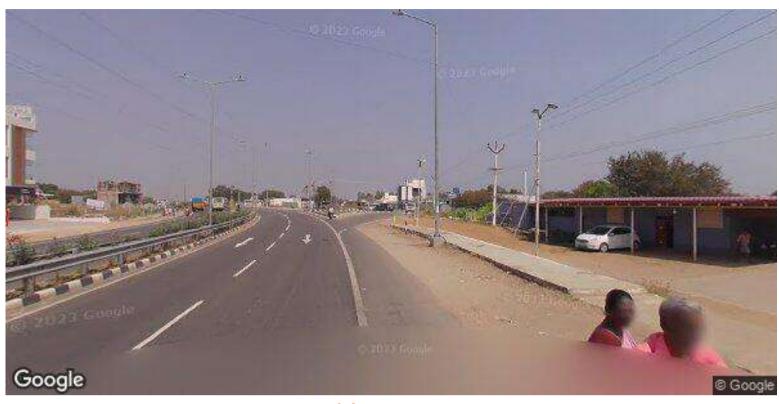
Coordinates: 10.75722, 77.51935

Risk Type: Turn
Risk Level: Medium
Speed Limit: 30 KM/Hr

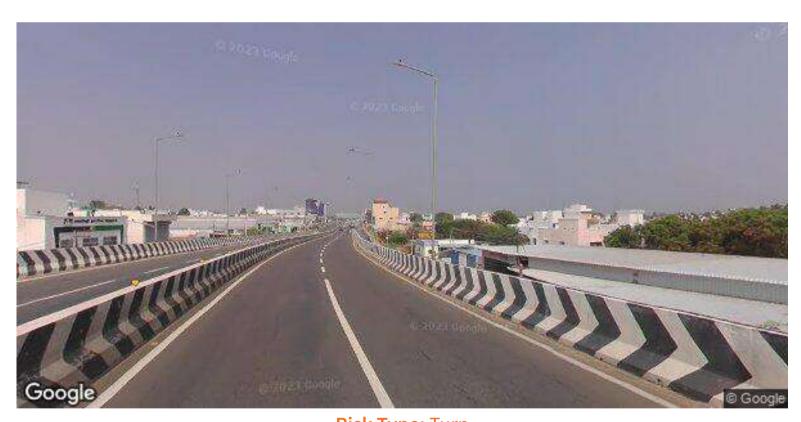
Coordinates: 10.73670, 77.51731

Risk Type: Turn
Risk Level: Medium
Speed Limit: 30 KM/Hr

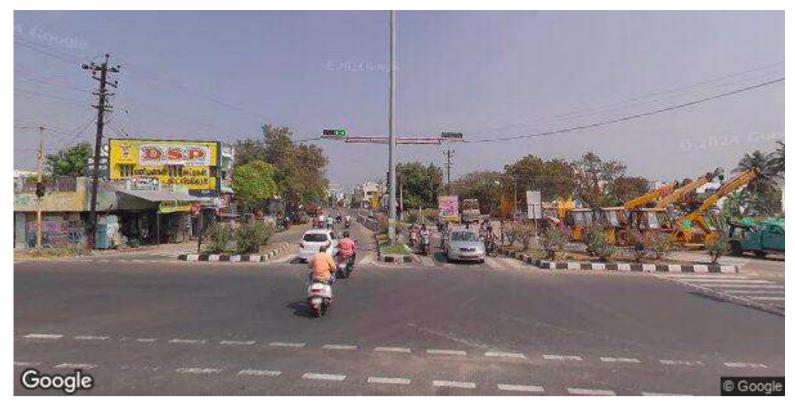
Coordinates: 10.72415, 77.52567

Risk Type: Blind Spot Risk Level: Blind Spot Speed Limit: 10 KM/Hr

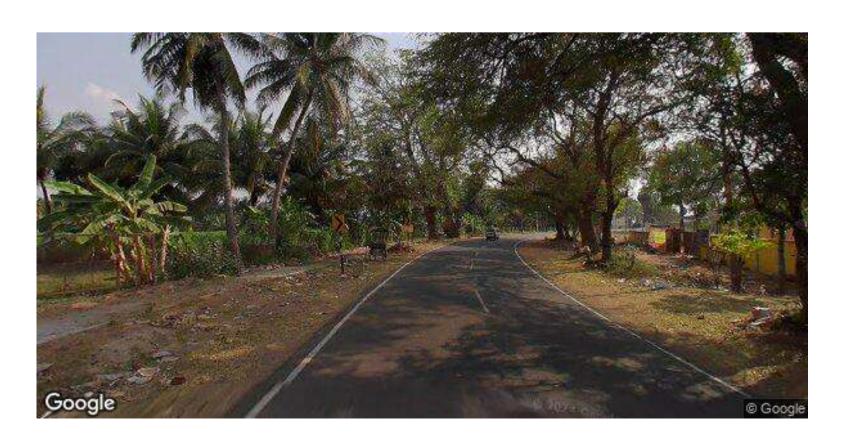
Coordinates: 10.67423, 77.50673

Risk Type: Turn
Risk Level: High
Speed Limit: 15 KM/Hr

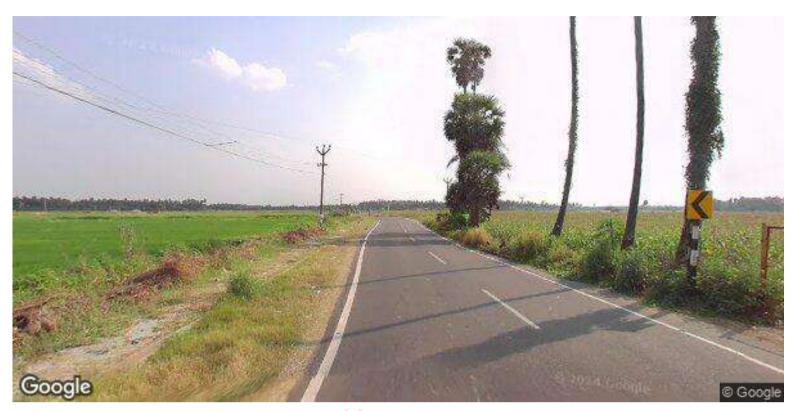
Coordinates: 10.67029, 77.50333

Risk Type: Turn
Risk Level: Medium
Speed Limit: 30 KM/Hr

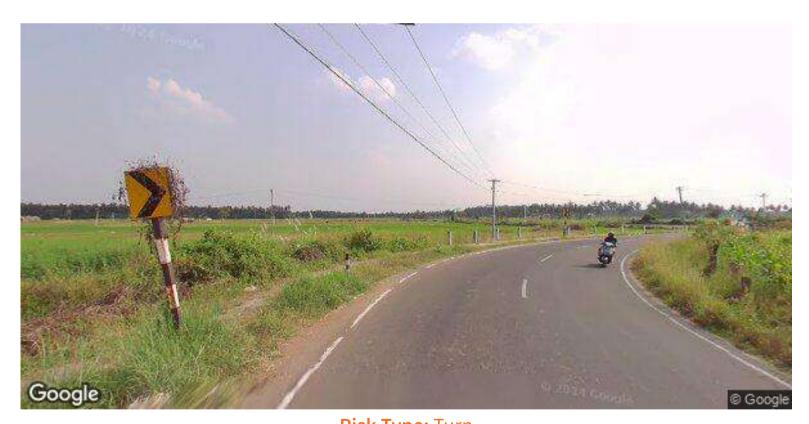
Coordinates: 10.66919, 77.50314

Risk Type: Turn
Risk Level: Medium
Speed Limit: 30 KM/Hr

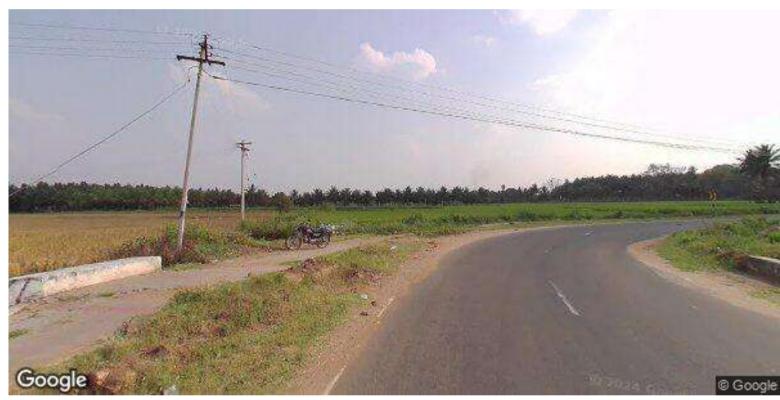
Risk Type: Turn
Risk Level: Medium
Speed Limit: 30 KM/Hr
Coordinates: 10.66449, 77.50294
