# JOURNEY RISK MANAGEMENT (JRM) STUDY

# Salem Terminal TO GEE AR AGENCY

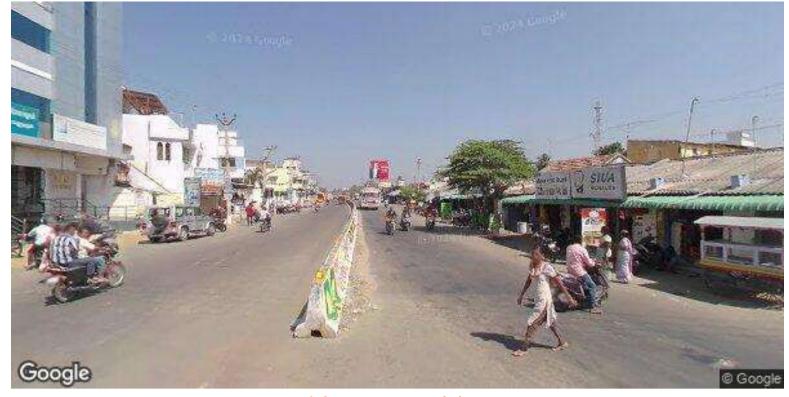
Risk Type: Roundabout
Risk Level: High
Speed Limit: 15 KM/Hr
Coordinates: 11.37086, 77.74828

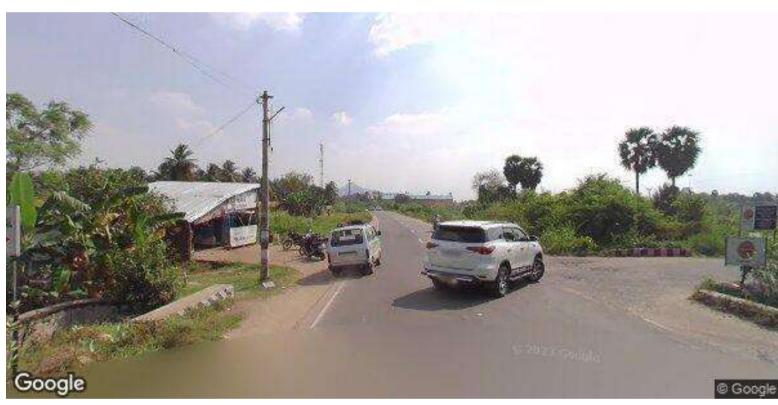
Risk Type: Turn
Risk Level: High
Speed Limit: 15 KM/Hr
Coordinates: 11.44029, 77.87544

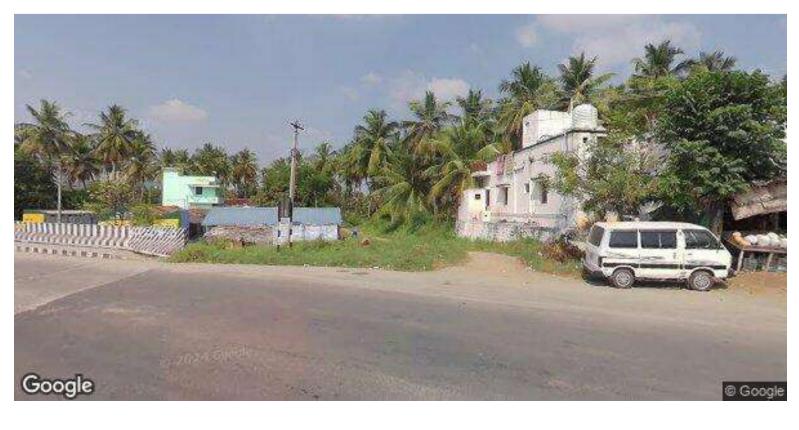
**Coordinates:** 11.44898, 77.87410

Risk Type: Turn
Risk Level: Medium
Speed Limit: 30 KM/Hr

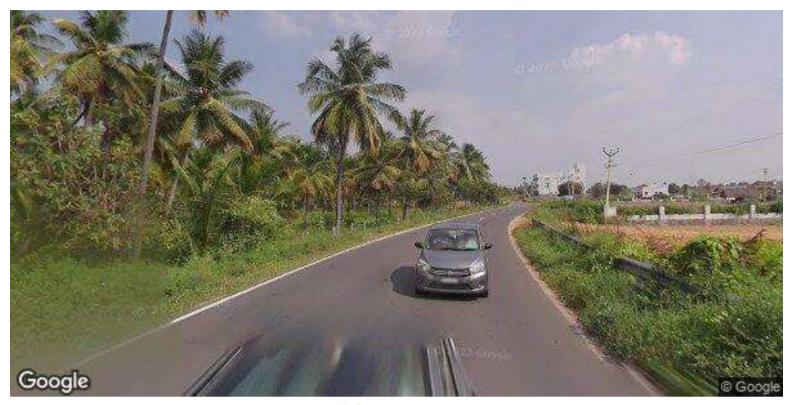
**Coordinates:** 11.45357, 77.85789

Risk Type: Turn
Risk Level: Medium
Speed Limit: 30 KM/Hr

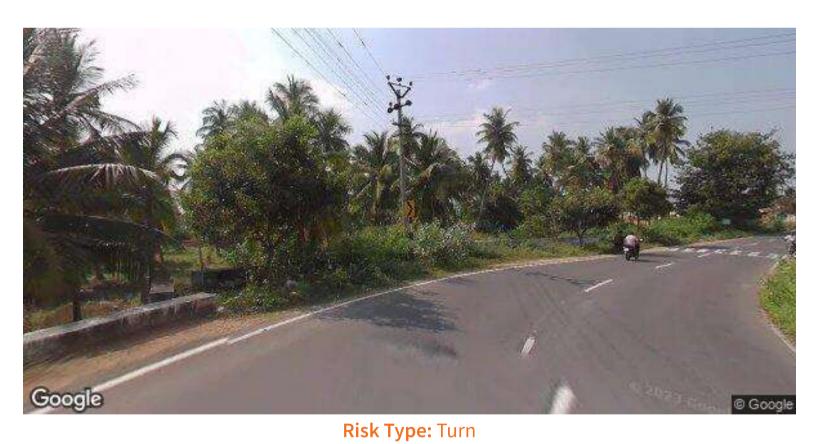
**Coordinates:** 11.45348, 77.85706

Risk Type: Turn
Risk Level: Medium
Speed Limit: 30 KM/Hr

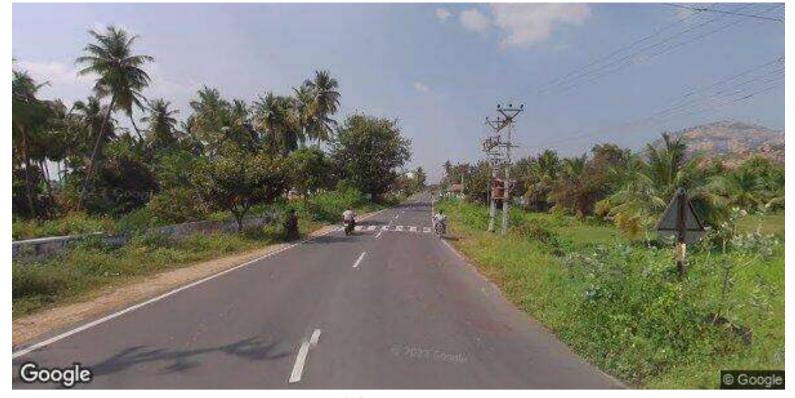
Risk Type: Turn
Risk Level: Medium
Speed Limit: 30 KM/Hr
Coordinates: 11.45352, 77.85698

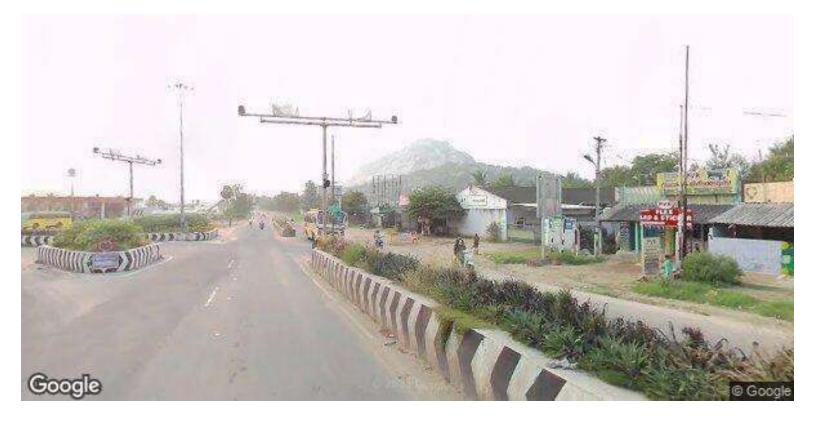
**Coordinates:** 11.46312, 77.84886

Risk Type: Turn
Risk Level: Medium
Speed Limit: 30 KM/Hr

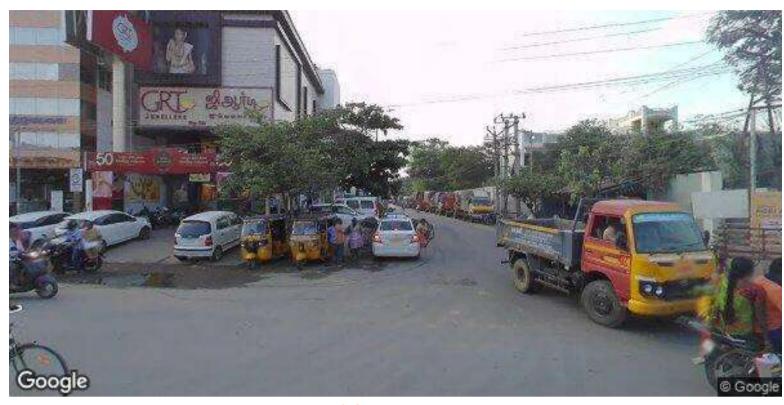
**Coordinates:** 11.34678, 77.73104

Risk Type: Turn
Risk Level: High
Speed Limit: 15 KM/Hr

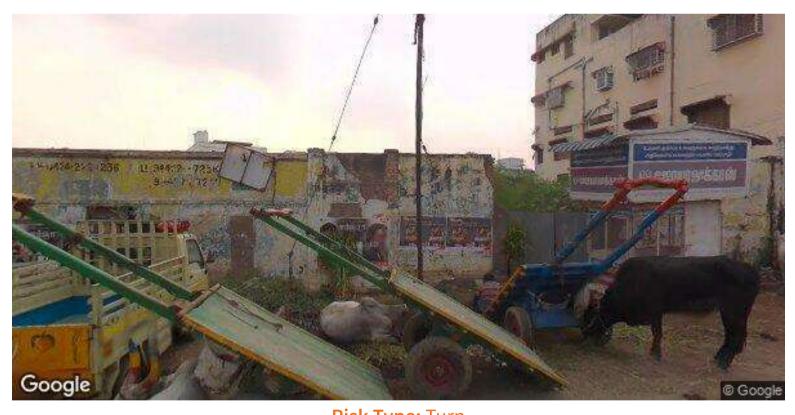
**Coordinates:** 11.34678, 77.72581

Risk Type: Turn
Risk Level: High
Speed Limit: 15 KM/Hr

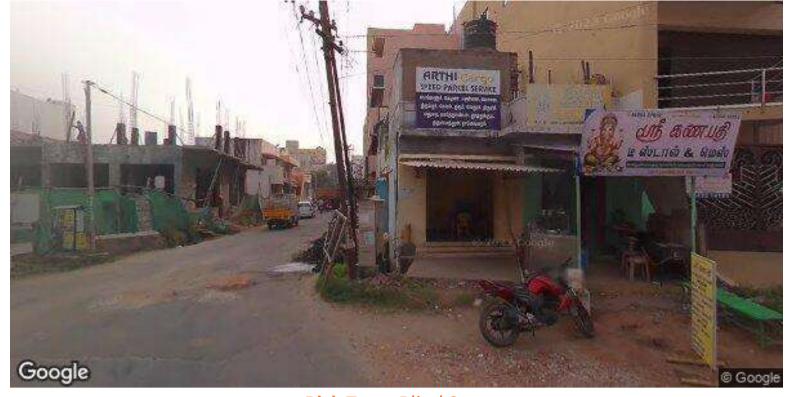
Risk Type: Blind Spot
Risk Level: Blind Spot
Speed Limit: 10 KM/Hr
Coordinates: 11.34803, 77.72478

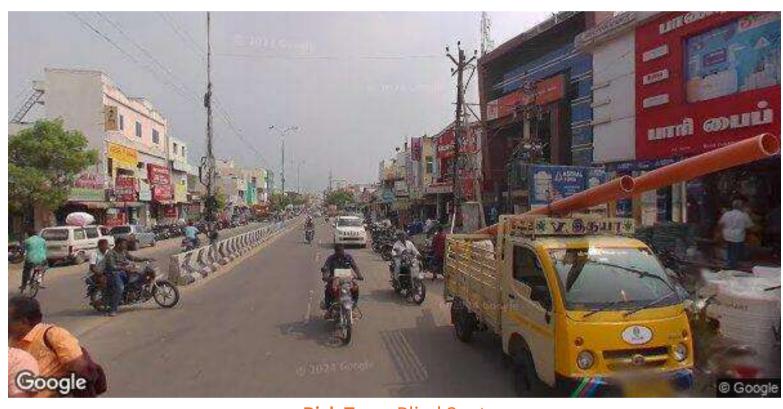
Risk Type: Blind Spot
Risk Level: Blind Spot
Speed Limit: 10 KM/Hr
Coordinates: 11.34625, 77.72392

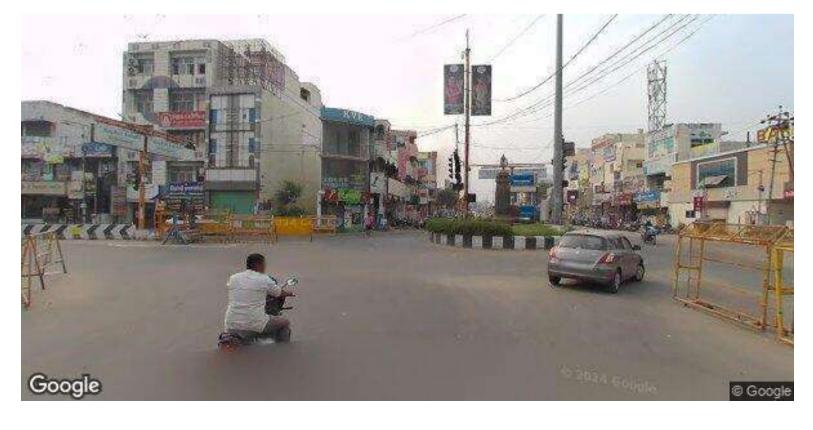
**Coordinates:** 11.34796, 77.71921

Risk Type: Turn
Risk Level: High
Speed Limit: 15 KM/Hr

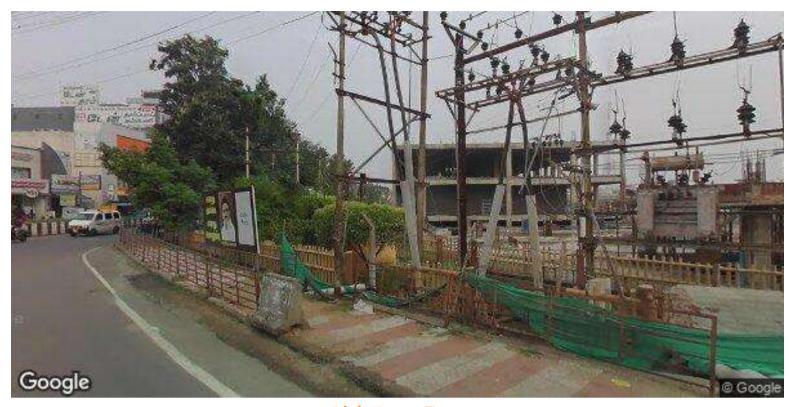
Risk Type: Turn
Risk Level: Medium
Speed Limit: 30 KM/Hr
Coordinates: 11.34784, 77.71903

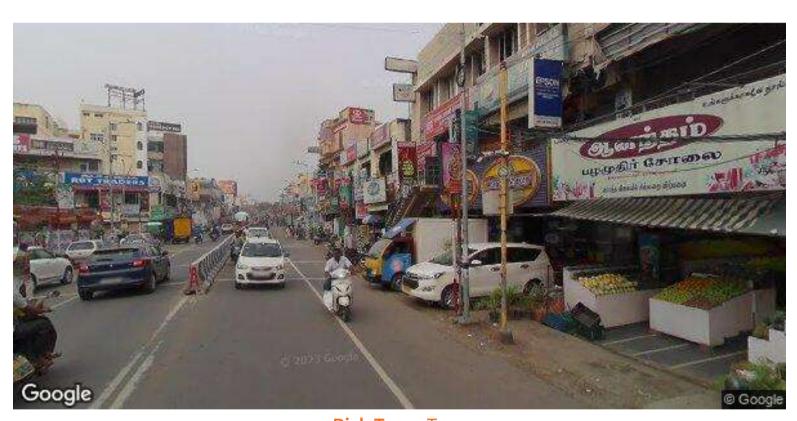
Risk Type: Turn
Risk Level: High
Speed Limit: 15 KM/Hr
Coordinates: 11.34389, 77.71797

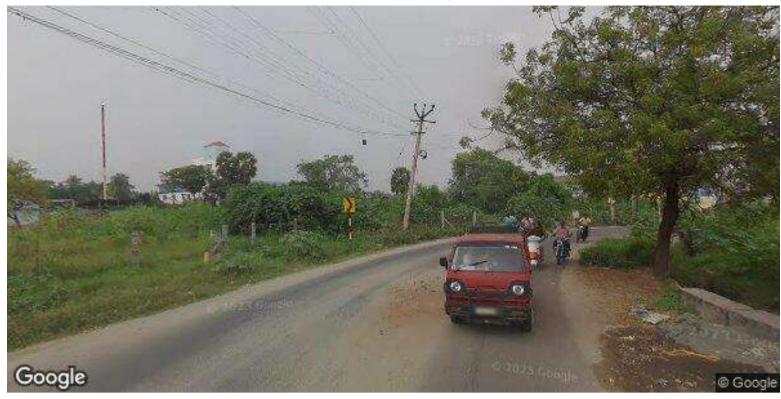
**Coordinates:** 11.35059, 77.70315

Risk Type: Turn
Risk Level: Medium
Speed Limit: 30 KM/Hr
