JOURNEY RISK MANAGEMENT (JRM) STUDY

IOCL Coimbatore Terminal to Shri Lakshmi Thirumal Fuel Station

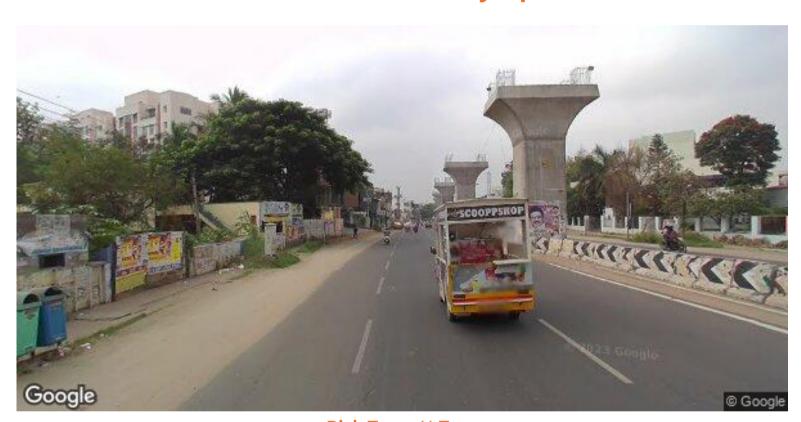
Coordinates: 11.0161282, 76.9896128

Risk Type: U-Turn
Risk Level: High
Speed Limit: 10 KM/Hr

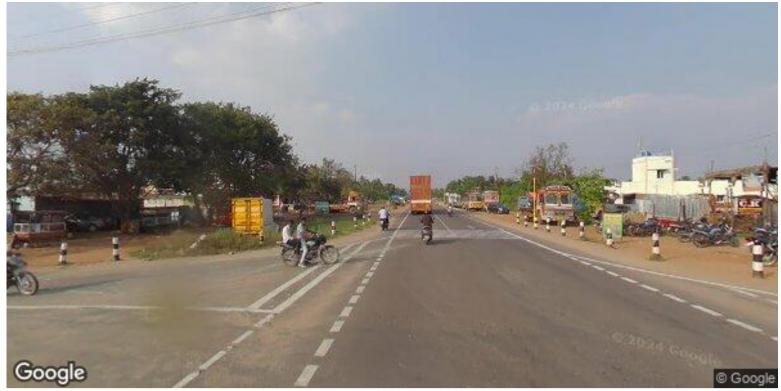
Coordinates: 11.03211, 77.07640

Risk Type: Turn
Risk Level: High
Speed Limit: 15 KM/Hr

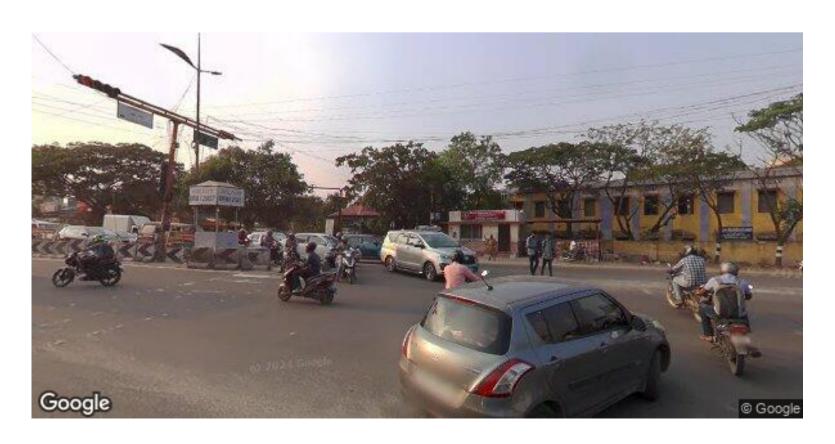
Coordinates: 11.05529, 77.06566

Risk Type: Turn
Risk Level: High
Speed Limit: 15 KM/Hr

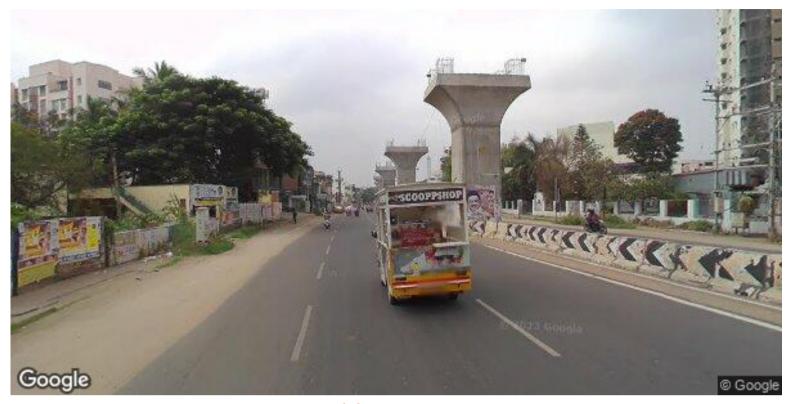
Risk Type: Turn
Risk Level: High
Speed Limit: 15 KM/Hr
Coordinates: 11.01613, 76.98961

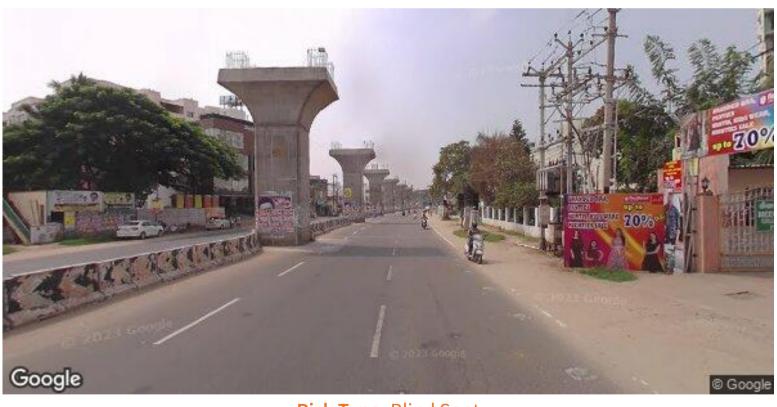
Coordinates: 11.01618, 76.98951

Risk Type: Blind Spot Risk Level: Blind Spot Speed Limit: 10 KM/Hr

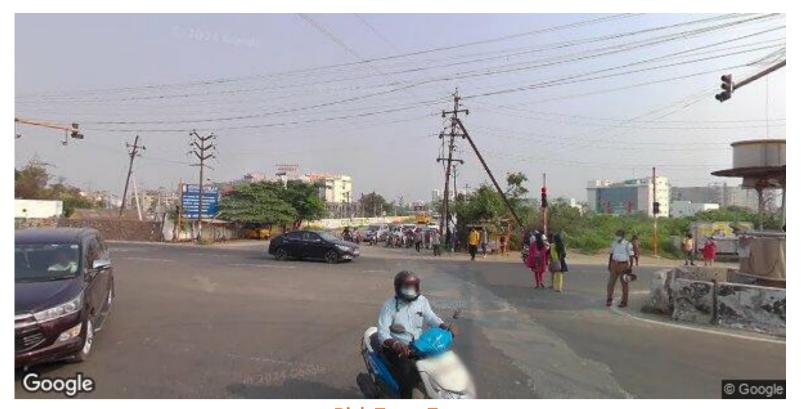
Risk Type: Turn
Risk Level: High
Speed Limit: 15 KM/Hr
Coordinates: 11.02014, 76.99212

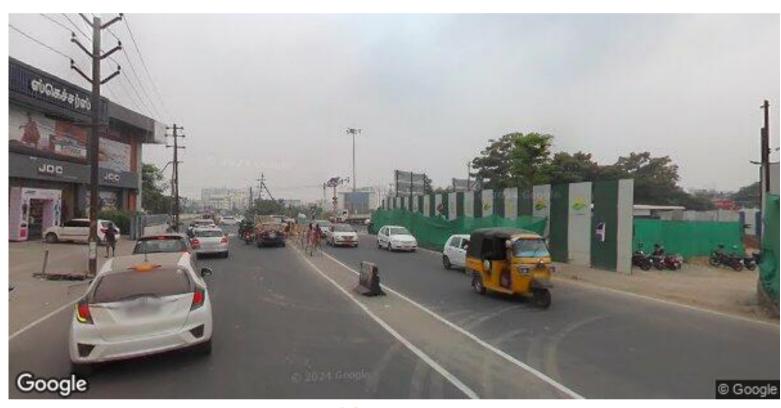
Risk Type: Turn
Risk Level: Medium
Speed Limit: 30 KM/Hr
Coordinates: 11.02051, 76.99177

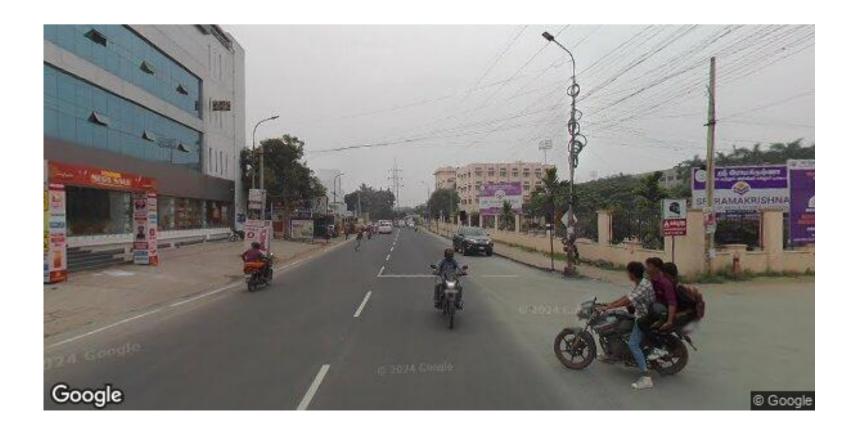
Coordinates: 11.02135, 76.98788

Risk Type: Turn
Risk Level: High
Speed Limit: 15 KM/Hr

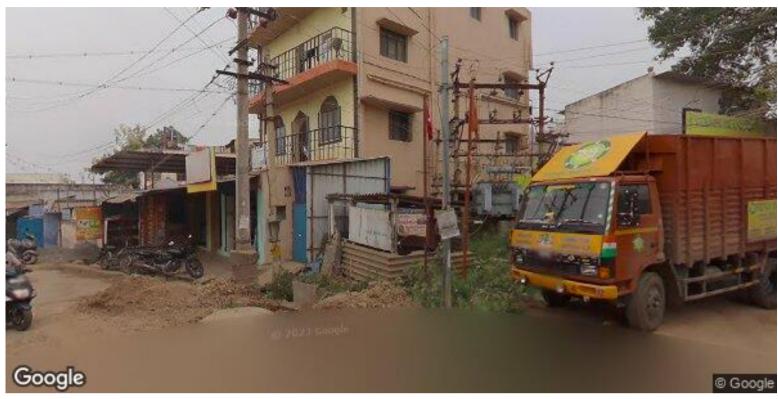
Coordinates: 11.02453, 76.98806

Risk Type: Turn
Risk Level: High
Speed Limit: 15 KM/Hr

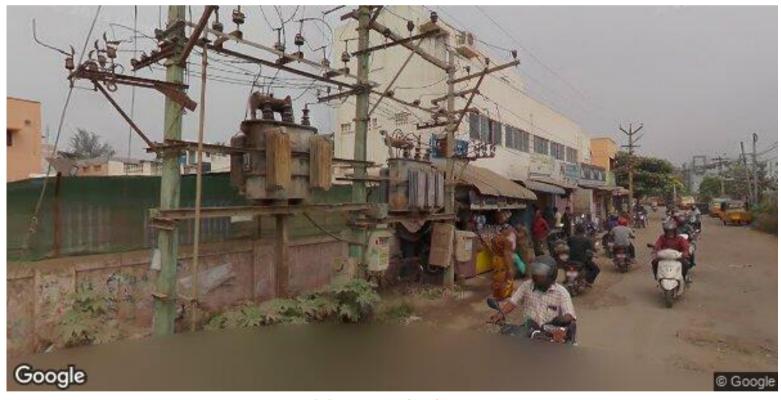
Coordinates: 11.02562, 76.98730

Risk Type: Blind Spot Risk Level: Blind Spot Speed Limit: 10 KM/Hr

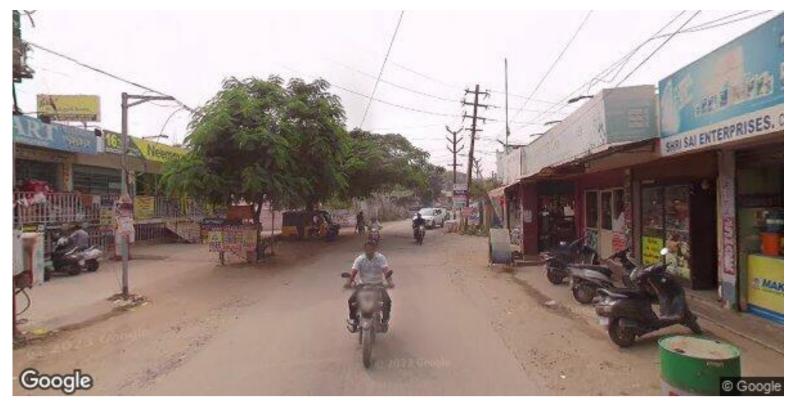
Coordinates: 11.02401, 76.98291

Risk Type: Blind Spot Risk Level: Blind Spot Speed Limit: 10 KM/Hr

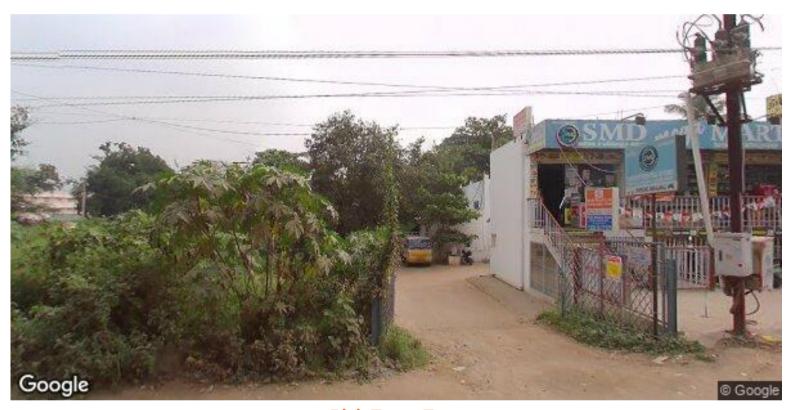
Risk Type: Turn
Risk Level: Medium
Speed Limit: 30 KM/Hr
Coordinates: 11.02386, 76.98298

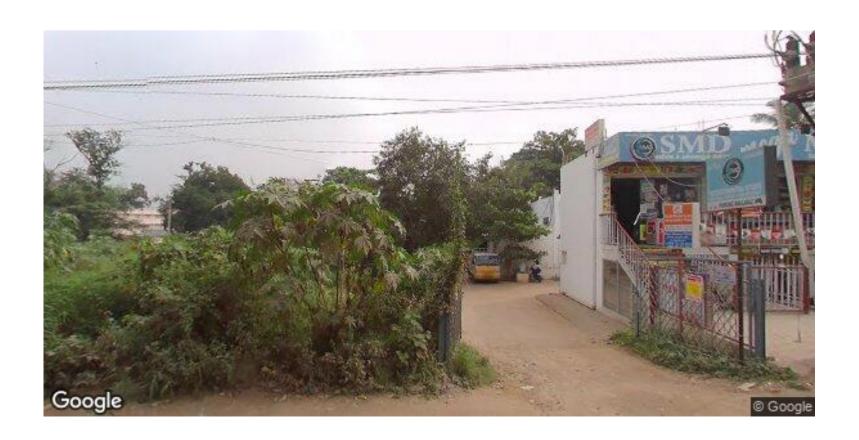
Coordinates: 11.02385, 76.98300

Risk Type: Turn
Risk Level: Medium
Speed Limit: 30 KM/Hr
