# JOURNEY RISK MANAGEMENT (JRM) STUDY

# IOCL Coimbatore Terminal to Shri Maruthi Agencies

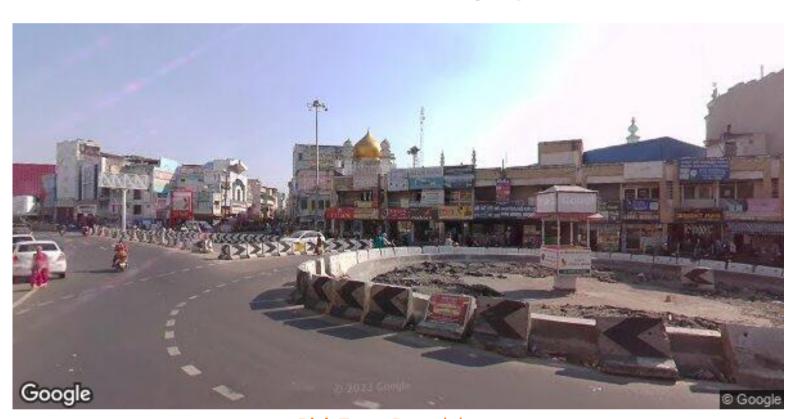
**Coordinates:** 10.65920, 77.00836

Risk Type: Roundabout
Risk Level: High
Speed Limit: 15 KM/Hr

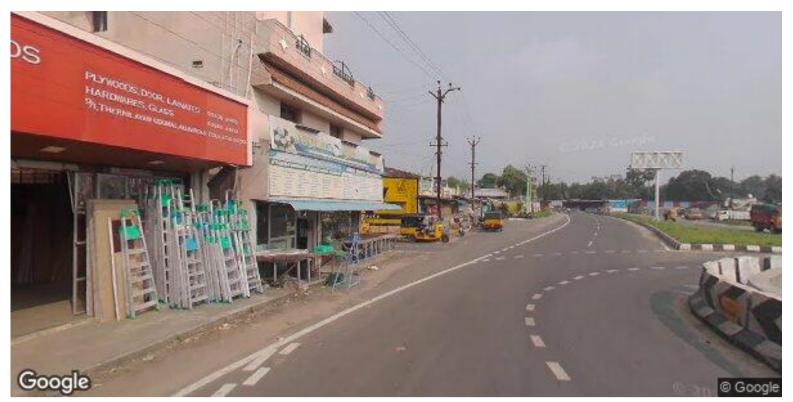
**Coordinates:** 10.65652, 77.01253

Risk Type: Roundabout
Risk Level: High
Speed Limit: 15 KM/Hr

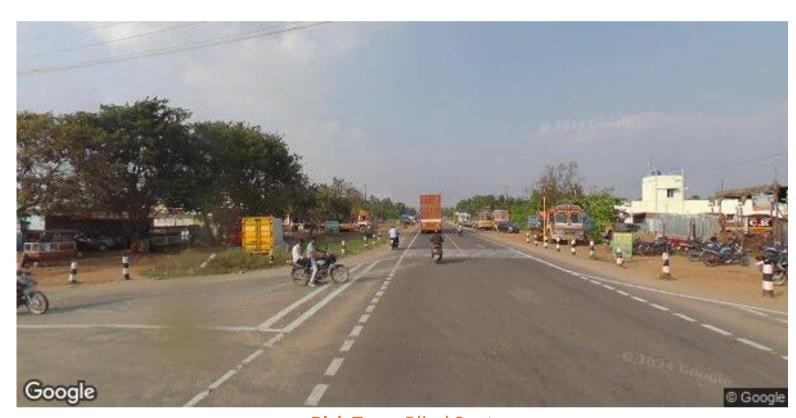
Risk Type: Blind Spot
Risk Level: Blind Spot
Speed Limit: 10 KM/Hr
Coordinates: 11.03211, 77.07640

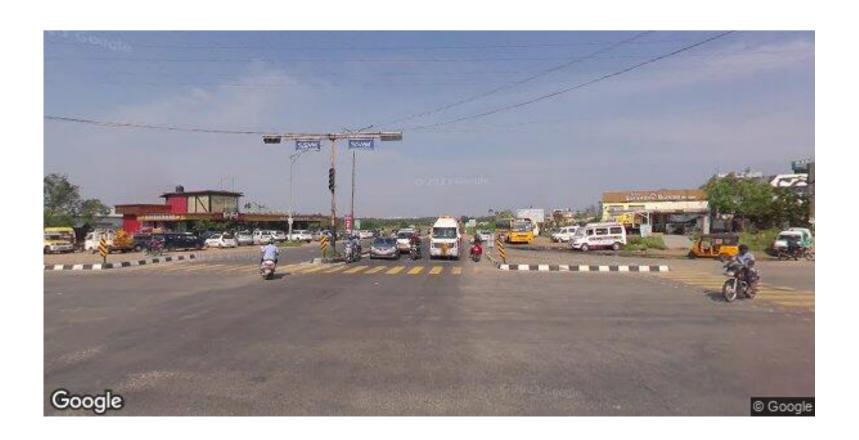
**Coordinates:** 10.91785, 76.98617

Risk Type: Blind Spot Risk Level: Blind Spot Speed Limit: 10 KM/Hr

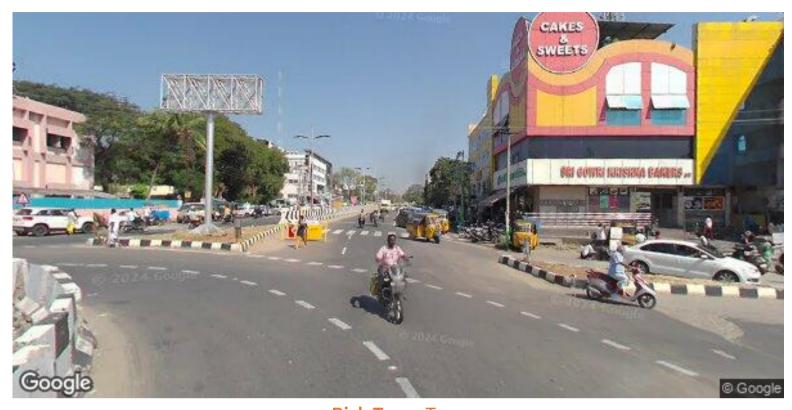
**Coordinates:** 10.66190, 77.00822

Risk Type: Turn
Risk Level: Medium
Speed Limit: 30 KM/Hr

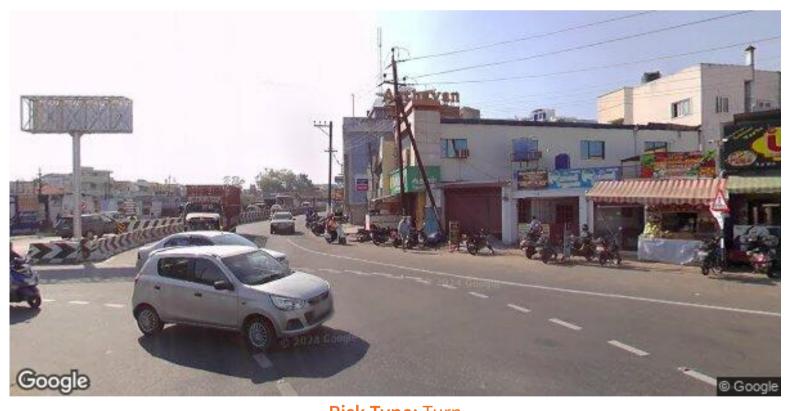
**Coordinates:** 10.65707, 77.01156

Risk Type: Turn
Risk Level: Medium
Speed Limit: 30 KM/Hr

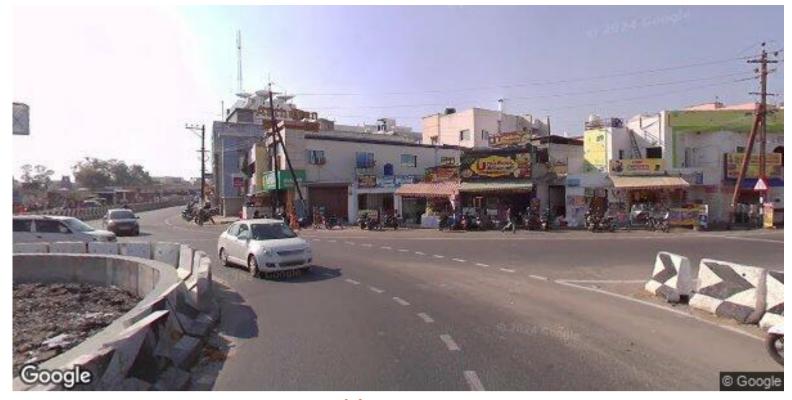
Risk Type: Turn
Risk Level: Medium
Speed Limit: 30 KM/Hr
Coordinates: 10.65704, 77.01162

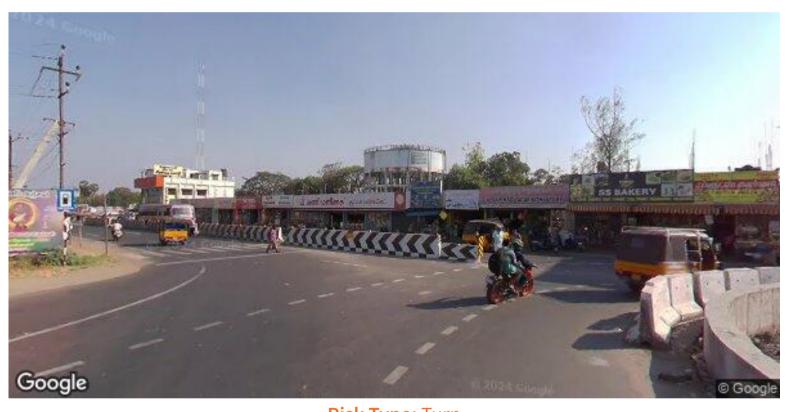
Risk Type: Turn
Risk Level: Medium
Speed Limit: 30 KM/Hr
Coordinates: 10.65698, 77.01166

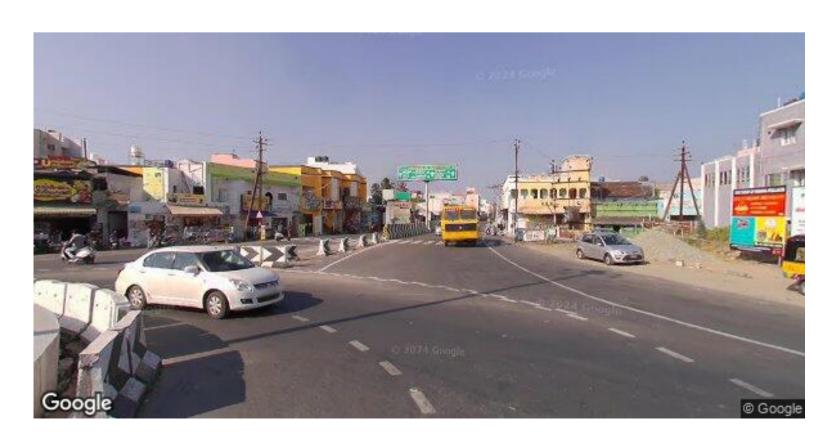
**Coordinates:** 10.65695, 77.01166

Risk Type: Turn
Risk Level: High
Speed Limit: 15 KM/Hr

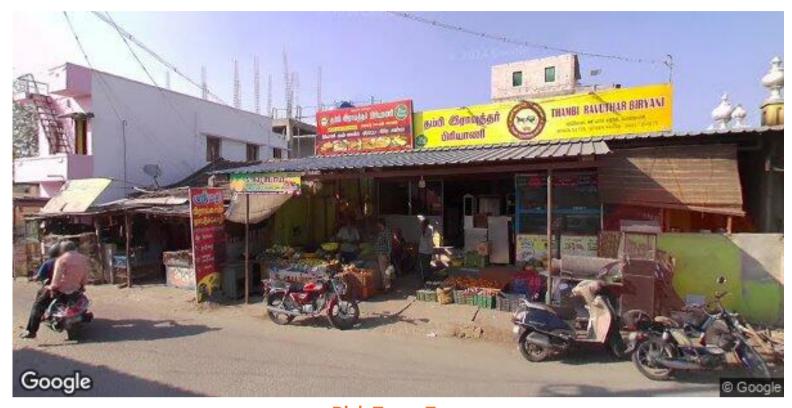
Risk Type: Turn
Risk Level: High
Speed Limit: 15 KM/Hr
Coordinates: 10.65643, 77.01141

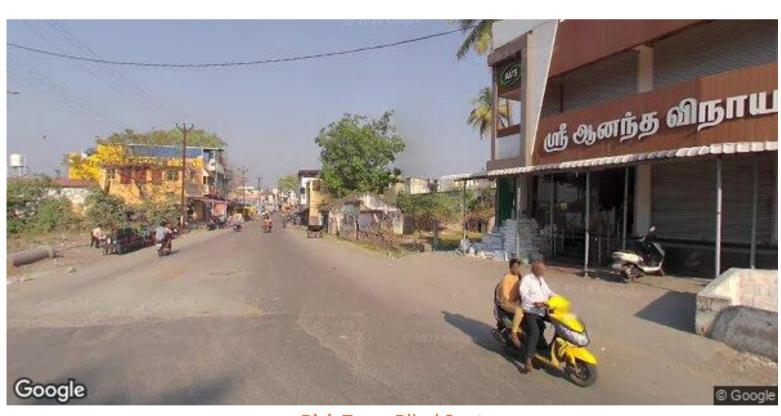
**Coordinates:** 10.65461, 77.01107

Risk Type: Blind Spot
Risk Level: Blind Spot
Speed Limit: 10 KM/Hr

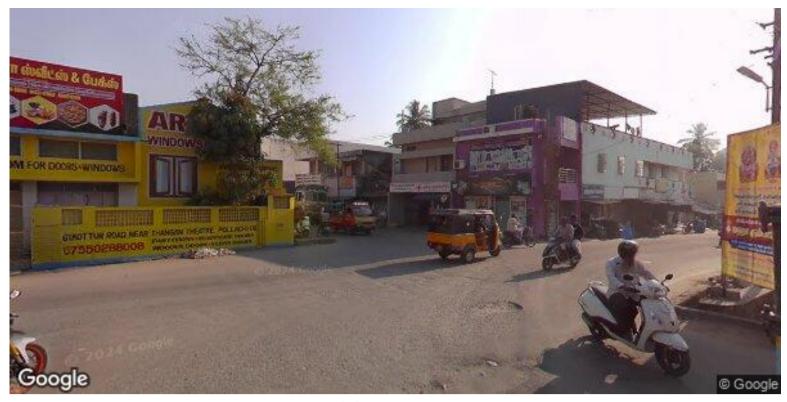
Risk Type: Turn
Risk Level: High
Speed Limit: 15 KM/Hr
Coordinates: 10.65494, 77.01008

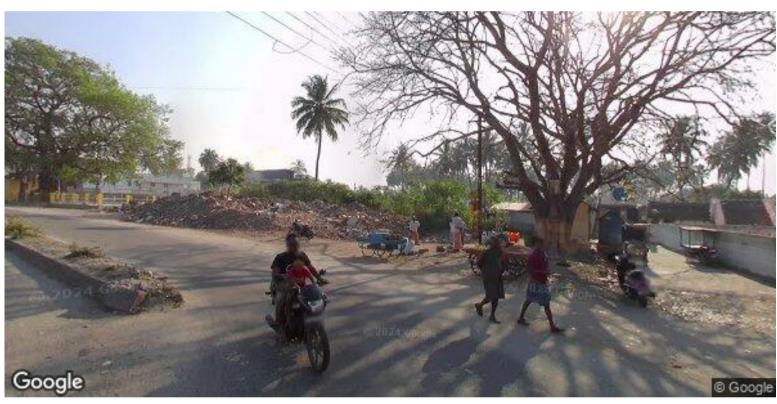
**Coordinates:** 10.65420, 77.00966

Risk Type: Turn
Risk Level: High
Speed Limit: 15 KM/Hr

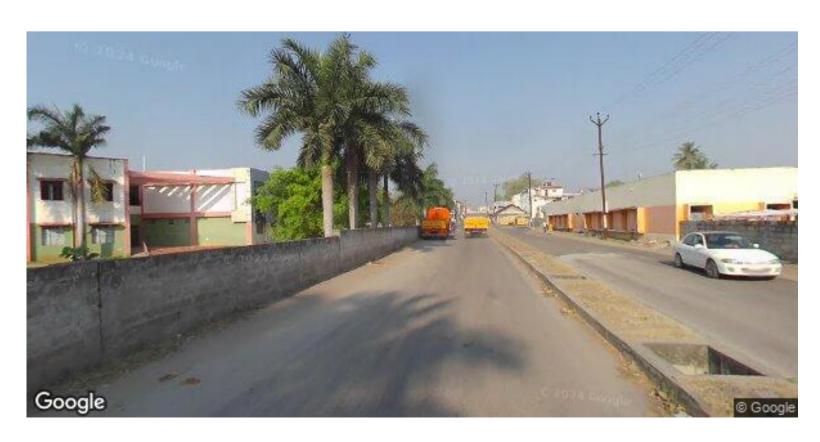
**Coordinates:** 10.65418, 77.00954

Risk Type: Turn
Risk Level: Medium
Speed Limit: 30 KM/Hr

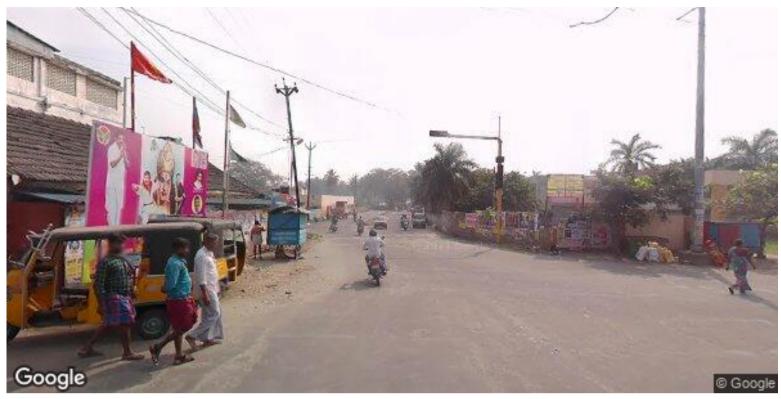
**Coordinates:** 10.65451, 77.00837

Risk Type: Blind Spot
Risk Level: Blind Spot
Speed Limit: 10 KM/Hr

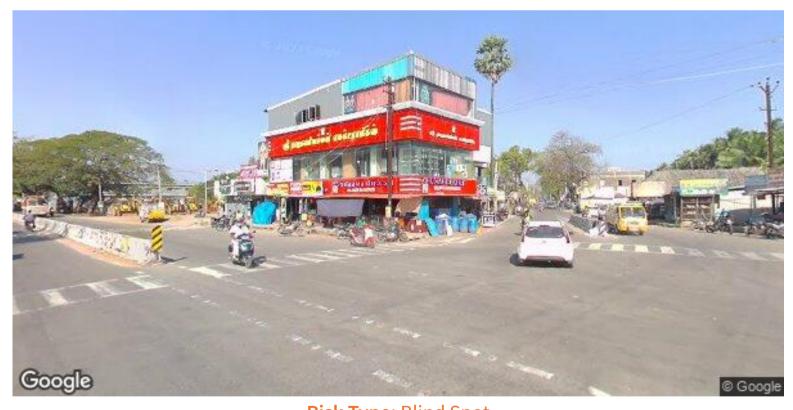
**Coordinates:** 10.55131, 77.00068

Risk Type: Blind Spot
Risk Level: Blind Spot
Speed Limit: 10 KM/Hr

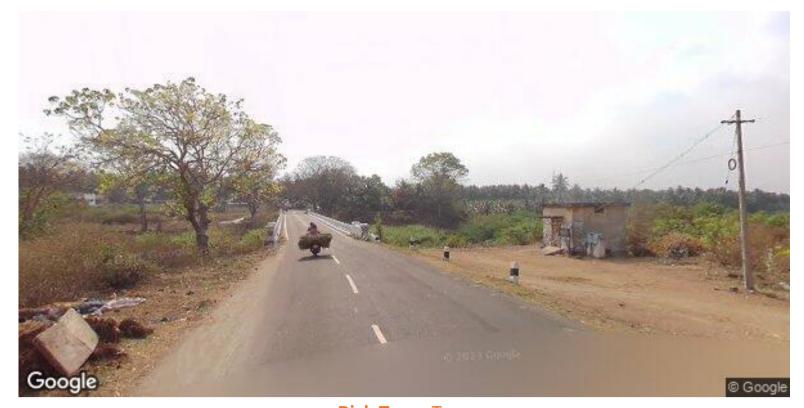
**Coordinates:** 10.55311, 77.02250

Risk Type: Turn
Risk Level: Medium
Speed Limit: 30 KM/Hr
