# JOURNEY RISK MANAGEMENT (JRM) STUDY

## **IOCL Coimbatore Terminal to Maruthi Auto Service**

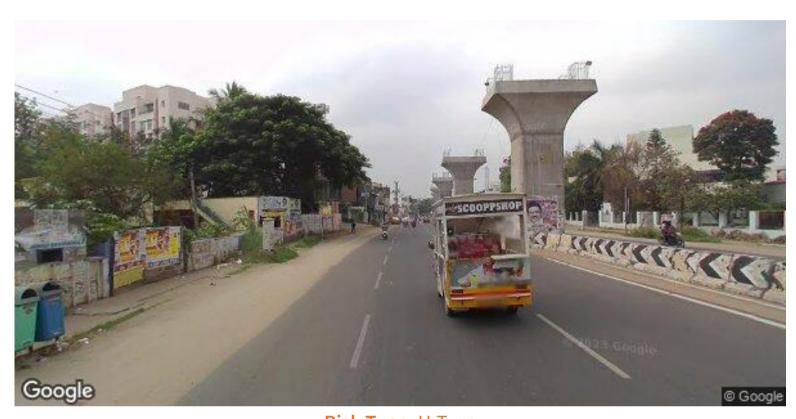
**Coordinates:** 11.0161282, 76.9896128

Risk Type: U-Turn
Risk Level: High
Speed Limit: 10 KM/Hr

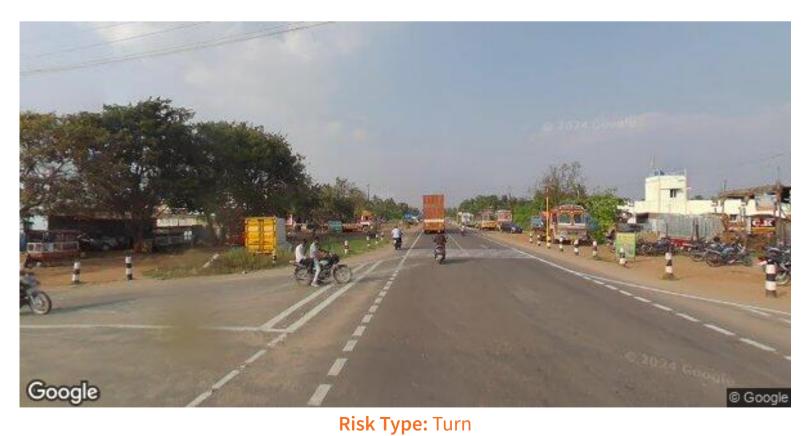
Risk Level: High
Speed Limit: 15 KM/Hr
Coordinates: 11.03211, 77.07640

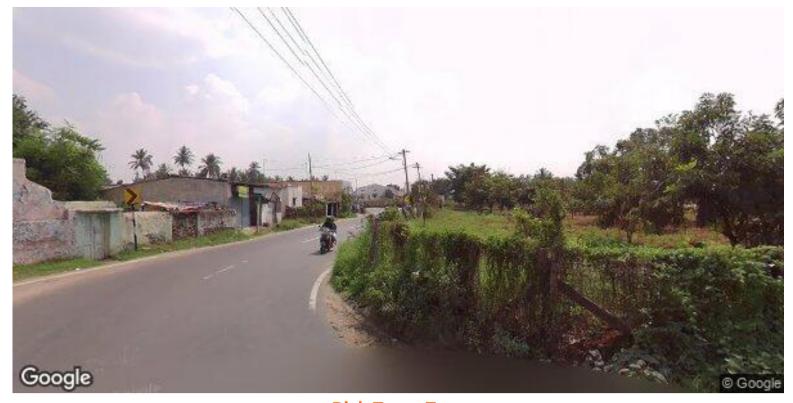
Risk Type: Turn
Risk Level: Medium
Speed Limit: 30 KM/Hr
Coordinates: 11.05411, 77.07097

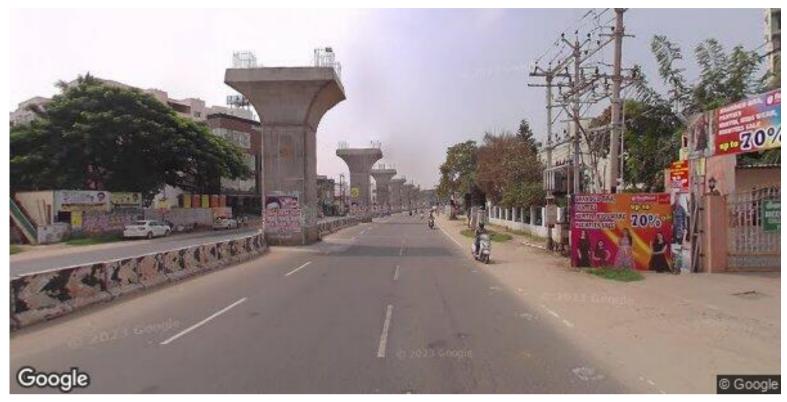
Risk Type: Blind Spot
Risk Level: Blind Spot
Speed Limit: 10 KM/Hr
Coordinates: 11.01618, 76.98951

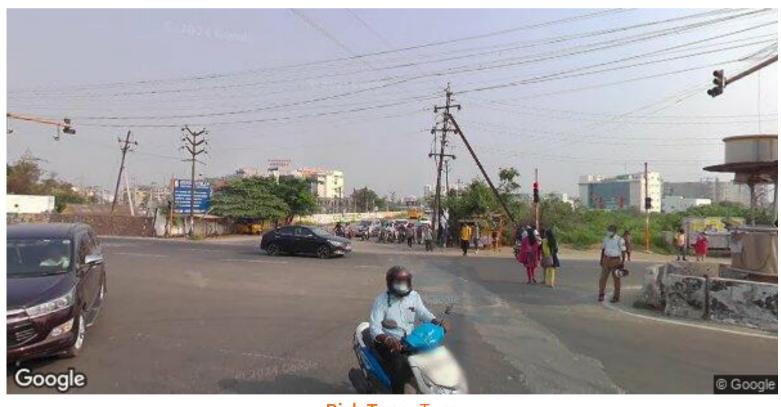
Risk Type: Turn
Risk Level: High
Speed Limit: 15 KM/Hr
Coordinates: 11.02014, 76.99212

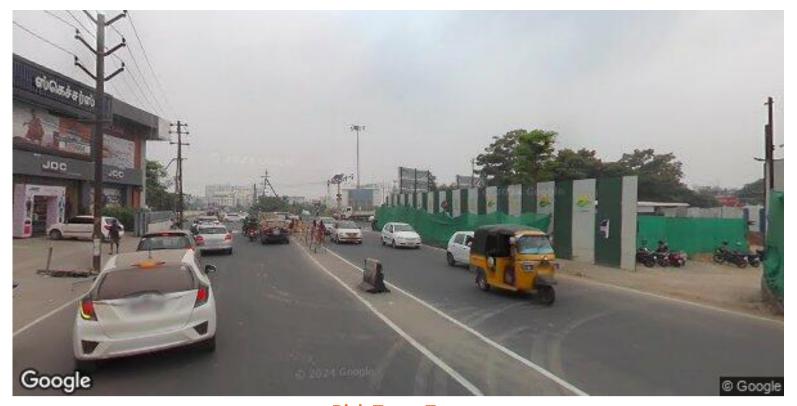
Risk Type: Turn
Risk Level: Medium
Speed Limit: 30 KM/Hr
Coordinates: 11.02051, 76.99177

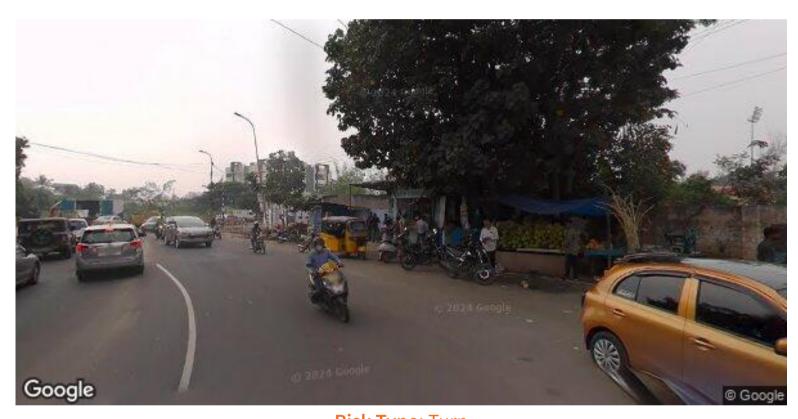
Risk Type: Turn
Risk Level: Medium
Speed Limit: 30 KM/Hr
Coordinates: 11.02137, 76.98673

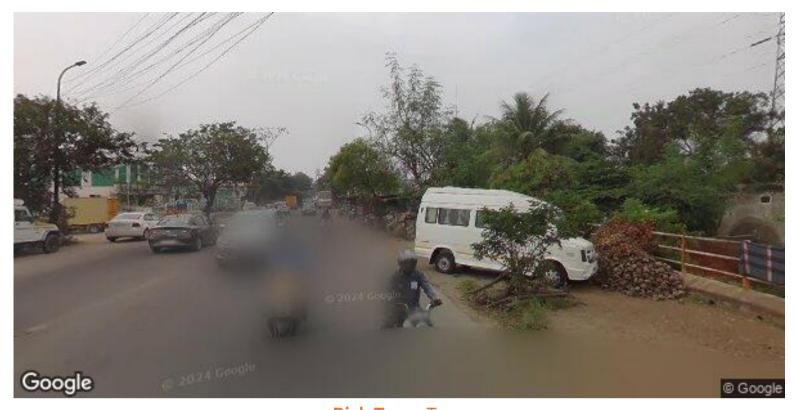
Risk Type: Turn
Risk Level: Medium
Speed Limit: 30 KM/Hr
Coordinates: 11.02095, 76.98644

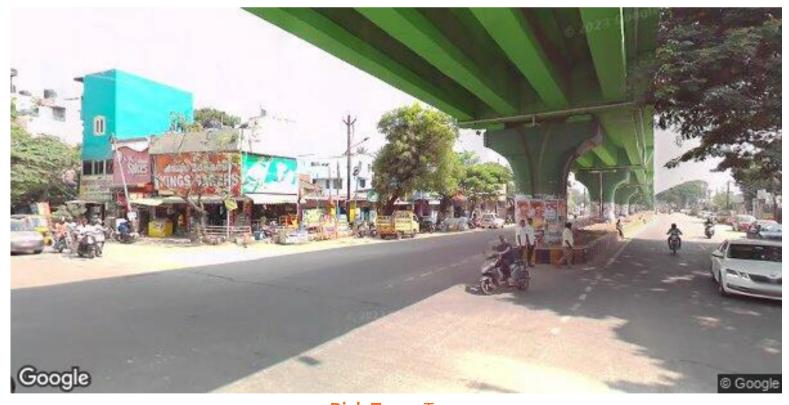
Risk Type: Turn
Risk Level: High
Speed Limit: 15 KM/Hr
Coordinates: 11.02119, 76.97860

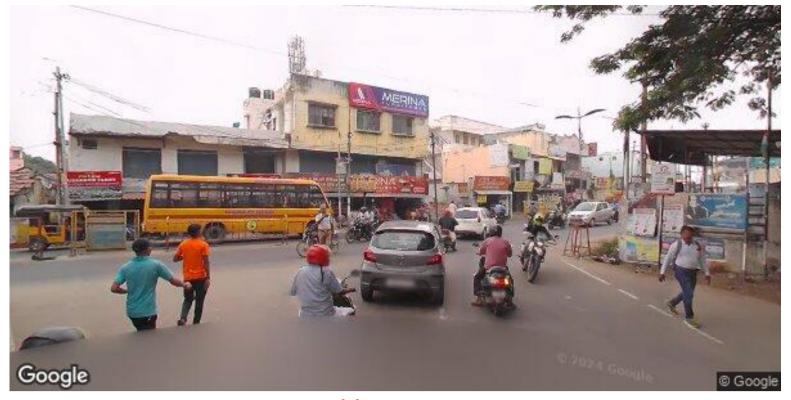
Risk Type: Turn
Risk Level: Medium
Speed Limit: 30 KM/Hr
Coordinates: 11.03370, 76.97857

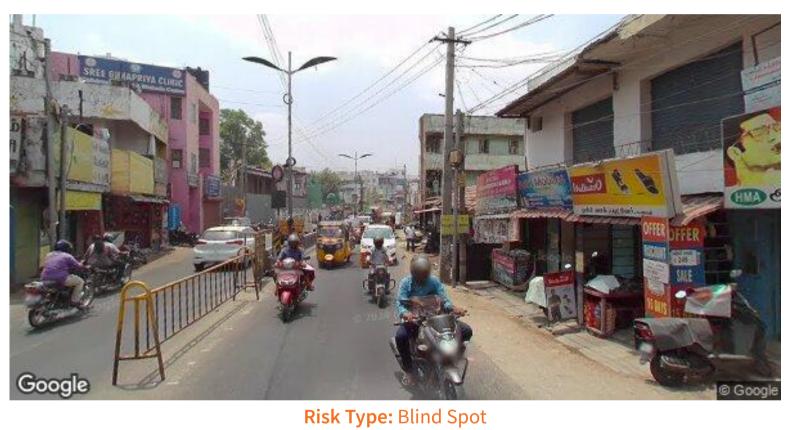
Risk Type: Blind Spot
Risk Level: Blind Spot
Speed Limit: 10 KM/Hr
Coordinates: 11.03374, 76.97843

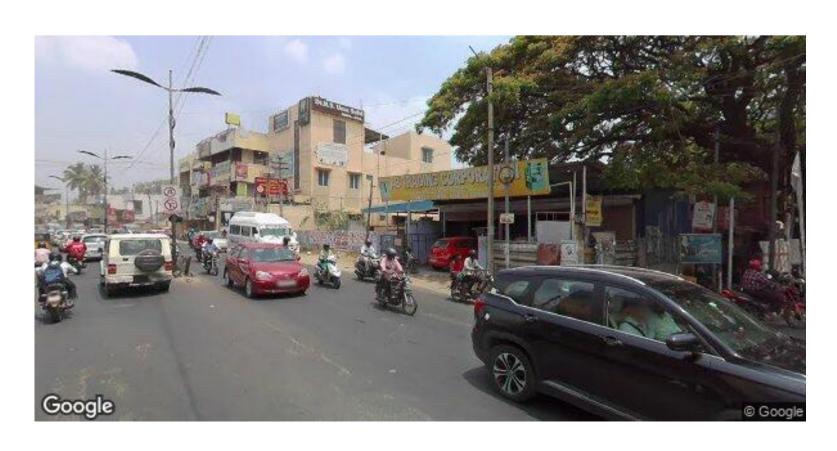
**Coordinates:** 11.03378, 76.97845

Risk Type: Turn
Risk Level: Medium
Speed Limit: 30 KM/Hr
