WELCOME TO JOURNEY RISK MANAGEMENT (JRM) STUDY USING ARTIFICIAL INTELLIGENCE (AI) FOR IOCL TRICHY TERMINAL

<u>IOCL TIRCHY TERMINAL (10.7753, 78.9.868) TO VIGNESH AGENCIES, (10.402063, 79.502371), TOTAL DISTANCE -9.8 KM</u>

JOURNEY RISK MANAGEMENT STUDY REPORT

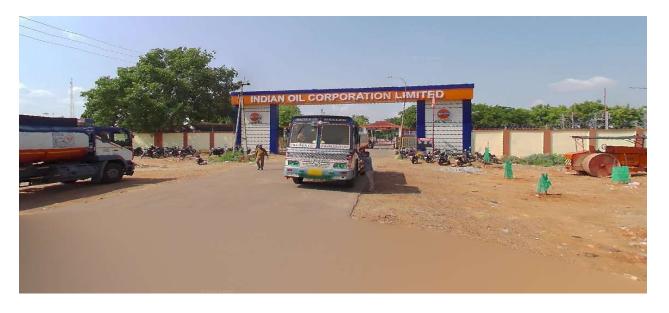
SHARP TURN IMAGE START FROM TRICY TERMINAL

Risk	Risk	Coordination	Distance	Recommendation
Type	Level		From Start	Speed
Sharp	Medium	10.769008535749057,	300 M	20km/hr TO 30
turn		78.83723765484662		Km/Hr
Sharp	Medium	10.765497799294907,	700 M	20km/hr TO 30
turn		78.83604620042777		Km/Hr
Sharp	Medium	10.764009578128617,	950 M	20km/hr TO 30
turn		78.83419636244746		Km/Hr
Sharp	Medium	10.758028485487644,	1.6 KM	20km/hr TO 30
turn		78.8334001457567		Km/Hr
Sharp	Medium	10.756122556562806,	2.0 KM	20km/hr TO 30
turn		78.83055889901199		Km/Hr
Sharp	Medium	10.751420920596344,	2.8 KM	20km/hr TO 30
turn		78.82521649200099		Km/Hr
Sharp	Medium	10.739011461069182,	4.9 KM	20km/hr TO 30
turn		78.83858885050212		Km/Hr
Sharp	High	10.771452950739656,	7.9 km	20km/hr TO 30
turn		78.79557417065378		Km/Hr

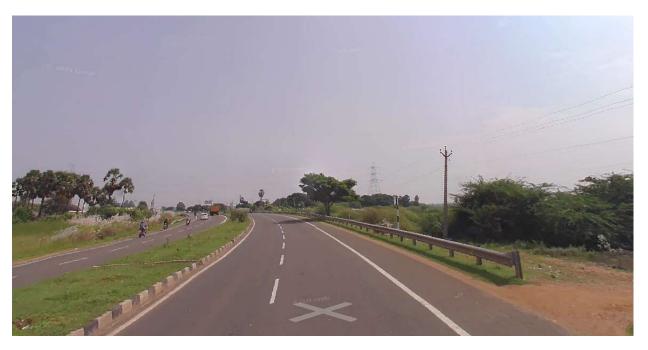
IMAGE: - SHARP TURN RISK LEVEL: - MEDIUM COORDI. 10.765497799294907, 78.83604620042777

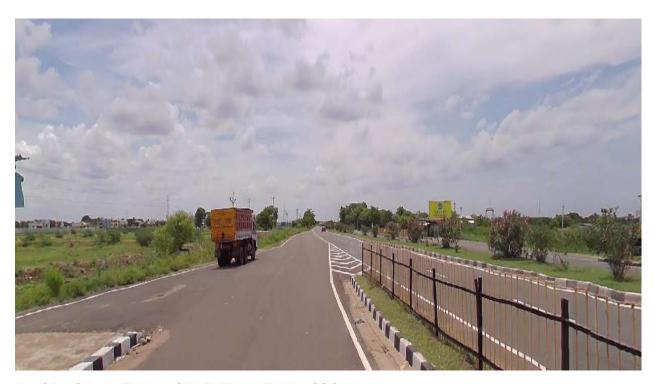
IMAGE: - SHARP TURN RISK LEVEL: - MEDIUM COORDI. 10.756122556562806, 78.83055889901199

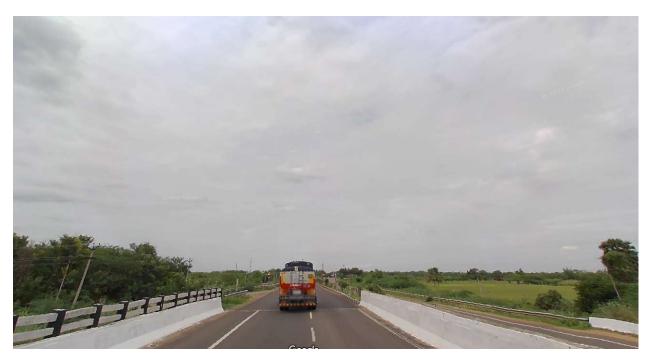
IMAGE: - SHARP TURN RISK LEVEL: - MEDIUM COORDI. 10.739011461069182, 78.83858885050212

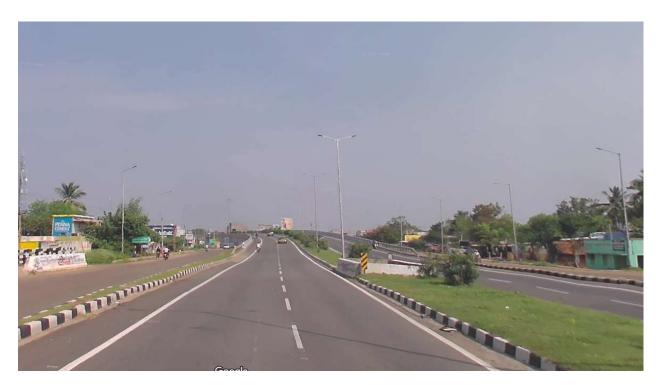
IMAGE:- SHARP TURN RISK LEVEL:- MEDIUM COORDI. 10.720753025938777, 78.96377618938521

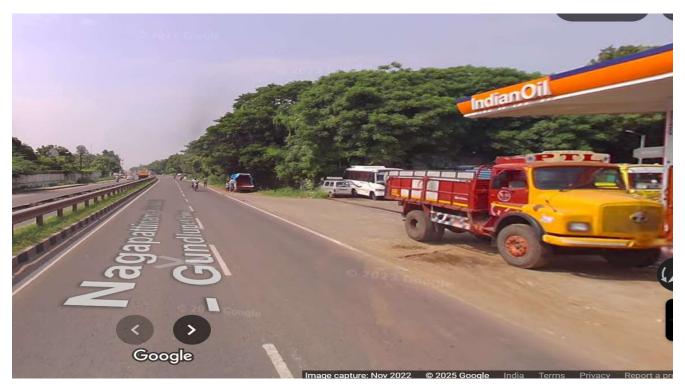
IMAGE: - SHARP TURN RISK LEVEL: - MEDIUM COORDI
