JOURNEY RISK MANAGEMENT (JRM) STUDY

Salem Terminal to SRIKRISHNA ENERGY

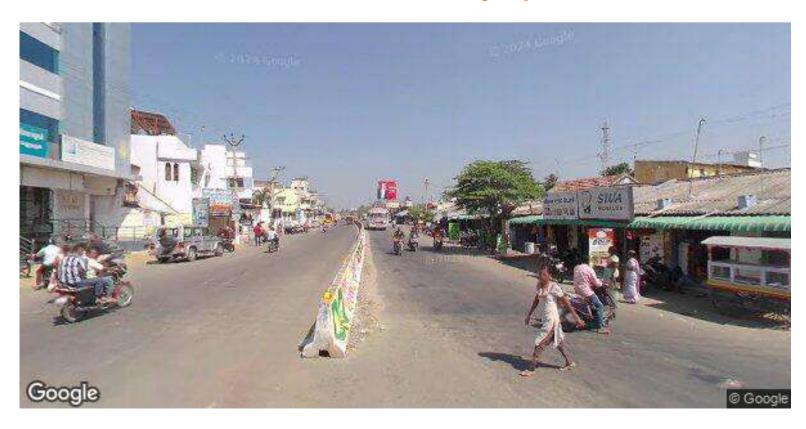
Coordinates: 11.37086, 77.74828

Risk Type: Roundabout
Risk Level: High
Speed Limit: 15 KM/Hr

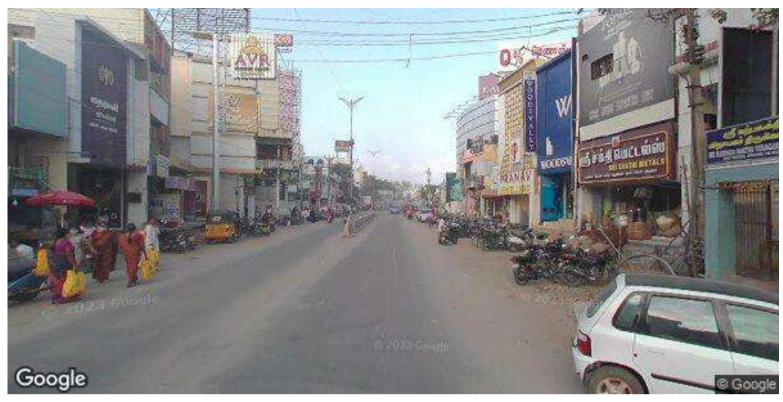
Coordinates: 11.3453211, 77.7304652

Risk Type: U-Turn
Risk Level: High
Speed Limit: 10 KM/Hr

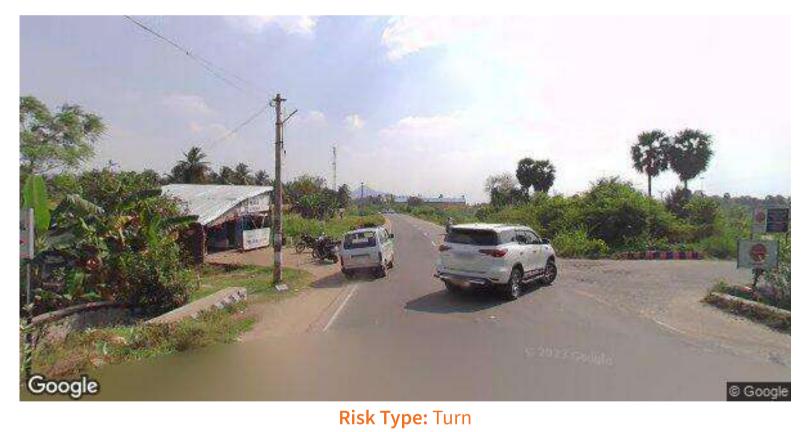
Risk Level: High
Speed Limit: 15 KM/Hr
Coordinates: 11.44029, 77.87544

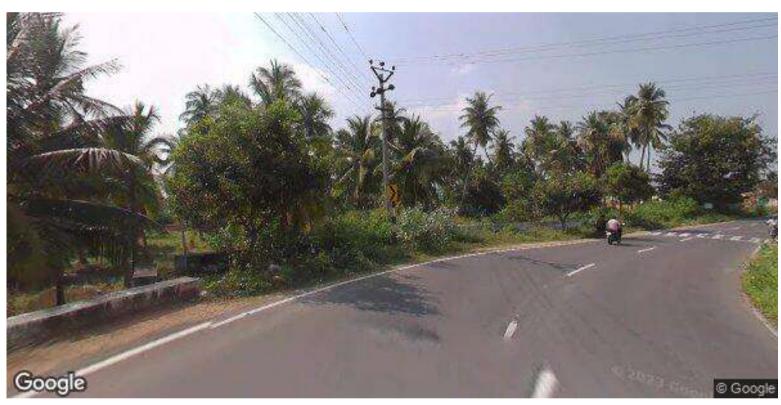
Risk Type: Turn
Risk Level: Medium
Speed Limit: 30 KM/Hr
Coordinates: 11.45348, 77.85706

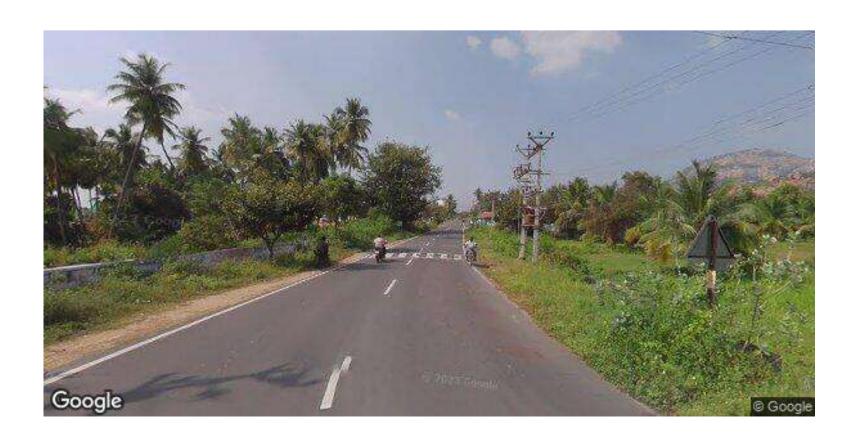
Coordinates: 11.45352, 77.85698

Risk Type: Turn
Risk Level: Medium
Speed Limit: 30 KM/Hr

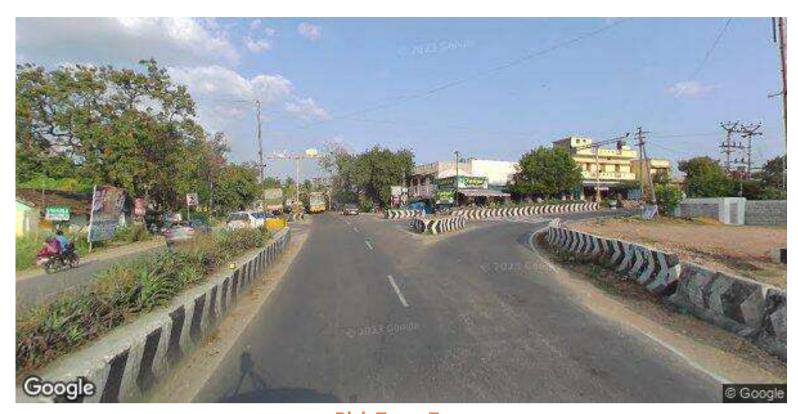
Coordinates: 11.46318, 77.84913

Risk Type: Turn
Risk Level: Medium
Speed Limit: 30 KM/Hr

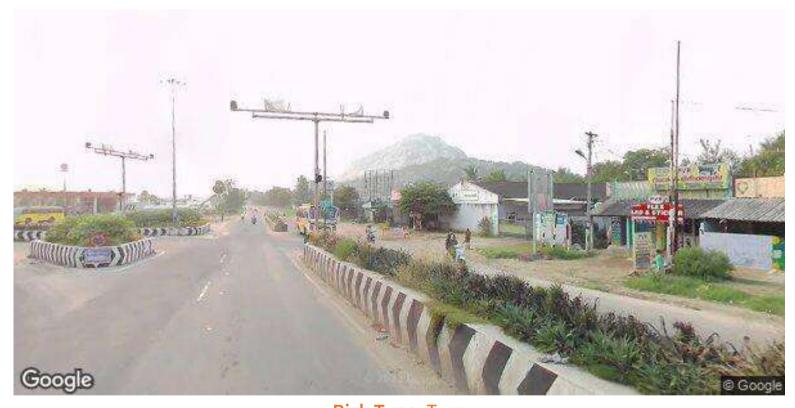
Coordinates: 11.46312, 77.84886

Risk Type: Turn
Risk Level: Medium
Speed Limit: 30 KM/Hr

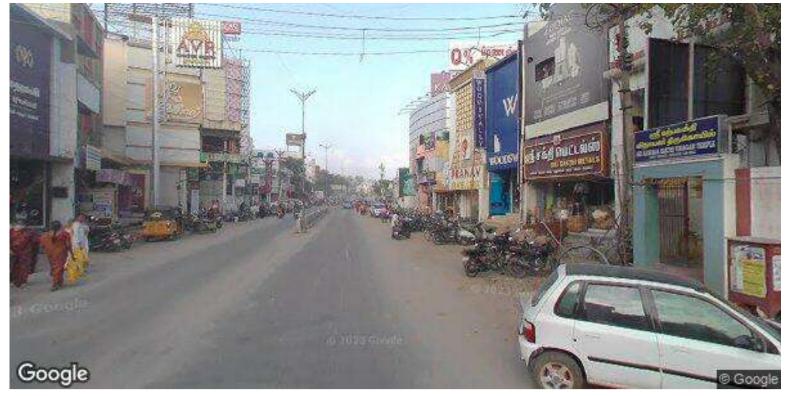
Coordinates: 11.34532, 77.73047

Risk Type: Turn
Risk Level: High
Speed Limit: 15 KM/Hr

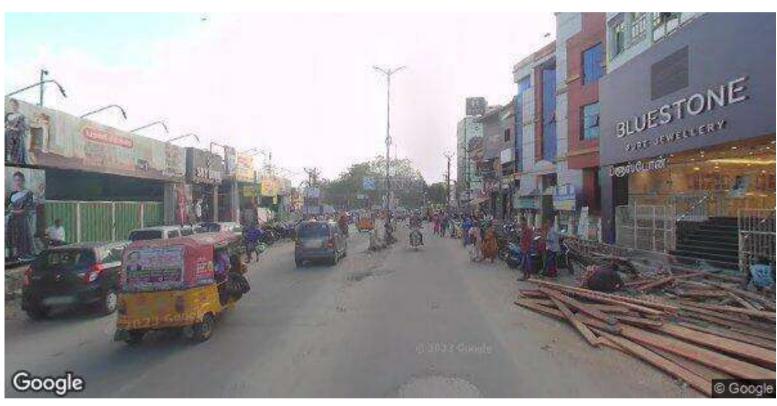
Coordinates: 11.34535, 77.73036

Risk Type: Blind Spot
Risk Level: Blind Spot
Speed Limit: 10 KM/Hr
