# JOURNEY RISK MANAGEMENT (JRM) STUDY

# **IOCL Coimbatore Terminal to Sri Muthu & Co**

# **Route Safety Analysis Report**

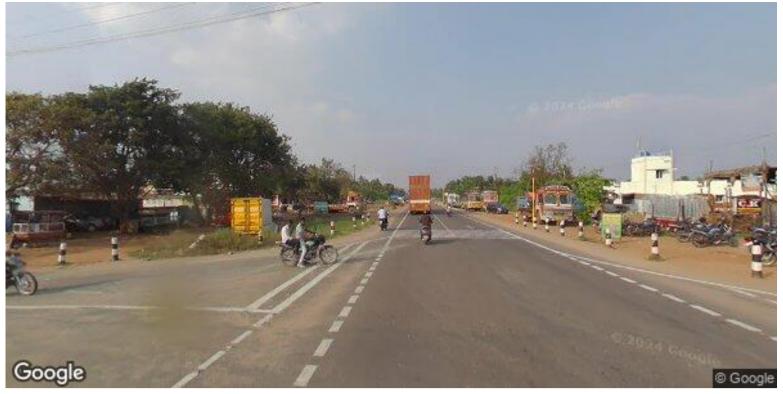
Coordinates: 11.03211, 77.07640

Risk Type: Turn
Risk Level: High
Speed Limit: 15 KM/Hr

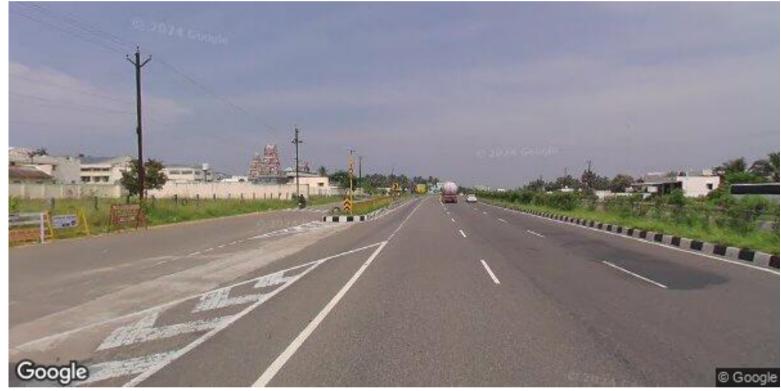
Risk Type: Turn
Risk Level: Medium
Speed Limit: 30 KM/Hr
Coordinates: 11.14084, 77.20403

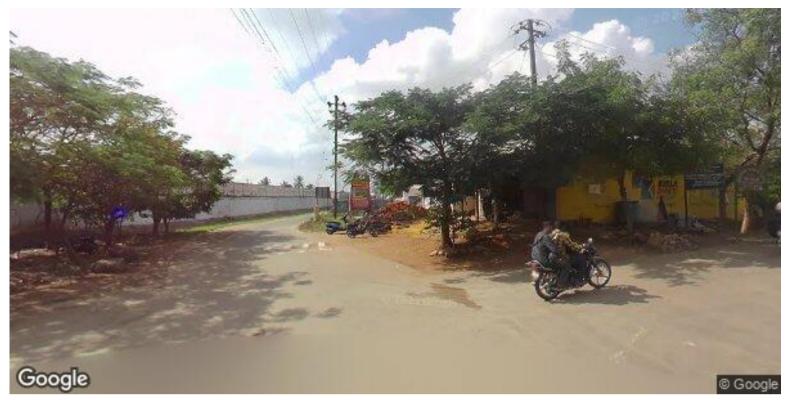
**Coordinates:** 11.14553, 77.20583

Risk Type: Turn
Risk Level: High
Speed Limit: 15 KM/Hr

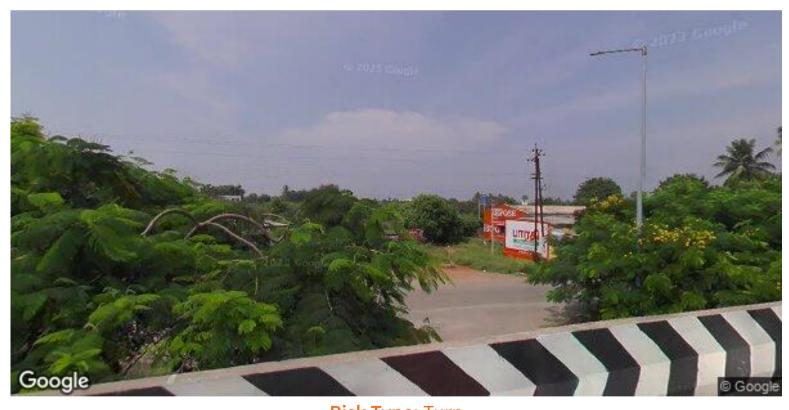
Risk Type: Turn
Risk Level: Medium
Speed Limit: 30 KM/Hr
Coordinates: 11.14553, 77.20601

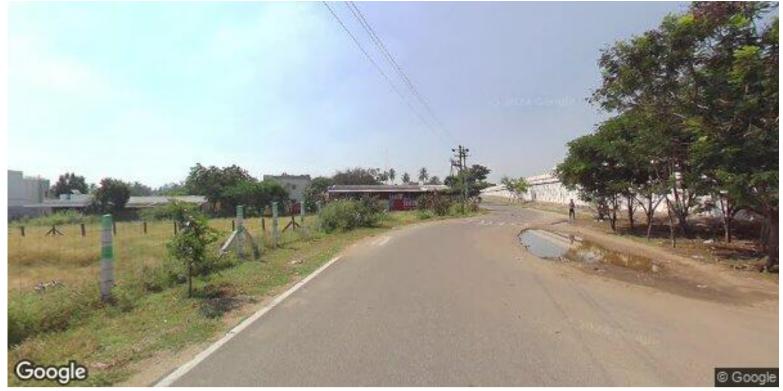
Risk Type: Turn
Risk Level: High
Speed Limit: 15 KM/Hr
Coordinates: 11.14531, 77.20643

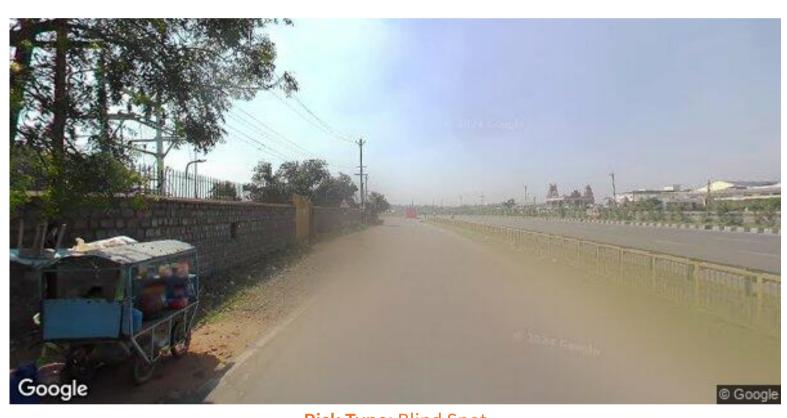
Risk Type: Blind Spot
Risk Level: Blind Spot
Speed Limit: 10 KM/Hr
Coordinates: 11.14274, 77.20477

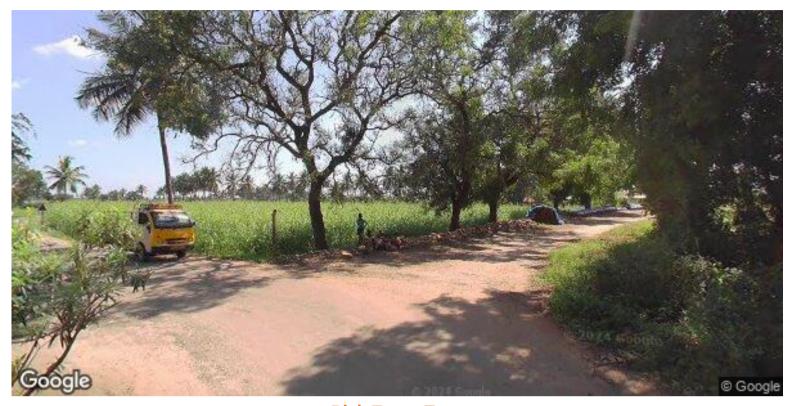
Risk Type: Turn
Risk Level: High
Speed Limit: 15 KM/Hr
Coordinates: 11.14223, 77.21518

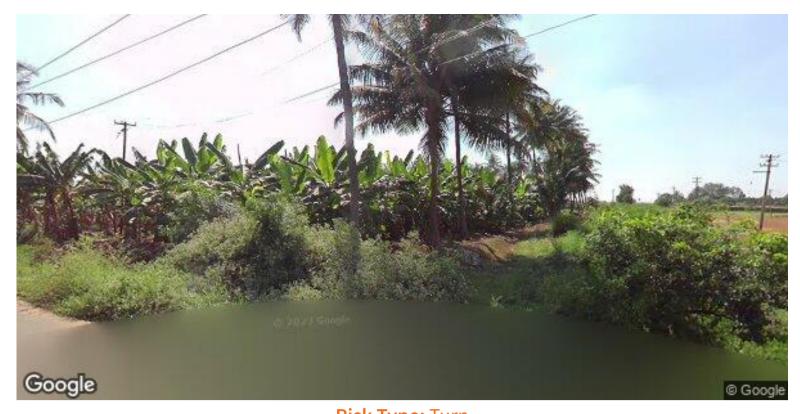
Risk Type: Turn
Risk Level: Medium
Speed Limit: 30 KM/Hr
Coordinates: 11.14129, 77.21785

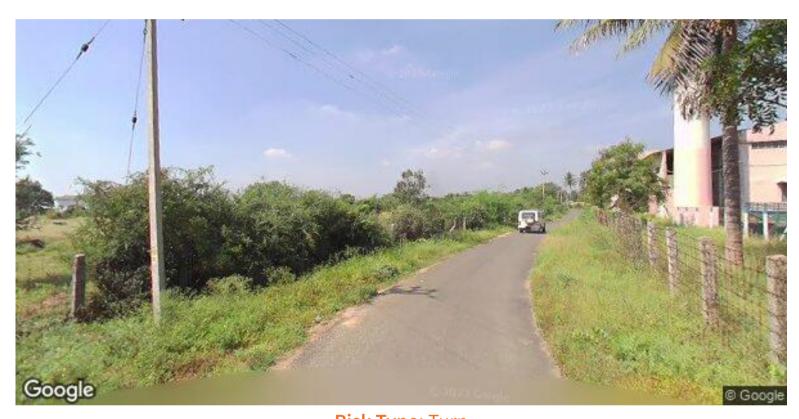
Risk Type: Turn
Risk Level: Medium
Speed Limit: 30 KM/Hr
Coordinates: 11.13940, 77.22532

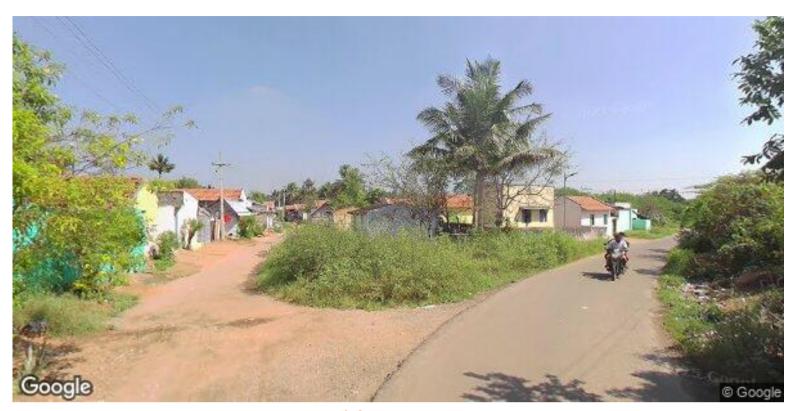
**Coordinates:** 11.13973, 77.22595

Risk Type: Turn
Risk Level: High
Speed Limit: 15 KM/Hr

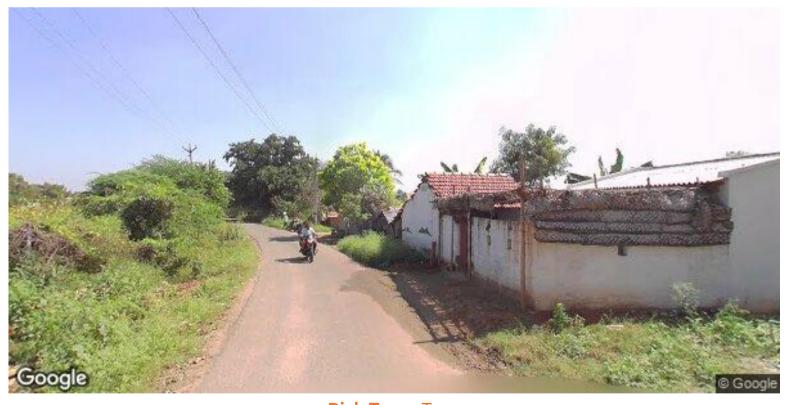
Risk Type: Turn
Risk Level: Medium
Speed Limit: 30 KM/Hr
Coordinates: 11.13957, 77.22709

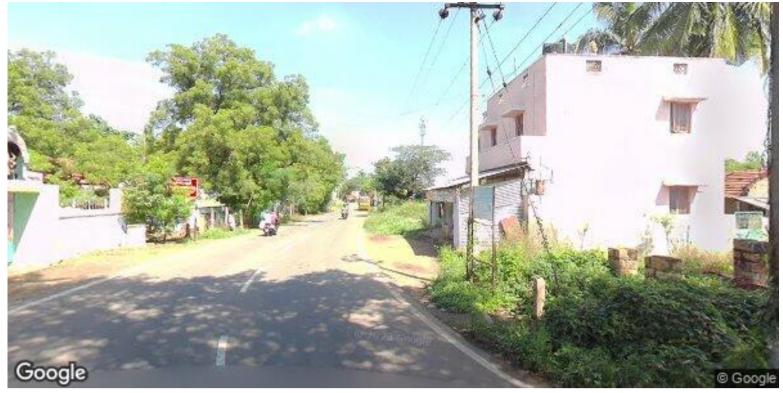
**Coordinates:** 11.14002, 77.22836

Risk Type: Turn
Risk Level: High
Speed Limit: 15 KM/Hr

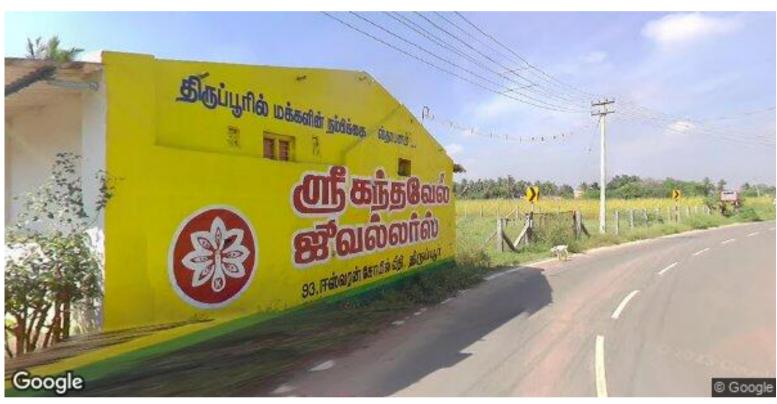
Risk Type: Turn
Risk Level: Medium
Speed Limit: 30 KM/Hr
Coordinates: 11.13932, 77.22930

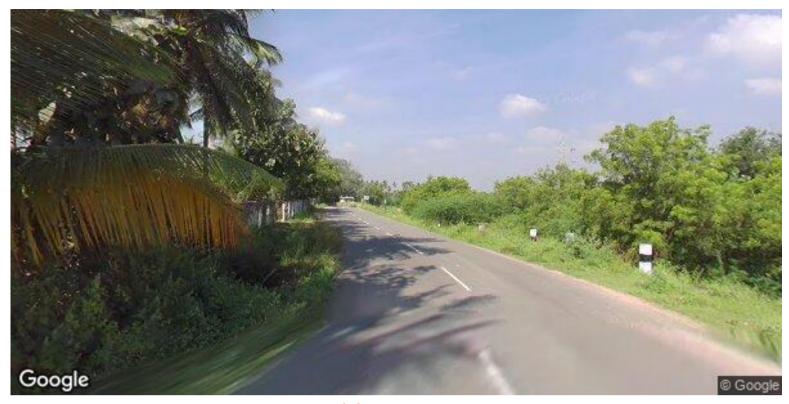
**Coordinates:** 11.13727, 77.23859

Risk Type: Turn
Risk Level: Medium
Speed Limit: 30 KM/Hr

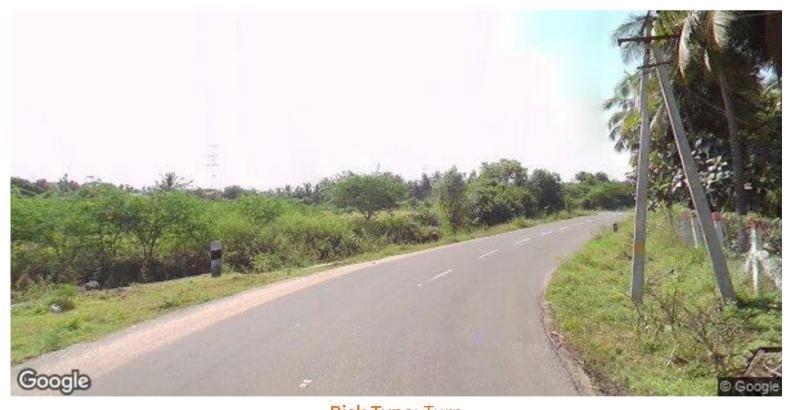
Risk Type: Turn
Risk Level: Medium
Speed Limit: 30 KM/Hr
Coordinates: 11.13715, 77.23867

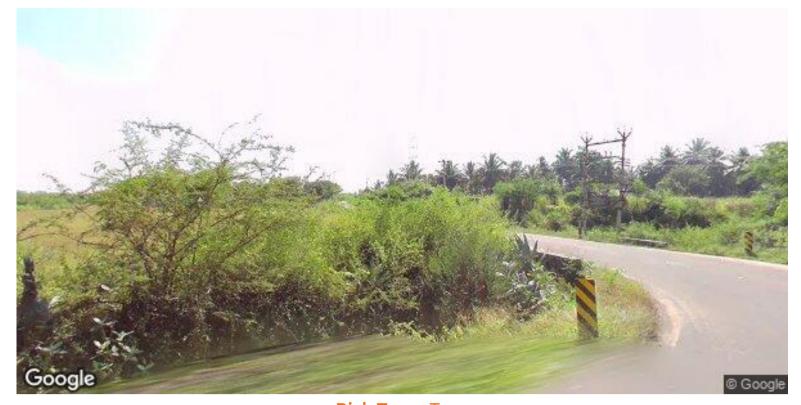
Risk Type: Turn
Risk Level: Medium
Speed Limit: 30 KM/Hr
Coordinates: 11.13649, 77.23844

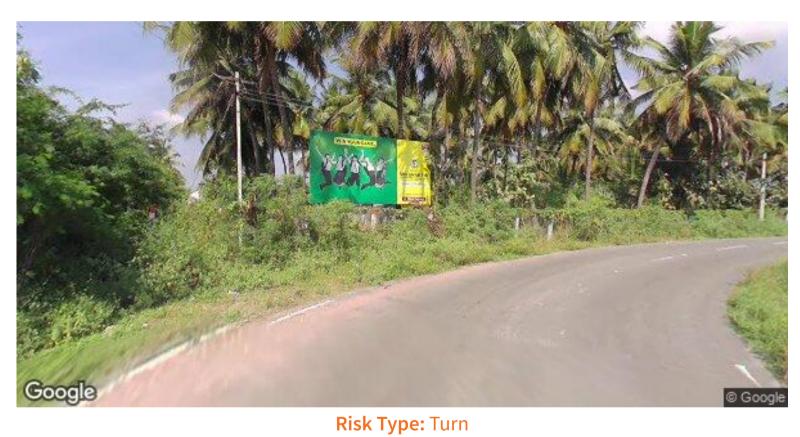
Risk Type: Turn
Risk Level: High
Speed Limit: 15 KM/Hr
Coordinates: 11.13638, 77.23845

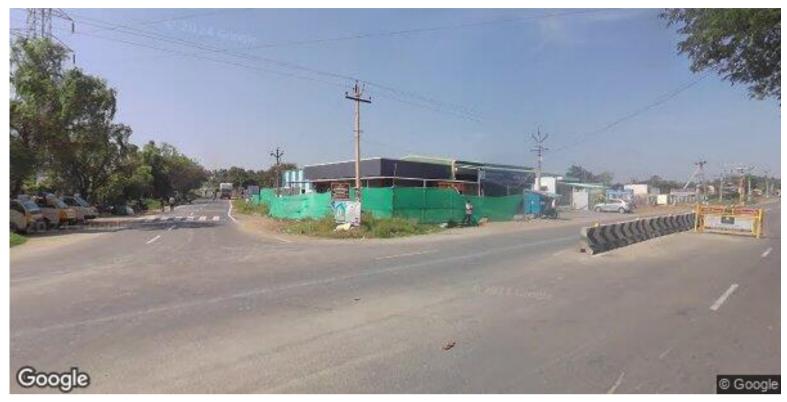
**Coordinates:** 11.12791, 77.26660

Risk Type: Turn
Risk Level: High
Speed Limit: 15 KM/Hr

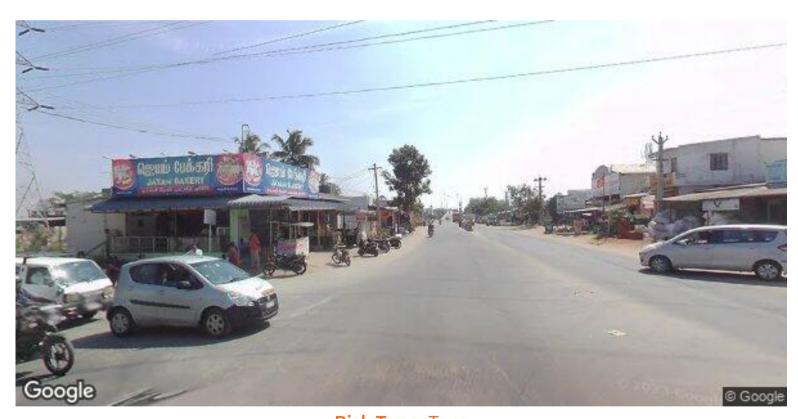
Risk Type: Turn
Risk Level: High
Speed Limit: 15 KM/Hr
Coordinates: 11.12148, 77.26743
