# JOURNEY RISK MANAGEMENT (JRM) STUDY

## Salem Terminal TO K P MARKETING

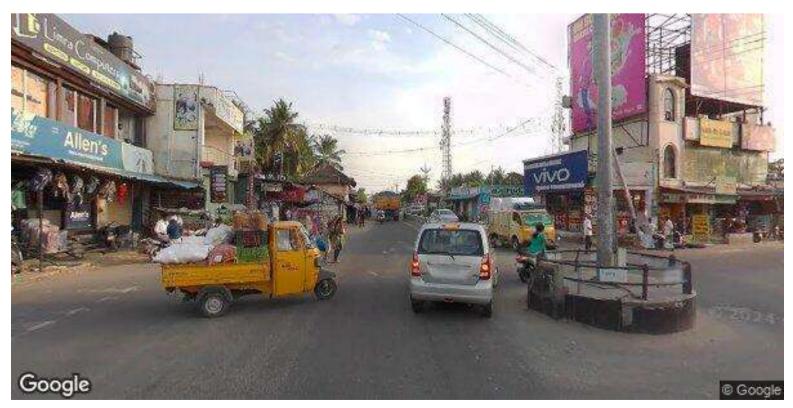
**Coordinates:** 11.10249, 77.27146

Risk Type: Roundabout
Risk Level: High

**Speed Limit:** 15 KM/Hr

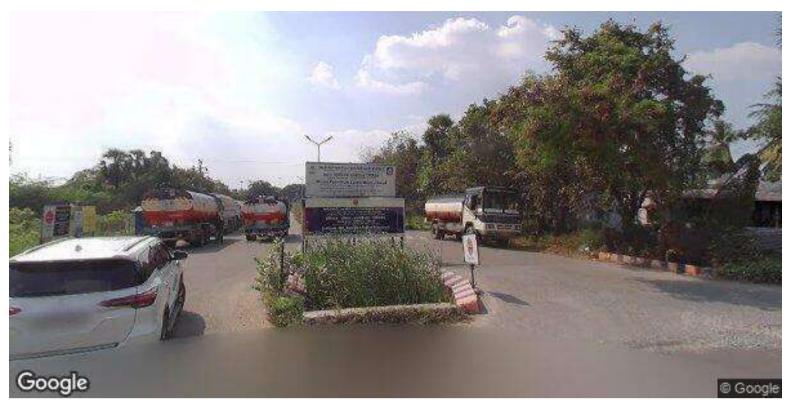
**Coordinates:** 11.44024, 77.87528

Risk Type: Turn Risk Level: High Speed Limit: 15 KM/Hr

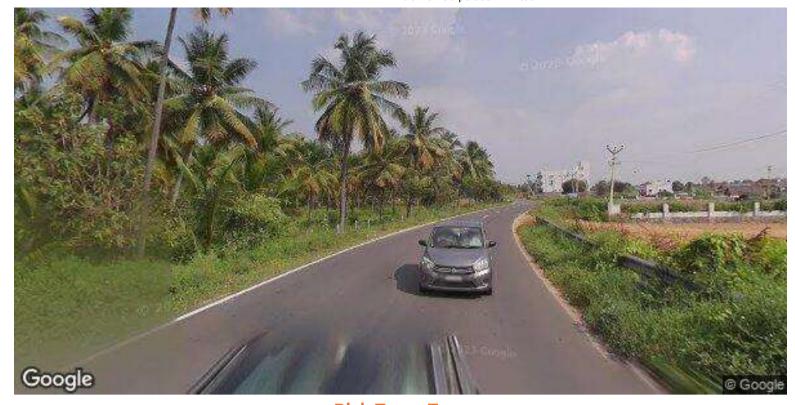
Risk Type: Turn
Risk Level: Medium
Speed Limit: 30 KM/Hr
Coordinates: 11.45357, 77.85789

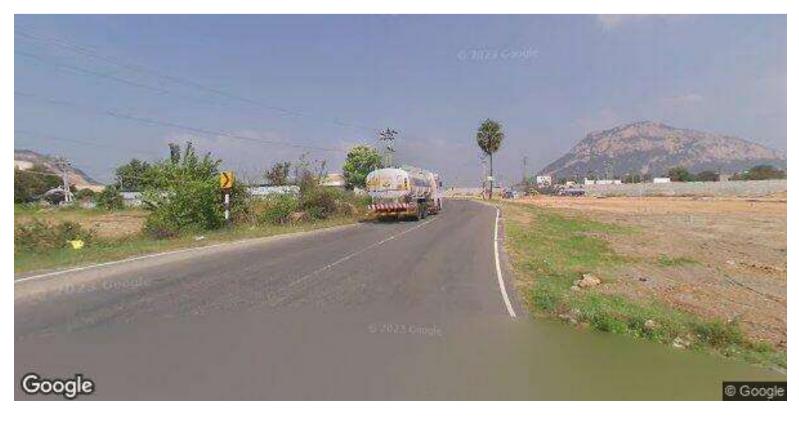
**Coordinates:** 11.45847, 77.85140

Risk Type: Turn
Risk Level: Medium
Speed Limit: 30 KM/Hr

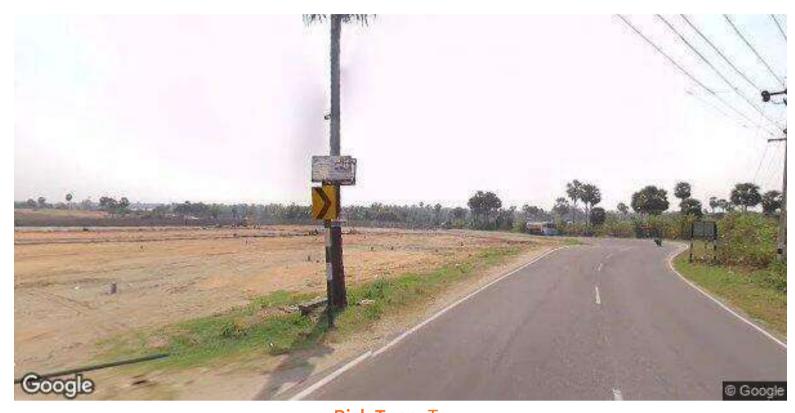
Risk Type: Turn
Risk Level: Medium
Speed Limit: 30 KM/Hr
Coordinates: 11.45898, 77.85135

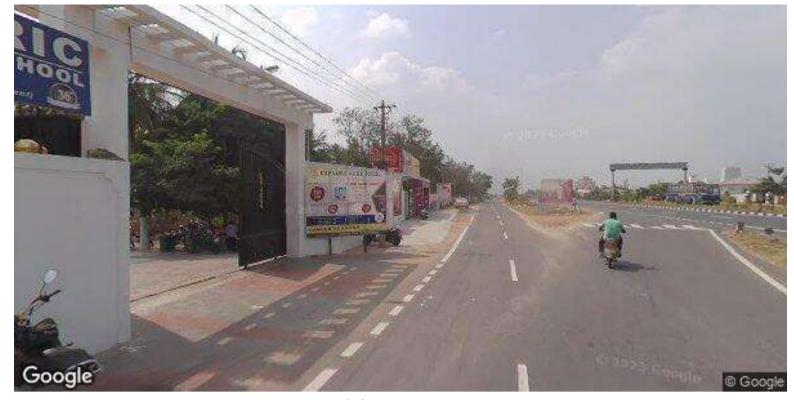
Risk Type: Turn
Risk Level: Medium
Speed Limit: 30 KM/Hr
Coordinates: 11.45509, 77.81383

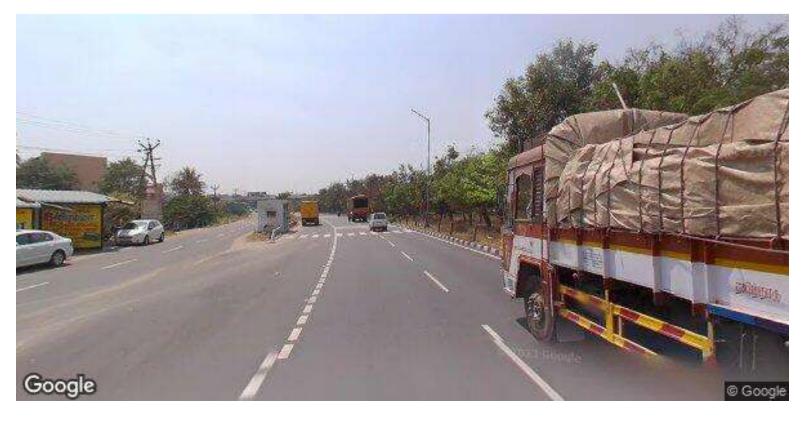
**Coordinates:** 11.43165, 77.67734

Risk Type: Turn
Risk Level: Medium
Speed Limit: 30 KM/Hr

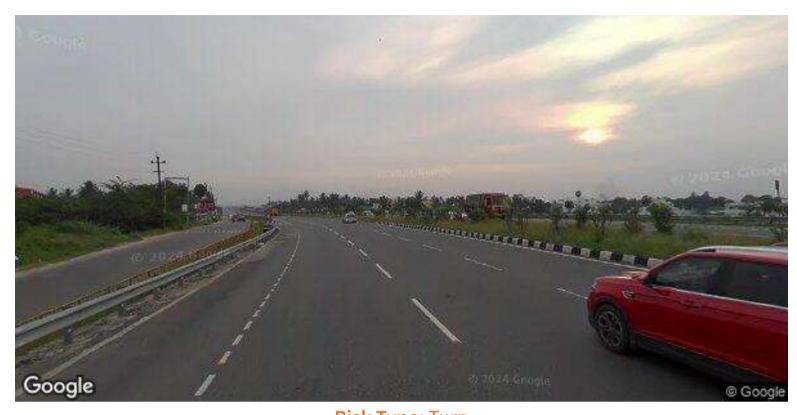
**Coordinates:** 11.18808, 77.28672

Risk Type: Turn
Risk Level: Medium
Speed Limit: 30 KM/Hr

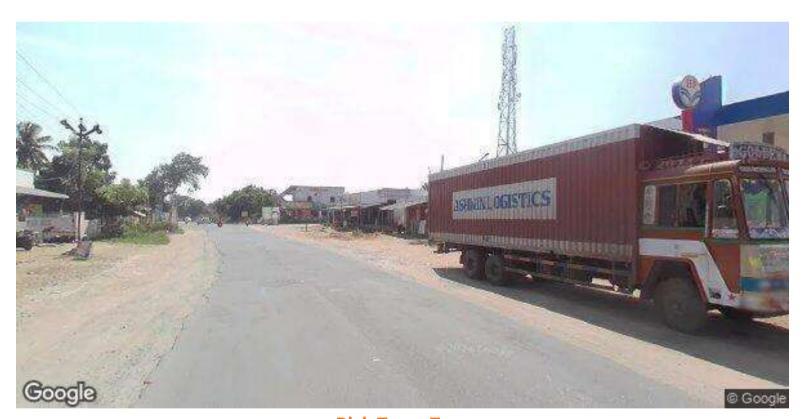
**Coordinates:** 11.16848, 77.26757

Risk Type: Turn
Risk Level: Medium
Speed Limit: 30 KM/Hr

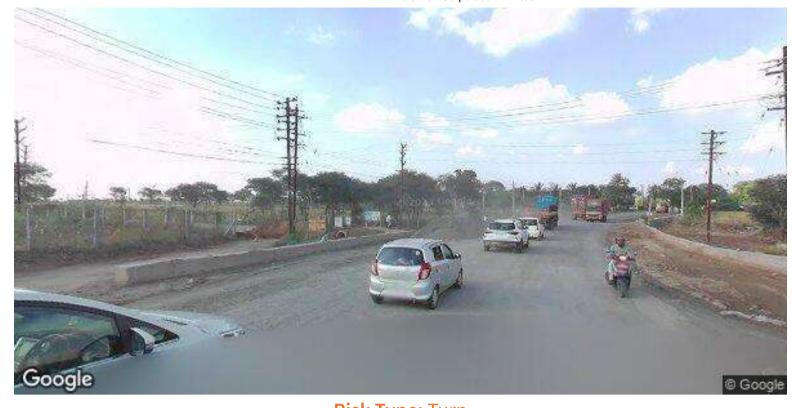
Risk Type: Turn
Risk Level: Medium
Speed Limit: 30 KM/Hr
Coordinates: 11.14580, 77.26363

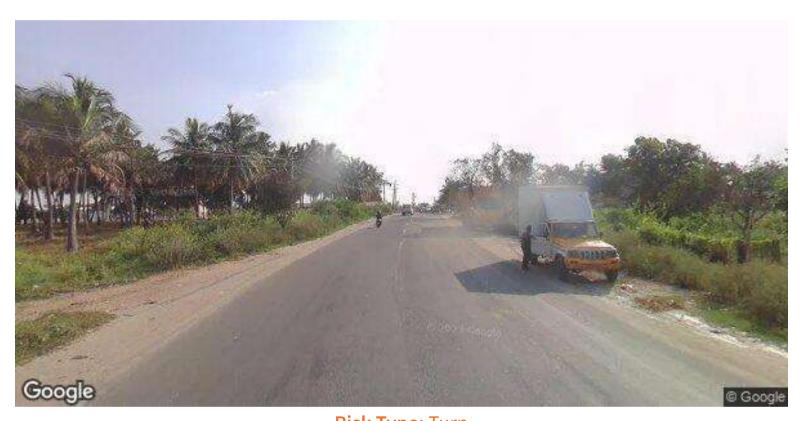
Risk Type: Turn
Risk Level: Medium
Speed Limit: 30 KM/Hr
Coordinates: 11.10890, 77.27134

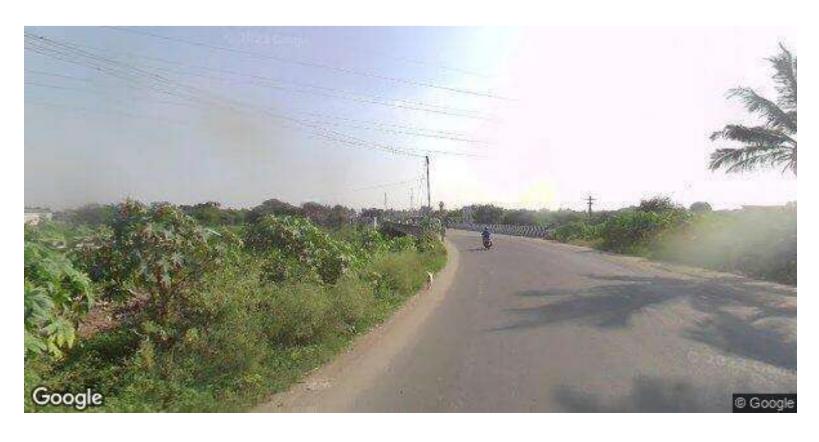
**Coordinates:** 11.10680, 77.27043

Risk Type: Turn
Risk Level: Medium
Speed Limit: 30 KM/Hr

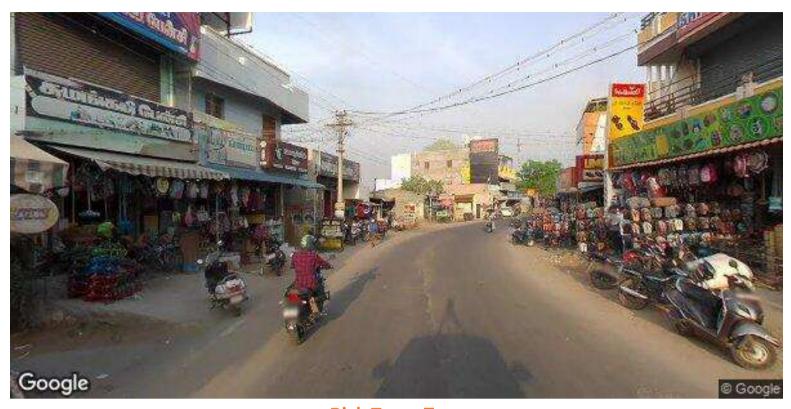
Risk Type: Turn
Risk Level: Medium
Speed Limit: 30 KM/Hr
Coordinates: 11.10256, 77.27210

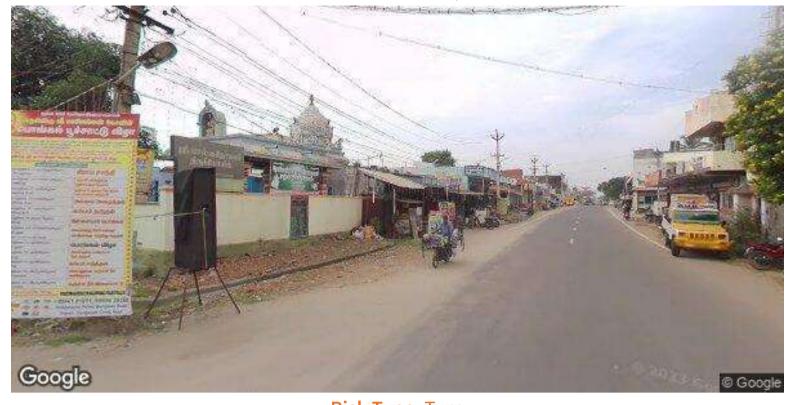
Risk Type: Turn
Risk Level: Medium
Speed Limit: 30 KM/Hr
Coordinates: 11.10164, 77.29834

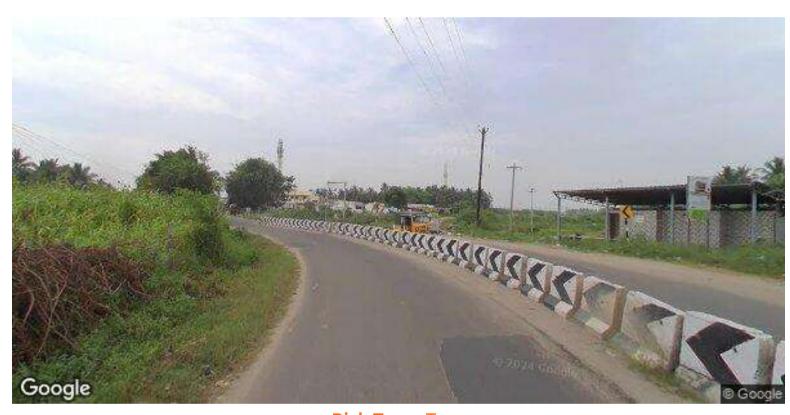
**Coordinates:** 11.10238, 77.29955

Risk Type: Turn
Risk Level: High
Speed Limit: 15 KM/Hr
