JOURNEY RISK MANAGEMENT (JRM) STUDY

IOCL Coimbatore Terminal to Shri Siddi Vinayaka Agencies

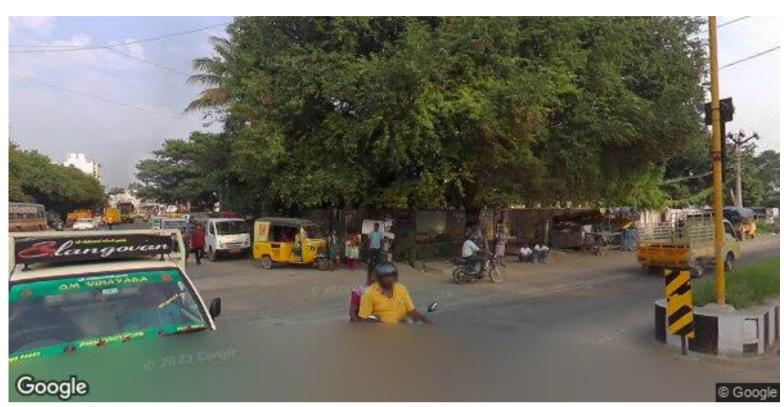
Coordinates: 11.07800, 77.03707

Risk Type: Roundabout Risk Level: High Speed Limit: 15 KM/Hr

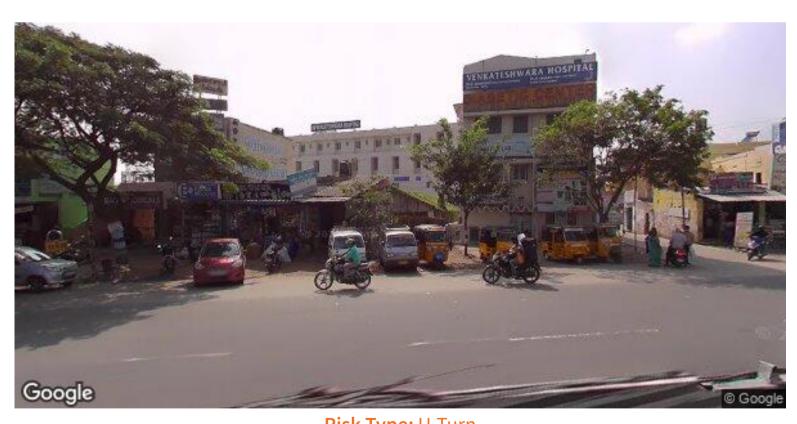
Coordinates: 11.0549503, 77.0650284

Risk Type: U-Turn
Risk Level: High
Speed Limit: 10 KM/Hr

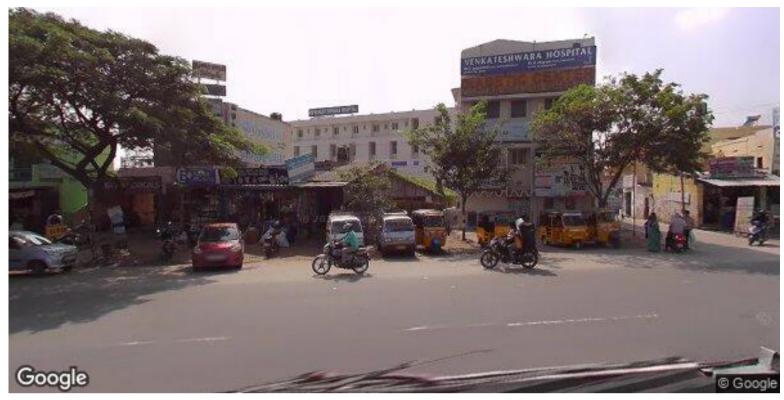
Coordinates: 11.05495, 77.06503

Risk Type: Turn
Risk Level: High
Speed Limit: 15 KM/Hr

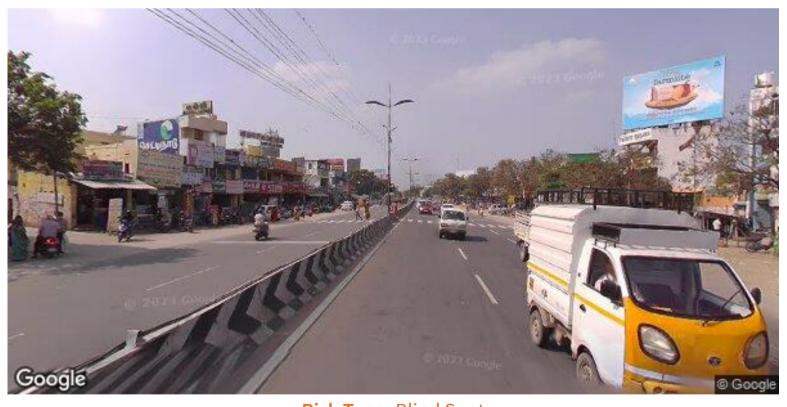
Coordinates: 11.05507, 77.06496

Risk Type: Blind Spot
Risk Level: Blind Spot
Speed Limit: 10 KM/Hr

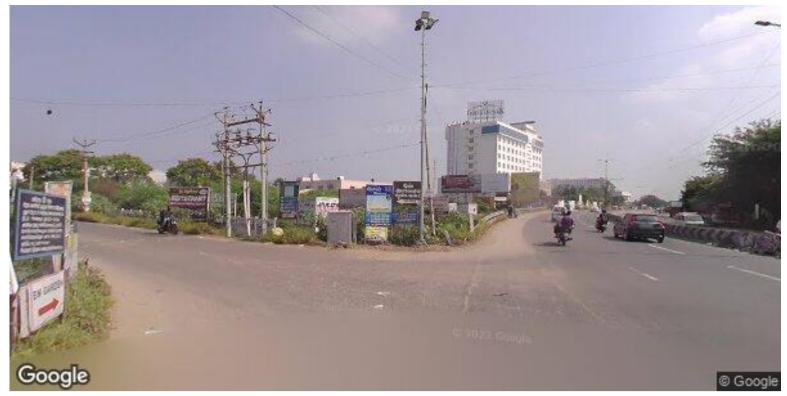
Coordinates: 11.05751, 77.06875

Risk Type: Turn
Risk Level: High
Speed Limit: 15 KM/Hr

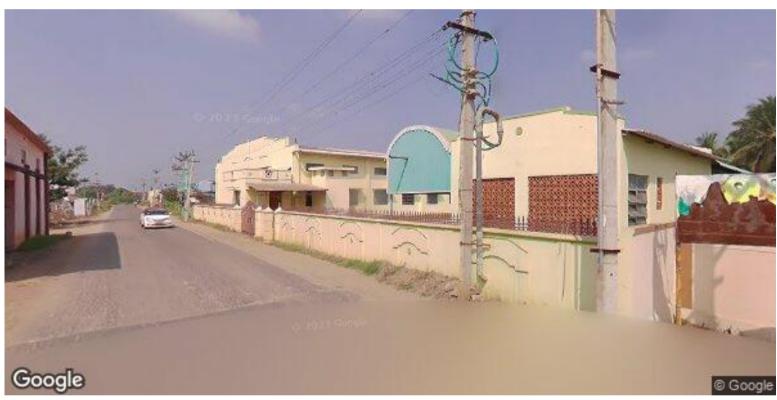
Coordinates: 11.06437, 77.06865

Risk Type: Turn
Risk Level: High
Speed Limit: 15 KM/Hr

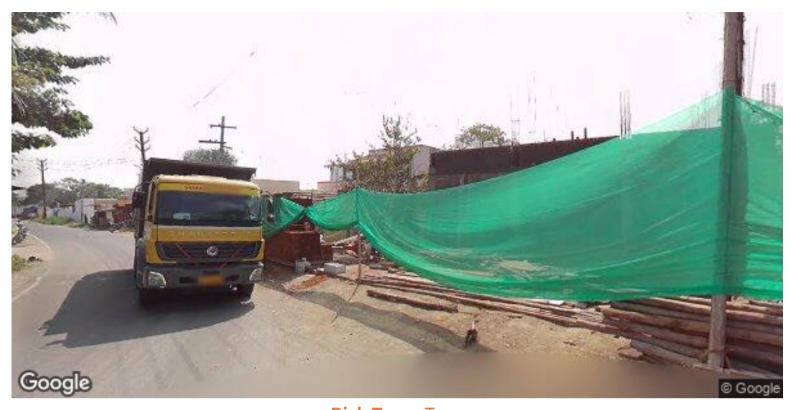
Coordinates: 11.06492, 77.06369

Risk Type: Turn
Risk Level: Medium
Speed Limit: 30 KM/Hr

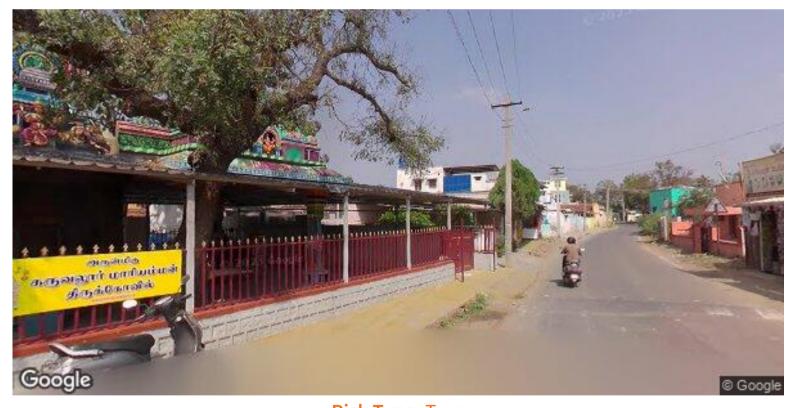
Coordinates: 11.06501, 77.06366

Risk Type: Turn
Risk Level: Medium
Speed Limit: 30 KM/Hr

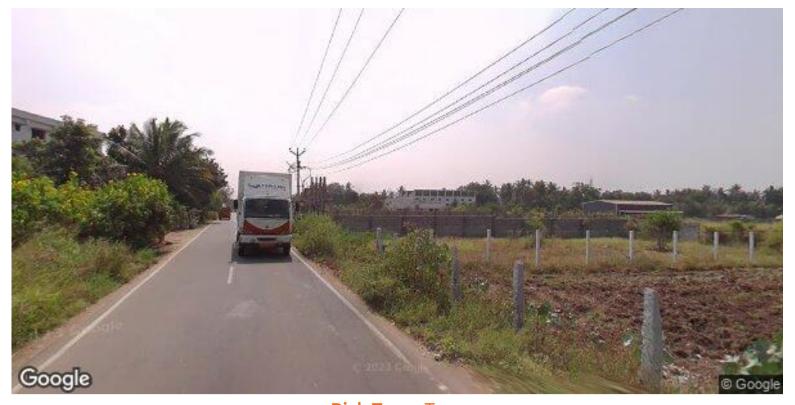
Coordinates: 11.07191, 77.06366

Risk Type: Turn
Risk Level: Medium
Speed Limit: 30 KM/Hr

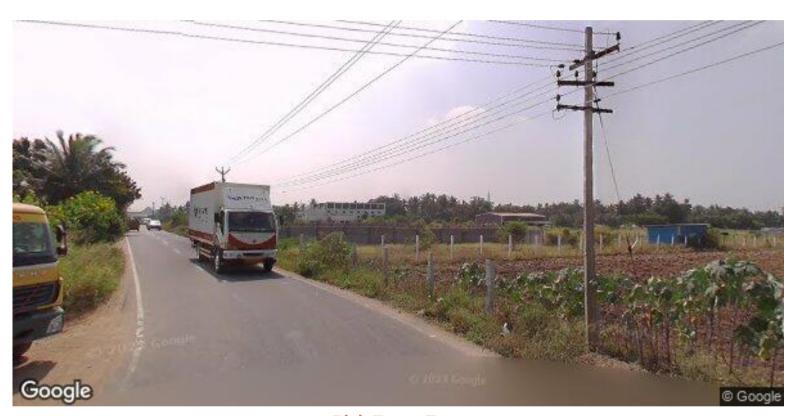
Risk Type: Turn
Risk Level: Medium
Speed Limit: 30 KM/Hr
Coordinates: 11.07201, 77.06366

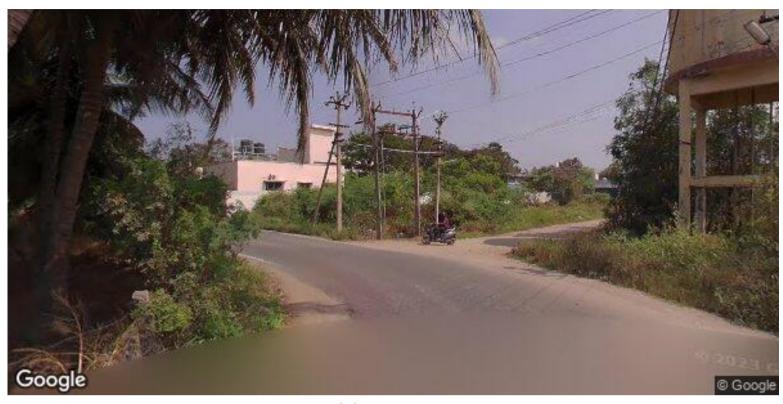
Coordinates: 11.07225, 77.06398

Risk Type: Turn
Risk Level: Medium
Speed Limit: 30 KM/Hr

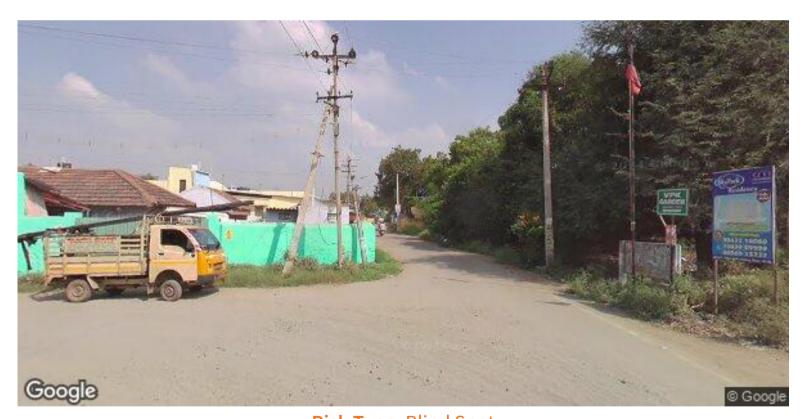
Coordinates: 11.07865, 77.06377

Risk Type: Blind Spot Risk Level: Blind Spot Speed Limit: 10 KM/Hr

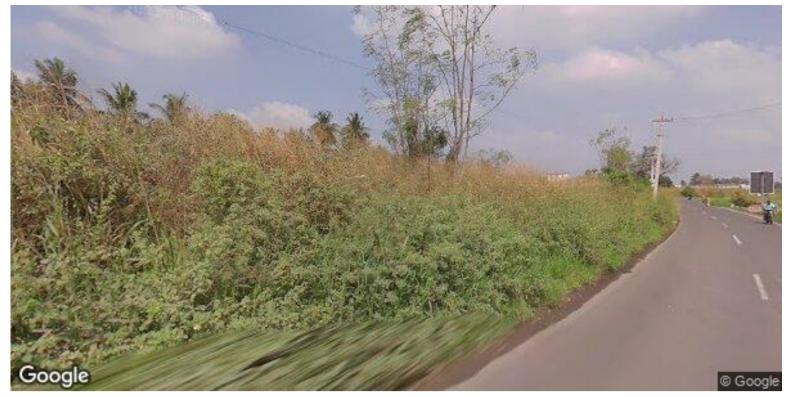
Risk Type: Turn
Risk Level: High
Speed Limit: 15 KM/Hr
Coordinates: 11.07773, 77.05884

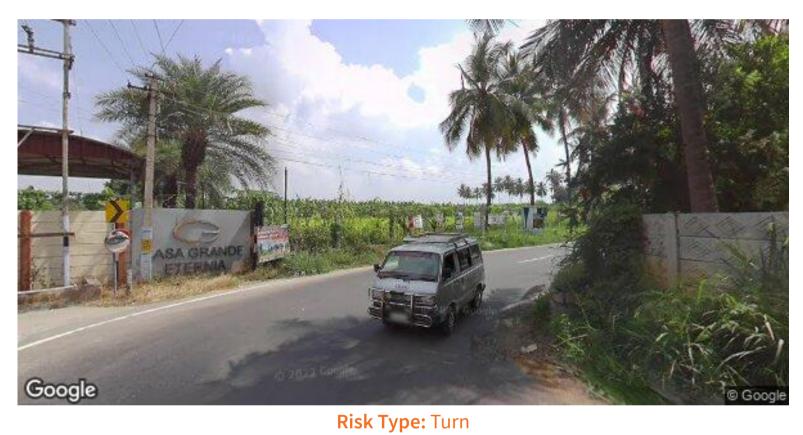
Risk Level: Medium
Speed Limit: 30 KM/Hr
Coordinates: 11.09846, 77.03245

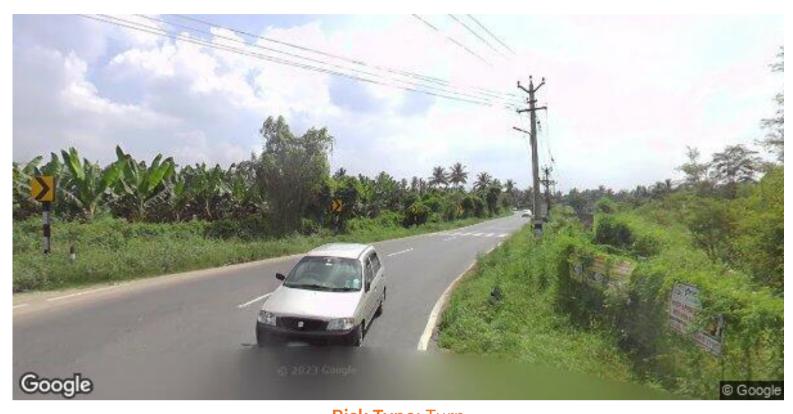
Risk Type: Turn
Risk Level: Medium
Speed Limit: 30 KM/Hr
Coordinates: 11.10295, 77.03049

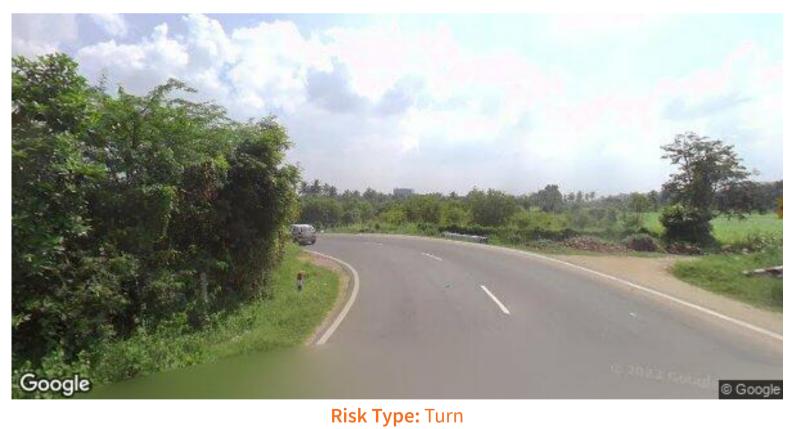
Risk Type. Turn
Risk Level: Medium
Speed Limit: 30 KM/Hr
Coordinates: 11.10331, 77.02984
