JOURNEY RISK MANAGEMENT (JRM) STUDY

Salem Terminal to A K N AGENCIES

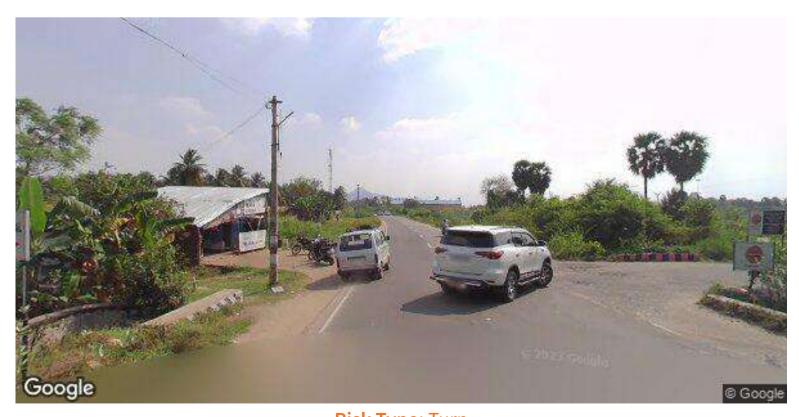
Risk Type: Turn
Risk Level: High
Speed Limit: 15 KM/Hr
Coordinates: 11.44029, 77.87544

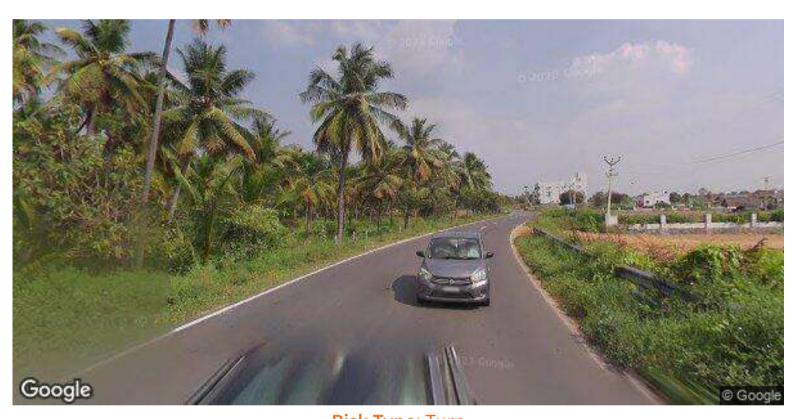
Risk Type: Turn
Risk Level: Medium
Speed Limit: 30 KM/Hr
Coordinates: 11.45357, 77.85789

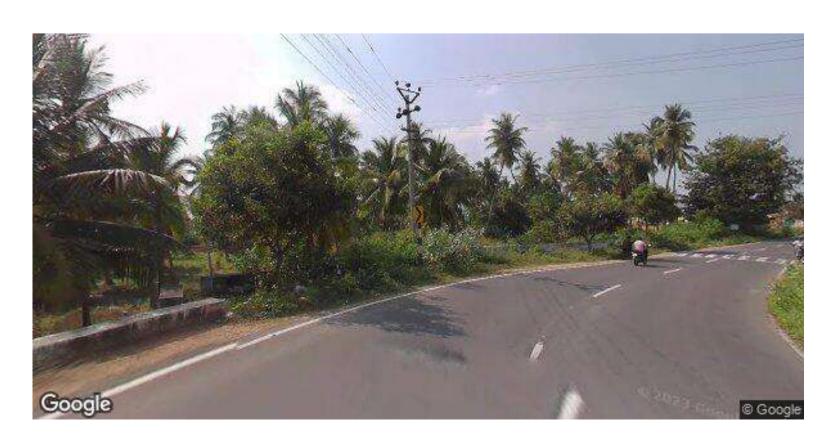
Coordinates: 11.45348, 77.85706

Risk Type: Turn
Risk Level: Medium
Speed Limit: 30 KM/Hr

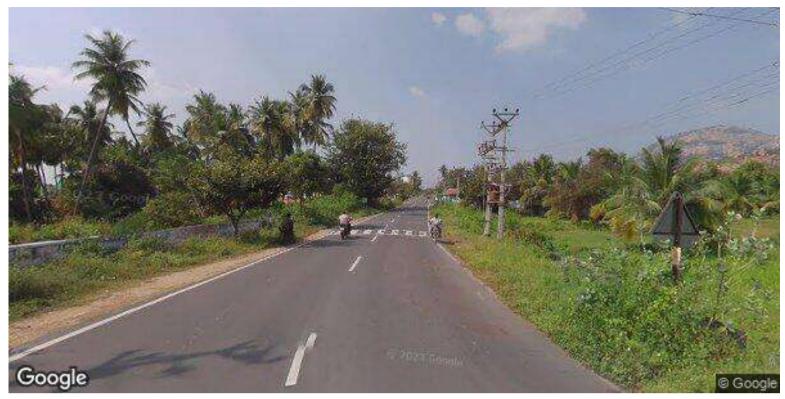
Coordinates: 11.45352, 77.85698

Risk Type: Turn
Risk Level: Medium
Speed Limit: 30 KM/Hr

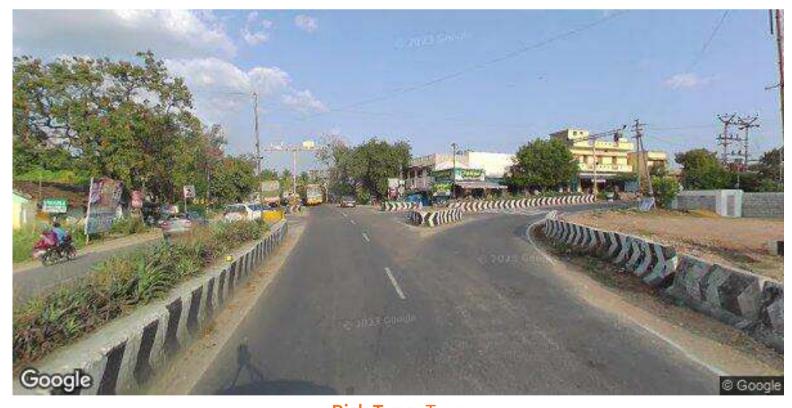
Coordinates: 11.46318, 77.84913

Risk Type: Turn
Risk Level: Medium
Speed Limit: 30 KM/Hr

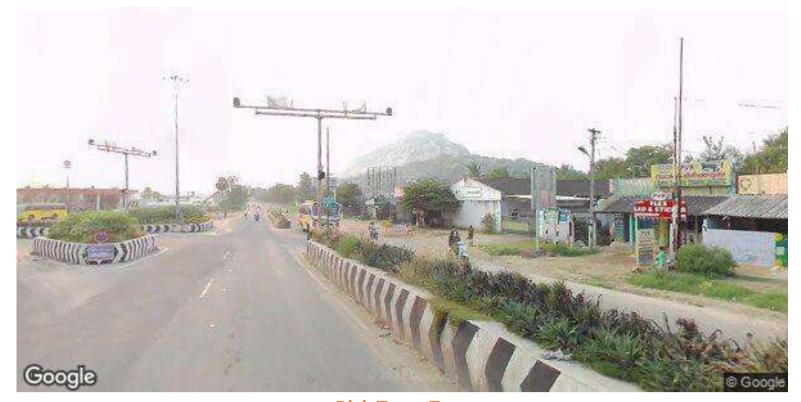
Risk Type: Turn
Risk Level: Medium
Speed Limit: 30 KM/Hr
Coordinates: 11.46312, 77.84886

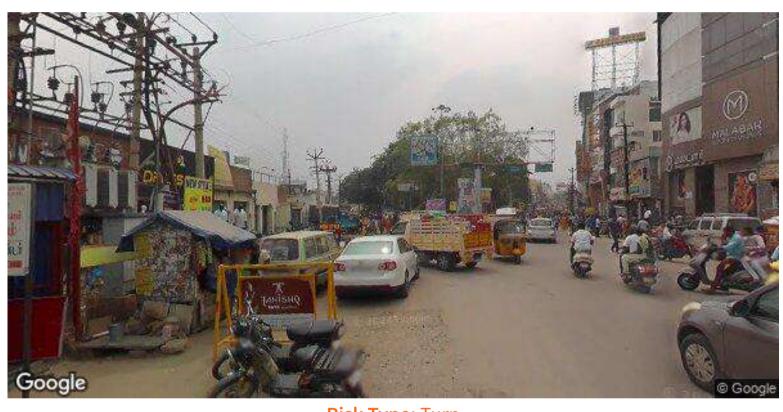
Risk Type: Turn
Risk Level: Medium
Speed Limit: 30 KM/Hr
Coordinates: 11.34493, 77.73032

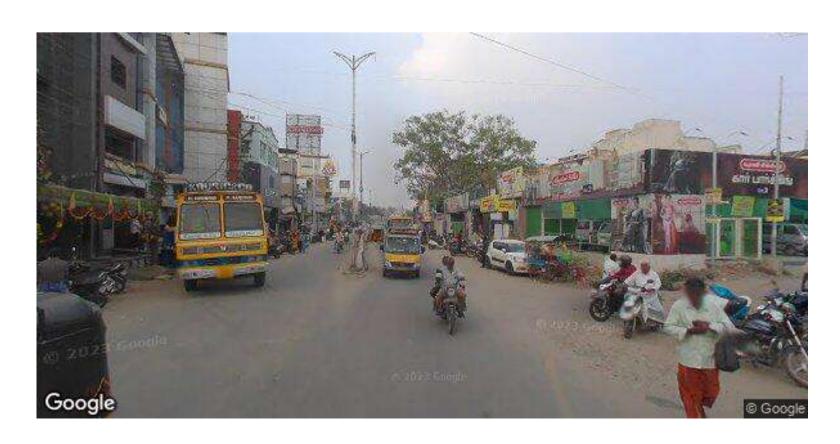
Coordinates: 11.34487, 77.73024

Risk Type: Turn
Risk Level: Medium
Speed Limit: 30 KM/Hr

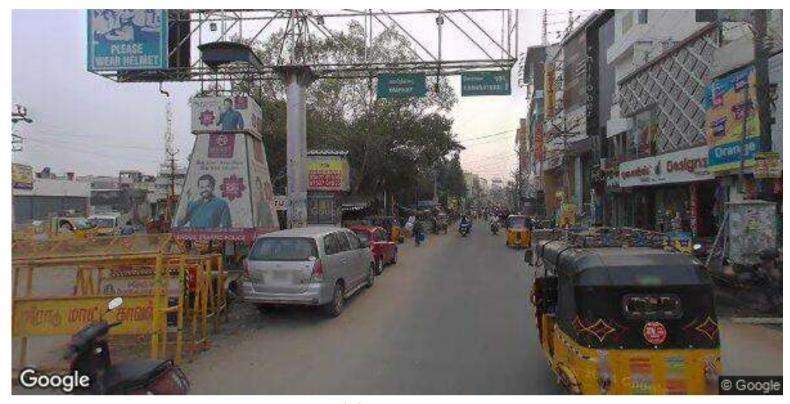
Coordinates: 11.34470, 77.73018

Risk Type: Turn
Risk Level: Medium
Speed Limit: 30 KM/Hr

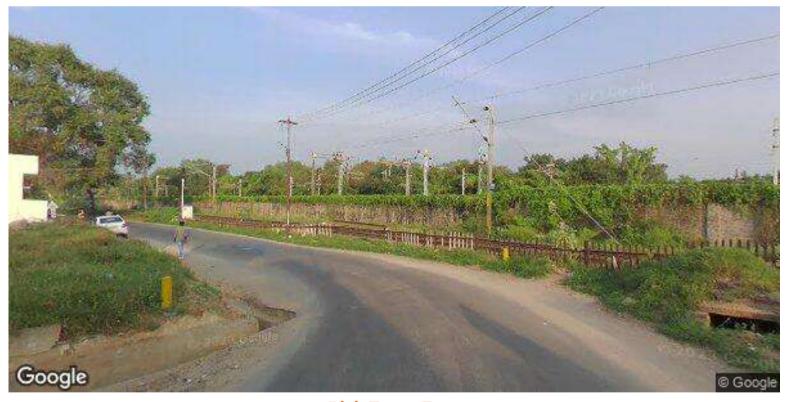
Coordinates: 11.33422, 77.73630

Risk Type: Turn
Risk Level: High
Speed Limit: 15 KM/Hr

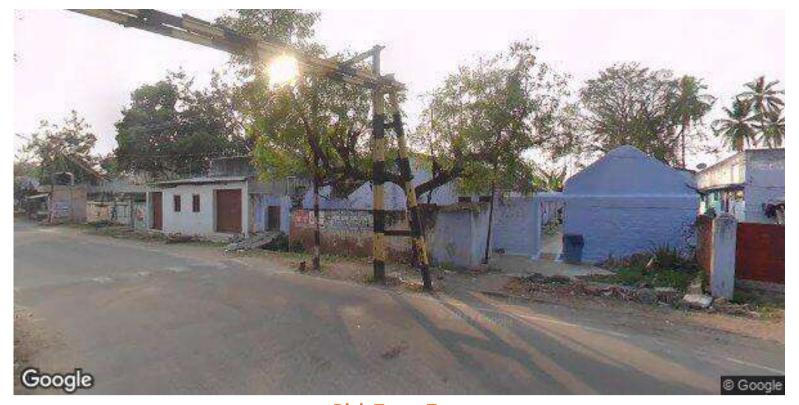
Risk Type: Turn
Risk Level: High
Speed Limit: 15 KM/Hr
Coordinates: 11.33607, 77.73724

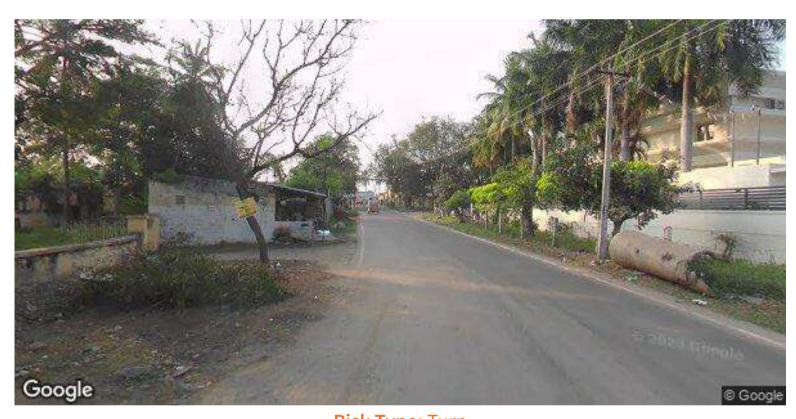
Risk Type: Turn
Risk Level: Medium
Speed Limit: 30 KM/Hr
Coordinates: 11.33575, 77.73807

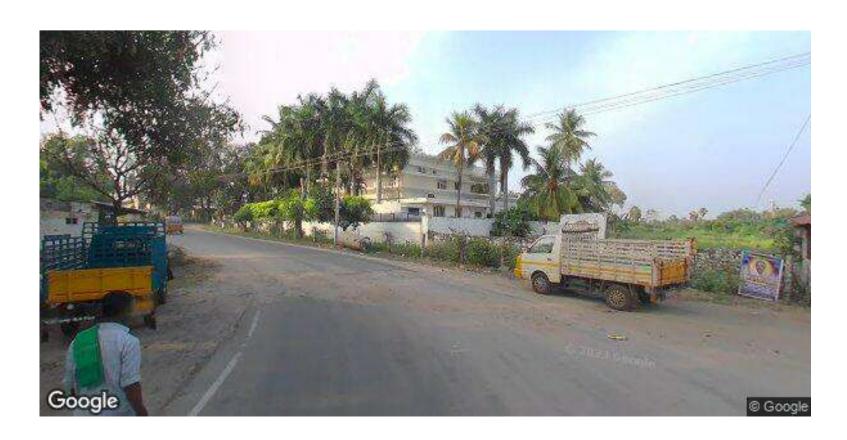
Coordinates: 11.33566, 77.73815

Risk Type: Turn
Risk Level: Medium
Speed Limit: 30 KM/Hr

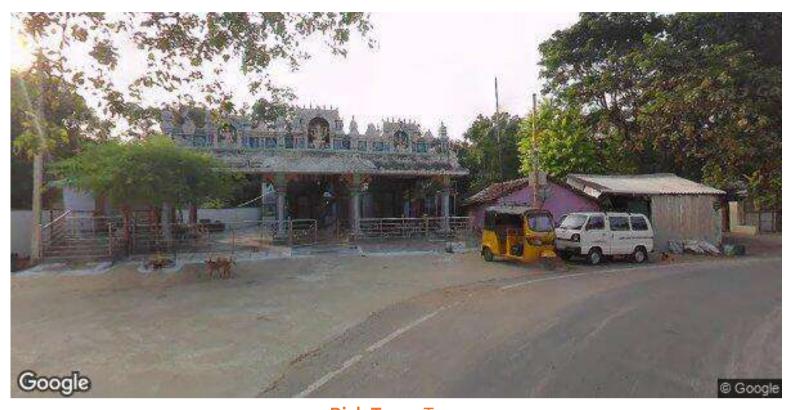
Coordinates: 11.33332, 77.73836

Risk Type: Turn
Risk Level: Medium
Speed Limit: 30 KM/Hr

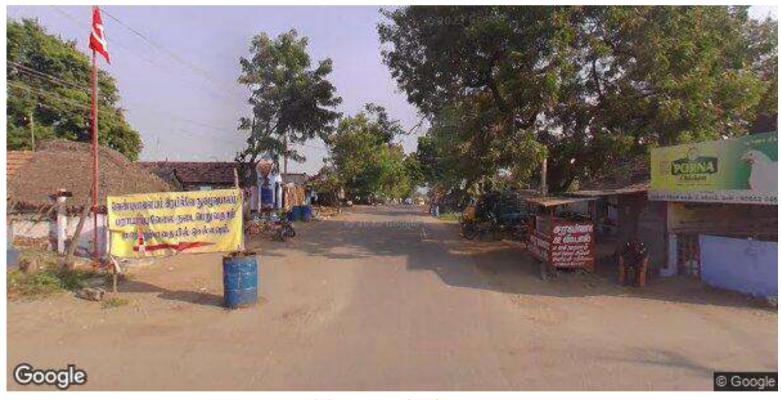
Coordinates: 11.33050, 77.74216

Risk Type: Blind Spot Risk Level: Blind Spot Speed Limit: 10 KM/Hr

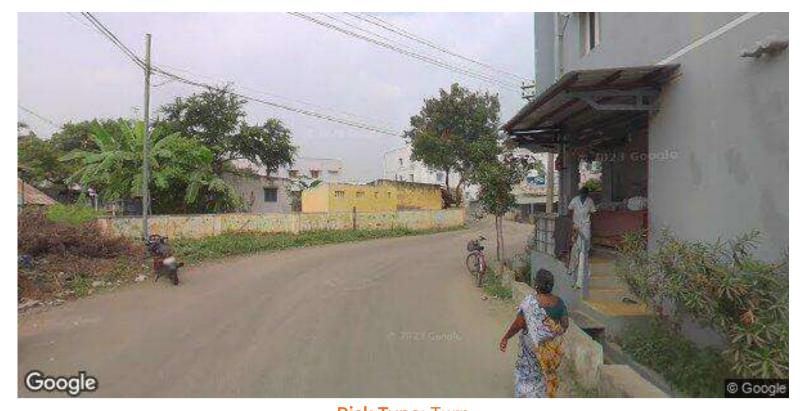
Risk Type: Turn
Risk Level: Medium
Speed Limit: 30 KM/Hr
Coordinates: 11.32586, 77.74133

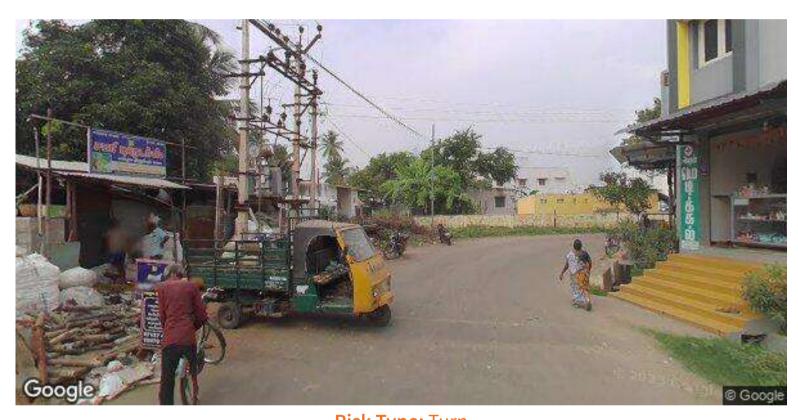
Risk Type: Turn
Risk Level: Medium
Speed Limit: 30 KM/Hr
Coordinates: 11.32577, 77.74130

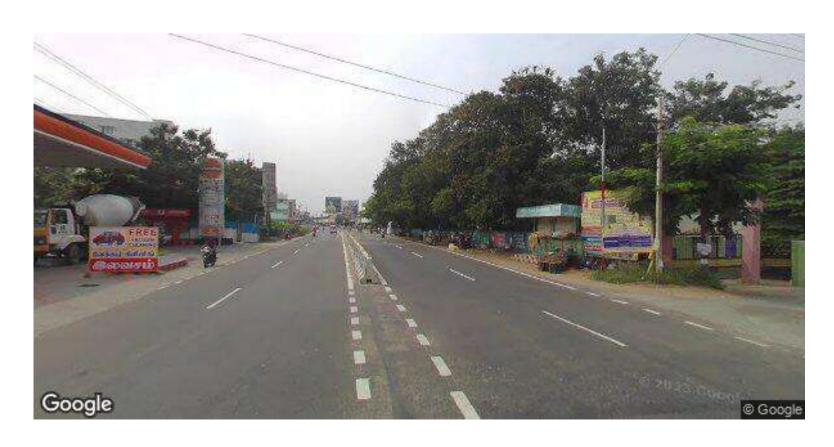
Coordinates: 11.32363, 77.74196

Risk Type: Blind Spot Risk Level: Blind Spot Speed Limit: 10 KM/Hr
