JOURNEY RISK MANAGEMENT (JRM) STUDY

Salem Terminal TO S K AGENCY

Route Safety Analysis Report

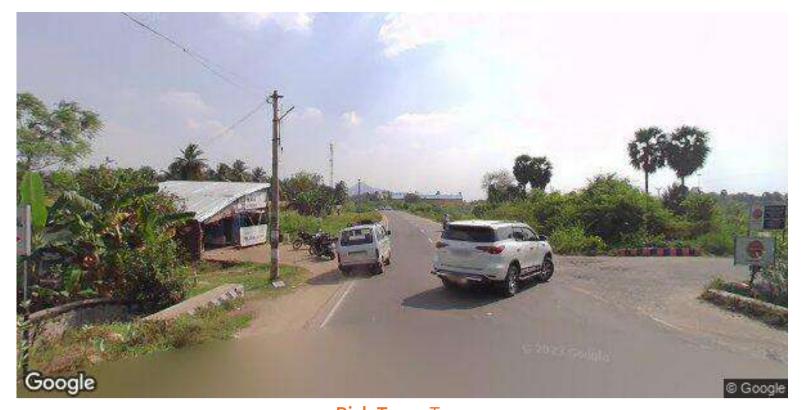
Risk Type: Turn
Risk Level: High
Speed Limit: 15 KM/Hr
Coordinates: 11.44029, 77.87544

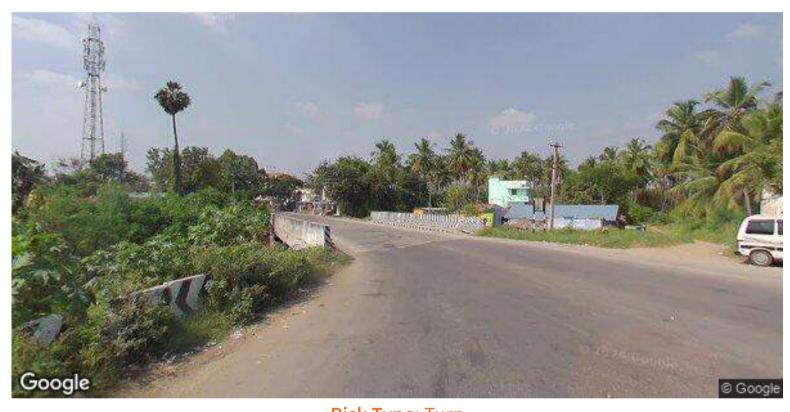
Risk Type: Turn
Risk Level: Medium
Speed Limit: 30 KM/Hr
Coordinates: 11.44893, 77.87413

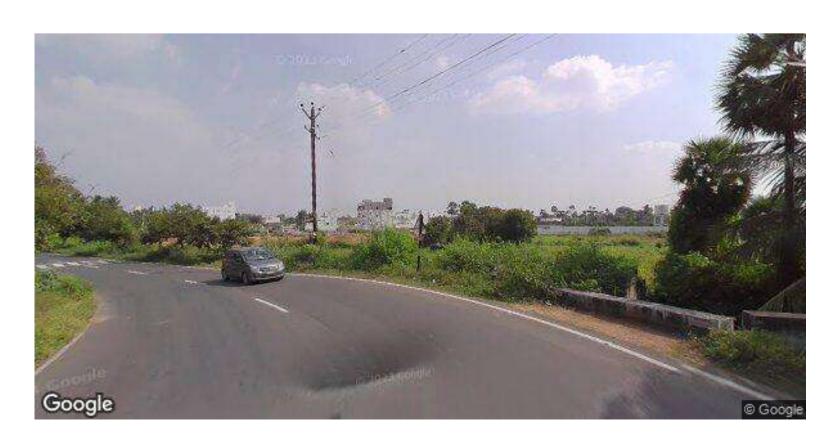
Risk Type: Turn
Risk Level: High
Speed Limit: 15 KM/Hr

Coordinates: 11.45350, 77.85700

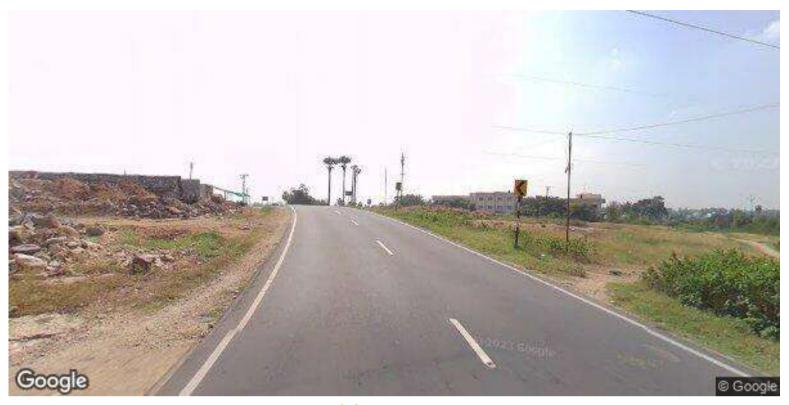
Risk Type: Turn
Risk Level: Medium
Speed Limit: 30 KM/Hr
Coordinates: 11.46046, 77.85037

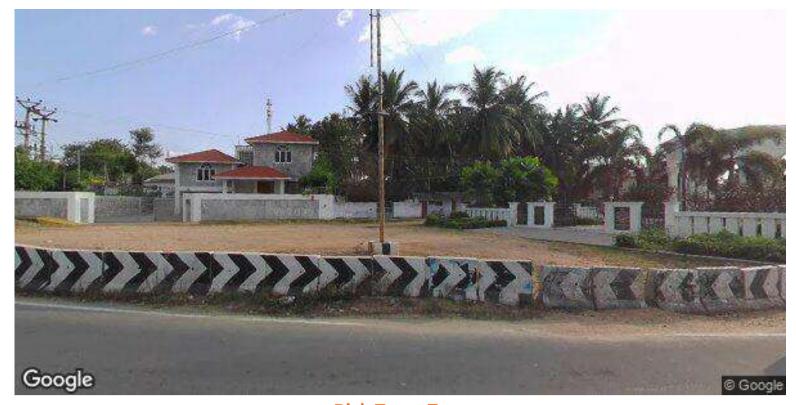
Risk Type: Turn
Risk Level: Medium
Speed Limit: 30 KM/Hr
Coordinates: 11.46316, 77.84921

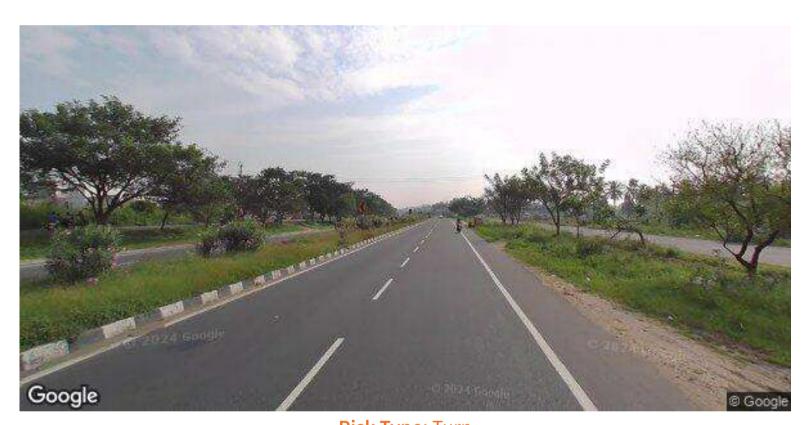
Risk Type: Turn
Risk Level: Medium
Speed Limit: 30 KM/Hr
Coordinates: 11.44467, 77.72092

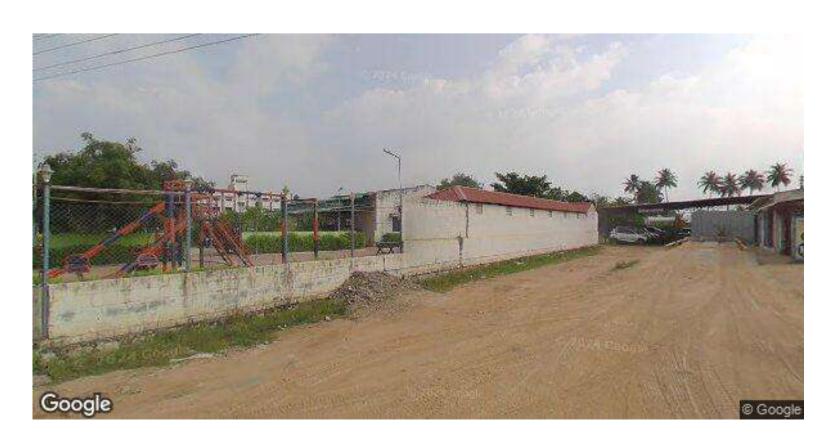
Risk Type: Turn
Risk Level: High
Speed Limit: 15 KM/Hr

Coordinates: 11.44377, 77.71562

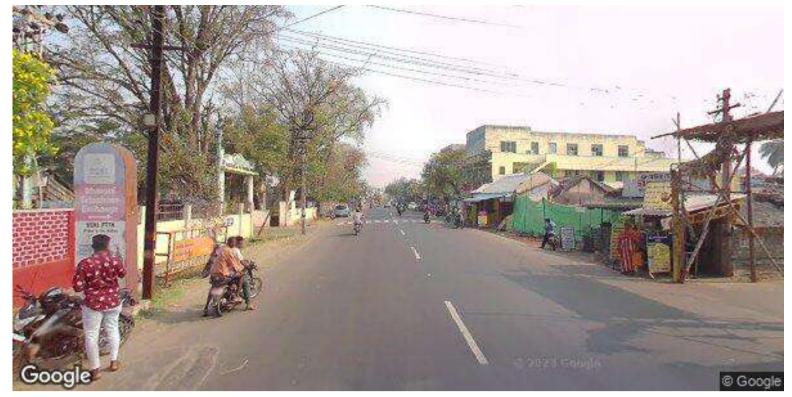
Risk Type: Blind Spot
Risk Level: Blind Spot
Speed Limit: 10 KM/Hr
Coordinates: 11.44842, 77.68473

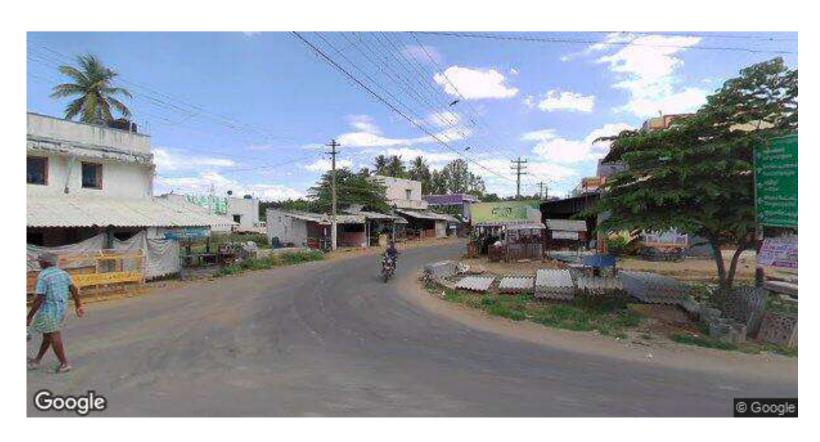
Risk Type: Turn
Risk Level: Medium
Speed Limit: 30 KM/Hr

Coordinates: 11.61011, 77.71752

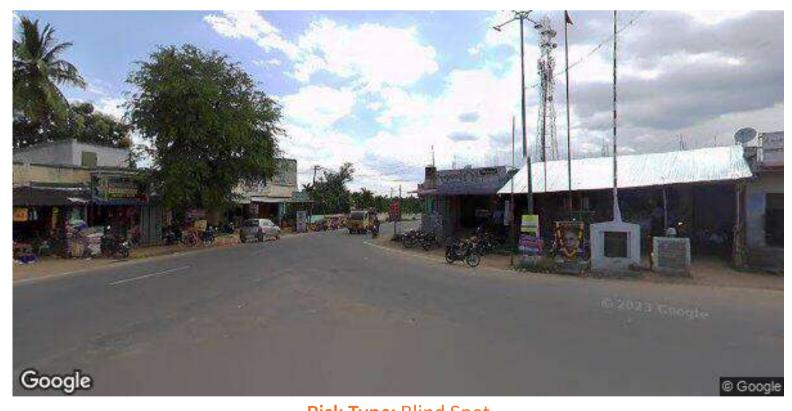
Risk Type: Blind Spot Risk Level: Blind Spot Speed Limit: 10 KM/Hr

Coordinates: 11.60971, 77.71572
